Florence County Aquatic Invasive Species Prevention and Management Program

Aquatic Invasive Species Education, Prevention and Planning Project

2015-2016 Final Report

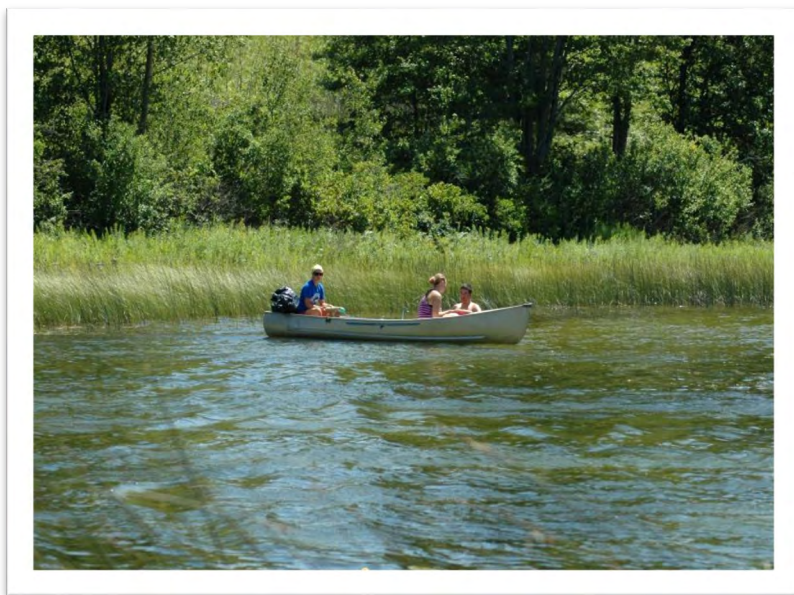
On July 28, 2015 four county AIS staff members conducted an exercise to hand-pull the invasive water-milfoil in the lake. This was largely unsuccessful due to numerous factors including the depth, bottom muck, loss of visibility, and number of the plants present. Removal of the invasive water-milfoil in Barrens Lake will require different methods, possibly a Diver Assisted Suction Harvesting (DASH) system, to make any headway. However, due to the difficulty in launching watercraft on this lake makes a standard pontoon boat-based

AIS staff conduct hand-pulling of Eurasian Water Milfoil on Barrrens Lake, 2015

With this problem in mind, in 2015 the Florence County Land Conservation Department assessed options for the development of a DASH vessel and system based on the concept of being easily broken down, transported, and reassembled. While such a versatile DASH vessel was, and still is, beyond the current resources of Florence County LCD, the information was passed to the Wild Rivers Invasive Species Coalition (WRISC).

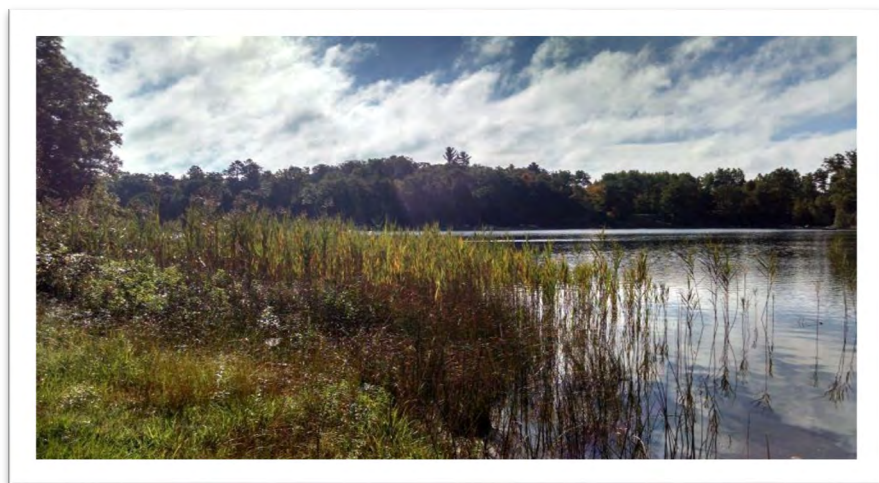
Phragmites at Cosgrove Lake Site 4

During this work two additional small stands of non-native Phragmites were located, bringing the total number of Phragmites locations on the lake to nine. The plants at these two sites had bolted between the August assessment and the September eradication work. As neither FCLCD nor WRISC had secured land-owner permission to treat these new locations they were left untreated. It is anticipated that after securing land-owner clearance these two sites will be treated in the 2017 season when additional treatment of the known sites is conducted.

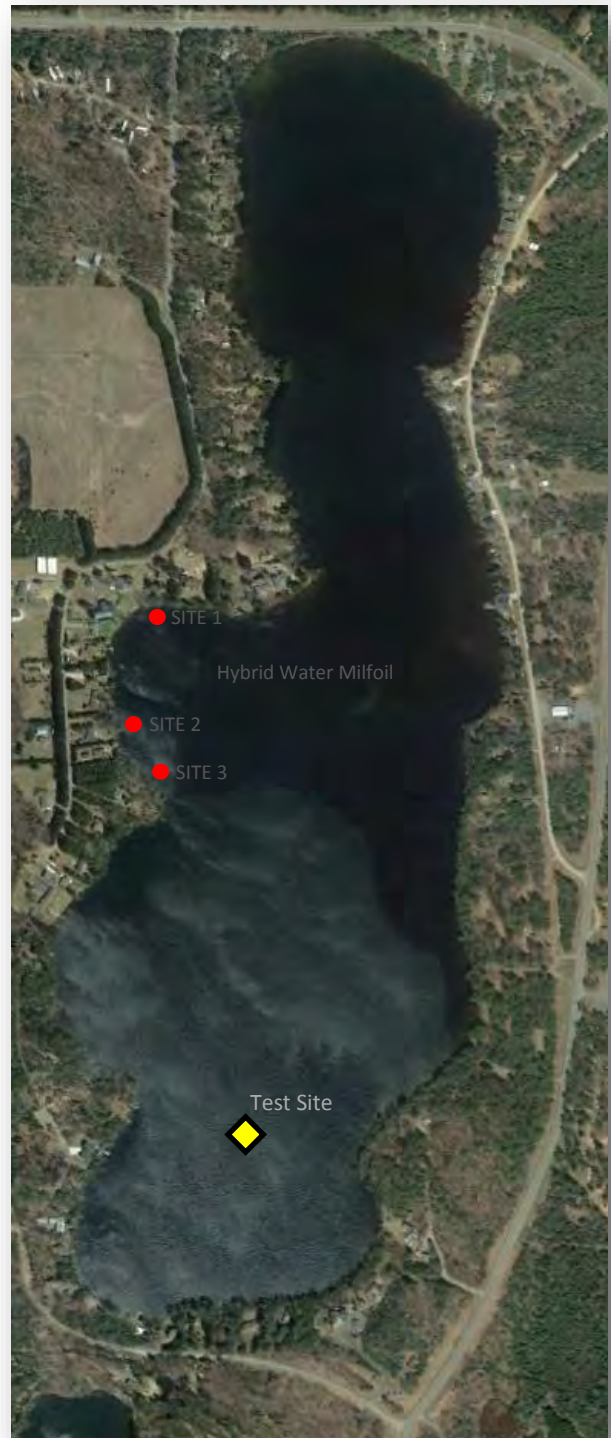
After the confirmation of hybrid water-milfoil on Keyes Lake a hand-pulling effort was launched. In 2015 Florence County AIS Staff, WRISC staff, and volunteers from the Florence County Lakes and Rivers Association (FCLARA) spent four hours hand pulling EWF in the three locations.

Image: Google Earth, Eurasian Water-milfoil locations from M. Nault WDNR

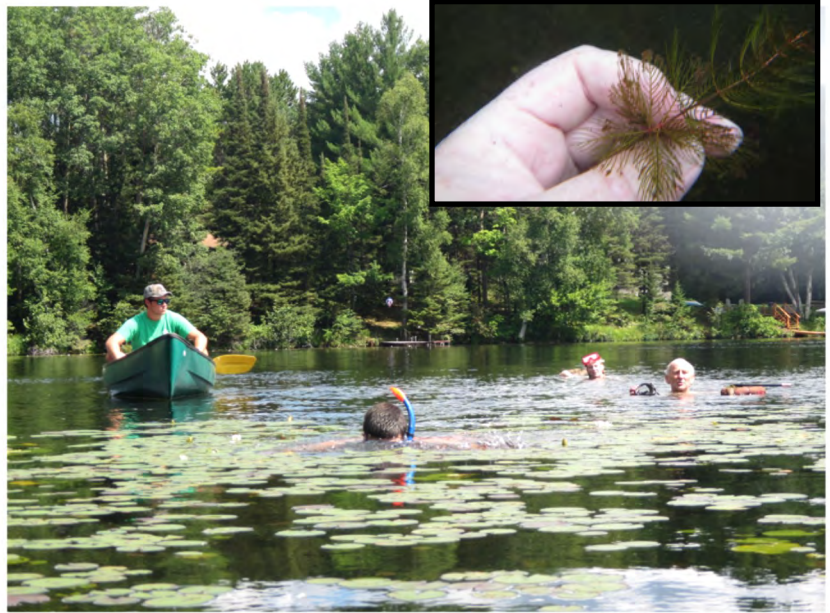
The depth of the hybrid/Eurasian water-milfoil infestations in Keyes Lake run from two feet to ten feet. This makes snorkeling borderline effective in the deeper areas. An additional 10 kilograms (dry weight) was removed in 2016, but late-season assessment by Cary Anderson (FCLARA) found pockets of the EWM still present at the three sites (Anderson, C. personal communication). These plants were either missed during the hand-pulling, or have grown back after as the workers were not able to remove all of the roots.

2015 hand pulling of Hybrid/Eurasian Water Milfoil

Inset: Underwater photograph of Hybrid Eurasian Water Milfoil in Keyes Lake

While the hand-pulling may have been effective at keeping this invasive from spreading throughout the lake up to this time, it is clear this method is limited in ability to eradicate the EWM. The Florence County Land Conservation Department will work with WDNR, WRISC, FCLARA, and the Keyes Lake Association to determine a plan. This could include the use of SCUBA equipment, a Diver Assisted Suction Harvesting (DASH) system, or benthic mats to control the EWM.

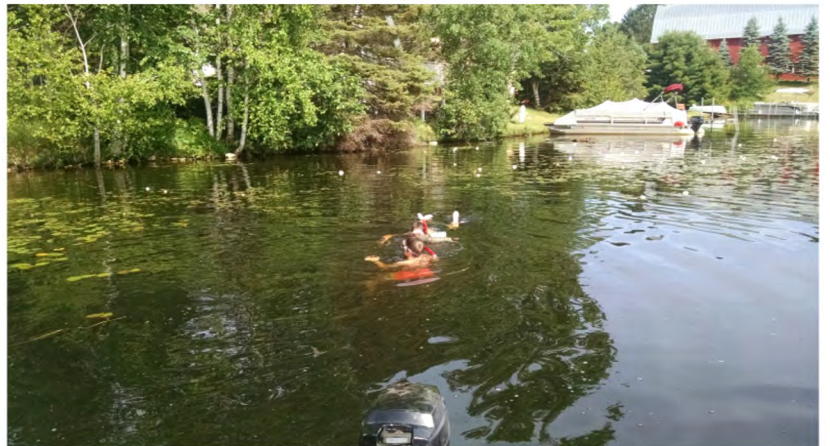
2016 The hand-pulling continues

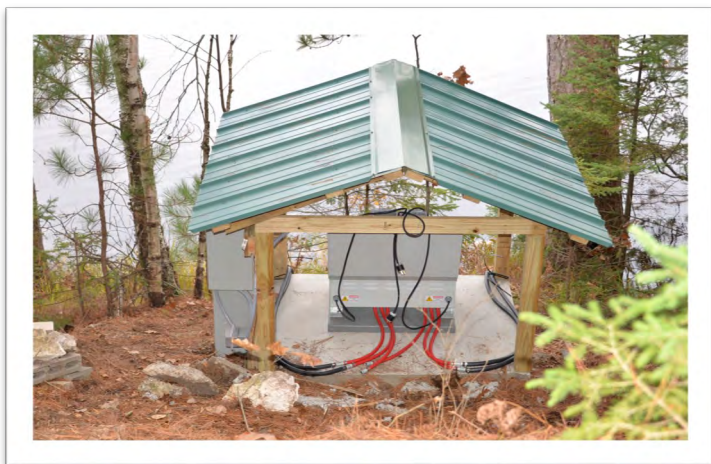
In the 2015 season the Florence County Land Conservation Department began working with the Lake Association of Long Lake and DNR Fisheries Biologist Greg Matzke to replace the inefficient aeration system on the lake. Due to the large area of shallow water and abundant summer plant growth, Long Lake has a history of winter fish kills. Wisconsin DNR Fisheries Biologist Greg Matzke recommended an aeration system be run from January 1 to ice out every year. Florence County LCD and AIS staff aided the Lake Association in their efforts to secure funding for a new aeration system through a Lumberjack R.C. & D. grant. By late summer 2016 a new aerator system had been purchased and installed. CT Goodwin inspected the site on January 5, 2017 after multiple sub-zero nights and found the aerator keeping an area ice free.

New Long Lake aerator during installation

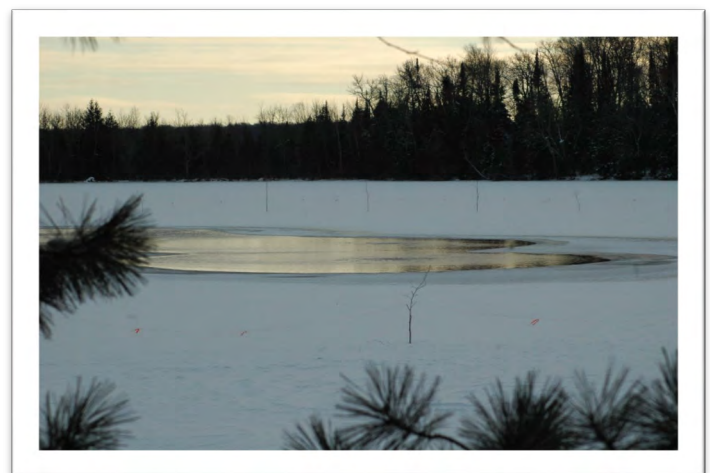
Long Lake open ice, January 2017

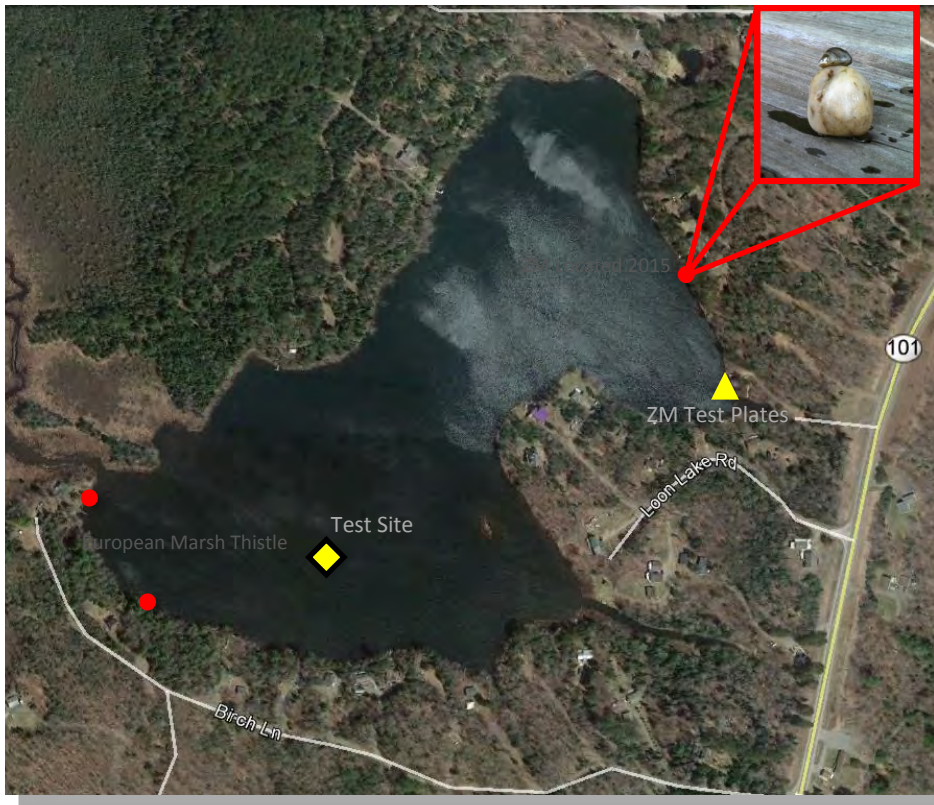
Within 24 hours CT Goodwin inspected the property and found multiple zebra mussels on uprooted aquatic vegetation gathered along the shoreline. An additional specimen was found on a rock under the dock at the property. Samples were collected, photographed, and turned over to DNR personnel. No zebra mussels were found to be on the dock itself at that time. However, 2015 end-of-season reports from additional Loon Lake property owners came into the Land Conservation Office about finding zebra mussels on docks and boats being removed for winter storage. 2015 was the first time owners have complained about the infestation.

Inset: Zebra mussel on rock found during initial investigation

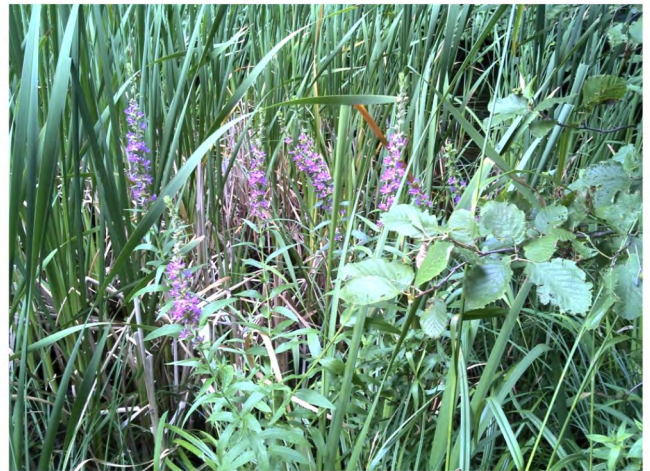
The 2016 monitoring was conducted on August 5, by AIS staff Weber-Starling and Crago. Purple loosestrife (*Lythrum salicaria*) was documented on the southeast shore. Subsequent work by WRISC removed the plants for use in rearing biological control beetles.

Purple Loosestrife on Montgomery Lake

Montgomery Lake will be inspected for new growth of purple loosestrife in the 2017 season. If new stems are found a management plan will be developed in consultation with the DNR and WRISC.

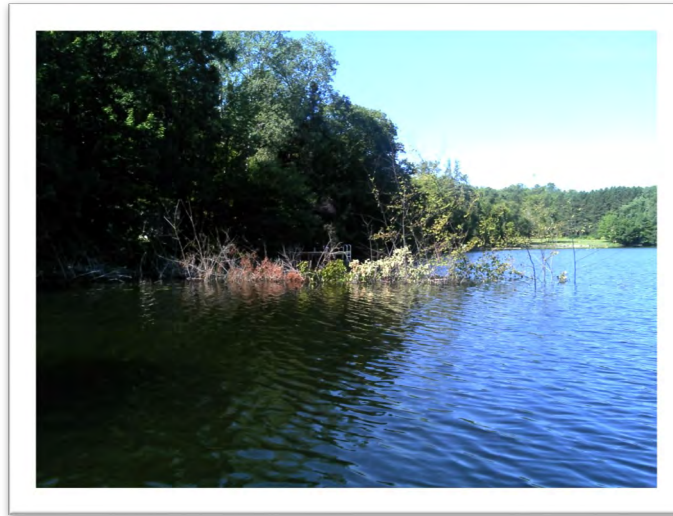
Treefall in Porcupine Lake, 2016

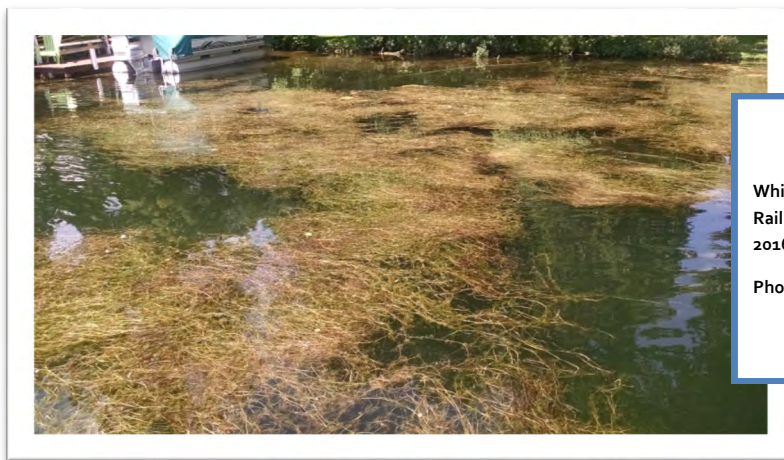
In 2016 the Florence County Land Conservation Department and the officers of the Spread Eagle Chain of Lakes Association had both received complaint calls from Railroad Lake residents about an aquatic plant bloom. This was mistakenly referred to a “milfoil”. AIS staff, SECOLA members, and White Water Associates personnel, Angie Stein, assessed the growth and found it to be native White water crowfoot (*Ranunculus aquatilis*).

White water crowfoot bloom in Railroad Lake, Spread Eagle Chain, 2016.

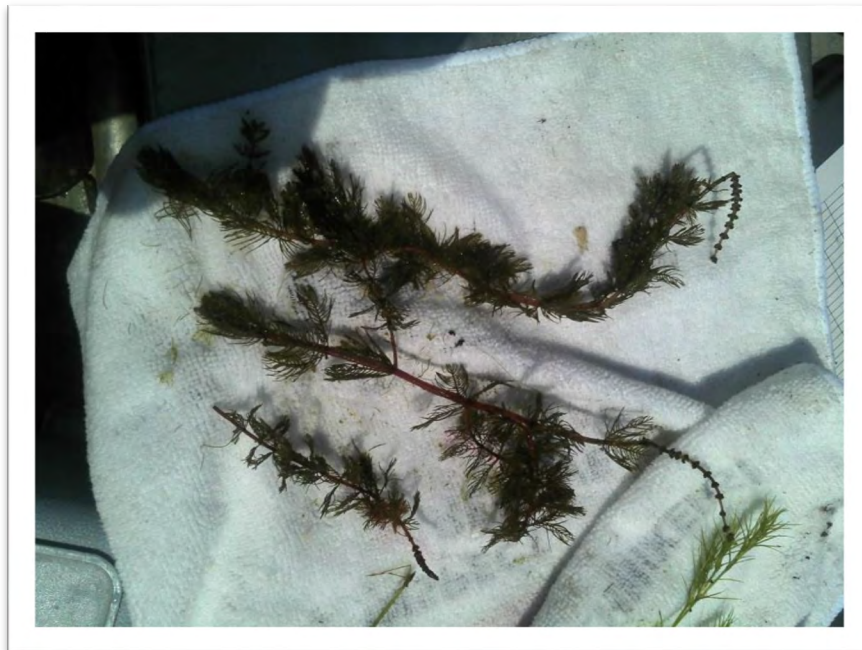
Eurasian/northern water-milfoil hybrid, Barrens Lake, 2015.

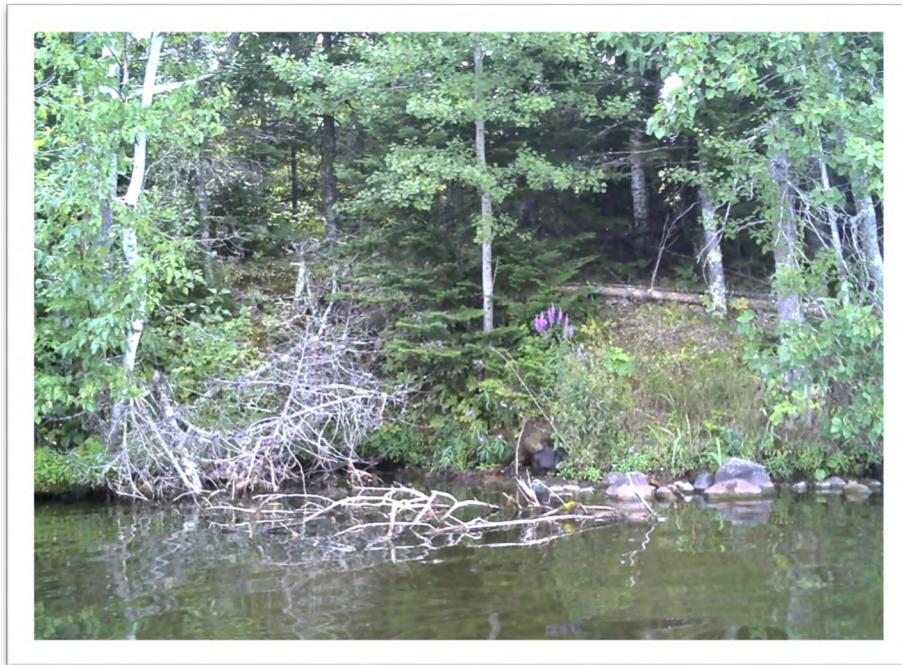
Purple Loosestrife on the north shore of Long Lake, 2016.
