# Rocky Run and Muskellunge Creek East Fork Chippewa River TWA WQM Plan 2017

**ROCKY RUN CREEK AND MUSKELLUNGE  
CREEK EAST FORK CHIPPEWA RIVER  
TWA WQM PLAN 2017**

*East Fork Chippewa River (UC21)*  
HUC: 070500010208 and 07050010207, Monitored  
2015

EGAD # 3200-2017-17  
Water Quality Bureau,  
Wisconsin DNR

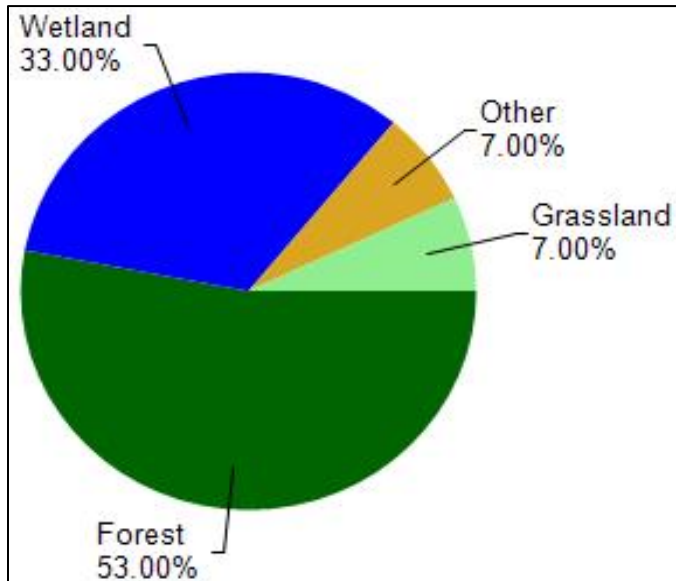
# Land Use

The East Fork Chippewa River watershed (UC21) has 310.53 stream miles, 2,431.41 lake acres and 65,073.81 wetland acres. The landscape in the area is primarily forest (53%), wetland (33%) and a mix of grassland (7%) and other uses. The watershed has a small agricultural presence that is dominated by grass fields and few row crop fields.

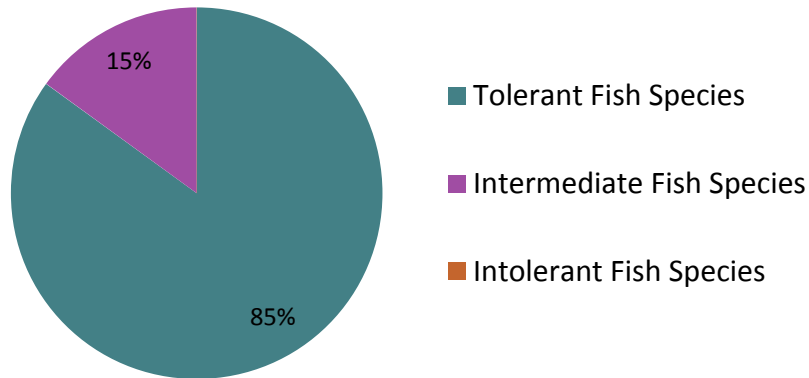
## Fish Assemblage in Tributaries

The most common fish species collected from the headwater tributaries were creek chub, brook stickleback, white sucker, central mudminnow and fine scale dace.

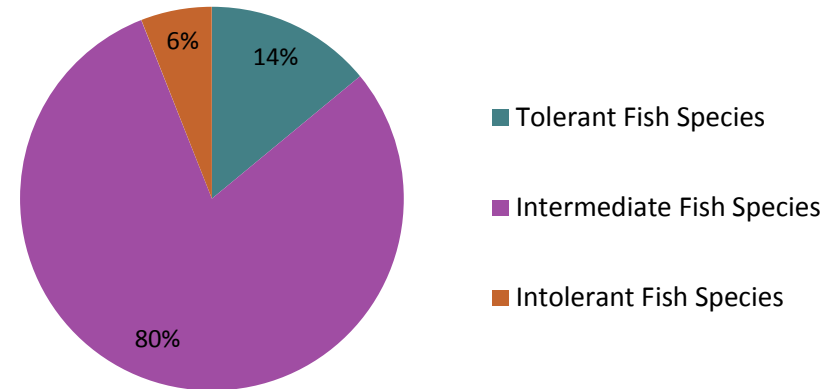
## Fish Assemblage in E.F. Chipewa River

The most common fish species collected from the two mainstem sites were burbot, blackside darter, common shiner, central mudminnow, fantail darter and longnose dace.

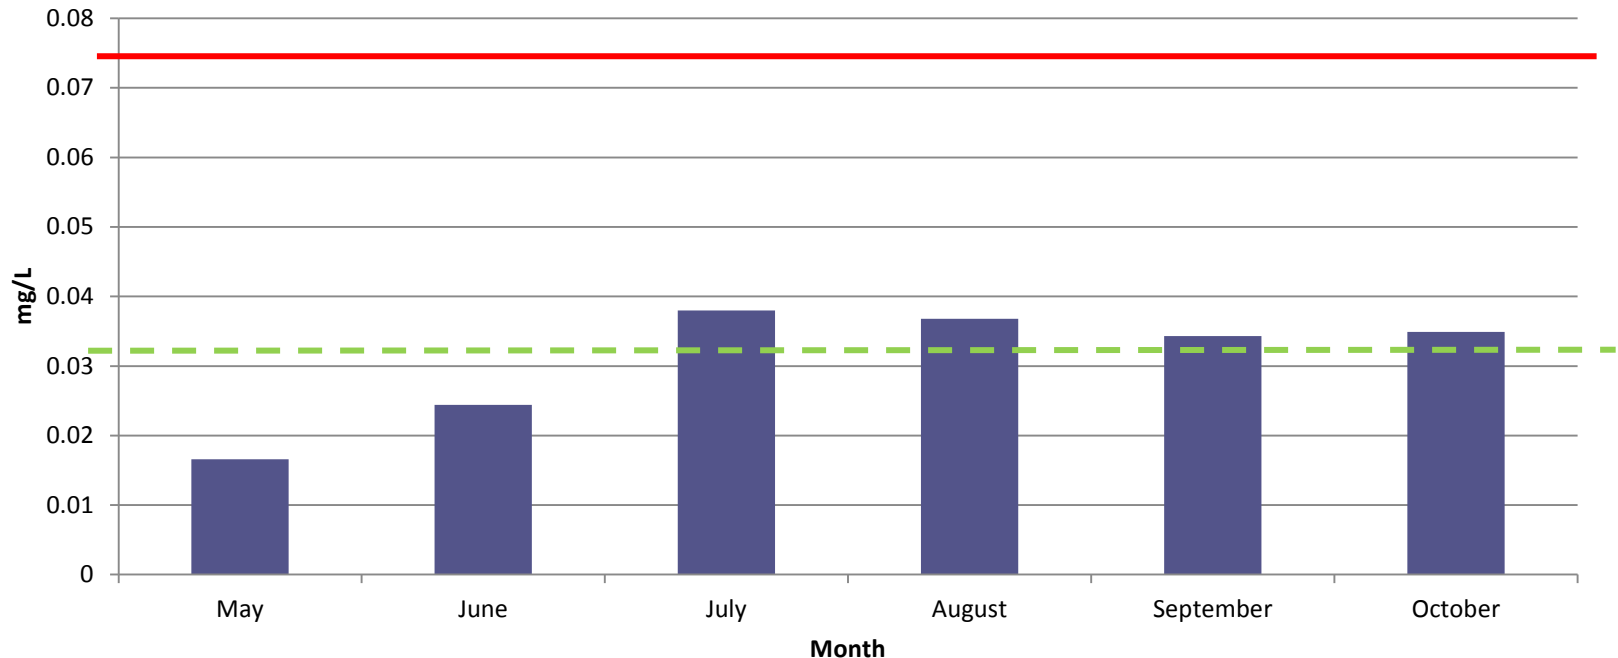
## Phosphorus Concentration on Muskellunge Creek

Water quality standard 0.075mg/L

Average 0.0308 mg/L

These results show total phosphorus levels are below the water quality standard and the waters are not impaired for total phosphorus. .

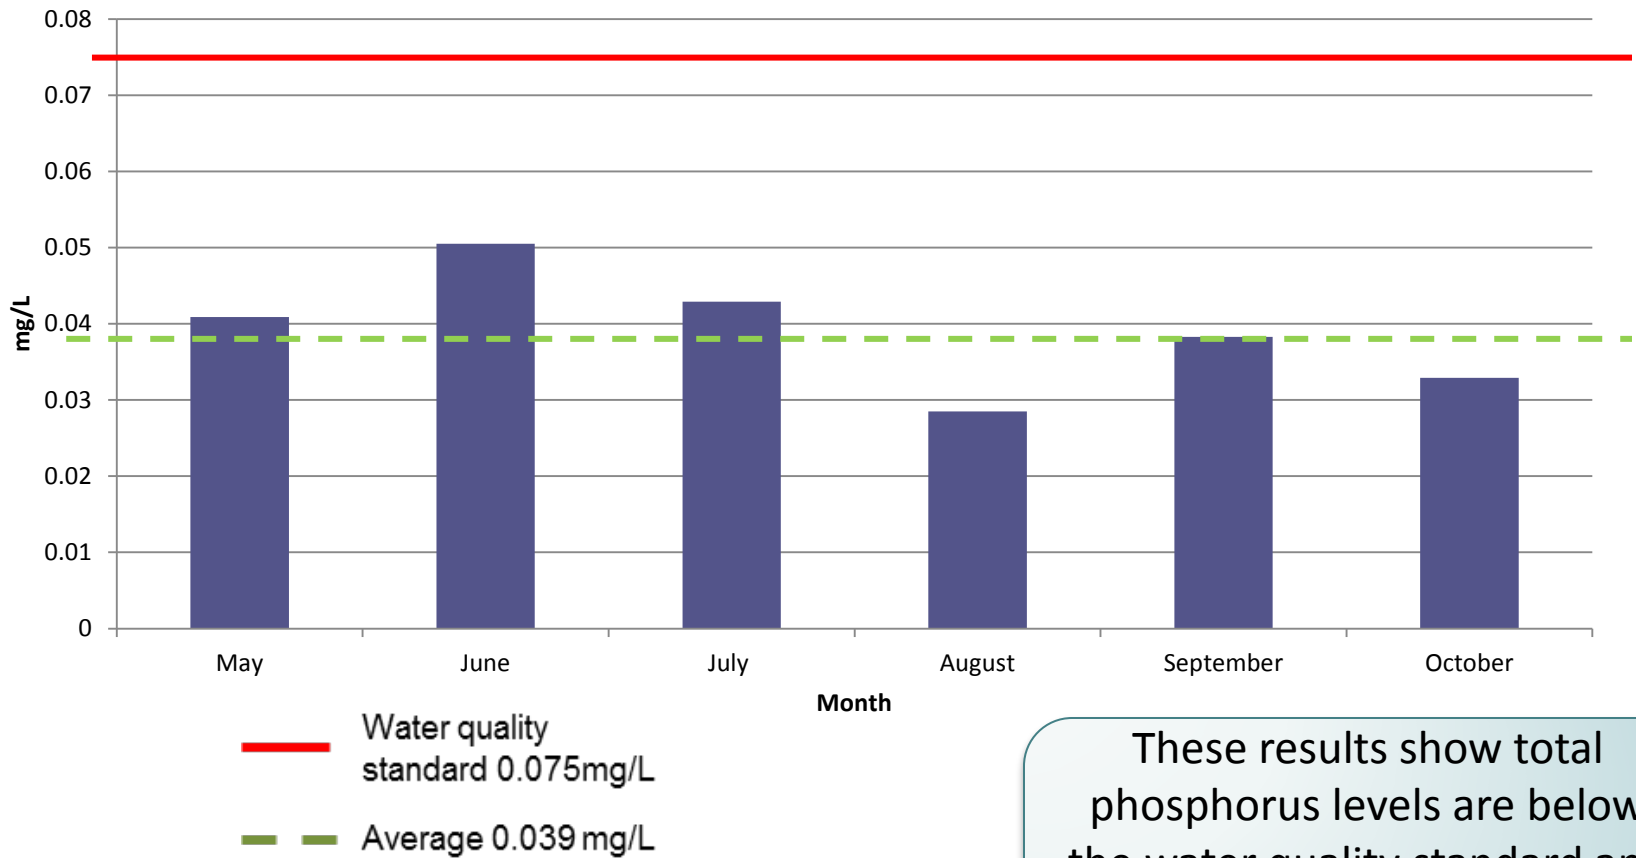
## Phosphorus Concentration at East Fork Chippewa River

These results show total phosphorus levels are below the water quality standard and the waters are not impaired for total phosphorus. .
