Aquatic Plant Management Plan
Big Dummy and Little Dummy Lakes
Dummy Lakes Management District

**AQUATIC PLANT MANAGEMENT PLAN
BIG DUMMY AND LITTLE DUMMY LAKES**

Flambeau Engineering, LLC
PO Box 273
Park Falls, WI 54552

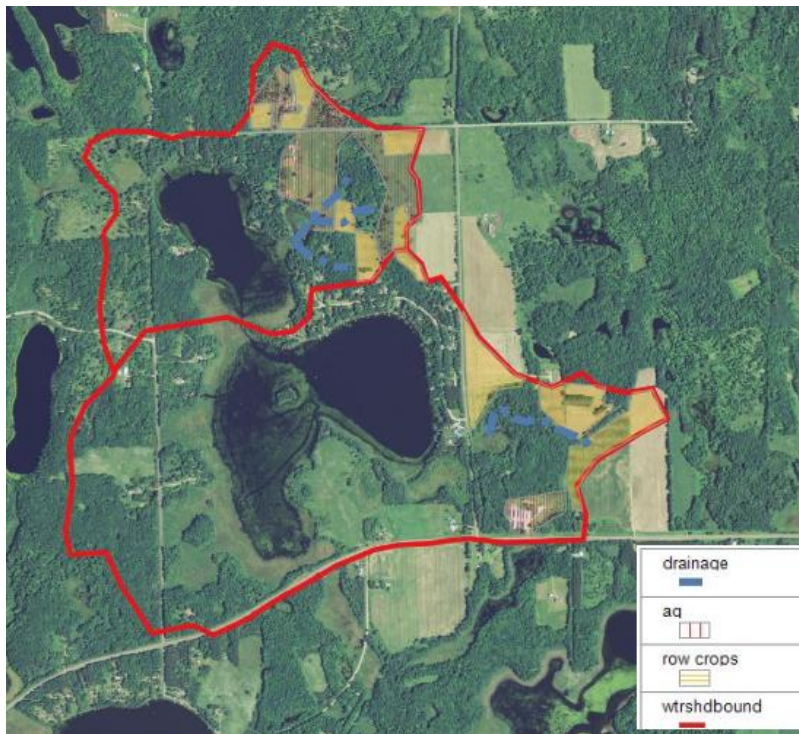
Figure 4 - Watershed Boundary and Agricultural Landuse

Land Use	Area - ac
Row Crop	12
Mixed Use Ag	25
MD Residential	26
Wetland	17
Forest	124
Little Dummy	33
Total	236

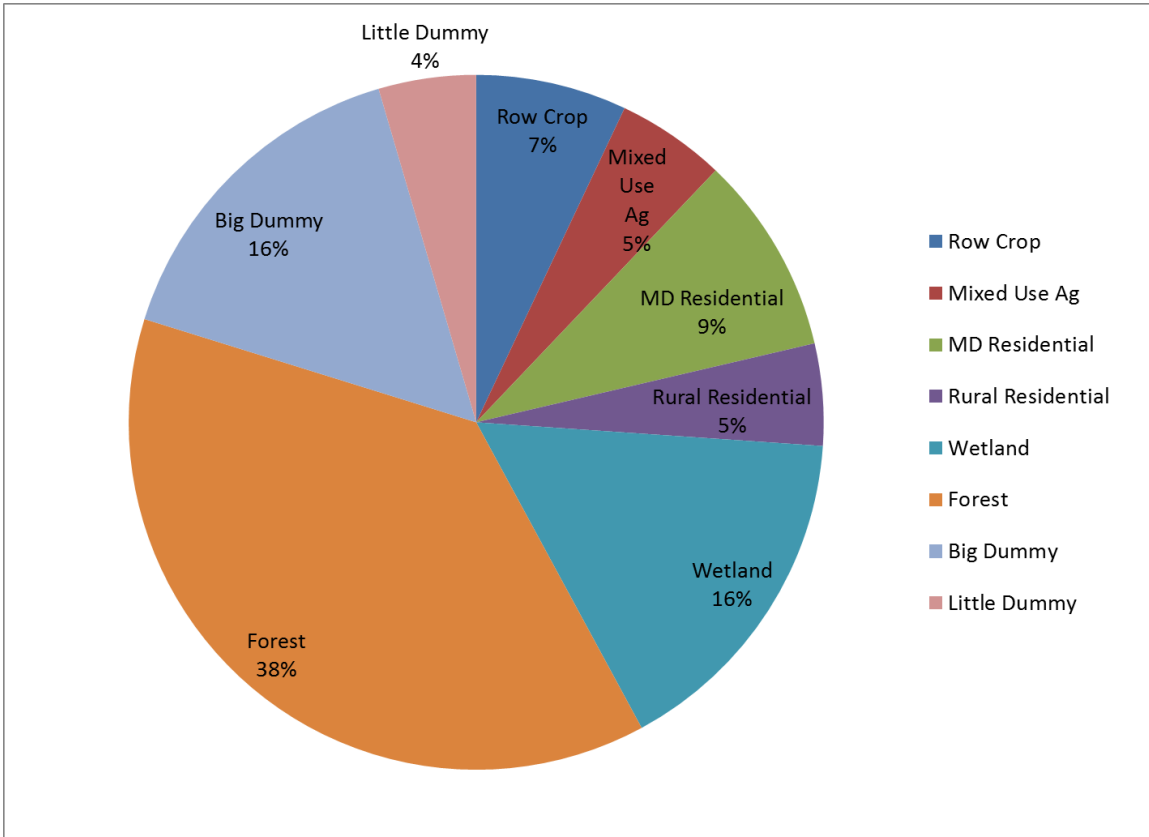
Figure 5 - Total Watershed Landuse Percent of Area

The following figure depicts the land use as a percent of the watershed area.

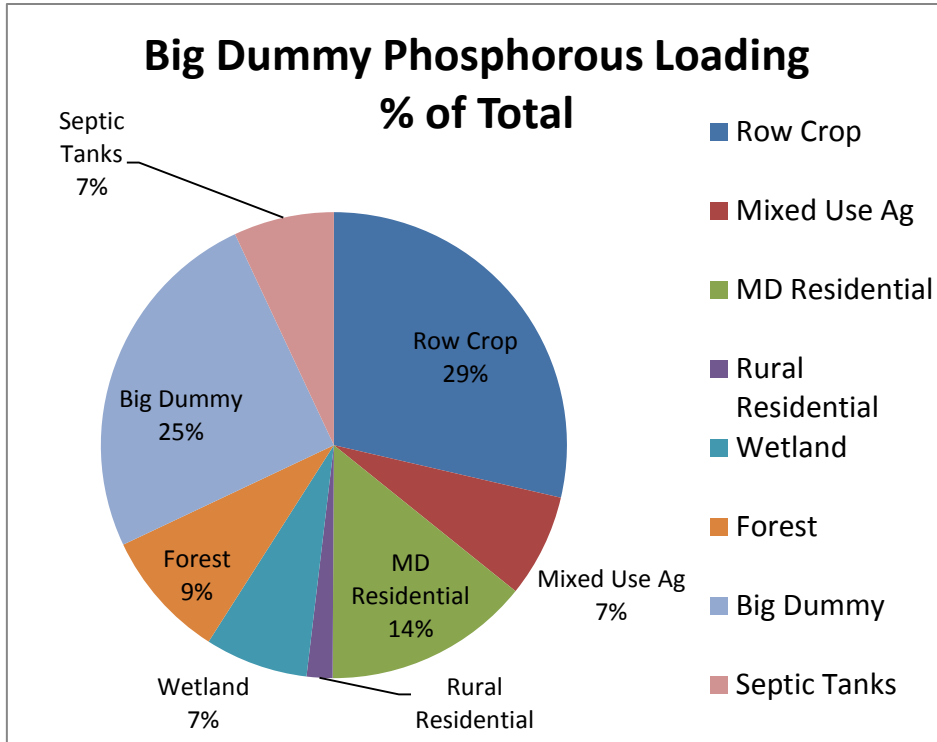
Figure 8 - Big Dummy Phosphorous Loading

<i>Big Dummy</i>		
Land Use	Area - ac	Likely Loading (kg/yr)
Row Crop	40	16.0
Mixed Use Ag	12	4.0
MD Residential	41	8.0
Rural Residential	34	1.0
Wetland	100	4.0
Forest	151	5.0
Big Dummy	114	14.0
Septic Tanks		3.9
Total		56

The largest contributor to phosphorus loading is from row crops in the watershed followed closely by atmospheric loading to the lakes surface.

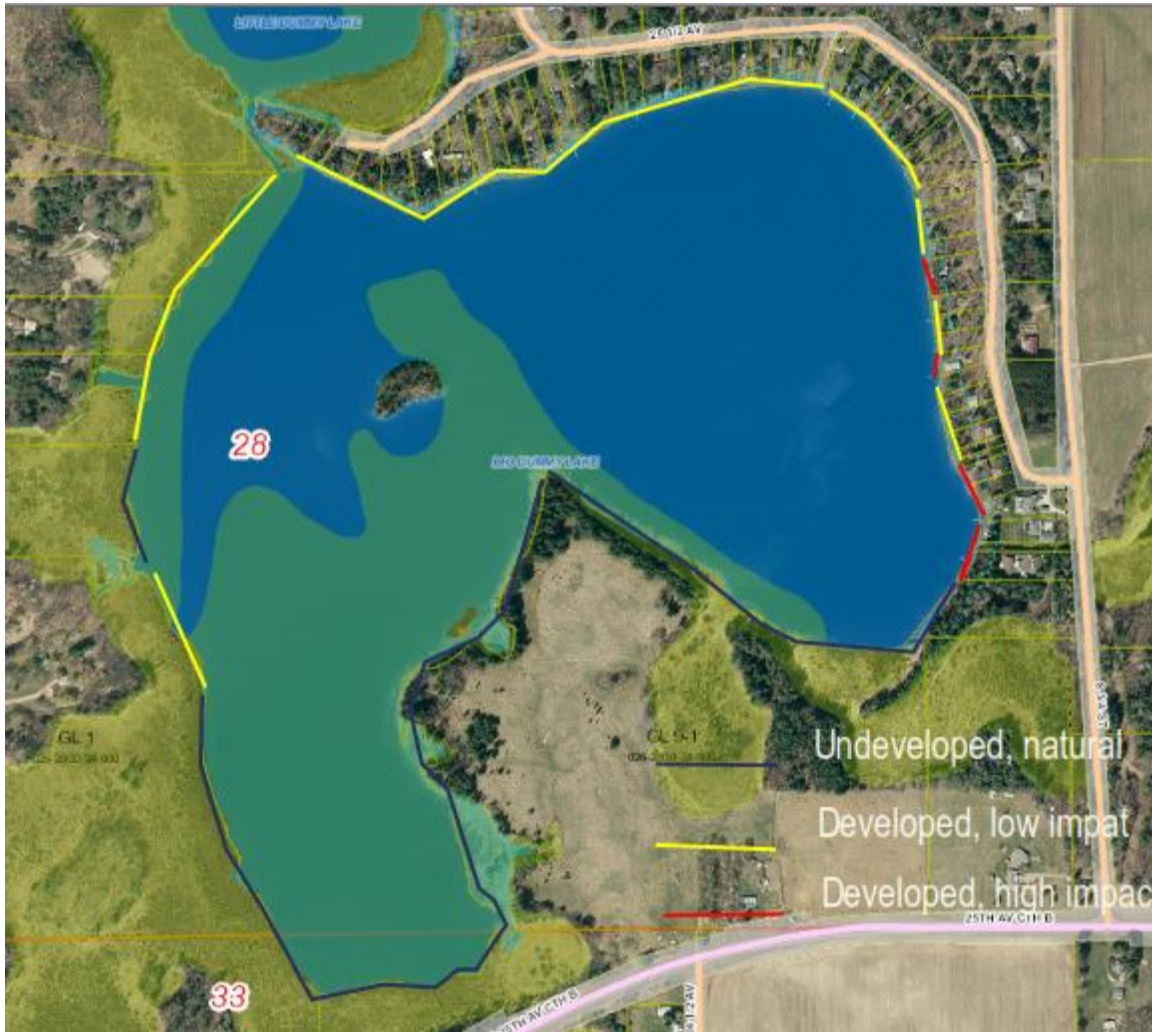
Figure 12 - Big Dummy Shoreline Characterization

palustrine wetlands. The blue green indicates aquatic beds in open water. These wetlands are as shown on the Barron County GIS and classified according to Wisconsin Wetland Inventory mapping.

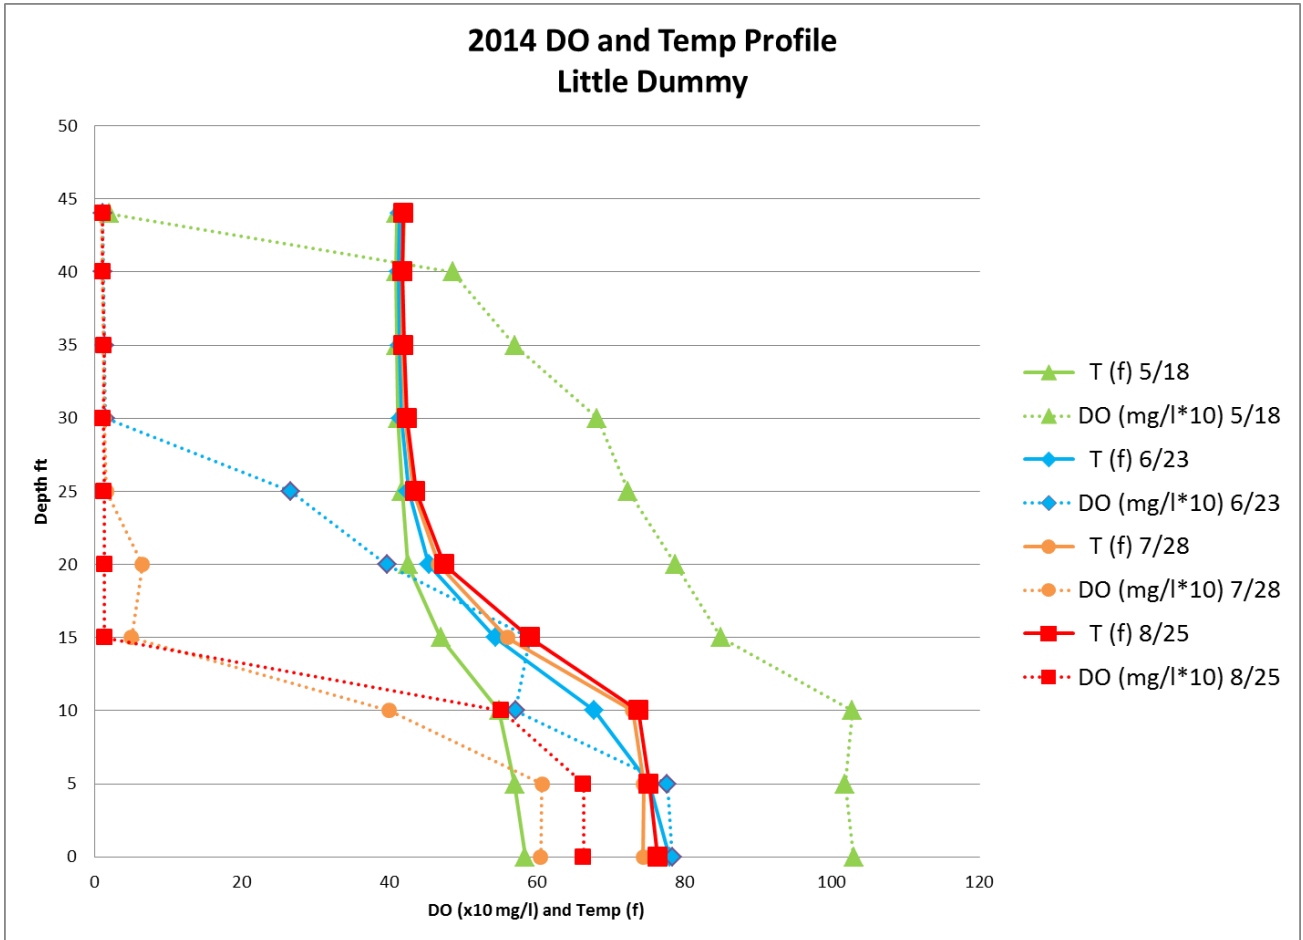
Figure 21 - Little Dummy Dissolved Oxygen Profile

The thermocline in Little Dummy appears to be at approximately 12 feet.

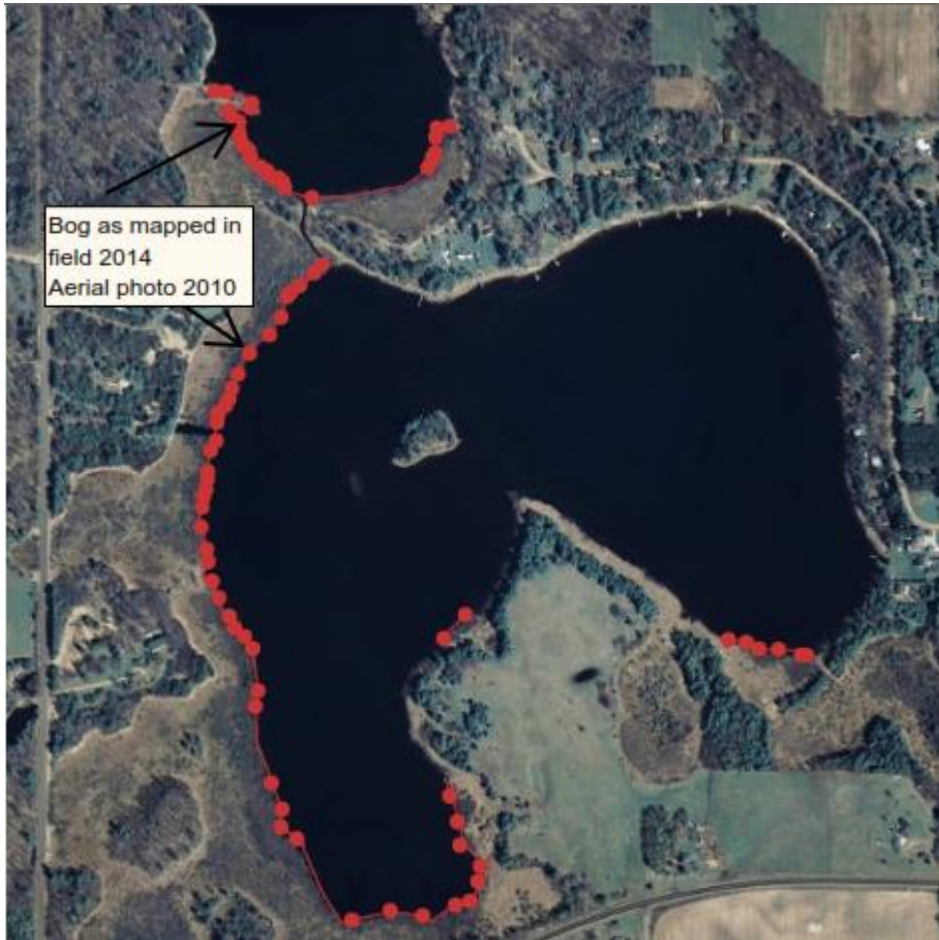
Figure 25 - Bog as Mapped in Field

The edge of the bog on both lakes was recorded with GPS and overlaid on an aerial photo from 2010.

The bog mapped above is floating bog consisting of grasses, sedges and shrubs. It is currently attached to the shoreline and stationary. Sections of bog may break free and float about the lake causing navigation issues; this has happened in the past on the lake. If this happens in the future the bog may be dealt with in a number of ways including:

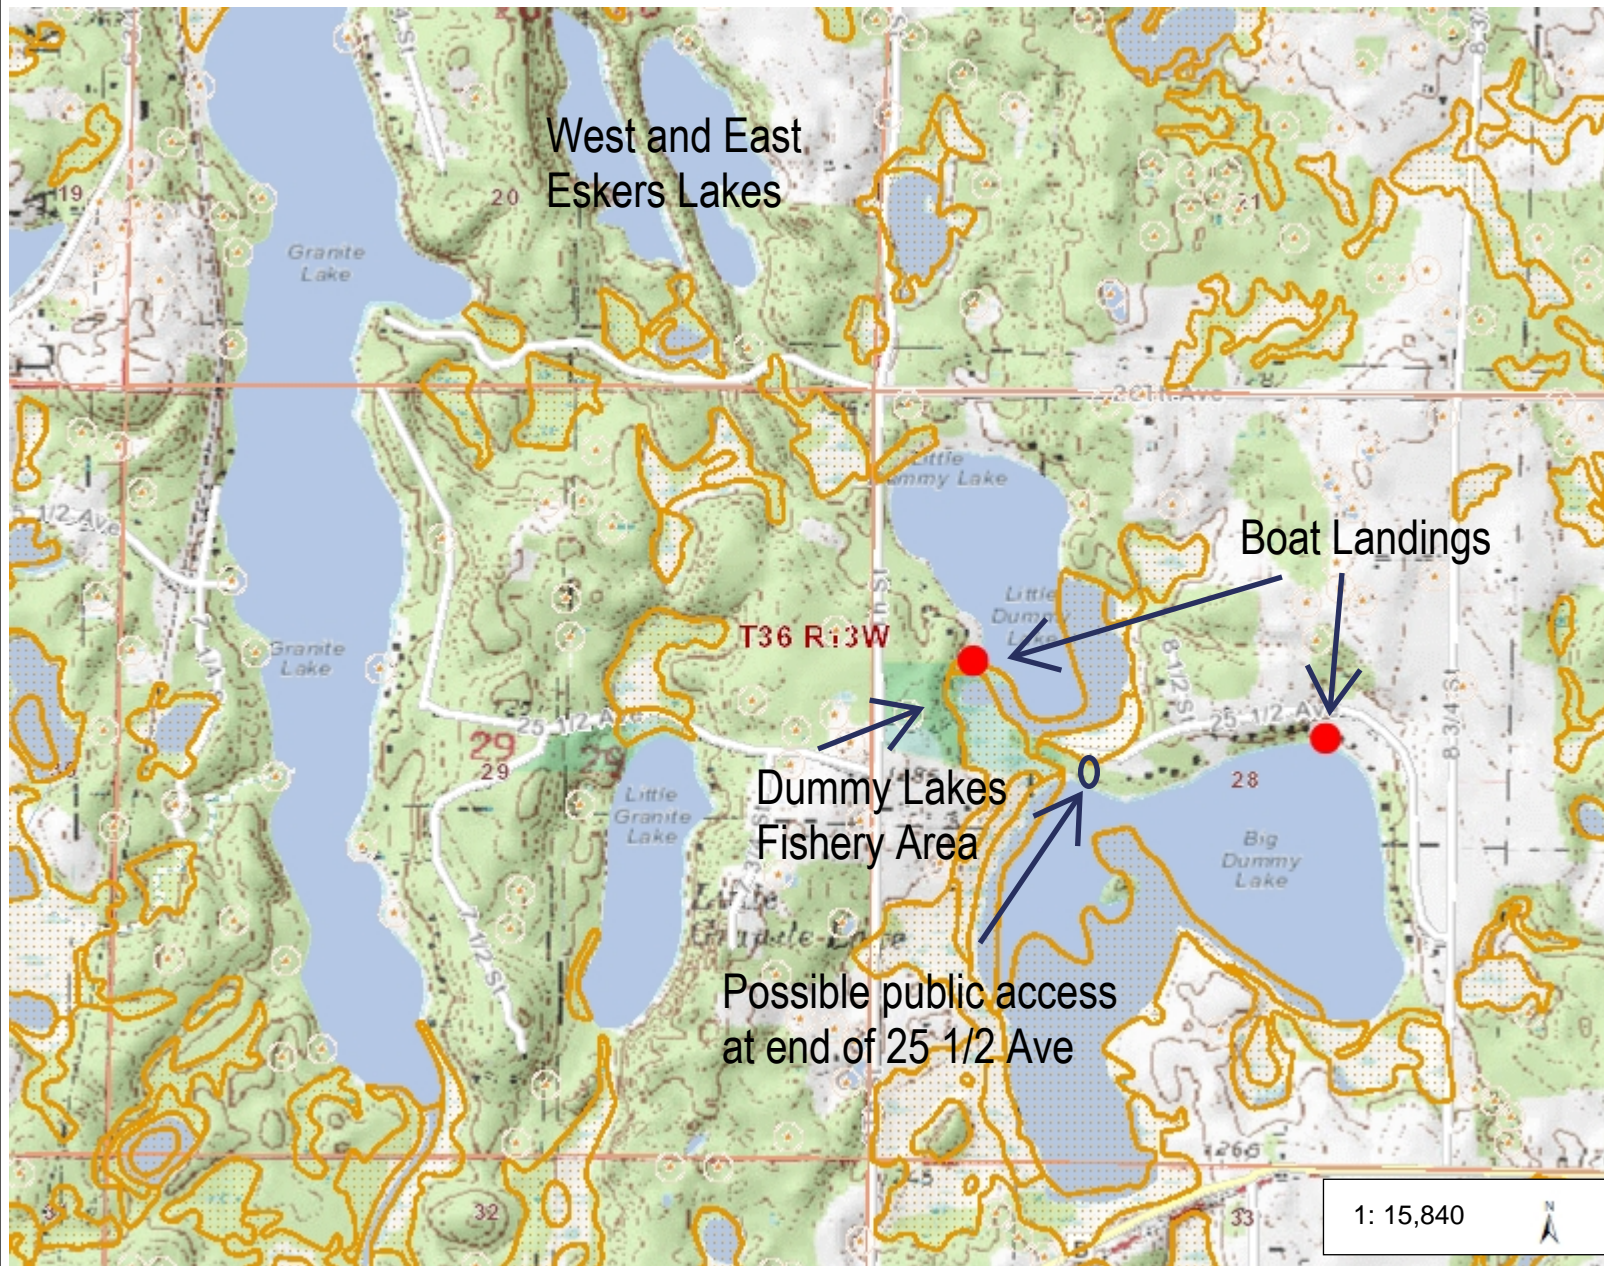
Figure 1 Dummy Lakes Public Access

Each lake has a public boat landing with ramps of gravel and a depth of 1 to 3 feet. Big Dummy landing has enough space for up to five vehicles with trailers. Annual improvements have been made by WDNR since 2011 to enlarge parking area, gravel road, improve boat launch. The lake District chemically treats nuisance aquatic plants each year. Public access is also available through the Dummy Lakes Fishery Area located on the southwest corner of Little Dummy and along the connecting channel. This public land is accessible from 8th Street and allows walking access to the lakes. There is also a small parcel at the end of 25 ½ Ave that is shown on the Barron County GIS website and appears to allow public access to both lakes. See Figure 1 in Figures Section for access locations.
