Buckatabon Lakes Eurasian Watermilfoil Control and Prevention Rapid Response Project

Upper and Lower Buckatabon Lakes - Vilas County, WI

2016 Annual Reporting

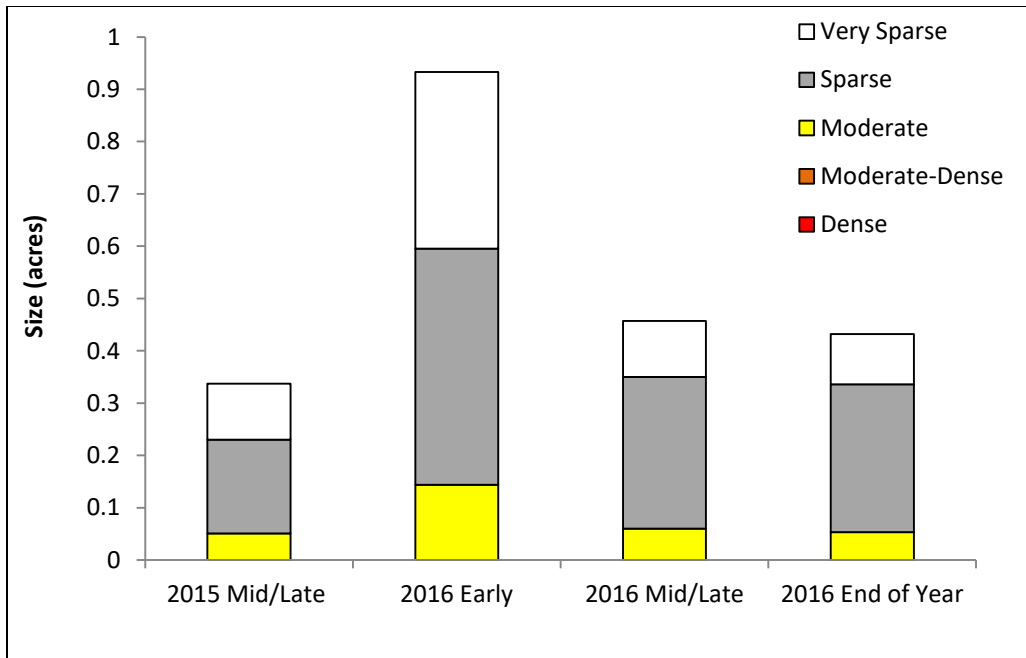
Figure 3: EWM point based abundance estimate on Upper and Lower Buckatabon combined from 2015 to 2016.

The management strategy for hand removal was to have one round of hand removal across all known sites (minus D-16) prior to the mid/late season survey. An additional round of hand removal on new and re-visits to existing areas occurred, however, the majority of observed reduction occurred between the 2016 early seasons surveys to the mid/late season survey. Furthermore, no EWM was detected on Lower Buckatabon during the post management evaluation.

Values are determined by using an infield visual estimate in feet circumference converted to acres as represented by point based GPS mapping. This is not an estimate of overall footprint, but rather an estimate of exact extent.
