**Herbicide Treatment Analysis for
Potamogeton crispus (Curly-leaf pondweed)**

**Deer Lake, Polk County Wisconsin
WBIC: 2619400
October, 2017**

***Survey and analysis conducted by: Ecological Integrity Service, LLC
Amery, WI***

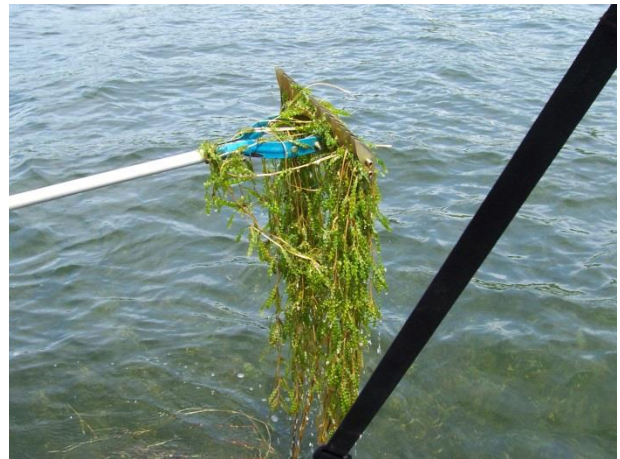
Figure 3: Density rating system and example CLP rake sample.

The second survey is referred to as the post treatment survey. This survey involves going to the same GPS coordinates as the pre-treatment survey and doing a rake sample at the point. If any CLP is on the rake, the density of the CLP is recorded (see Figure 3 for reference). All other species are also recorded from the rake sample in order to verify no damage to the native plants.

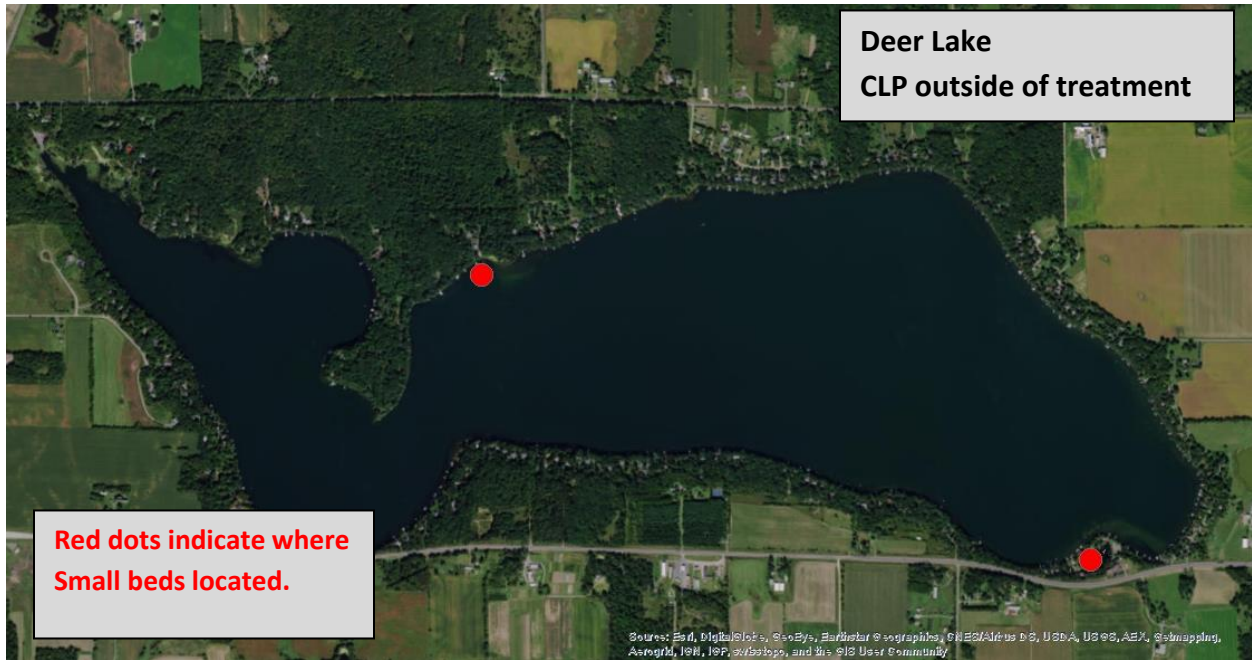
Figure 11: Map of the CLP bed locations outside of the treatment area.

After the post treatment survey is completed, the entire lake is surveyed looking for CLP beds. A bed is defined as an area of CLP that is dominated by CLP, has a mean CLP density >2, and can be delineated by sight. In order to be delineated by sight, the CLP must be growing at or near the lake surface. There were three CLP beds seen outside of treatment and no beds within the treatment areas. Figure 11 shows the location of the CLP observed out of the treatment beds. Figure 12 and 13 are the maps of the CLP beds observed on the north shoreline and in the lagoon. These beds totaled 0.04 acres. There was no other CLP observed in the lake.

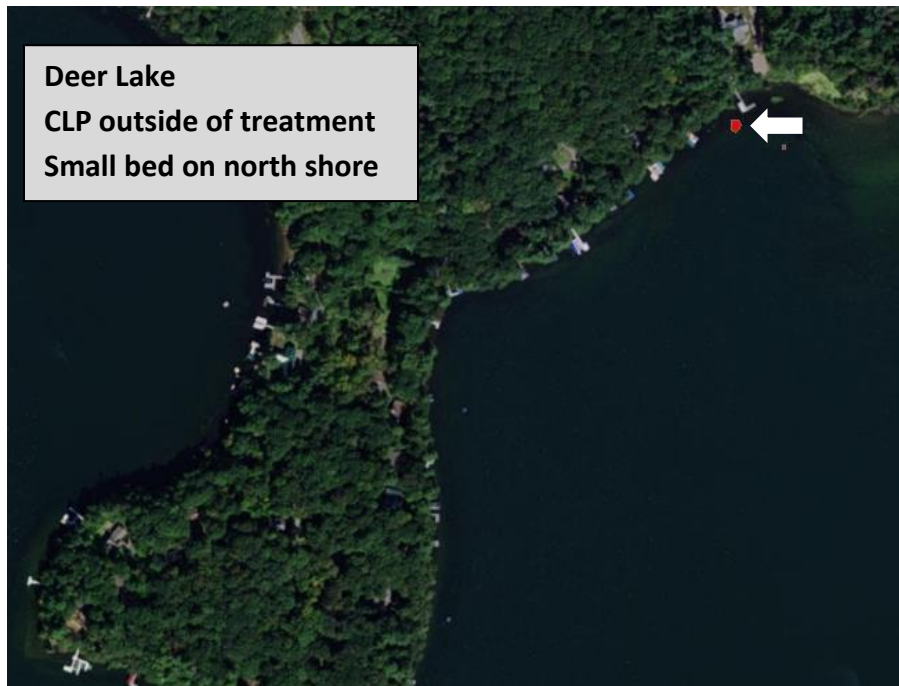
Figure 12: Small CLP bed observed on the north shoreline Deer Lake-June, 2017.

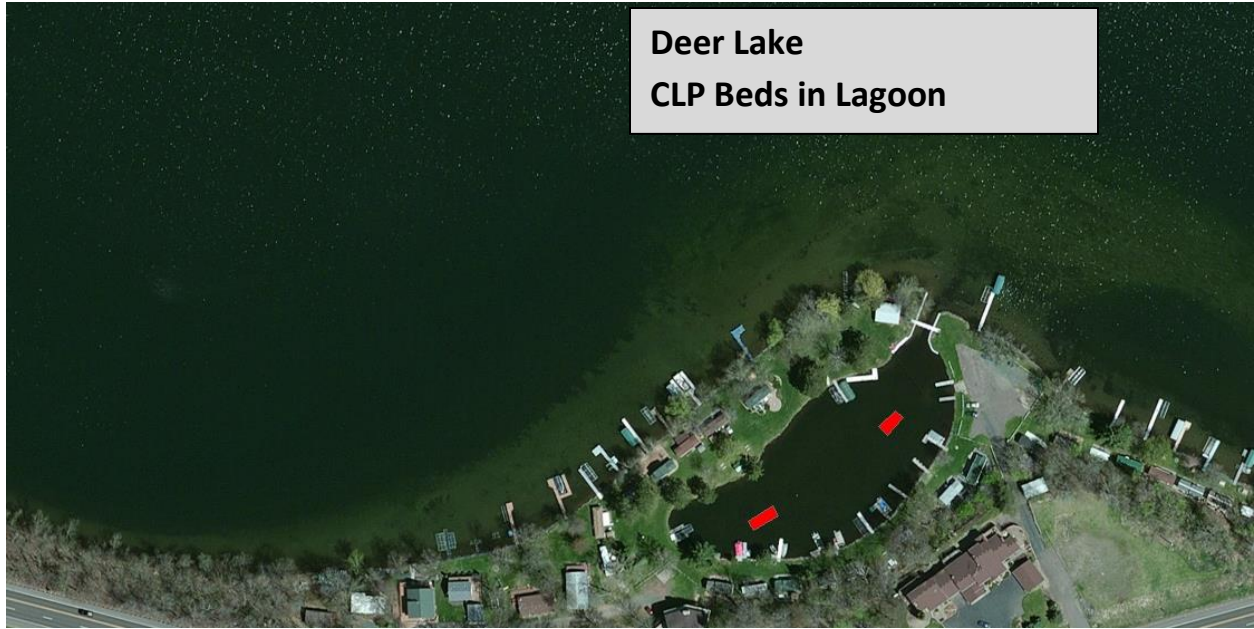
Figure 13: CLP beds observed in the lagoon area of Deer Lake-June, 2017.

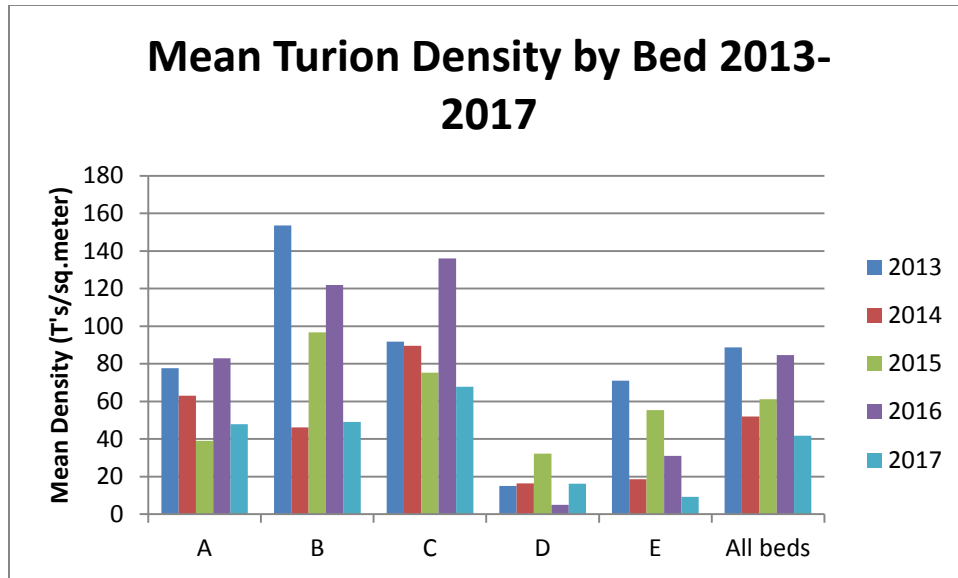
Figure 14: Turion densities by bed for comparison 2013 through 2017.

The turion analysis was conducted on October 7, 2017. Table 6 summarizes the turion density comparison from 2013 to 2017. Figures 14 and 15 graphically show the changes.

As the data shows, the mean turion density in all beds combined declined from 2016 to 2017. This follows increases in 2015 and 2016. It is desired to see annual reduction in turion density. If any treatment areas are not successful in killing the CLP, these plants can produce turions, which can germinate the following year. The mean turion density did increase slightly in bed D.

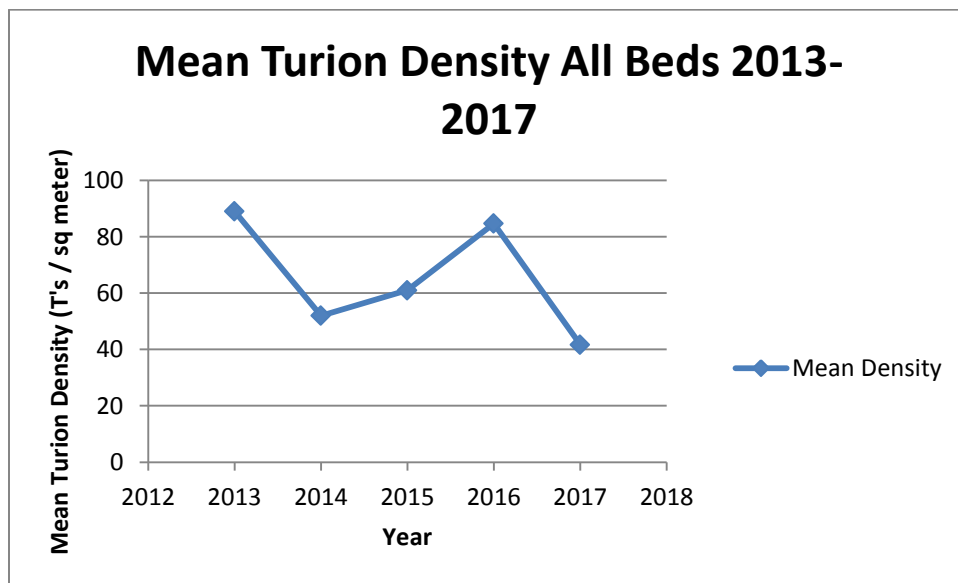
Figure 15: Change in turion density, all beds 2013 through 2017.
