Aquatic Plant Management Plan

Apple River Flowage

Polk County, Wisconsin

September 2017

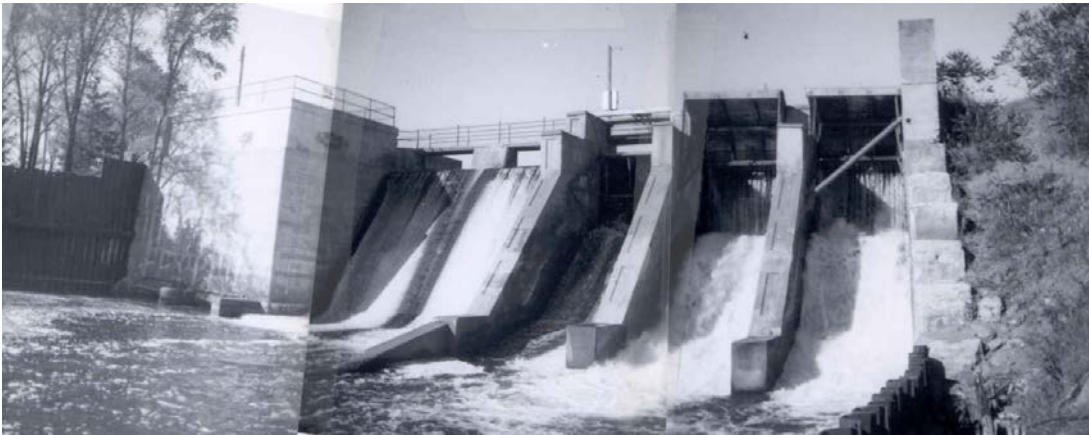
Figure 9. The Black Brook Dam

The Apple River is a free-flowing river downstream of the Amery dam for about 4 river miles or to about one mile south of the city limits where the river crosses State Highway 46. The Black Brook Flowage begins at this point. The Black Brook Dam holds back a height of 25 feet of water to create a 98 acre flowage.¹¹
