Buckatabon Lakes Eurasian Watermilfoil Control and Prevention Rapid Response Project

Upper and Lower Buckatabon Lakes - Vilas County, WI

2016 Annual Reporting

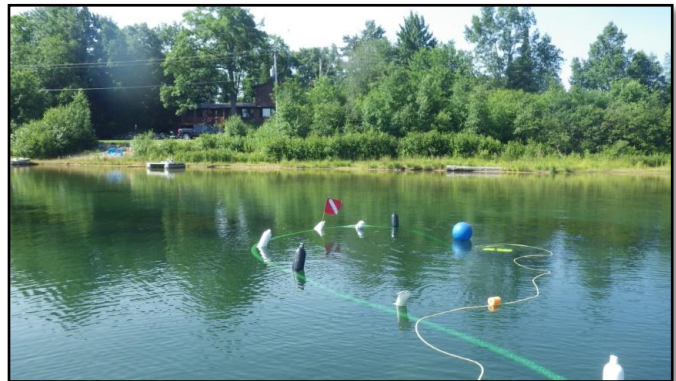
Divers Using DASH to Remove EWM

While using DASH, a diver typically begins by locating a EWM plant from the surface, and then descends next to the plant while lowering the nozzle of the suction hose. Divers works along the bottom by using fin pivots, kneeling on the bottom or hovering above the bottom at a distance where the root mass of the plant is within hands reach. Divers either feed the top of the plant into the hose first and then uproot the plant or uproot the plant and feed it root wad first into the hose. We feel it is very important that as much sediment from the root is removed before plants enter the nozzle. This helps maintain visibility for the diver and minimizes debris
