LAKE CLASSIFICATION REPORT MASON LAKE, ADAMS COUNTY

**Presented by Reesa Evans, CLM, Lake Specialist
Adams County Land & Water Conservation Department
P.O. Box 287, Friendship, WI 53934**

NOVEMBER 2008

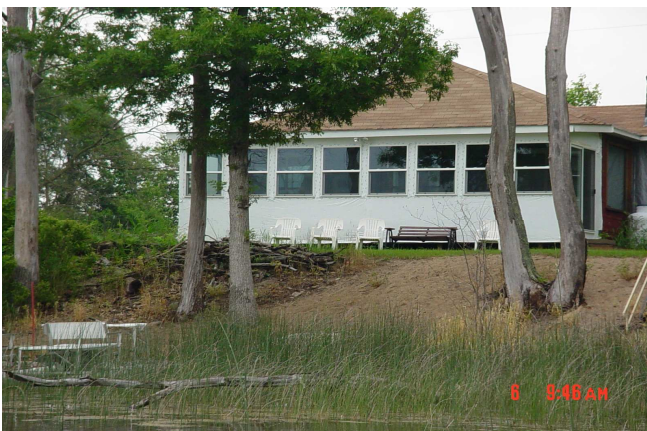
Figure 12: Example of Inadequate Vegetative Buffer

A 2004 survey showed that 52.4% of Mason Lake's shoreline was vegetated with native vegetation. The rest of the shoreline contained a combination of traditional cultivated lawn, rock riprap, seawalls, and sand. The 2004 inventory included classifying areas of the Mason Lake shorelines as having "adequate" or "inadequate" buffers. An "adequate" buffer was defined as one having the first 35 feet landward covered by native vegetation. An "inadequate" buffer was anything that didn't meet the definition of "adequate buffer", including native vegetation strips less than 35 feet landward. Using these definitions, about 62%% of Mason Lake's shoreline had an "adequate buffer" in 2004, leaving 38% as "inadequate." Most of the "inadequate" buffer areas were found with mowed lawns and/or insufficient native vegetation at the shoreline to cover 35 feet landward from the water line.

Adequate buffers on Mason Lake in some places could be easily installed on the inadequate areas by either letting the first 35 feet landward from the water just grow without mowing it, except for a path to the water, or by planting native seedlings sufficient to fill in the first 35 feet or using biologists to protect the shore that are vegetated. Where areas are deeply eroded, shaping, revegetating and protecting the shores will be necessary to prevent further erosion.

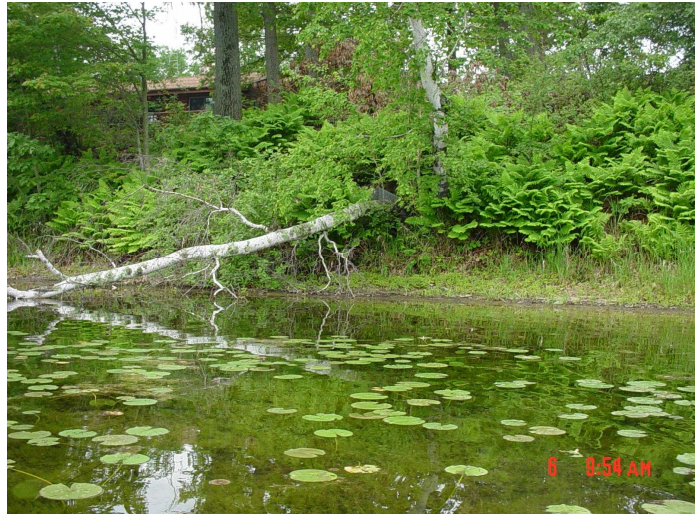
Figure 13: Example of Adequate Buffer

The filtering process and bank stabilization that buffers provide help improve a lake's water quality, including water clarity. Studies in Minnesota, Maine and Michigan have shown that waterfront property value increases for every foot the water clarity of a lake increases. (Krysel et al, 2003).

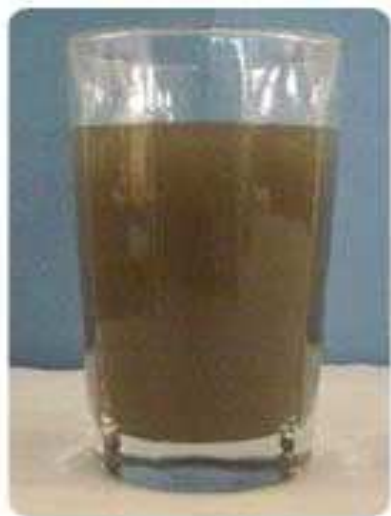
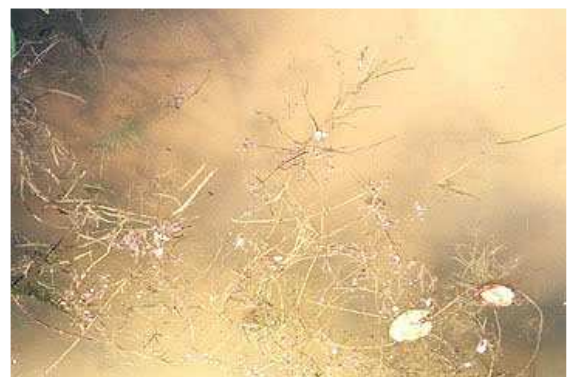
**Figure 31:
Examples of Very
Turbid Water**

TURBIDITY: Turbidity reflects water clarity. The term refers to suspended solids in the water column—solids that may include clay, silt, sand, plankton, waste, sewage and other pollutants. Turbid water may mask the presence of bacteria or other pollutants because the water looks murky or muddy. In general, turbidity readings of less than 5 NTU are best. Very turbid waters may not only smell, but also tend to be aesthetically displeasing, thus curtailing recreational uses of the water. Turbidity levels for Mason Lake’s waters were 3.2 NTU in 2004, 4.24 NTU in 2005 and 5.22 NTU in 2006. These levels suggest that further research should be done on what appears to be increasing turbidity levels in Mason Lake.

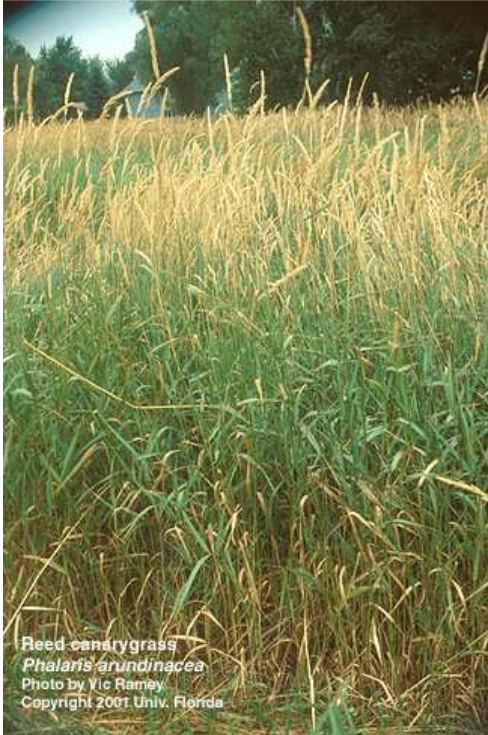
Phalaris arundinacea
(Reed Canarygrass)

**Figure 46: The Three Invasive
Aquatic Plants in Mason Lake**

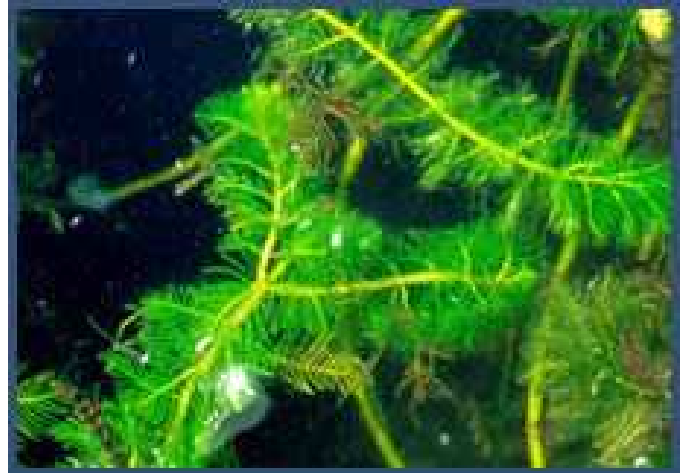
Myriophyllum spicatum
(Eurasian Watermilfoil)

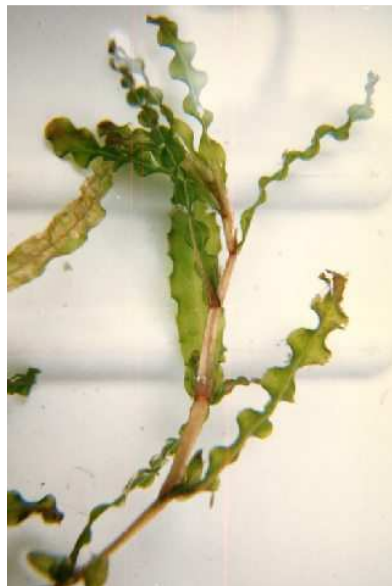
*Potamogeton
crispus*
(Curly-Leaf
Pondweed)
