**AQUATIC PLANT REPORT
FOR BIG ROCHE A CRI LAKE,
ADAMS COUNTY, WI
1996-2013**

**Presented by Reesa Evans,
Lake Specialist, Certified Lake Manager
Adams County Land & Water Conservation Dept
P.O. Box 287 Friendship, WI 53934
December 2013**

The Aquatic Plant Community in Big Roche-a-Cri Lake, Adams County 2004-2013

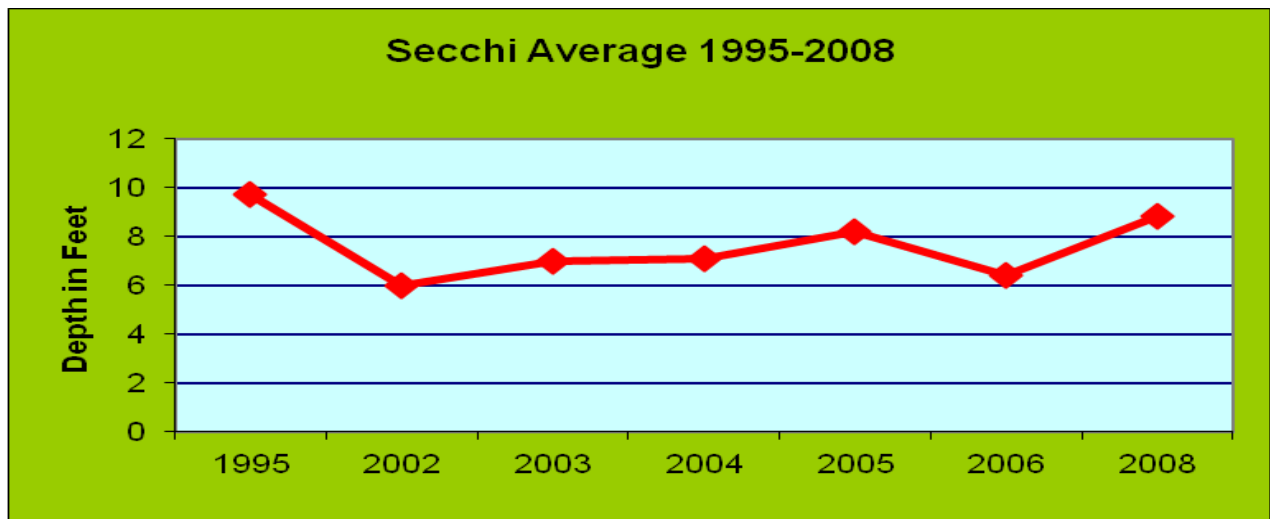
Figure 5: Summer Water Clarity Averages 1995-2008

Water clarity is a critical factor for plants. If plants don't get more than 2% of the surface illumination, they won't survive. Water clarity can be reduced by turbidity (suspended materials such as algae and silt) and dissolved organic chemicals that color or cloud the water. Water clarity is measured with a Secchi disk. Average summer Secchi disk clarity in Big Roche a Cri Lake in 2004-2013 was 7.7 feet. This is good water clarity, putting Big Roche a Cri Lake into the "mesotrophic" category for water clarity.

When these figures are compared to the table outlining water quality status, it is clear that Big Roche a Cri scores as a mesotrophic lake, with all readings in the "fair" to "good" category

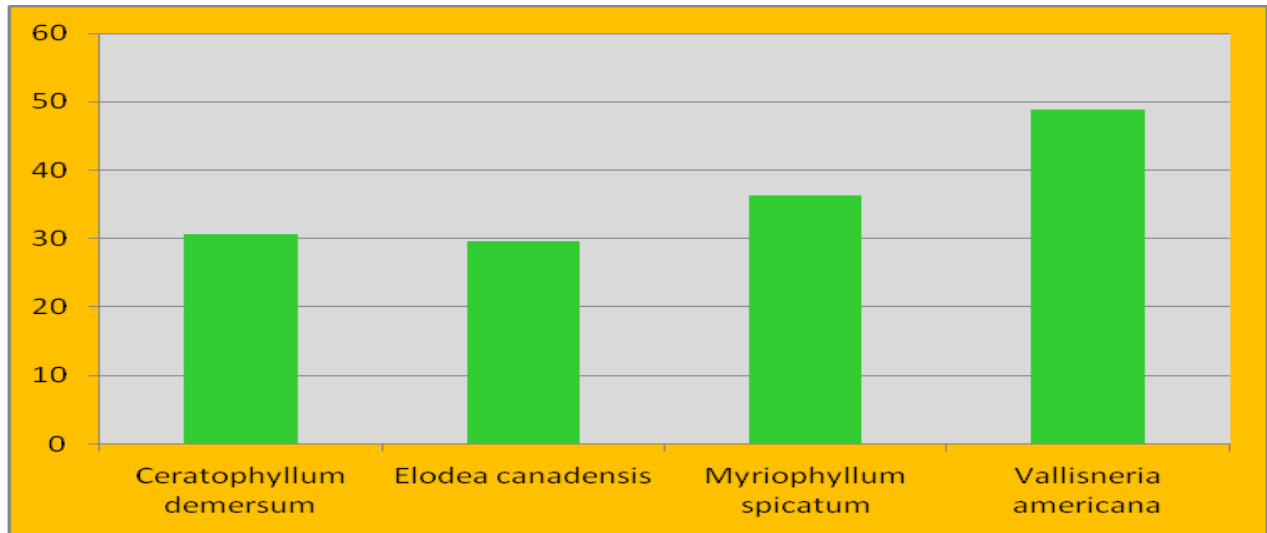
Figure 12: Most-Frequently Occurring Plants 2013

In 2013, the most frequently-occurring aquatic plant was *Vallisneria americana* (water celery), which was found at 30.7% of the sample sites. Other commonly-occurring aquatic plants included *Ceratophyllum demersum* (Coontail), *Elodea canadensis* (Common Waterweed), and the invasive *Myriophyllum spicatum* (Eurasian watermilfoil).

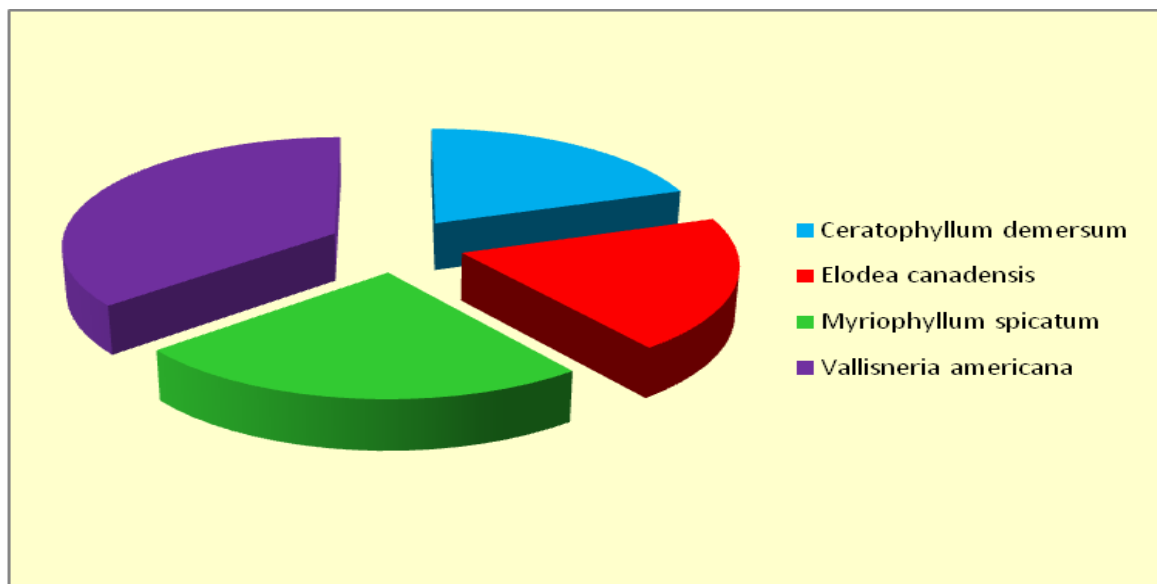
Figure 14: Dominance in 2013

Combining the relative frequency and relative density of a species into a Dominance Value illustrates how dominant that species is within the aquatic plant community. Water Celery was the overall dominant plant in Big Roche a Cri Lake in 2013. This plant alone comprised 20% of the aquatic plant community. If the other three most commonly-occurring plants—Common Waterweed, Coontail and Eurasian Watermilfoil—are added in, these four species were 55.5% of the aquatic plant community in Big Roche a Cri Lake in 2013.

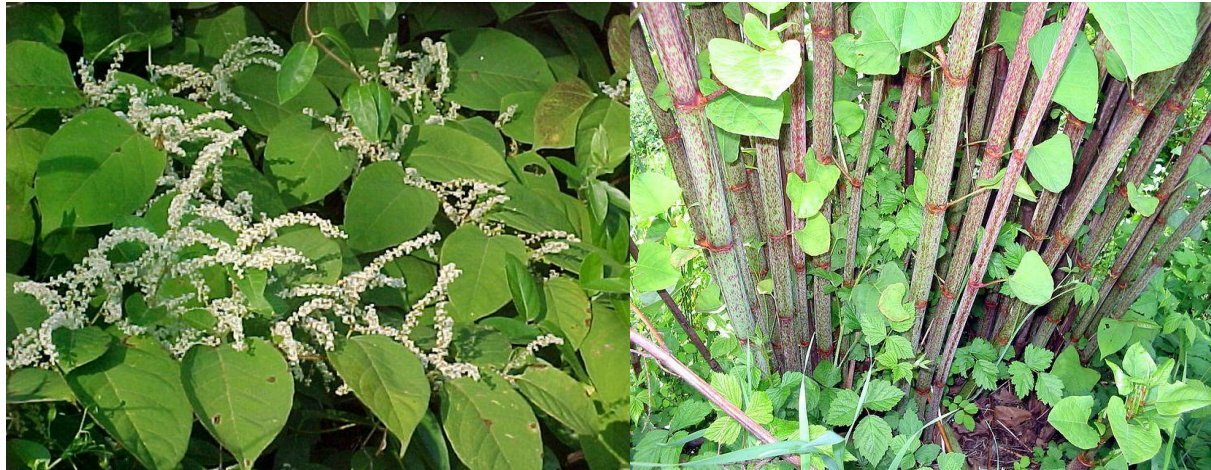
Figure 20: Photos of Japanese Knotweed

Japanese knotweed is also called “Mexican bamboo” or “Japanese bamboo” due to its tall hollow stocks. It was originally used as an ornamental. However, it quickly spreads and crowds out all other plants. A common habitat for Japanese knotweed is sunny, moist areas, including riverbanks and lake banks.

- 14) Make arrangements immediately for the removal of Japanese Knotweed from the shore before it spreads further.

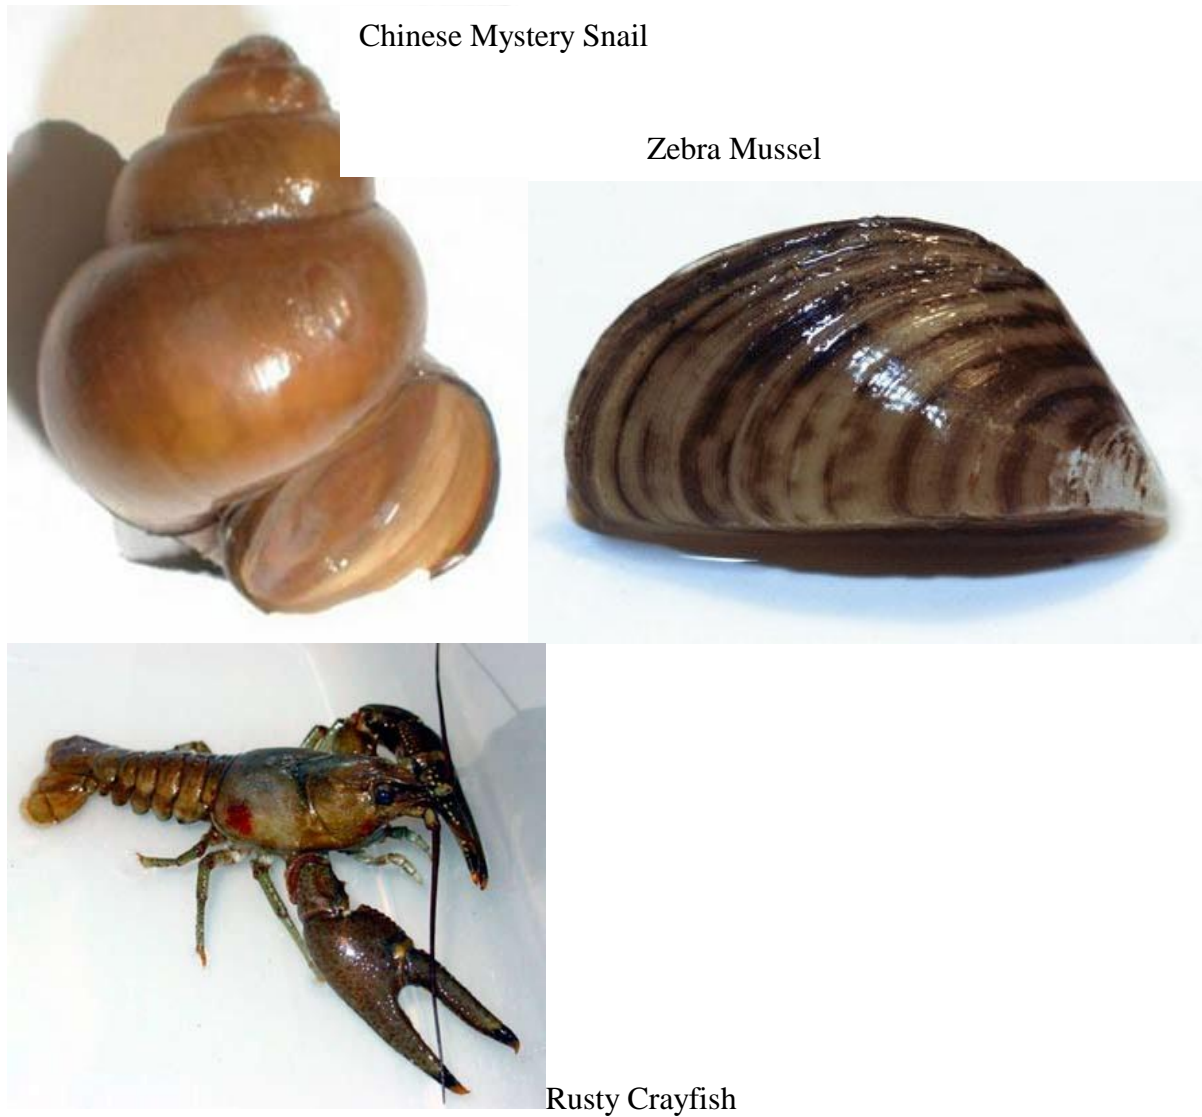
Figure 25: Invasive Aquatic Animals in Big Roche a Cri Lake

The first Rusty Crayfish was discovered partially-digested in the stomach of a large mouth bass caught in the lake. Since then, reproducing rusty crayfish have been collected from the lake. Monitoring is being conducted to evaluate any impact at the lake. These crayfish are known to outcompete native crayfish, plus eat native crayfish and fish roe, as well as pull up aquatic plants.

Most problematic was the discovery of adult zebra mussels on platform samples in the fall of 2013. These platforms had been hung in the lake during the summer for several years with no result. However, when they were pulled from the lake in September 2013, it was discovered that both had a few adult zebra mussels on them. This was reported to the WDNR for further investigation.

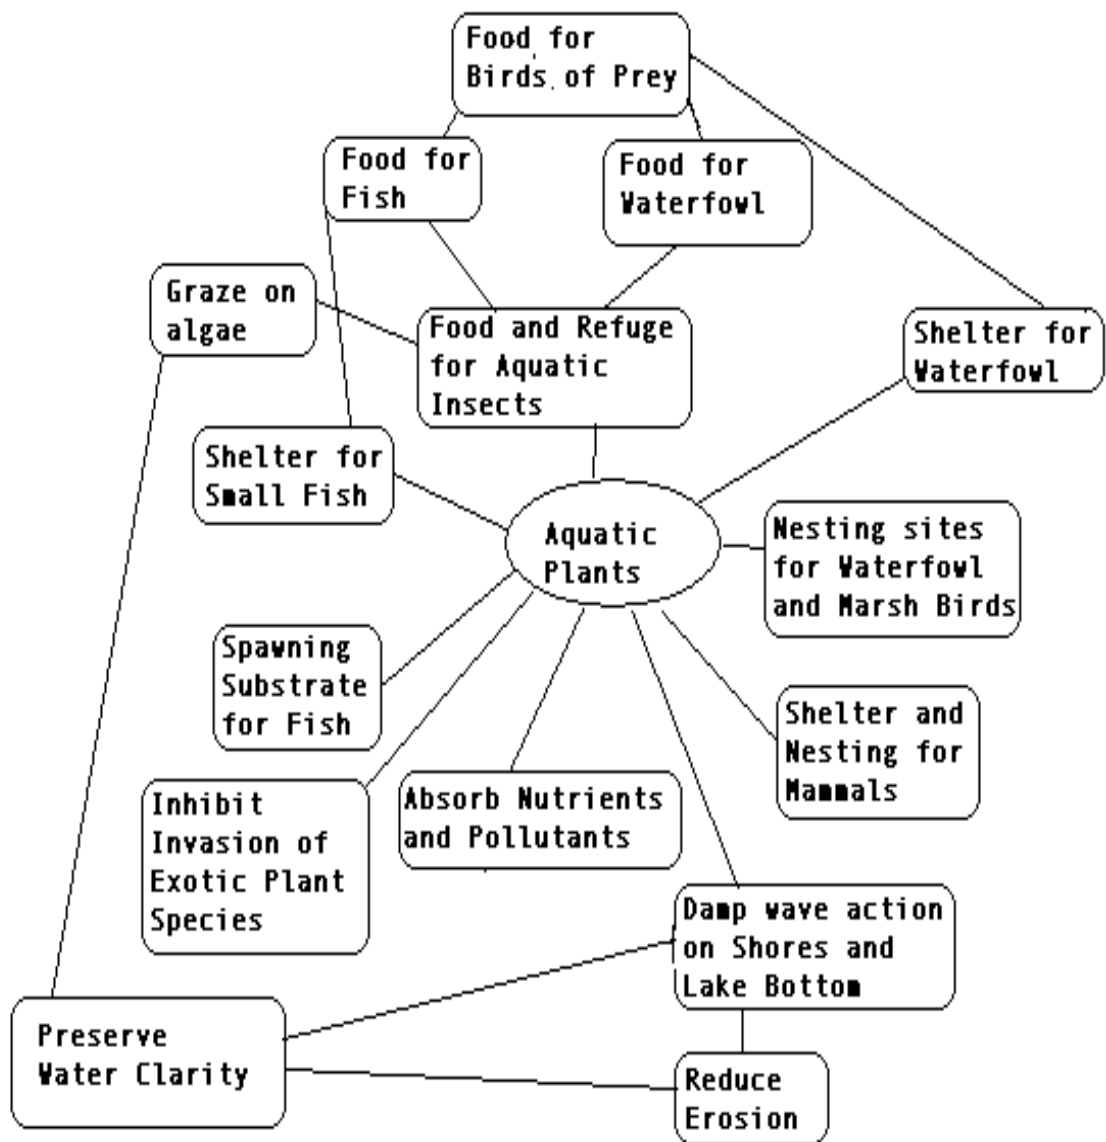
Figure 25: Lake Food Web

4) Additionally, mixed stands of macrophytes support 3-8 times as many invertebrates and fish as monocultural stands (Engel 1990). Diversity in the plant community creates more microhabitats for the preferences of more species. Macrophyte beds of moderate density support adequate numbers of small fish without restricting the movement of predatory fish (Engel 1990).
