BIG ROCHE A CRI LAKE LAKE CLASSIFICATION REPORT

NOVEMBER 2008

**BIG ROCHE A CRI LAKE
LAKE CLASSIFICATION REPORT
TABLE OF CONTENTS**

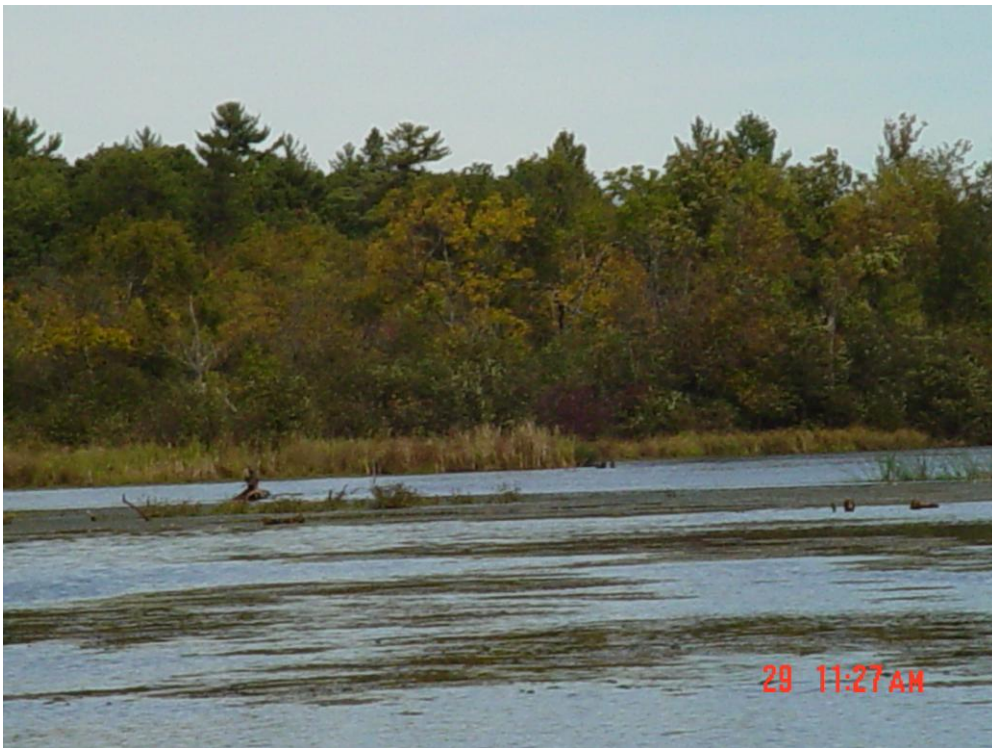
**Figure 8:
Wetland at
East End of
Big Roche a
Cri Lake**

The large areas of wetlands in the Big Roche a Cri Lake watersheds serve as filters and traps that help keep Big Roche a Cri Lake as clean as it is. It is essential to preserve these wetlands for the health of Big Roche a Cri Lake.

The Big Roche a Cri Lake District might consider approaching the WDNR or conservancy organizations to explore putting the east end of the lake, with its meandering stream and wetlands, into a conservancy or limited development area to assure that those areas won't be changed in a way that would degrade water quality of the lake.

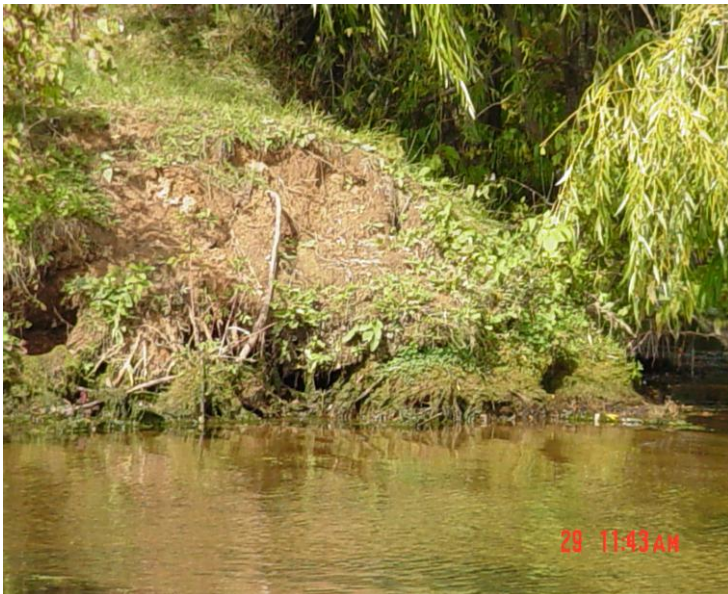
**Figure 10:
Example of Erosion
on Big Roche a Cri
Lake**

Big Roche a Cri Lake has a total shoreline 6.1 miles (32,208 feet). Much of the lakeshore is in residential use. Many of the areas near the shore are very sandy and steeply sloped. A 2004 shore survey revealed that 64% of Big Roche a Cri Lake's shoreline is vegetated. The rest of the shore is a mix of active erosion, sand, rock and/or other hard structure. Since the survey was done, Big Roche a Cri Lake District was awarded a lake management plan implementation grant that allowed several property owners to install shore protection practices to reduce some of the erosion. It has recently applied for an additional grant to address properties not previously covered.

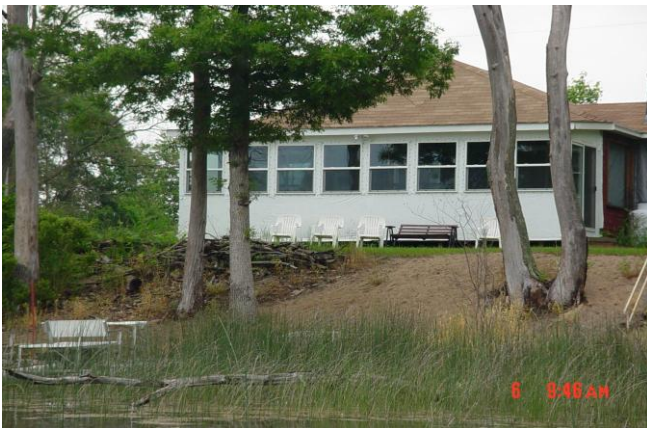
Figure 14: Example of Inadequate Vegetative Buffer

The filtering process and bank stabilization that buffers provide help improve a lake's water quality, including water clarity. Studies in Minnesota, Maine and Michigan have shown that waterfront property value increases for every foot the water clarity of a lake increases. (Krysel et al, 2003).

Adequate buffers on Big Roche a Cri Lake in some places could be easily installed on the inadequate areas by either letting the first 35 feet landward from the water just grow without mowing it, except for a path to the water, or by planting native seedlings sufficient to fill in the first 35 feet or using biologists to protect the shore that are vegetated. Where areas are deeply eroded, shaping, revegetating and protecting the shores will be necessary to prevent further erosion.

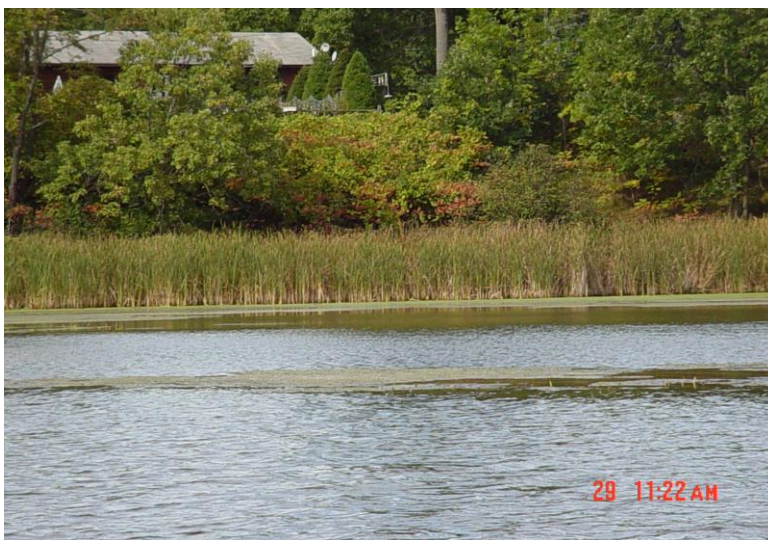
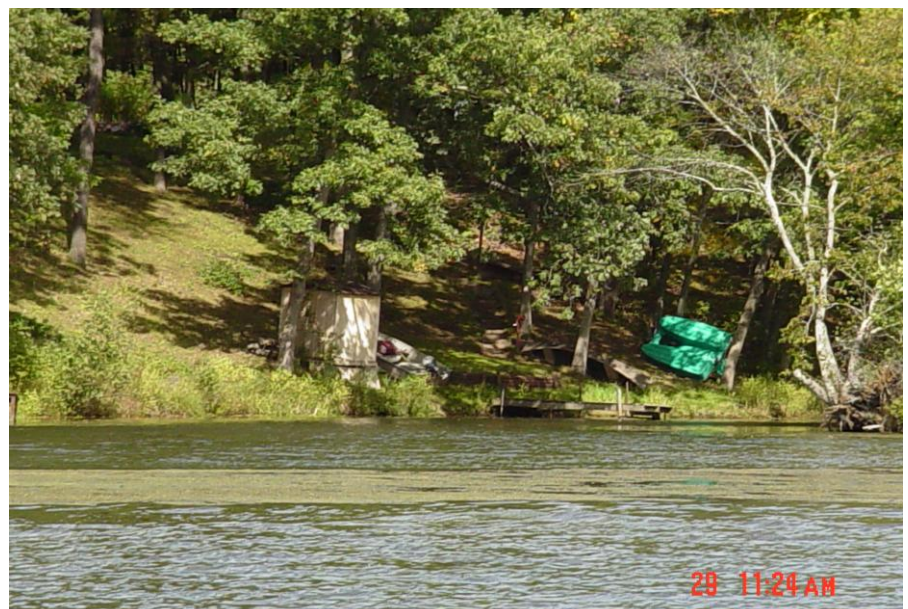
Figure 50: Some Areas in RC1

Wild celery and water stargrass are present here; common waterweed and coontail are abundant. One invasive aquatic species, Curly-Leaf Pondweed, was found in this area. Nesting bald eagles were reported in this area as recently as 2002. A threatened species, Bog bluegrass (*Poa paludigena*), was present in the wetlands that make up much of RC1. Just upstream of this area, in Big Roche a Cri Creek, a fish species of special concern, Pirate Perch (*Aphredonderus sayanus*), was found.

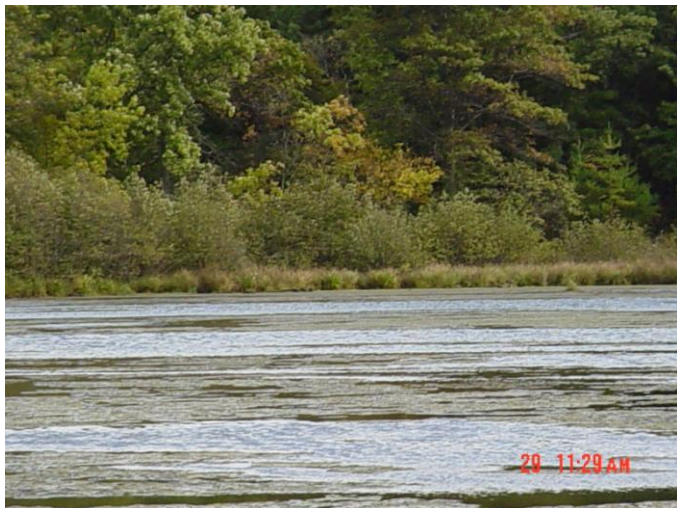
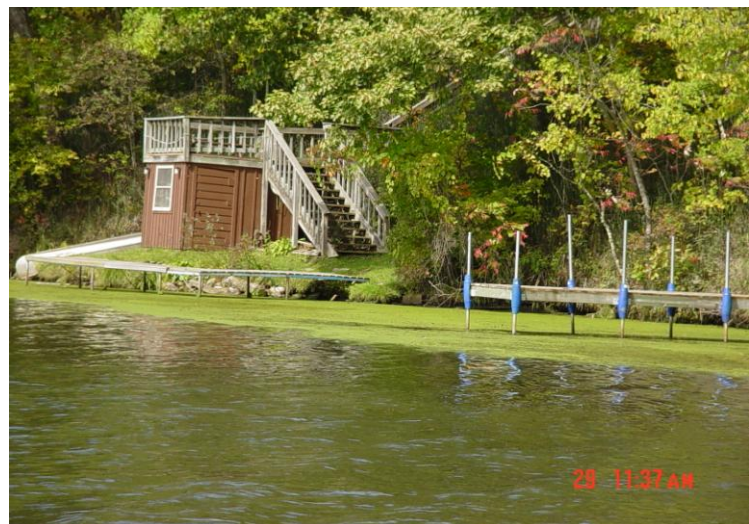
Figure 51: Parts of RC2

RC2 extends along approximately 1500 feet of the northern shoreline of the east basin of the lake and is about 8 acres in size. It includes deep marsh and shrub-carr wetlands. Shoreline habitat includes woodland cover, with an understory of shrub and herbaceous vegetation. There are some scattered homes in this area, with some leaving the natural vegetation at the shore and some cleaning the natural vegetation out.

Nineteen species of aquatic plants were found here: four emergent aquatic species; one floating-leaf rooted plant; two free-floating species; and six submergent species. Water stargrass is present, and wild celery is common at this site. Both coontail and common waterweed are abundant here. The invasive Curly-Leaf Pondweed was also found in this area. The important habitat features at this site are the emergent vegetation, floating-leaf vegetation, shoreline shrubs, snag trees, perch trees and fallen logs in the water.

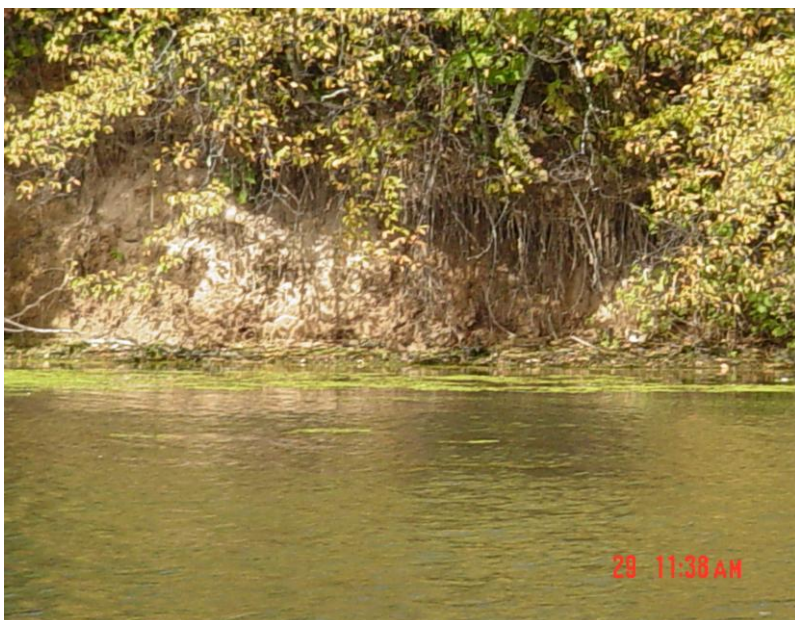
**Figure 53: Area
of Severe Erosion
in RC3**

RC3 comprises about 1500 feet of shoreline along the north shore, just west of Highway 13. The shore is mostly wooded covered with some shrub growth, herbaceous cover and shoreline development. 13 species of aquatic plants were found at this site: two free-floating aquatic species and eleven submergent species. Wild Celery and Coontail were dominant at this site. The aquatic invasive plants, Curly-Leaf Pondweed and Eurasian Watermilfoil, were both found at this site. RC4 is about 1100 feet of the south shore, just west of Highway 13. It has important shallow water habitat. The shore is mostly wooded cover, with some shrub growth, herbaceous plants and shoreline development. 13 aquatic plant species were found at this site: one emergent plant, one floating-leaf rooted plant, two free-floating aquatic plant species, and nine submergent plan species. The invasive, Eurasian Watermilfoil, was common at this site. Finally, RC5 is about 1900 feet of shore on the south shore of the lake, in

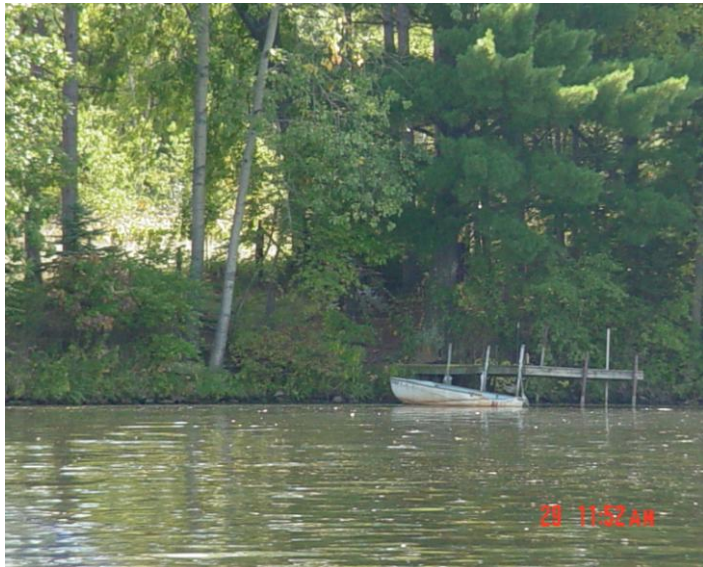
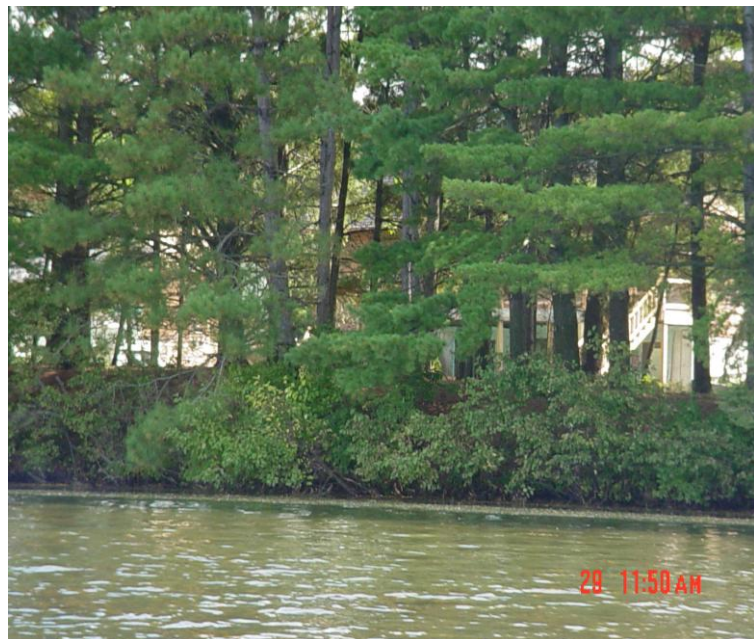
Figure 56:
Sections of RC5

Finally, RC5 is about 1900 feet of shore on the south shore of the lake, in the narrows areas. It has important near-shore terrestrial habitat and shallow water habitat. The shoreline is mostly wooded cover with a fair amount of shrub understory and some housing development. Six aquatic plant species were found in this area, all submergent aquatic plant species. Wild celery and coontail dominate, and common waterweed is common. The invasive Curly-Leaf Pondweed was present at this site; the invasive Eurasian Watermilfoil was abundant.
