Curly-leaf pondweed (*Potamogeton crispus*)
Post Herbicide Turion Survey
Long Lake – WBIC: 2620600
Polk County, Wisconsin

Survey Conducted by and Report Prepared by:
Endangered Resource Services, LLC
Matthew S. Berg, Research Biologist
St. Croix Falls, Wisconsin
October 28-29, 2016

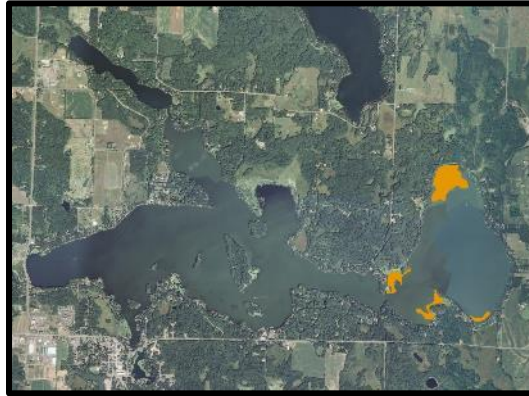
Figure 1: Long Lake with 2016 CLP Treatment Areas

Curly-leaf pondweed (*Potamogeton crispus*) (CLP) is an invasive exotic plant that is common to abundant in parts of Long Lake. In their 2010 Wisconsin Department of Natural Resources (WDNR) approved Aquatic Plant Management Plan (APMP), the Long Lake Protection and Rehabilitation District's (BLPRD) identified a) reducing overall lake coverage of CLP to <20 acres and b) relieving navigation impairment caused by canopied CLP beds as management goals (Clemens 2010). As part of their continuing efforts to meet these goals, in May 2014 and 2015, the BLPRD and the WDNR authorized the herbicide treatment of five CLP beds in East Long Lake. These beds, which totaled 65.49 acres, were selected based on the 2013 spring CLP bed mapping survey that found they were the largest areas of CLP on the lake, and because they were interfering with boat traffic and/or restricting resident access to the lake from their docks. Although no CLP beds were found in East Long following the treatments, the fall 2015 turion survey suggested there would again be significant amounts of CLP in East Long. Because of this, in spring 2016, 58.27 acres or approximately 2.84% of the lake's total surface area were again treated (Figure 1).

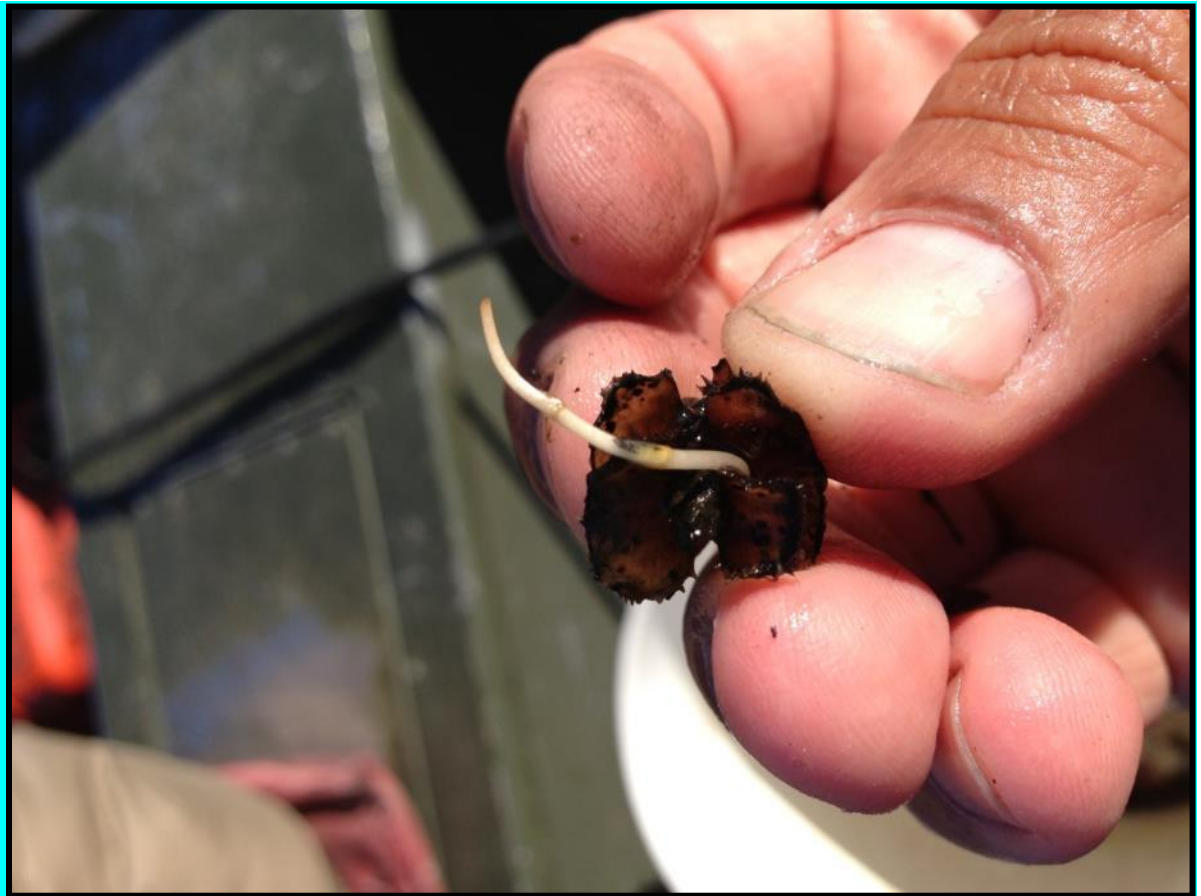
Figure 2: Germinating CLP Turion

Although Curly-leaf pondweed occasionally reproduces by seed, the vast majority of plants resprout from stiff overwintering buds called turions that are normally produced in number by the plants prior to their late June/early July senescence (Figure 2). After the pinecone-like turions germinate in late fall or early winter, plants continue to grow slowly under the ice. Following ice out, growth accelerates, and plants rapidly canopy allowing them a competitive advantage over slower growing native species (Capers 2005).

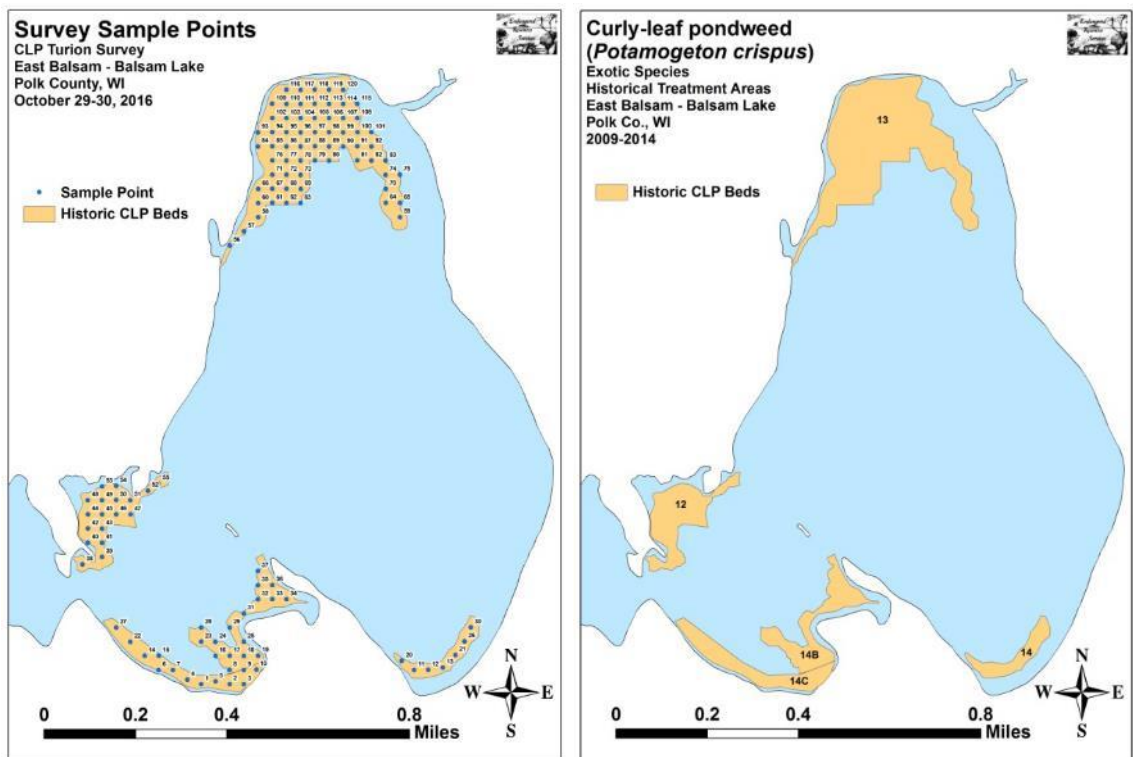
Figure 3: Turion Survey Sample Points in Historical Treatment Areas

After merging the 2014 treatment areas and the 2009 treatment of Bed 14C into a single shapefile, we used Hawth's Analysis Tools Extension to ArcGIS 9.3.1 to generate regular points at the rate of approximately 1.7 points/acre. This produced a 120 point sampling grid of which 18 were in Bed 12, 65 were in Bed 13, 7 were in Bed 14, and the remaining 30 were in the combined area of Beds 14B and 14C. This same sampling grid was also used in 2015 and 2016 to allow for the most accurate comparisons possible (Figure 3) (Appendix I). For ease in determining the total impact of the current treatment program, we also left the 2014 and 2015 narratives in the results section of this report.

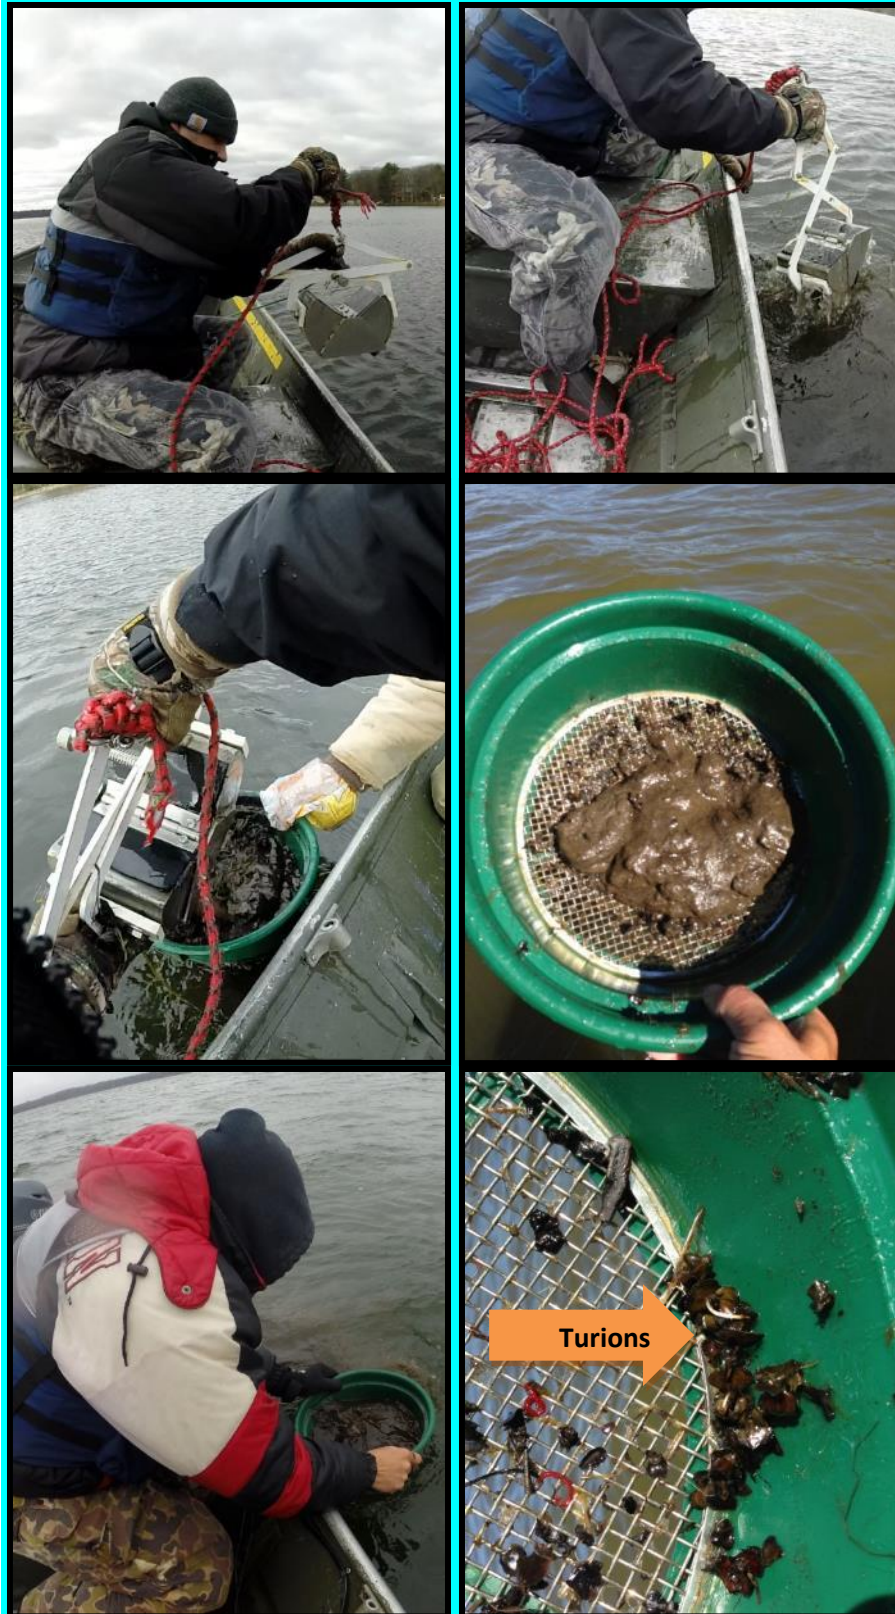
Figure 4: Ponar Grab and Turion Sieving

During the surveys, we located each point with a handheld mapping GPS unit (Garmin 76CSx) and used a Petite Ponar dredge with a 0.0232m^2 (36in^2) sample area to take a bottom sediment grab from each side of the boat at each location. These samples were then rinsed in a fine sieve to separate out the sediment (Figure 4). Samples with high numbers of turions/levels of detritus were bagged for later analysis at which time we discarded all rotten turions, tallied all live turions, and multiplied the combined total live turions from the two samples by 21.53 to estimate turions/ m^2 at each location. This value gives an idea of how many CLP plants will germinate in an area in 2017.

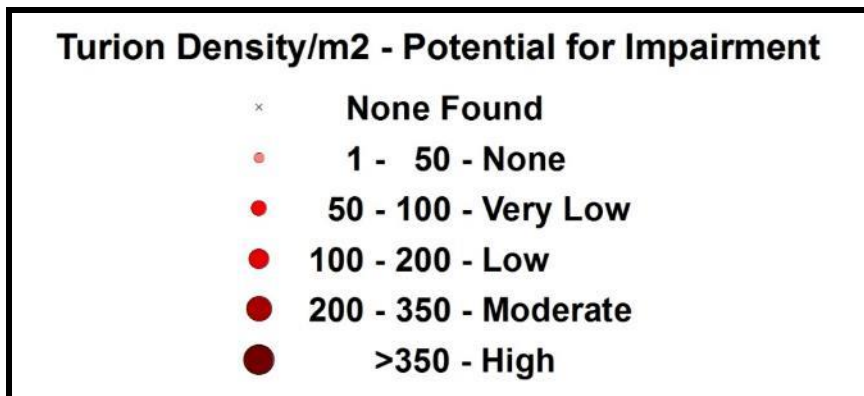
Figure 5: Predicted Navigation Impairment Based on Turion Density

Points at or above nuisance level: This value gives the number of survey sites within the study area that were above the predicted nuisance threshold (Figure 5). Research suggests that when the turion density is at or above 200/m², the following year's CLP growth has the potential to at least moderately impair navigation (Johnson 2012).

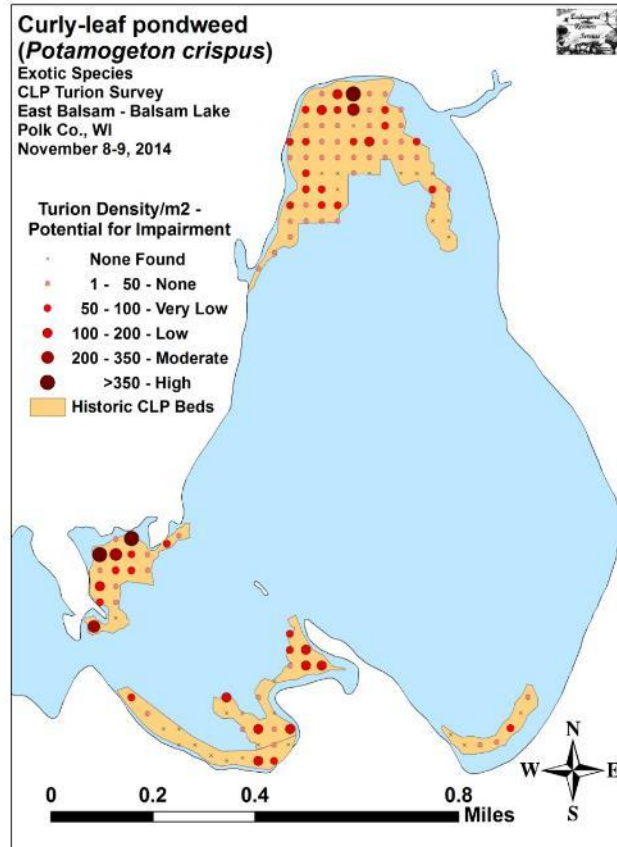
Figure 6: 2014 Fall CLP Turion Survey Density and Distribution
2015 Fall Ponar Dredge Turion Survey:

The November 8-9th, 2014 survey revealed CLP turions were present throughout much of the 2014 treatment areas with 92 of 120 points having live turions (76.67%) (Figure 6) (Appendix II). Despite this, only six points (5.00%) suggested CLP growth in 2015 had the potential to exceed the nuisance threshold with densities >200 turions/m² (Table 1). When broken down by area, Bed 12 had the highest rate with over 22% of the bed projected to exceed this level. Bed 13 was the only other area with any nuisance points, and both of them were located at the very northern edge of the bed. All of the nuisance points were in areas with shallow water (<5 ft) that historically have also had dense canopied CLP.

The overall mean turion density was 61.53 turions/m². This value suggested that the average potential for impairment would be very low. Turion densities were somewhat variable with all standard deviations values being greater than the mean. However, only Bed 12 was more than 25% higher than the mean, and none were double the mean.

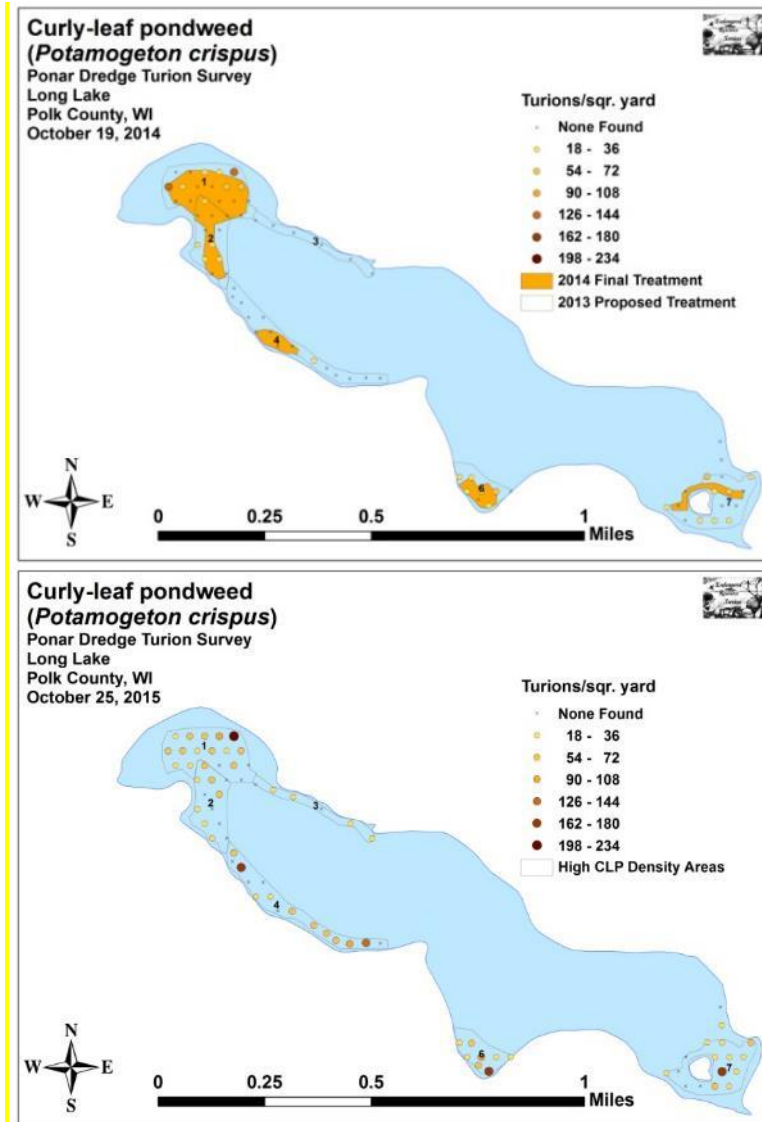
Figure 8: 2014 and 2015 CLP Turion Density and Distribution

During the October 25th, 2015 Ponar dredge survey, we found 167 CLP turions at 55 of 75 survey points (73.3%). This was nearly triple the density and double the distribution of turions when compared to the 2014 and 2013 surveys (59 turions found at 27 of 75 survey points (36.0%) in 2014 and the 56 turions found at 28 points (37.3%) in 2013). Of these, only one point (in Bed 1) exceeded the expected “navigation nuisance level” of 200/sqr. yd., but 27 (up from eight in 2014 and six in 2013) topped 50/sqr. yard (Figure 8) (Appendix IV). Using a t-test to comparing these results to the 2014 turion survey, **we found that the increase in lakewide turion levels was highly significant ($p \lll .001$)** as the mean density increased from 14.16 in 2014 (13.44 in 2013) to 40.08 turions in 2015 (Table 2).

Broken down by polygon, we found that the density also increase in each of the six high density areas. This increase was highly significant in Area 4, and significant in Areas 1, 3, and 6. These results further suggest that Areas 1, 4, and 6 can expect the highest CLP density in 2016.

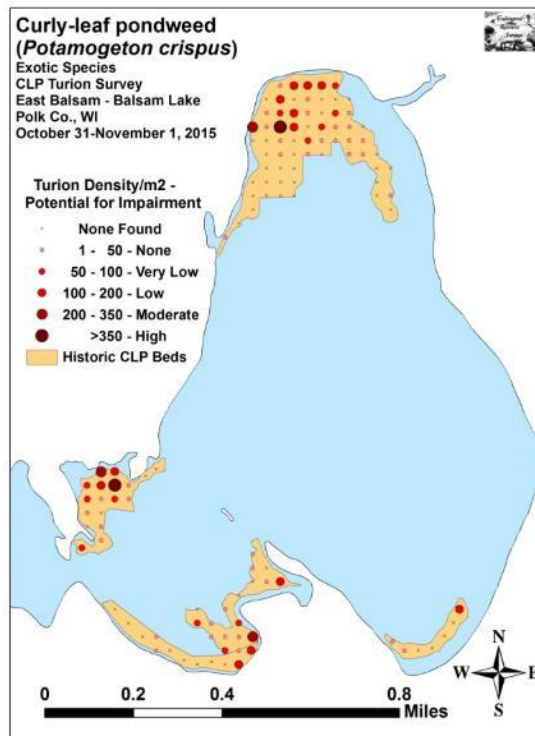
Figure 7: 2015 Fall CLP Turion Survey Density and Distribution

During the October 31st - November 1st, 2015 survey, we found live CLP turions at 67 of 120 points (55.83%) (Figure 7) (Appendix II). This was a decline in distribution of 27.17% from the 92 points with turions in 2014. When broken down by area, all beds showed a decline in distribution except for Bed 14B/C which increased from 56.67% coverage in 2014 to 60.00% coverage in 2015 (Table 1).

The number of high density “predictive nuisance” locations also declined fractionally from six points (5.00%) in 2014 to five points (4.17%) in 2015. As in 2014, Bed 12 had the highest percentage of high density points (11.11%). Outside this area, no other bed had more than 3.33% (Bed 14B/C). The majority of the highest density turion points again occurred in areas with shallow water (<5ft) that historically have had dense canopied CLP growth in the spring as well as moderate levels later in the summer. These areas may be producing a “second crop” of plants that sprout from latent turions after the treatment and, consequently, are able to produce turions/maintain the bank at these locations.

We calculated the overall mean density within the study areas at 44.13 turions/m² with a standard deviation of 75.04 turions/m². This was a nearly significant decline from 2014 ($p = 0.057$) when we found a mean of 61.53 turions/m² with a standard deviation of 114.47 turions/m². Visual analysis of the 2014 and 2015 maps suggested the turion bank has been nearly exhausted in most deep water areas over 8ft while shallow areas continue to have regular turions present. Densities continue to be variable with all standard deviations values being greater than the mean. With the exception of Bed 14 (southeast bay) which showed a slight increase, all other areas declined, although none of these changes were significant.

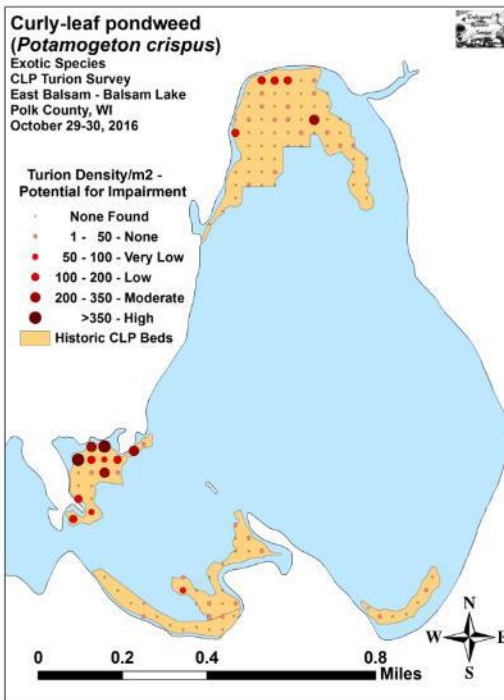
Figure 8: 2016 Fall CLP Turion Survey Density and Distribution

During the October 28-29th, 2016 survey, we found live CLP turions at 45 of 120 points (37.50%) (Figure 8) (Appendix II). This 32.84% decline in distribution from the 67 points with turions (55.83%) in 2015 and a further decline from the 92 points with turions in 2014 (76.67%) suggests the current treatment program has significantly reduced the “turion bank”. When broken down by area, all beds showed a decline except for Bed 12 which remained at 77.78%. No other bed had coverage higher than 33.33% (Table 2).

The total number of high density “predictive nuisance” locations ticked back up to six points (5.00%) from five points in 2015 (4.17%) with all but one occurring in Bed 12. Although Bed 12 has always had the largest percentage of high density points (27.78% of the bed in 2016), the nearly significant increase in density (82.52/m² in 2015 to 145.91/m² in 2016 - $p = 0.057$), and the more than doubling of the number of high density points from two (11.11% of bed) in 2015 to five in 2016 was unexpected based on the successful treatments in this area from 2014-2016.

We calculated the overall mean density within the study areas at 35.70 turions/m² with a standard deviation of 85.86 turions/m². This was a further decline ($p = 0.17$) from the 44.13 turions/m² with a standard deviation of 75.04 turions/m² in 2015 and the 61.53 turions/m² with a standard deviation of 114.47 turions/m² in 2014. Visual analysis of the 2016 map continues to show that the turion bank appears to have been nearly exhausted in most deep water areas over 8ft, and many shallow areas now have only scattered turions present. Densities continue to be variable with all beds having standard deviations values that were greater than the mean. With the exception of Bed 12 (southwest bay), all other area mean densities declined with Bed 14B/C showing a significant decline ($p = 0.17$), and Bed 13 (north bay) a nearly significant decline ($p = 0.06$).

The 2016 turion survey suggests there will again be CLP throughout much of East Long Lake in 2017; however, densities are expected to be quite low with the exception of Bed 12 just northeast of the Big Narrows outlet to the main lake. Despite solid herbicide kill of CLP in this area following the May 2016 treatment, we again witnessed a “second crop” of CLP in the shallower parts of this bay during our July and August landing surveys. It seems likely that these late-growing plants are the reason for the continued moderate to high turion levels throughout much of this area. Because of this localized regrowth, harvesting in this area later in the summer and possibly even the far north shore of Bed 13 in the north bay may be necessary to both relieve navigation impairment as well as eliminate late-growing CLP.

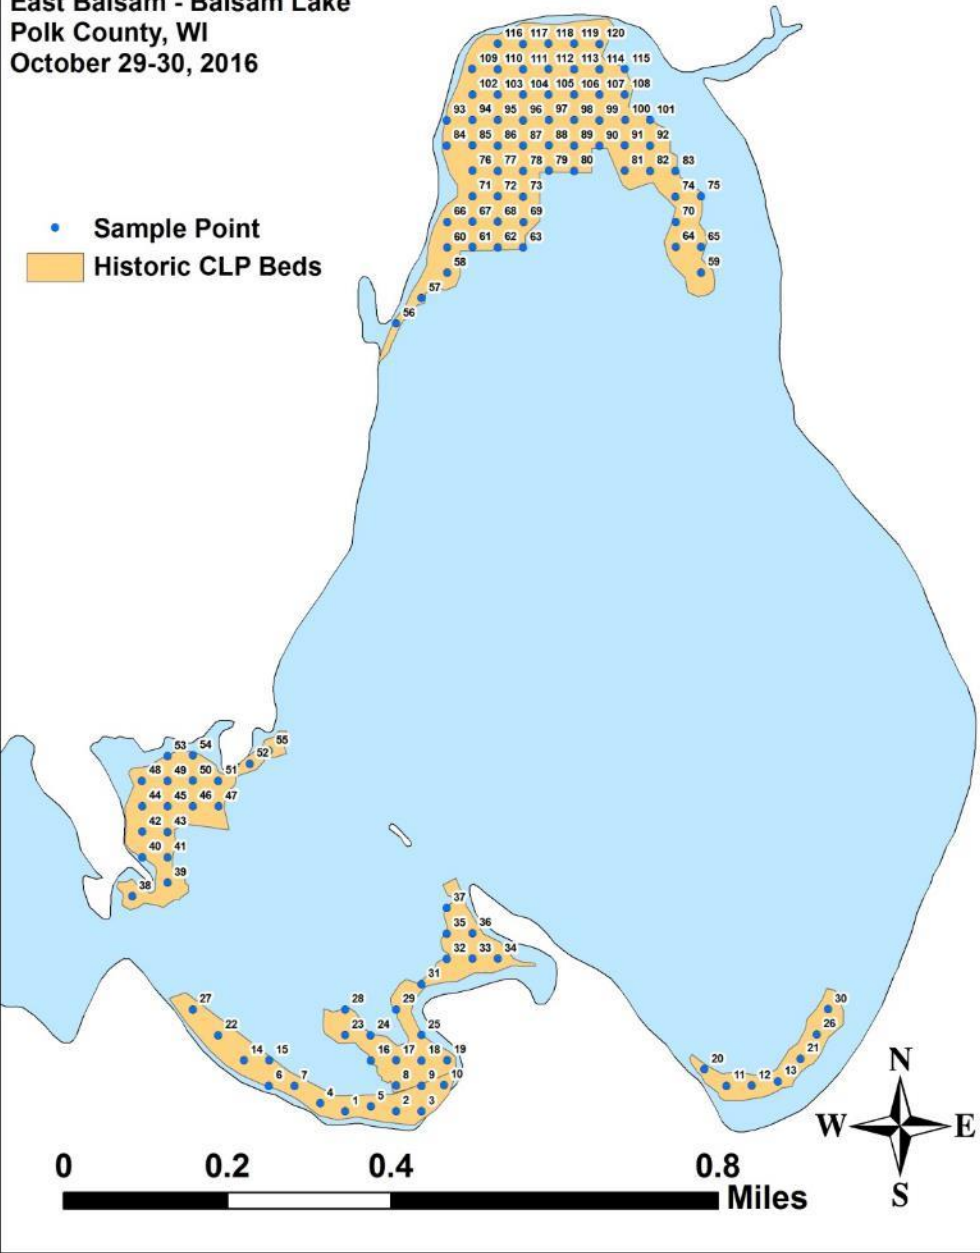
Survey Sample Points

CLP Turion Survey
East Balsam - Balsam Lake
Polk County, WI
October 29-30, 2016

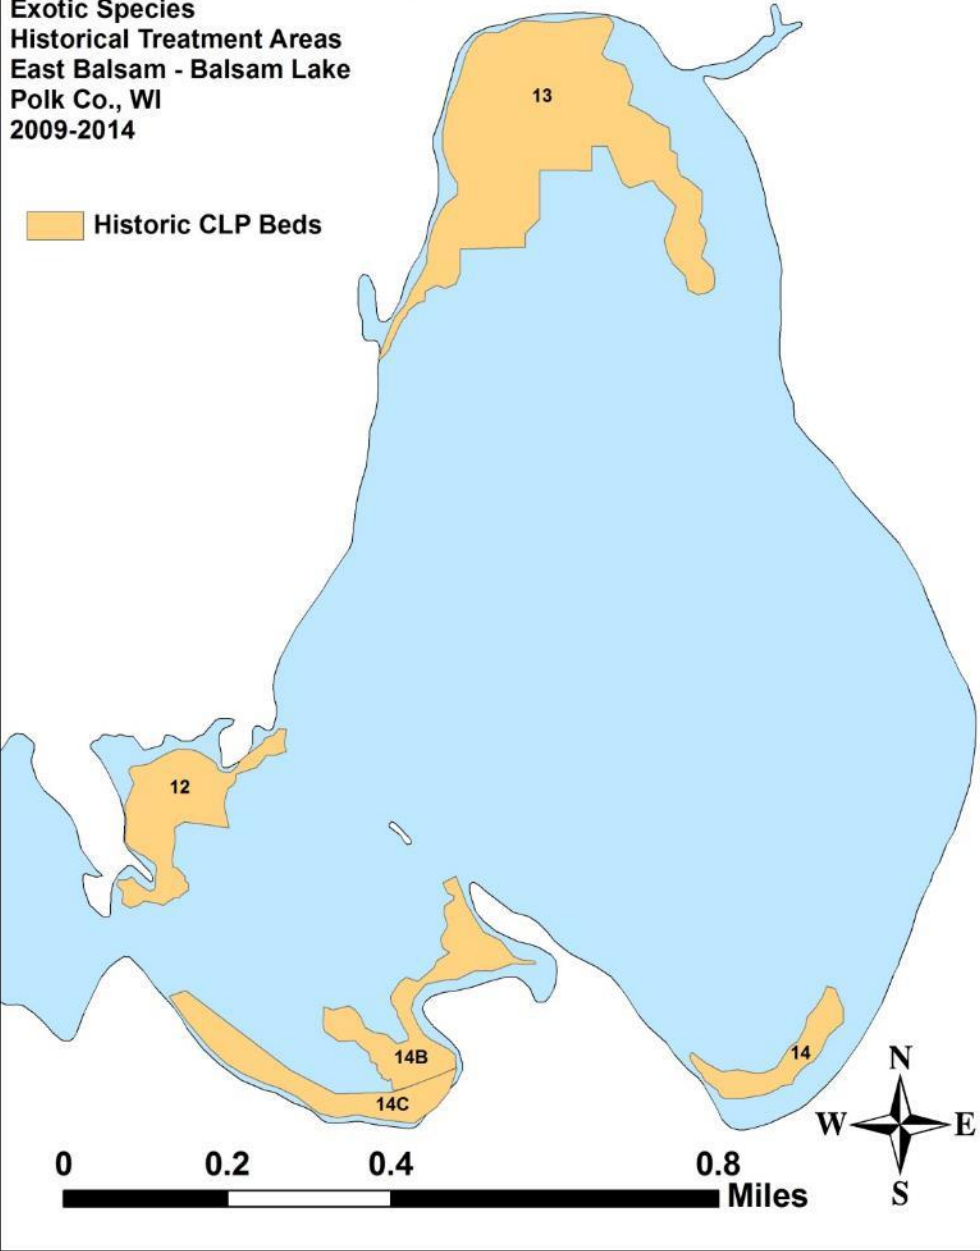
Exotic Species
Historical Treatment Areas
East Balsam - Balsam Lake
Polk Co., WI
2009-2014

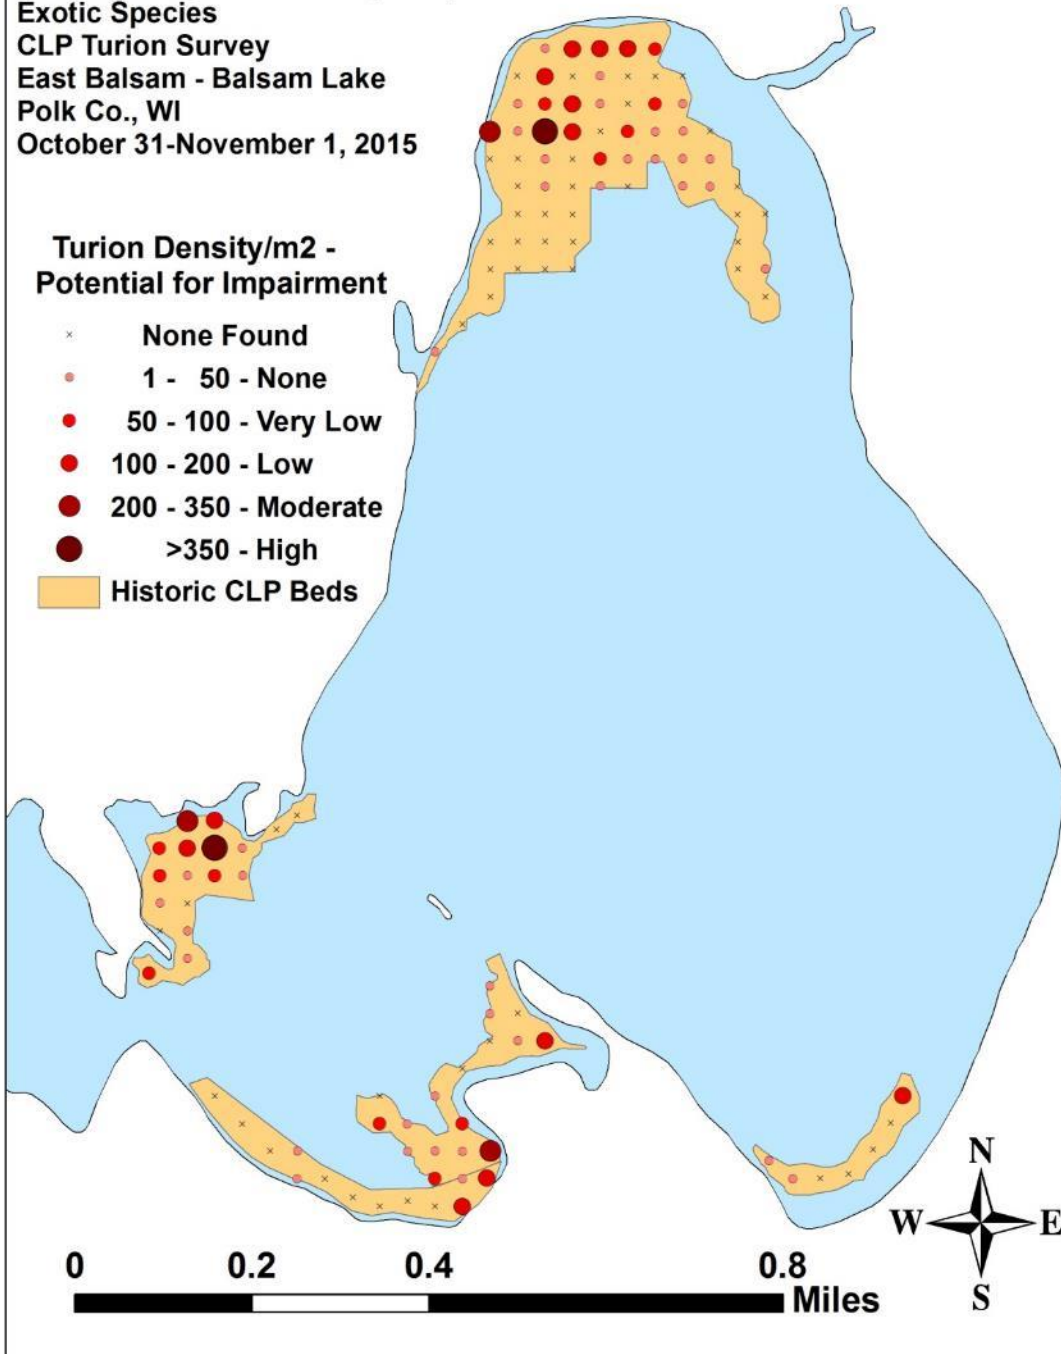
Exotic Species
CLP Turion Survey
East Balsam - Balsam Lake
Polk Co., WI
October 31-November 1, 2015

Turion Density/m² - Potential for Impairment

- × None Found
- 1 - 50 - None
- 50 - 100 - Very Low
- 100 - 200 - Low
- 200 - 350 - Moderate
- >350 - High
- Historic CLP Beds

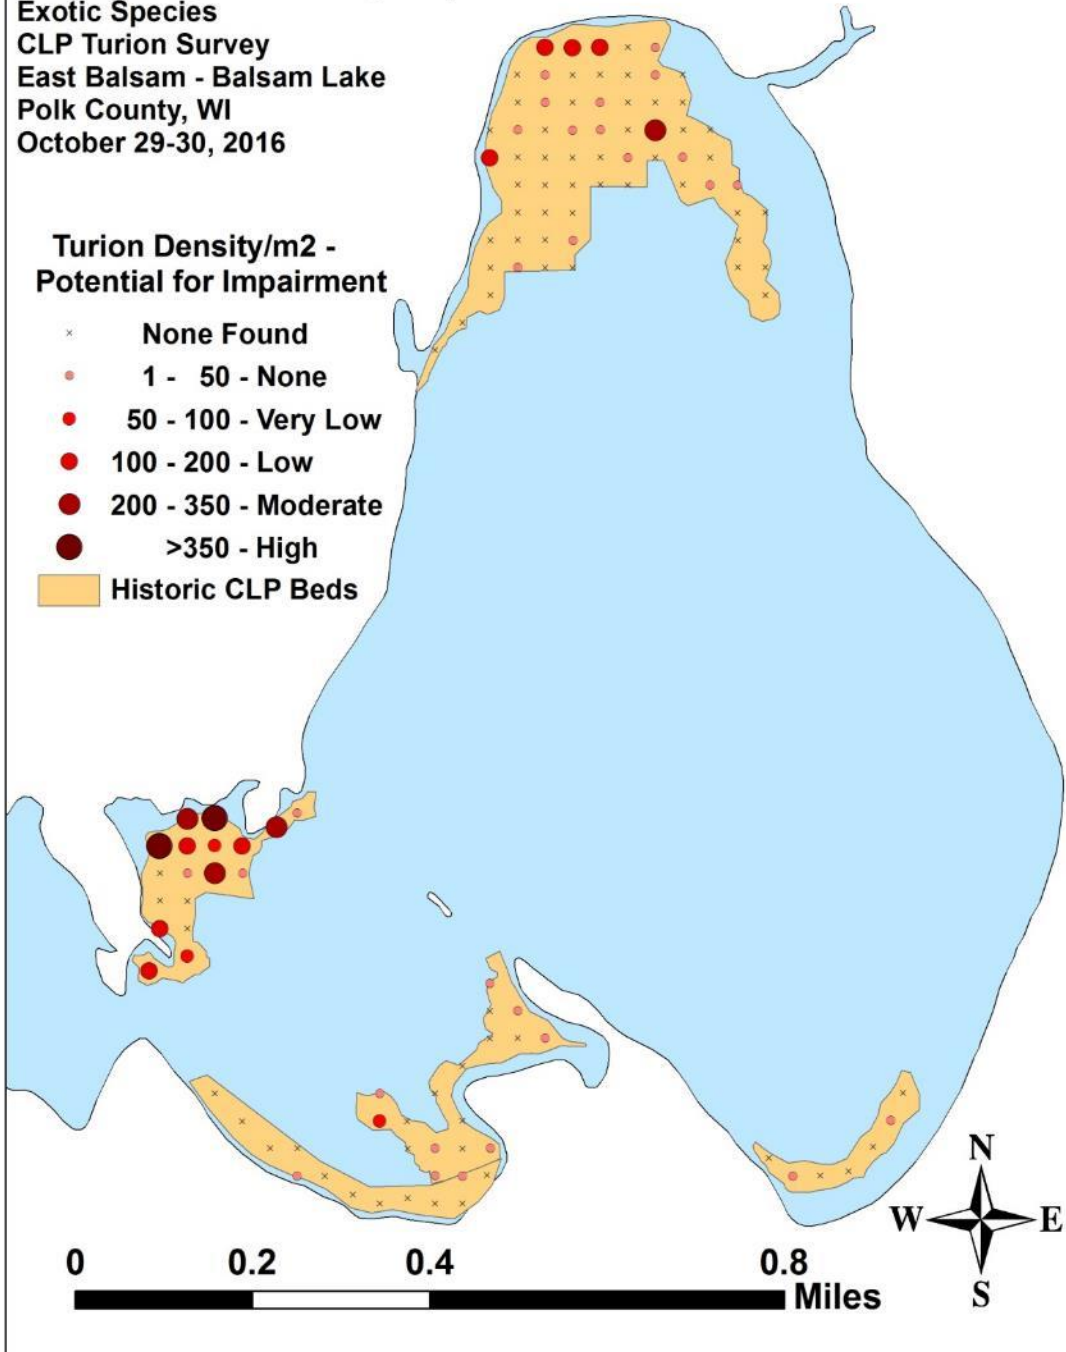
Exotic Species
CLP Turion Survey
East Balsam - Balsam Lake
Polk County, WI
October 29-30, 2016
