Kentuck Lake

Forest / Vilas County, Wisconsin

May 2001

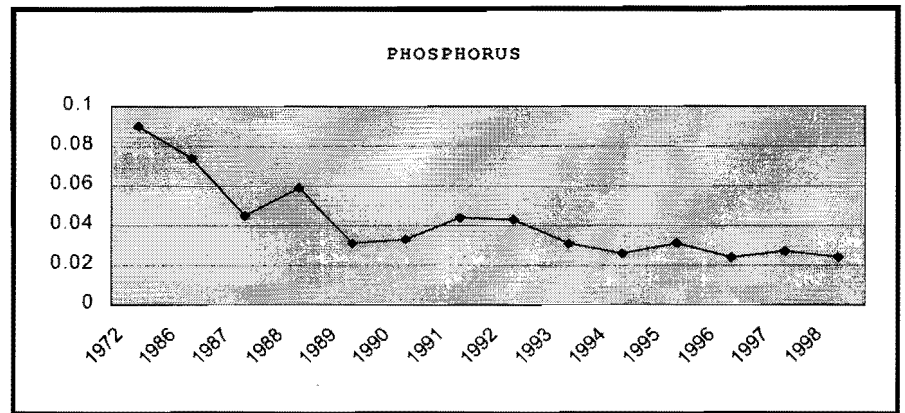
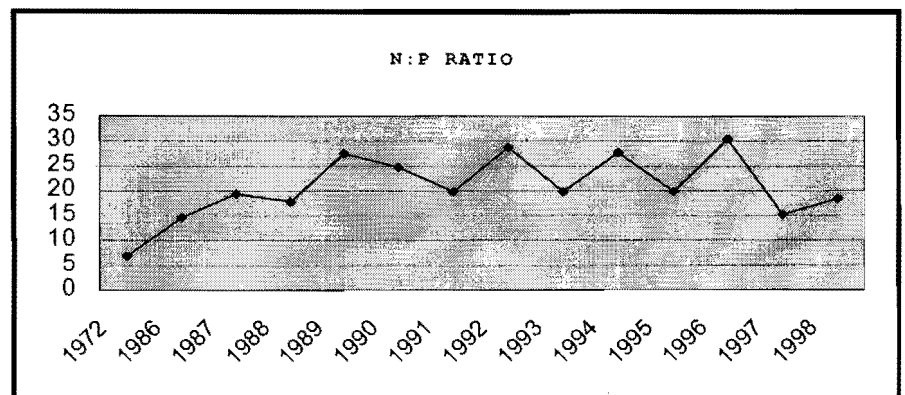
Phosphorus comes from the surrounding shoreline and from the sediments. Removal of shoreline vegetation, fertilization, and improper or insufficient waste treatment (septic systems) can all contribute enormously to the phosphorus loading from the shoreline. Off shore, weed removal and high-impact activities in shallow areas can lead to additional nutrient loading from the sediment. Generally, phosphorus levels of greater than .013 PPM can support nuisance levels of plants and algae. The accompanying graph shows that while the phosphorus levels have remained above that level, that they have decreased significantly over the past thirty years.

Nitrogen levels over that same period have fluctuated but remain within an expected range. Nitrogen levels tend to fluctuate seasonally due to natural processes.

In most lakes, Kentucky among them, nitrogen is present in excess. That means that the amount of phosphorus present determines the amount of plant and algae growth, which in turn affects the fishery, the aesthetics and our lake experi-

ence in general. A ratio of nitrogen to phosphorus of 13 or greater indicates that this is the case.

The third graph on this page shows that ratio over the same period of time.

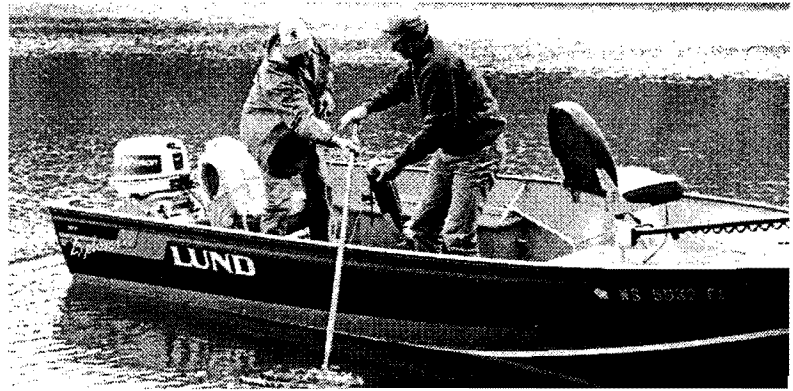
munity in Kentuck Lake has been collected. Studies were performed in 1989, 1993, 1996, 1997 and 1999. The plant community in 1989 was characterized as “recovering” from the effects of the rusty crayfish. Since then, diversity and density of aquatic plants has increased. A good balance of submerged, emergent and floating-leaf vegetation exists. Such a balance is necessary to provide the full compliment of benefits listed above.

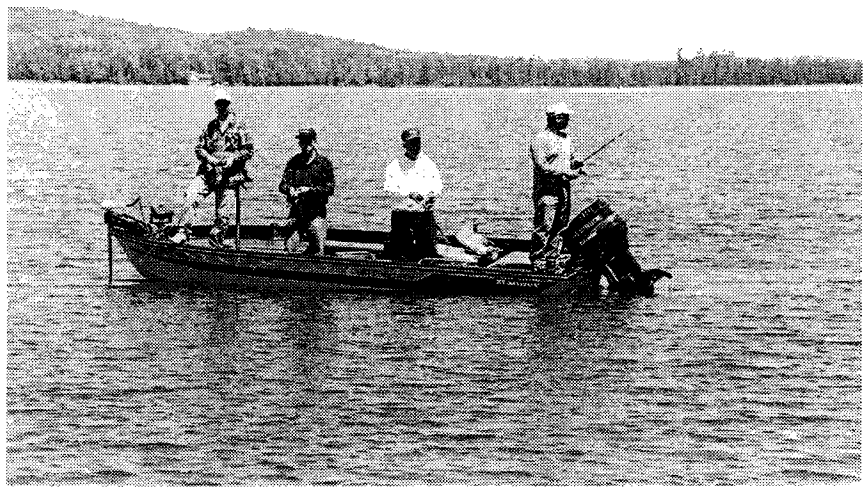
Eurasian water milfoil

Eurasian milfoil has not been reported in Kentuck Lake, but the likelihood of it finding its way here is high. It is important to know how to identify this plant and closely monitor the boatlandings for its presence.
