Loon Lake

Comprehensive Survey Results and Management Plan

February 6, 2003

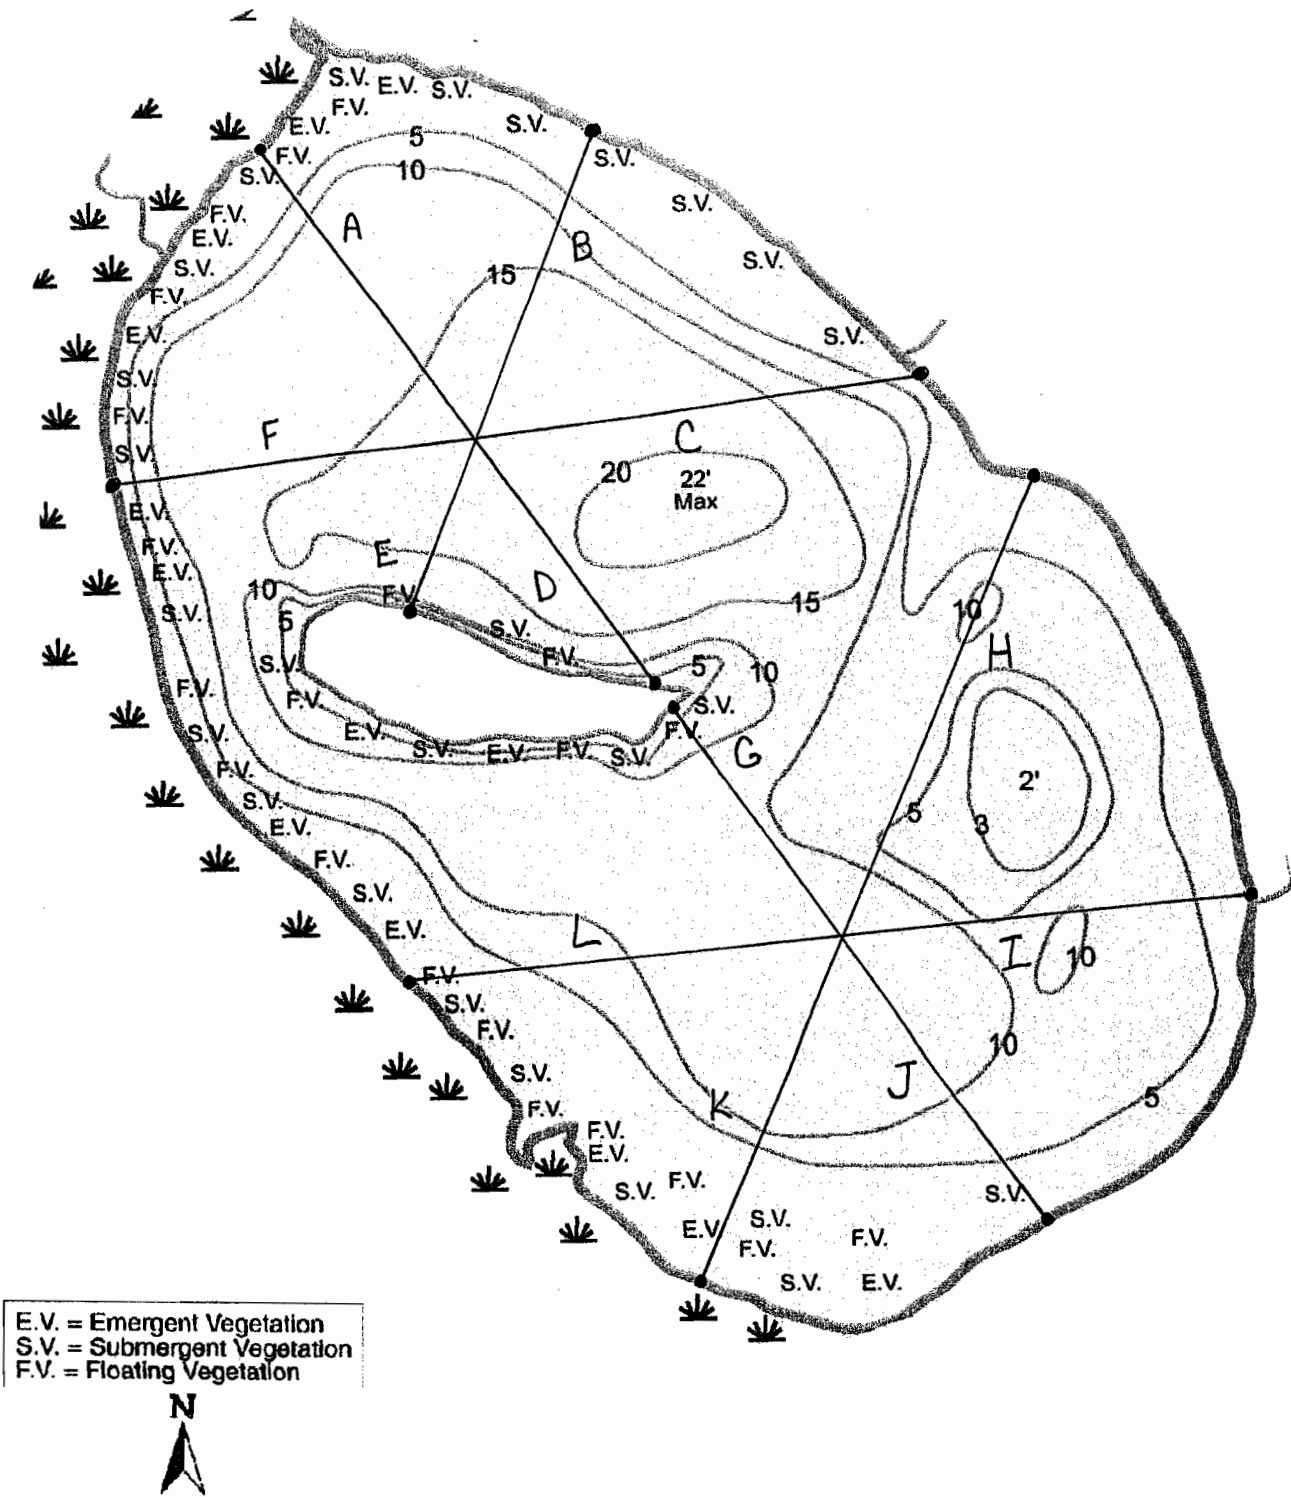
Figure 1. Loon Lake 2002 submergent plant survey transects.

The aquatic plant surveys utilized reproducible methods so that future surveys can accurately assess changes to the plant community. For the first survey, a series of twelve transects (labeled A through L) were laid out on the lake – radiating at 60 degree intervals from two central points in the lake basin (**Figure 1**). While all species encountered were recorded, this survey was more likely to encounter submergent plants and was called the Submergent Plant Survey. Plant samples were collected at four quadrants along each transect at 2.5, 5, 7.5, and 10-foot depths. Samples were collected with a tethered short-toothed rake. Four rake tows were made at each quadrant, for a total of 192 rake tows. All samples collected were identified to *genus* and to *species* whenever possible. Data tabulated included species composition, percent frequency and relative abundance. GPS coordinates for transect starting points are given in **Table 1**.

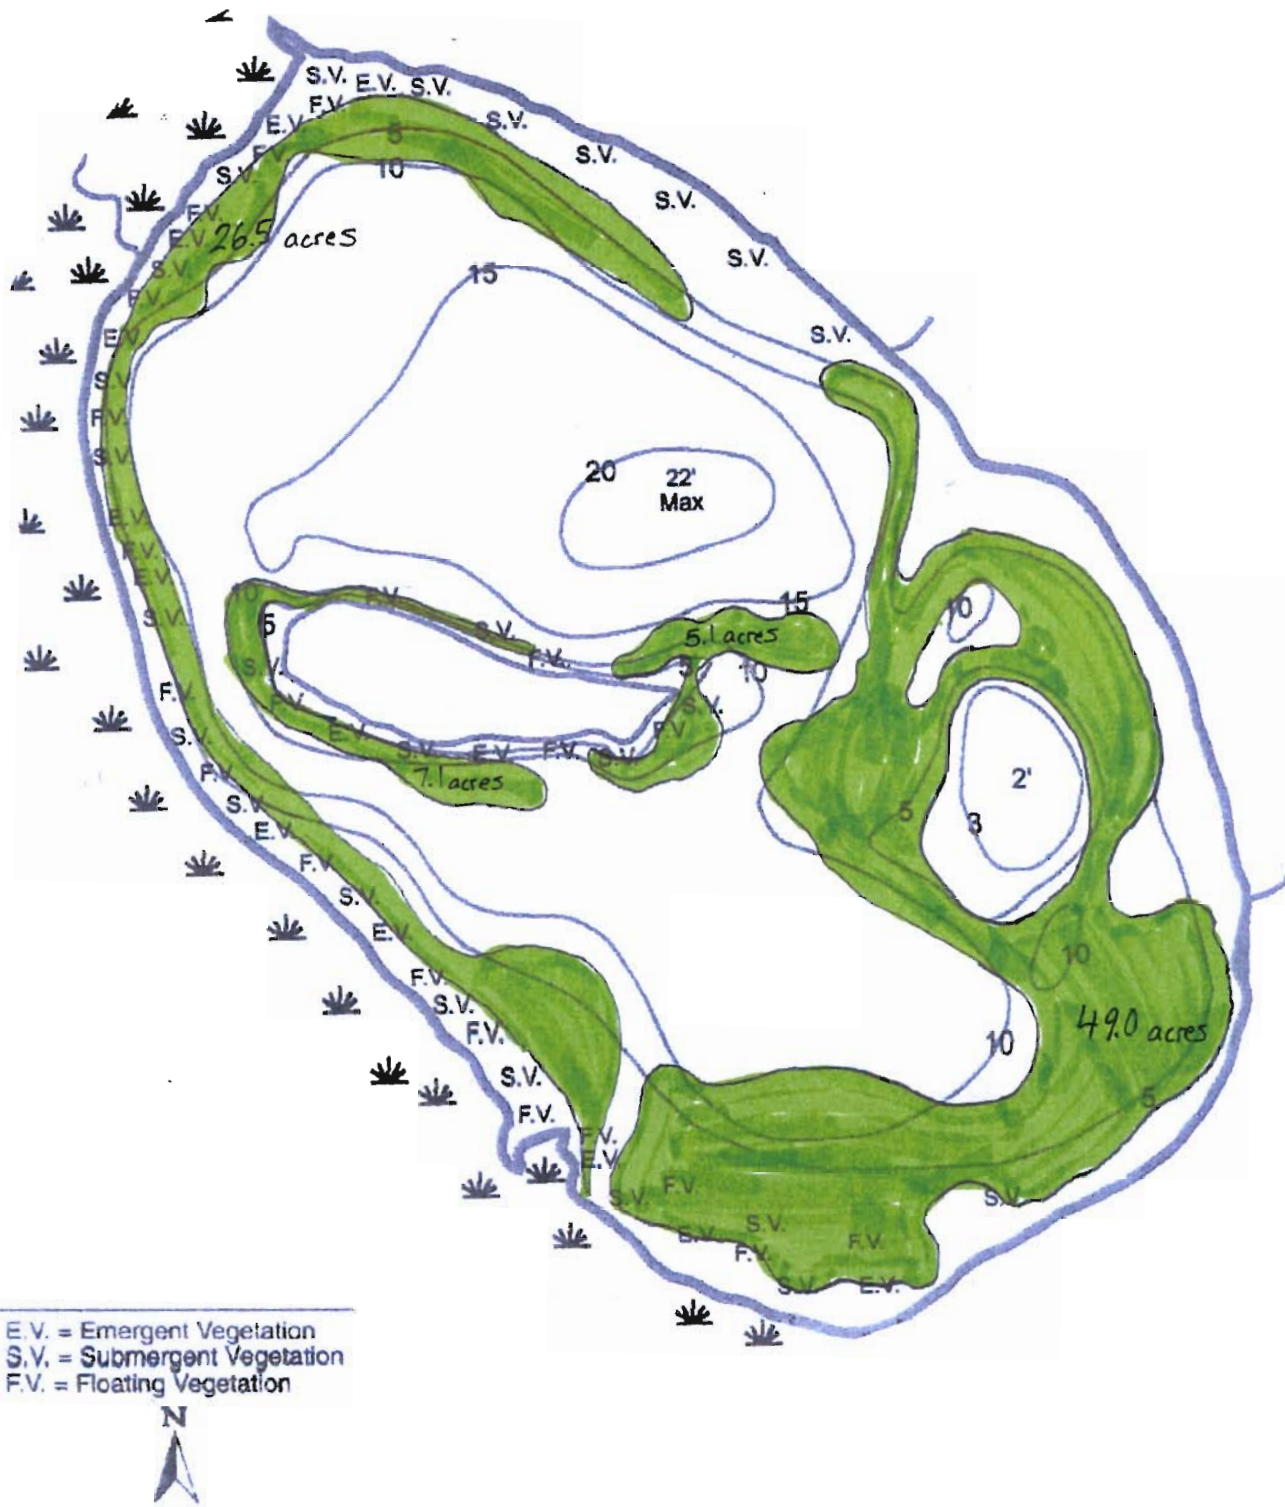
Figure 3. 2002 distribution of Eurasian watermilfoil in Loon Lake.
 Total area = 87.7 acres.

The distribution of Eurasian watermilfoil found during the survey is shown in **Figure 3**. A total of 87.7 acres were mapped. This is approximately 29% of the lake. Eurasian watermilfoil was most abundant in depths of three to ten feet. The maximum depth of the plant was apparently limited by water clarity. The minimum depth of the plant was likely limited by bottom substrate composition or competition from floating-leaf plants.

This conclusion was further supported by late season observations of milfoil growth patterns on Loon Lake. By late summer, the narrow milfoil beds found along the steep-dropping west and north shores (see **Figure 3**) had become very sparse. The much wider beds along the south and east shores though, appeared unchanged. These expansive beds were able to absorb much more wave energy and were not as damaged as the narrow beds across the lake.

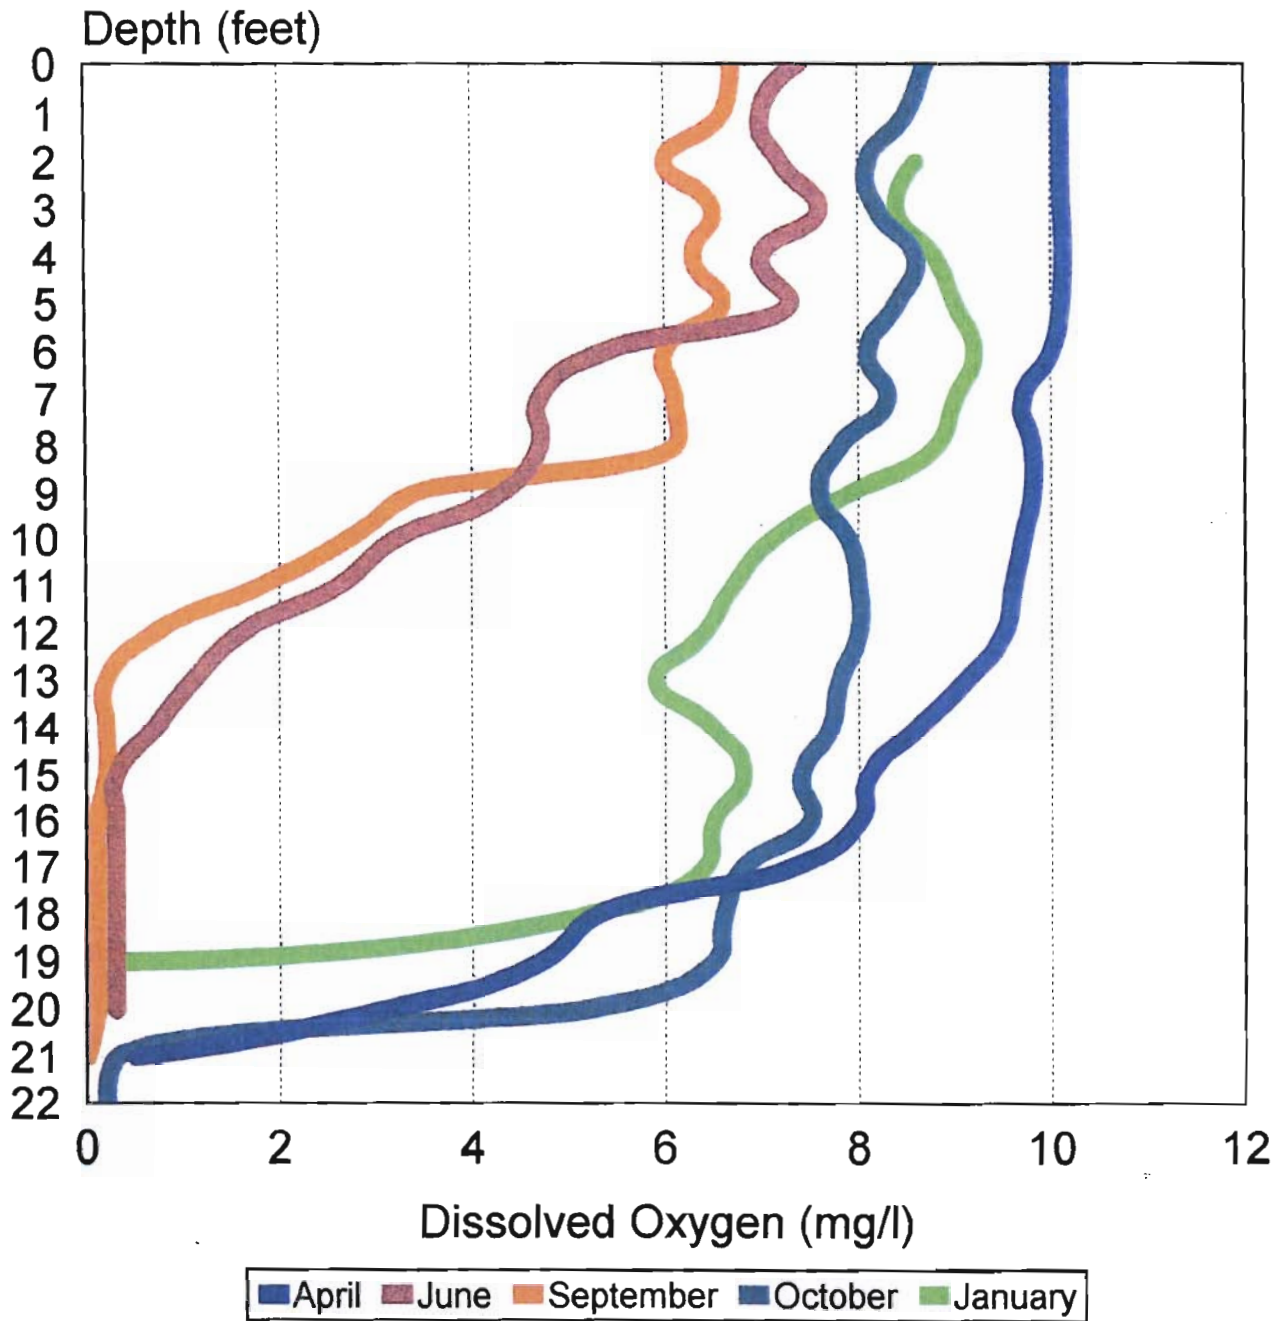
Figure 7. Loon Lake 2002 dissolved oxygen profiles.

Dissolved oxygen and temperature profiles are good indicators of the trophic state, or “age” of a lake. **Tables 9 and 10** show seasonal dissolved oxygen and temperature data collected from Loon Lake during 2002. Data are represented graphically in **Figures 7 and 8**. The dissolved oxygen and temperature profiles found were typical of early stage eutrophic lakes. Thermal stratification was found during June and September. Oxygen stratification occurred on all sample dates. During June and September, oxygen levels would have been stressful to fish below nine feet deep. During the cooler months oxygen levels were generally good above 18 feet deep. The good oxygen profile found during January was not typical of eutrophic lakes. This was probably due to the lack of snow cover on top of the ice sheet. With adequate light penetration, there was little macrophyte die off, and thus below average winter oxygen depletion.

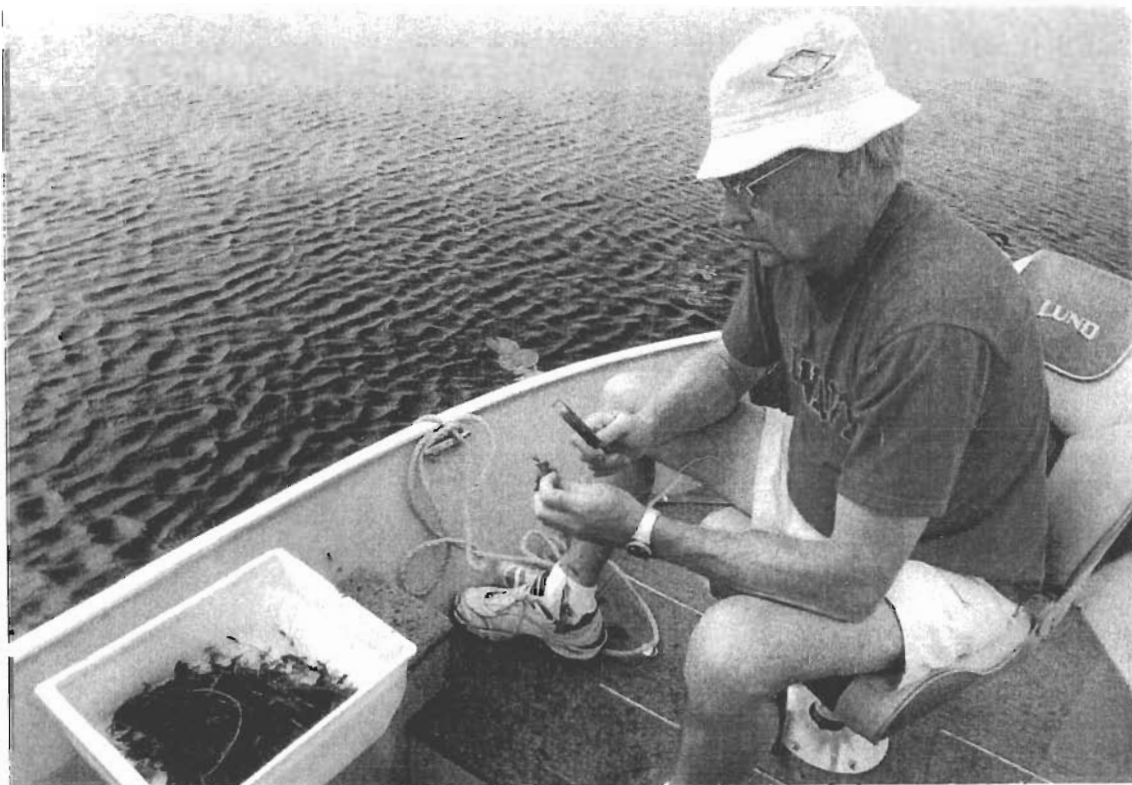
Lloyd Knope assessing milfoil stem damage.

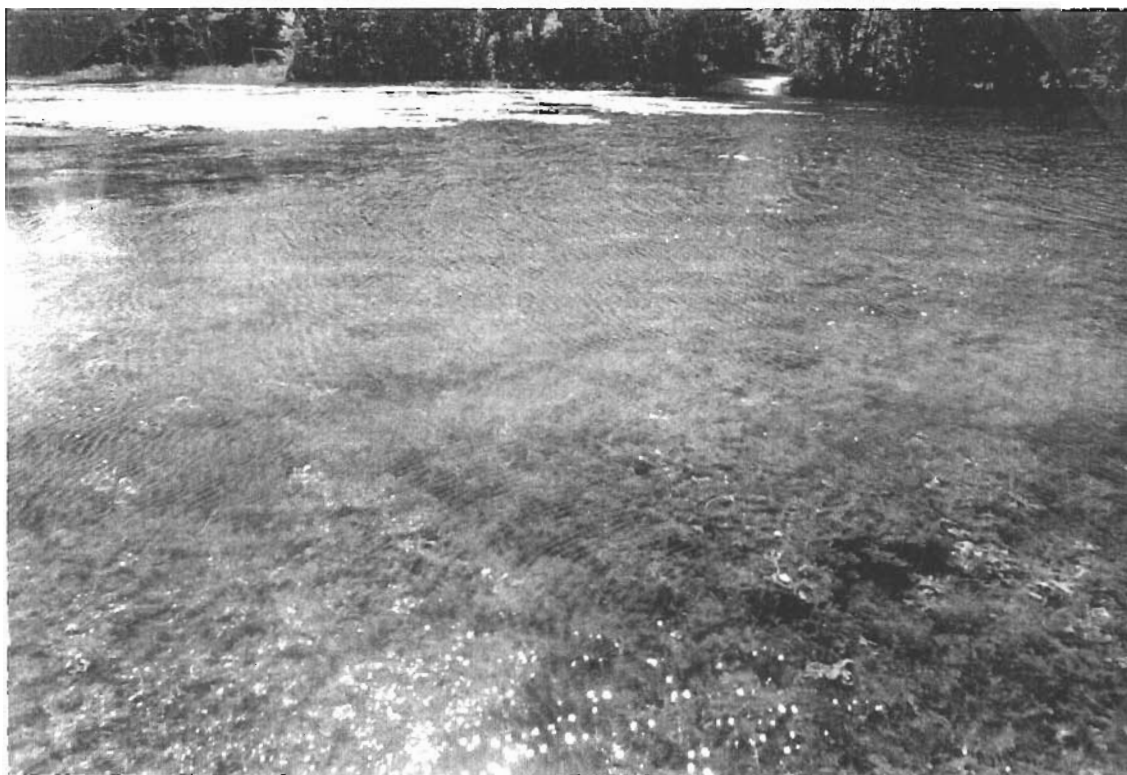
In contrast to Loon Lake, milfoil beds on Lulu Lake were extremely dense.

The characteristics of Eurasian watermilfoil on these two lakes were very different. Milfoil beds on Lulu were extremely dense and grew to the surface. These beds were monotypic, meaning that other species were crowded out. Outwardly, Lulu lake milfoil appeared vibrant and healthy. When plants were disturbed or handled though, they easily broke apart due to the extensive insect boring in the stems. While milfoil beds on Loon Lake were dense enough to be considered a major nuisance to lake users, the beds were not nearly as dense as those found on Lulu Lake. Despite its widespread occurrence in Loon Lake, Eurasian watermilfoil seldom formed monotypic beds. The milfoil beds were often sparse enough to allow native plants to coexist. It was concluded that this growth characteristic was influenced by milfoil weevils.

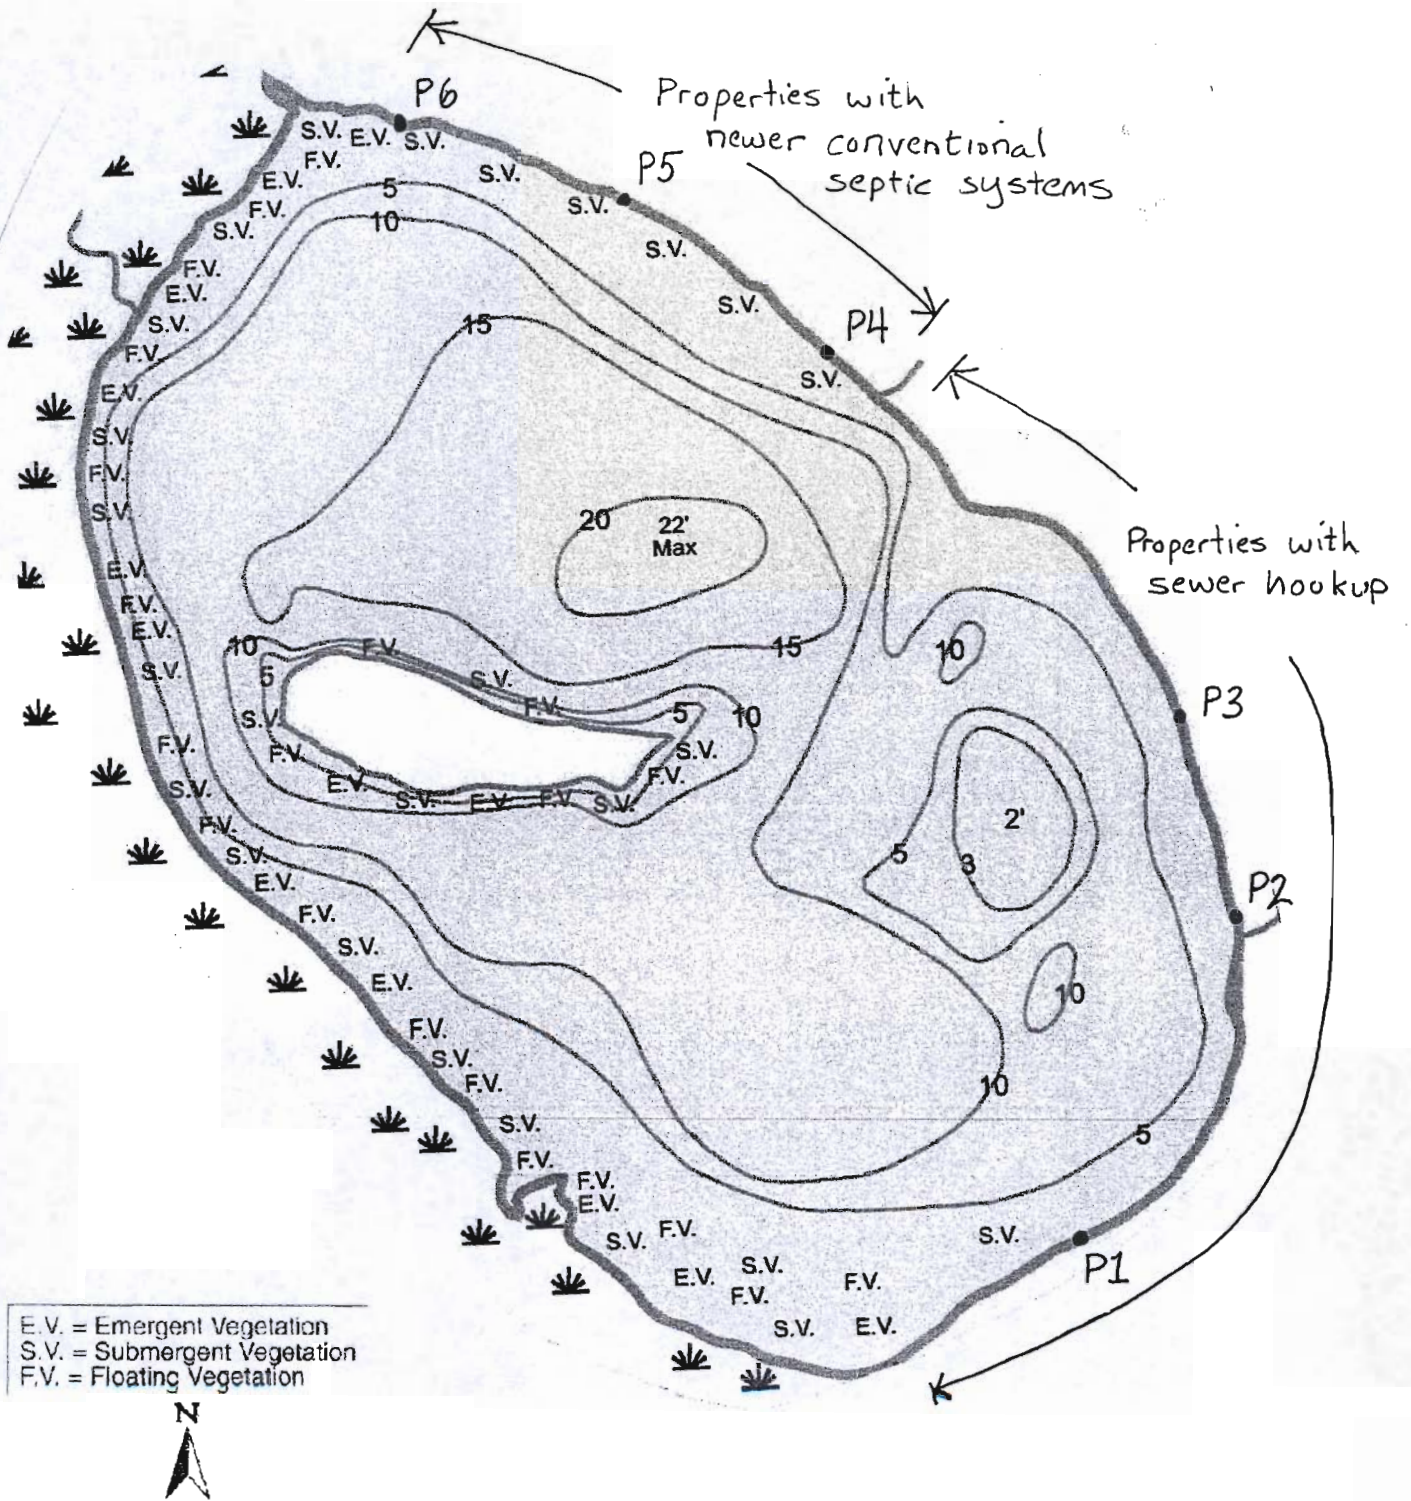
Figure 10. Loon Lake piezometer locations for groundwater flow analysis.

<u>Site</u>	<u>Piezometer reading</u>	<u>Direction of flow</u>
P1	8.7 mm	inflowing
P2	31.8 mm	inflowing
P3	44.5 mm	inflowing
P4	0.0 mm	static
P5	0.0 mm	static
P6	3.2 mm	inflowing

groundwater flow occurred at these sites, it was concluded that groundwater contamination from septic systems poses little risk to Loon Lake.
