**DESAIR LAKE RESTORATION, INC.
LAKE MANAGEMENT REPORT OF ACTIVITIES
AUGUST 2003 – MAY 2006**

Cedar Corporation
604 Wilson Avenue
Menomonie, WI 54751

May 2006

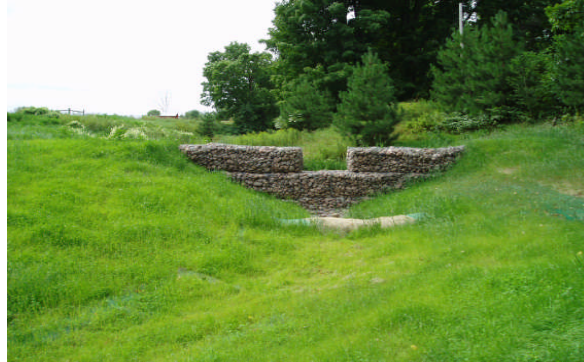
A series of rock gabion dams were installed along the swale creating check dams that would reduce runoff water velocity during runoff events and create sedimentation/ infiltration ponds to reduce sediment loading of runoff water.

Rock Gabion in restored Swale

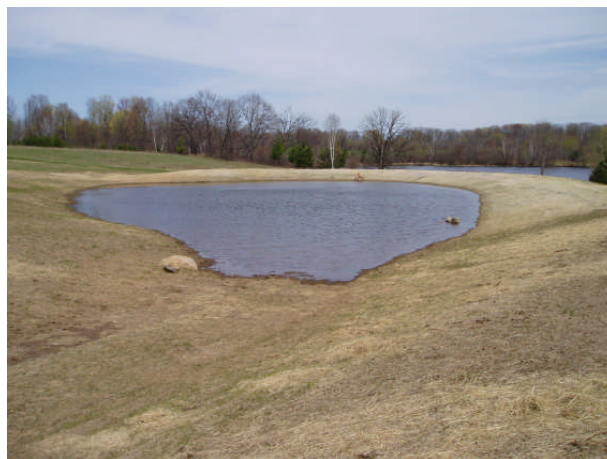
Installed on Rod Olson’s property to minimize runoff water from former agricultural fields and upstream forested areas, the pond is a simple retention pond with overflow to allow sediment stilling and a controlled discharge of the runoff water (Appendix J). The construction included stream bank restoration and erosion reduction projects at road and bridge crossings upstream of the pond. The pond controls erosion runoff from a cropland and wooded area of approximately 40 acres.

Olson Pond at Beginning of Restoration

This project involved diverting a waterway that drained 37 acres directly into the lake into a constructed basin. It has a pond area of about .5 acres. It is able to fill during a runoff event to a

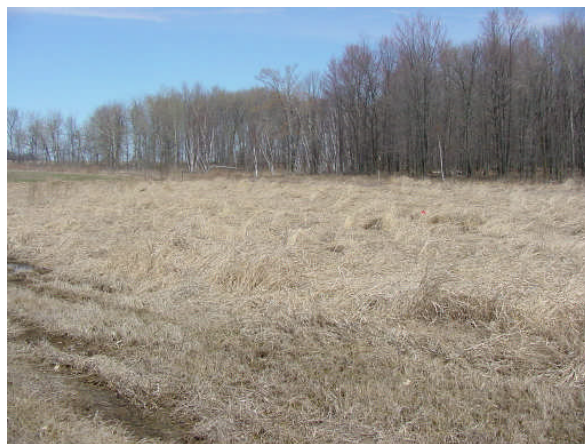
Before

The site was reed canary grass meadow surrounding an existing pond at the edge of a farm field. A drainage ditch had been constructed draining water to the East and eventually the south end of Lake Desair. Approximately 80 acres of cropland drains into and out of the wetland.

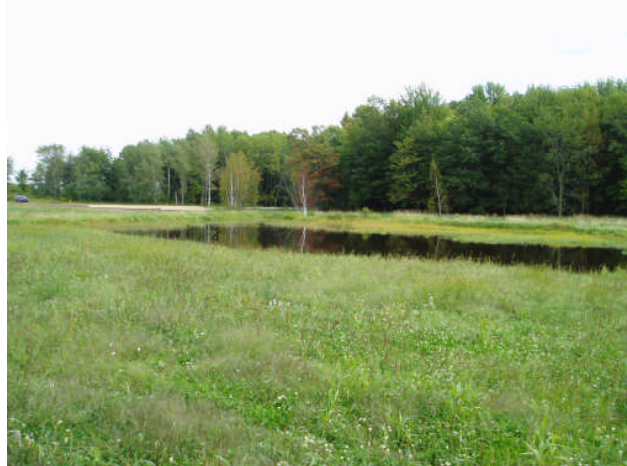
After

In the fall of 2003 the Reed Canary grass was scraped and removed. In the spring of 2004 a 4' high 200' long embankment was constructed using material from borrow sites adjacent to the dam. This created 2 additional 8' ponds on the site.

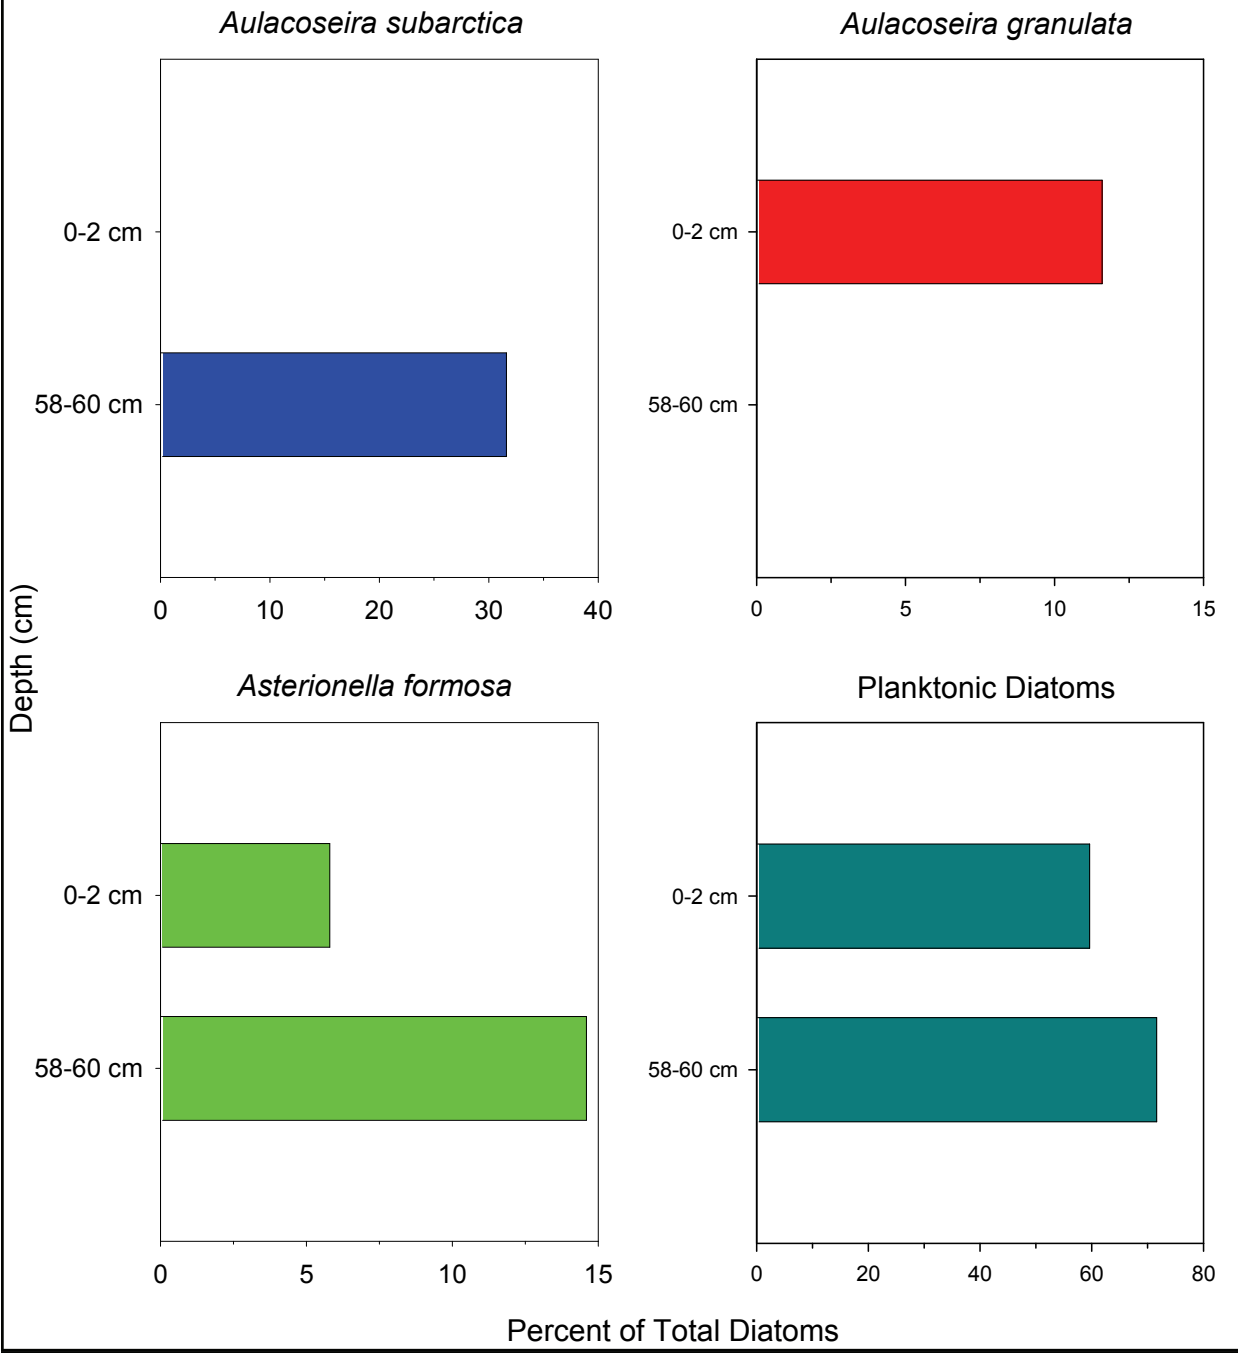
Figure 3. Changes in abundance of common diatoms found at present and presettlement times. *A. subarctica* is a planktonic diatom that is found under low nutrient levels. *A. granulata* indicates eutrophic phosphorus levels while *A. formosa* is found under moderate nutrient conditions.

The diatom community at the bottom of the core is much different than the one at the top. In fact the difference is greater than I have observed in any other lake. The difference is so great that none of the common species at the bottom are common at the top of the core. Although the percentage of planktonic diatoms (those that typically are found floating in the open water) at the top of the core is less than at the bottom by about 10% (Figure 3), the biggest difference is in species composition. Historically, the dominant diatom was *Aulacoseira subarctica*. This species is found in low nutrient conditions and often very softwater. This species was absent from the top of the core and was replaced by other *Aulacoseira*, e.g. *A. granulata* and *A. ambigua* (Figure 3). These species are typically found at higher nutrient levels, especially *A. granulata*. Other species which were common at the top of the core were *Fragilaria vaucheriae* and *F. capucina* var. *mesolepta* which also are found under elevated nutrient levels. The abundance of *Asterionella formosa* is more common at the bottom of the core. Its decline is also an indication of higher nutrient levels since it prefers moderate nutrient levels.
