Shoreland Survey Report

Round Lake, 2016

Sawyer County, Wisconsin

**Project initiated by:
Round Lake Property Owners Association**

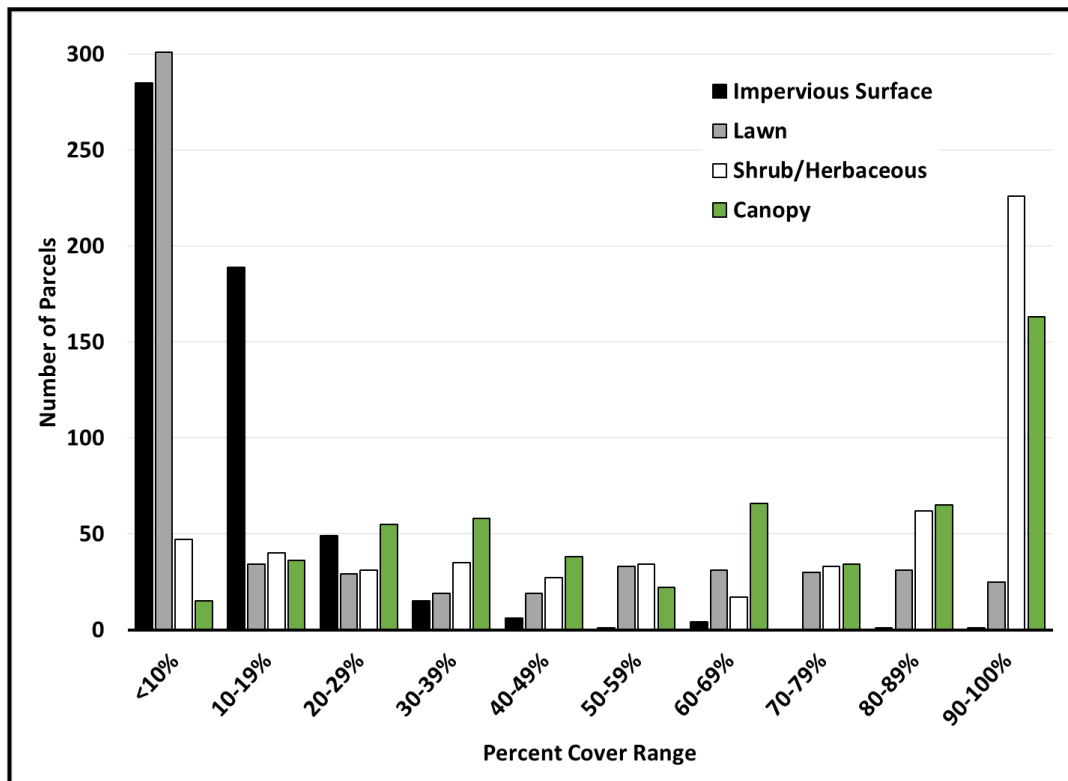
Figure 3 – Riparian Zone Percent Cover Graph

Many land parcels (41%) had 90-100% shrub and herbaceous cover within the 35-foot riparian zone (Figure 3, Table 2). There was at least 60% shrub and herbaceous cover at three-fifths of the parcels, but lower shrub and herbaceous cover (less than 60%) at the remaining two-fifths of parcels. Shrubs are woody plants with multiple stems and small trees less than 16 feet tall while herbaceous plants are plants without woody stems such as grasses, sedges, forbs, etc. Low shrub and herbaceous cover are the orange and red areas in Figure 7.

Impervious surfaces were the least common cover type in the riparian zone with 86% of parcels having less than 20% impervious surfaces (Figure 3, Table 2). This cover type includes the area where all or the majority of precipitation is released as runoff (e.g. rooftops, sidewalks, driveways, parking lots, concrete, boulders, stone, wooden decks, compacted gravel/soil, and boats flipped over on shore). Rocks used for rip rap also count as impervious surface. Very few areas of concern are illustrated in the map of impervious surfaces (Figure 5).

Lawn was a moderately common cover type in the riparian zone with one-third of parcels having greater than 40% lawn cover (Figure 3, Table 2). Lawn is grass that is mowed short illustrated as orange and red areas in Figure 6. Many of the areas with high lawn cover are the same areas as those with low shrub and herbaceous cover. Only 16% of parcels had riparian cover of 10% or higher that was classified as “other”. Some types of “other” riparian cover were sand, bare soil, duff, flowers, and mulch.

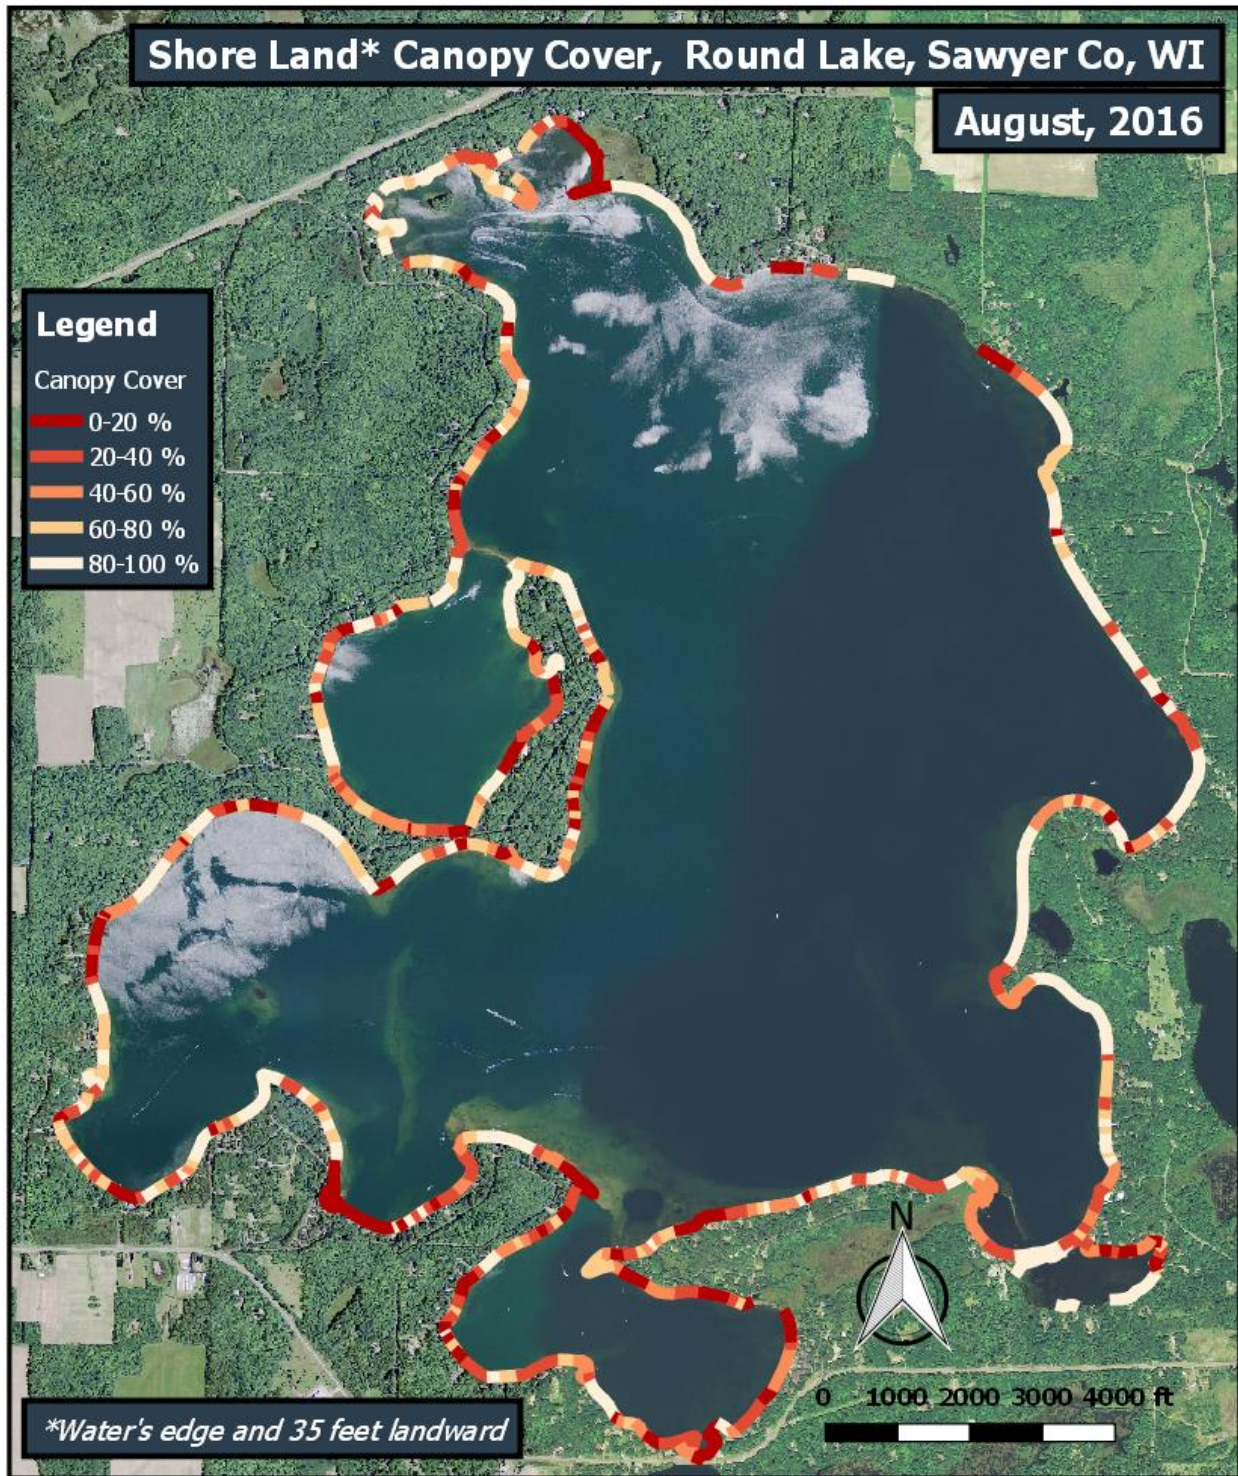
Figure 8 - Canopy Cover for the Riparian Zone of Round Lake

Canopy cover less than 60% was documented at nearly half the parcels. The canopy includes the cover of trees that are at least 16 feet tall. Because the tree canopy can overlap the other riparian cover types, canopy cover could range from 0%-100% independent of the other riparian cover types. Figure 8 illustrates low canopy cover with orange and red areas.
