Herbicide Treatment Analysis for *Potamogeton crispus*

Bone Lake, Polk County WI

2017

**Surveys, mapping and analysis provided by: Ecological Integrity Service, LLC
Amery, Wisconsin**

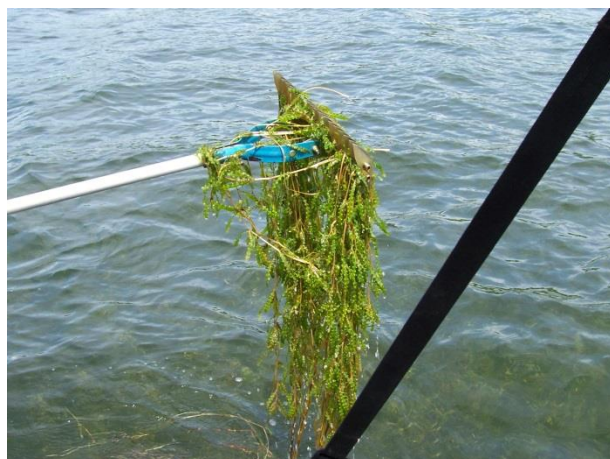
Figure 4: Density rating system and example CLP rake sample.

The second survey is referred to as the post treatment survey. This survey involves going to the same GPS coordinates as the pre-treatment survey and doing a rake sample at the point. If any CLP is on the rake, the density of the CLP is recorded (see Figure 2 for reference). All other species are also recorded from the rake sample in order to verify no damage to the native plants.

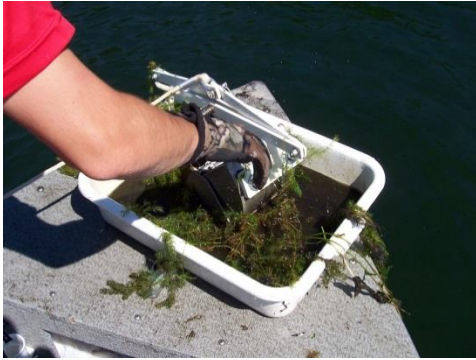
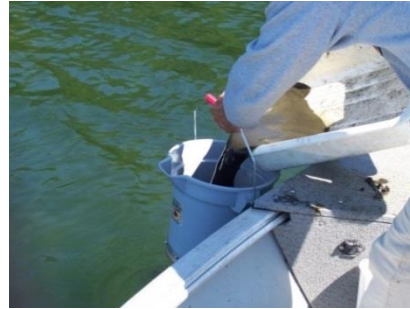
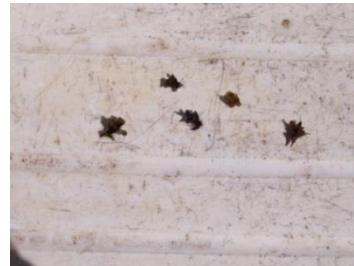
Figure 5: Pictures showing turion density methods. A shows sediment sample; b shows separation; c Shows separated turions.

In order to reflect potential future growth and the cumulative success of treatments, a turion analysis is conducted in the fall following treatment. This analysis involves going to sample points near the middle of the CLP bed (assuming this will reflect the highest density). At each sample point a sediment sampler is lowered to the lake sediment and a sediment sample is obtained. Two samples are obtained from each side of the boat at each location. The samples are then sifted with a screened bucket to isolate the turions. The turions are then counted and the density of turions is calculated in turions/square meter. Consistently successful treatments should show a trend of reduced turion density each year. This way

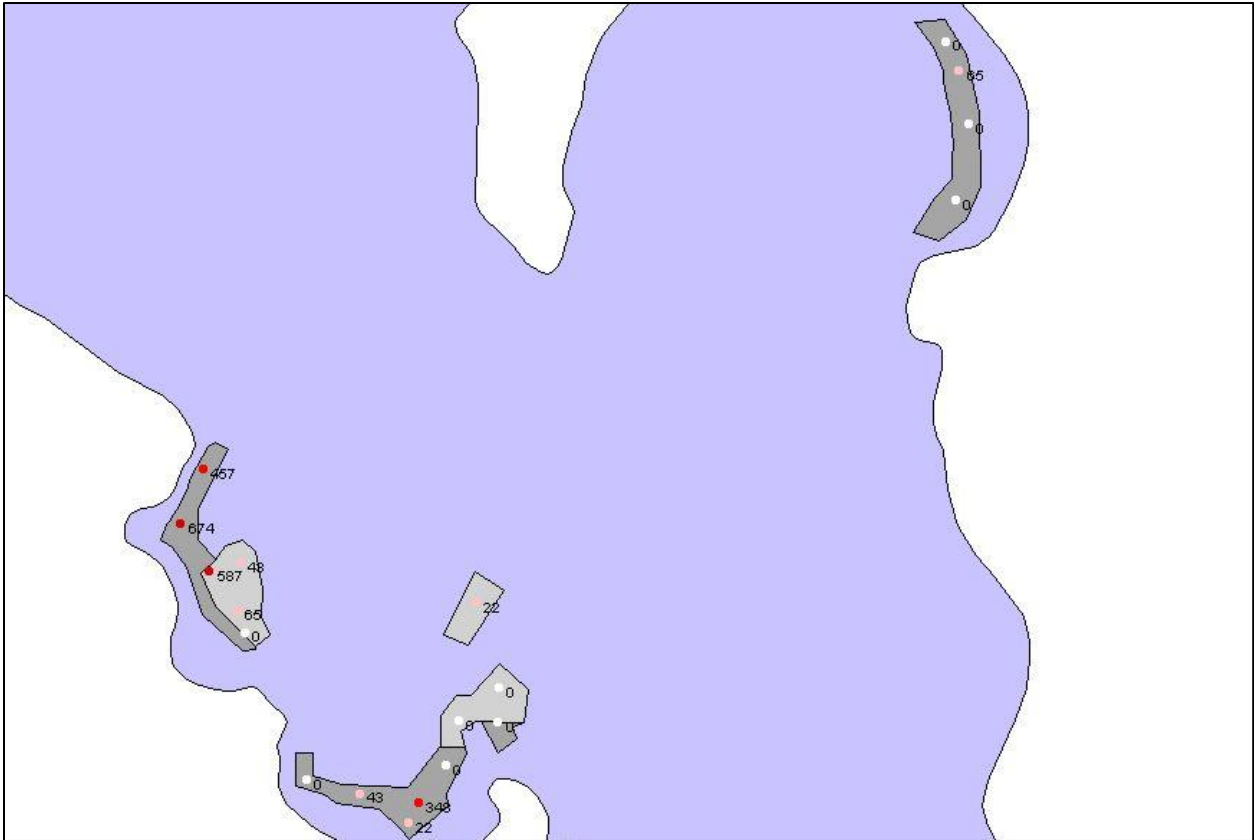
Figure 14: Turion density map for beds 5, 7 and 8.
