**Herbicide Treatment Analysis for *Potamogeton crispus***

***Bone Lake, Polk County WI***

**2017**

**Surveys, mapping and analysis provided by: Ecological Integrity Service, LLC  
Amery, Wisconsin**

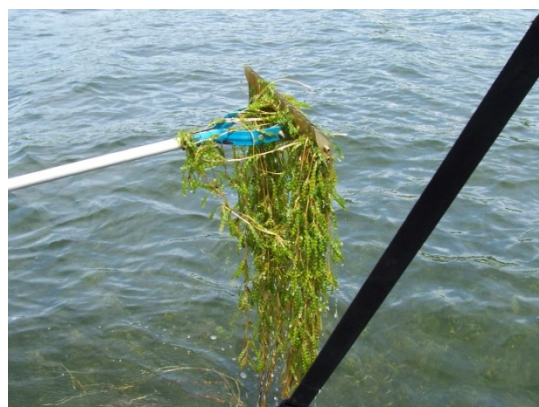
Figure 4: Density rating system and example CLP rake sample.

The second survey is referred to as the post treatment survey. This survey involves going to the same GPS coordinates as the pre-treatment survey and doing a rake sample at the point. If any CLP is on the rake, the density of the CLP is recorded (see Figure 2 for reference). All other species are also recorded from the rake sample in order to verify no damage to the native plants.

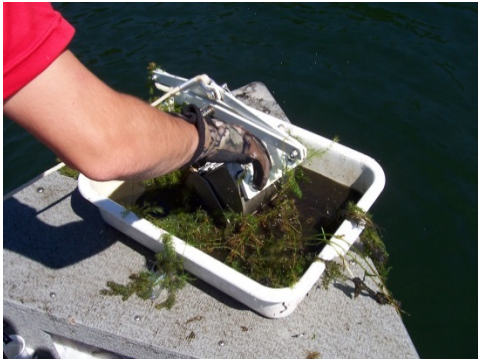
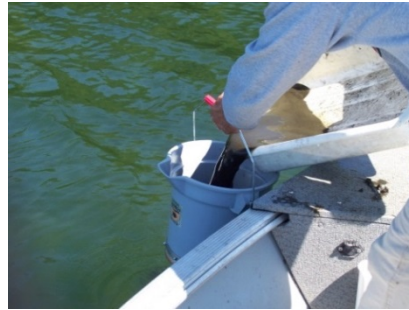
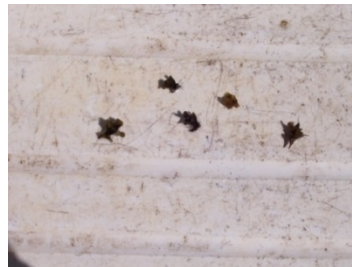
**Figure 5: Pictures showing turion density methods. A shows sediment sample; b shows separation; c Shows separated turions.**

In order to reflect potential future growth and the cumulative success of treatments, a turion analysis is conducted in the fall following treatment. This analysis involves going to sample points near the middle of the CLP bed (assuming this will reflect the highest density). At each sample point a sediment sampler is lowered to the lake sediment and a sediment sample is obtained. Two samples are obtained from each side of the boat at each location. The samples are then sifted with a screened bucket to isolate the turions. The turions are then counted and the density of turions is calculated in turions/square meter. Consistently successful treatments should show a trend of reduced turion density each year. This way we know the treatments are killing plants prior to turion production, resulting in overall reduction in CLP in those beds.

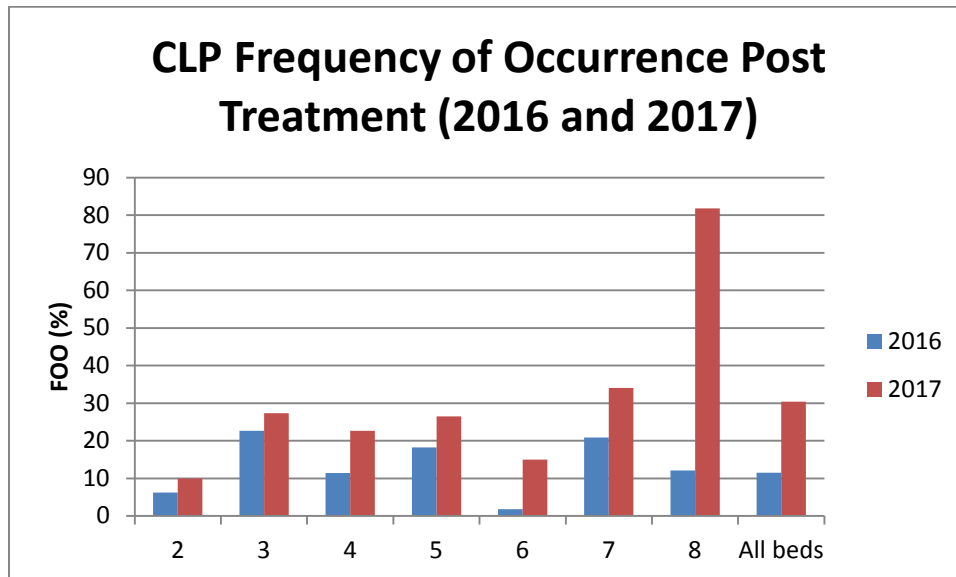
Figure 6: Frequency of occurrence of CLP after treatment 2016 to 2017 in each treatment bed.

A comparison between the 2016 post treatment frequency/density to the 2017 post treatments shows an increase in frequency in all beds from 11.5% in 2016 to 30.4% in 2017, which was significant. There was varying increases in frequency in each bed from 2016 to 2017.

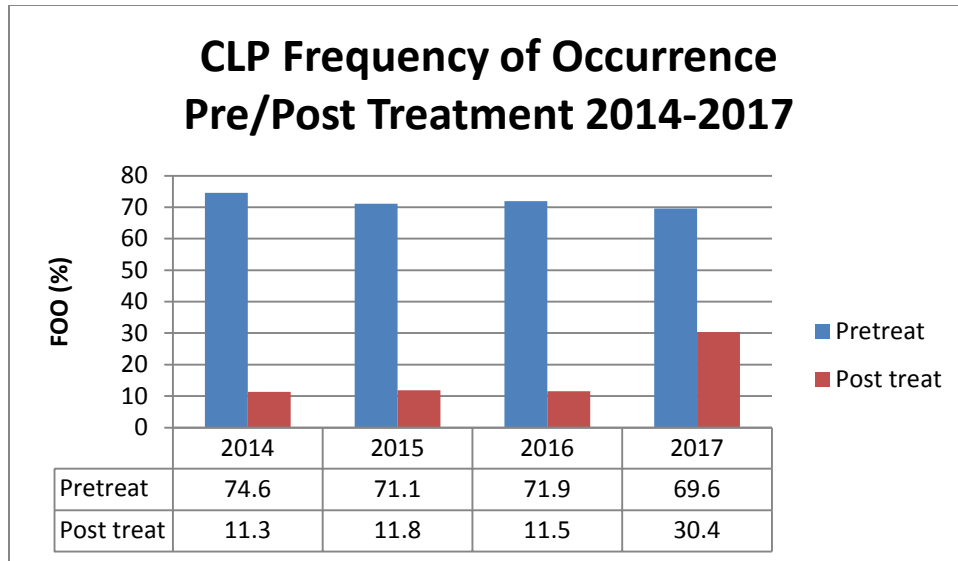
**Figure 7: Frequency of occurrence of CLP in all beds pre and post treatment 2013-2017.**

As the data shows, there was a significant reduction in CLP when comparing the pretreatment survey (April) of 2017 and the post treatment survey (June) of 2017 (69.6% to 30.4%). After the 2016 treatment, the CLP growth returned filling in much of the treatment polygons leading to a high frequency in the April pretreatment survey. After treatment occurred, the post treatment survey in June showed the frequency was significantly reduced.

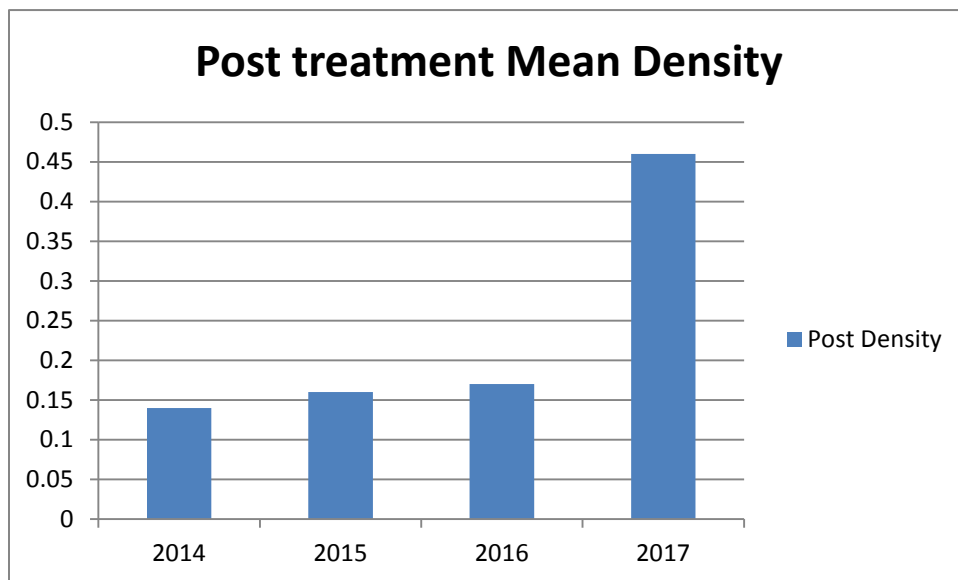
**Figure 8: CLP mean density 2013-2017, all treatment beds (scale of 0-3).**

Density is also determined in the post treatment surveys only. Table 5 and Figure 8 show changes in mean density from the last three post treatment survey years.

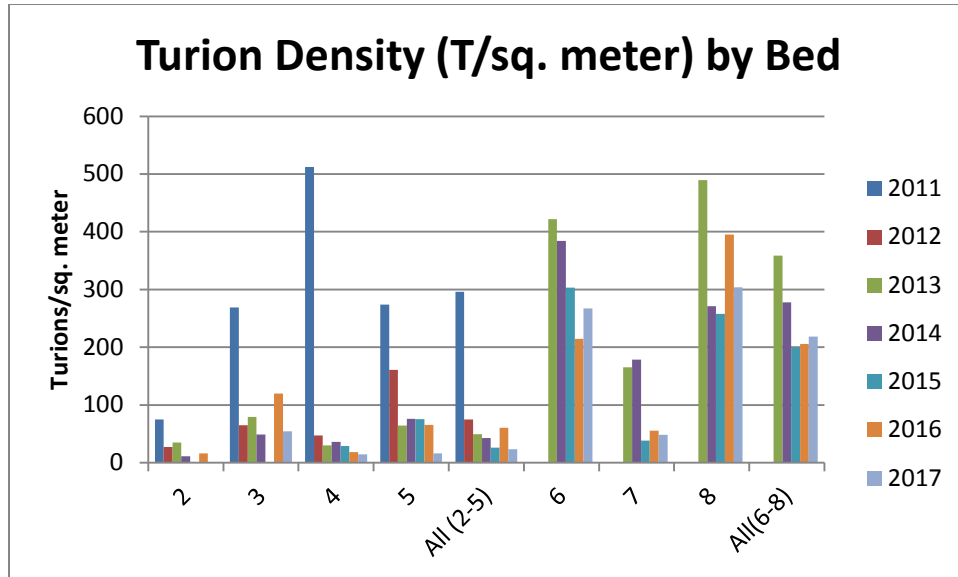
Figure 16 is a bar graph of the turion density by bed and all beds combined (separated as beds 2-5 and 6-8 due to total years of treatment).

Figure 16: Turion density by bed 2011-2017.

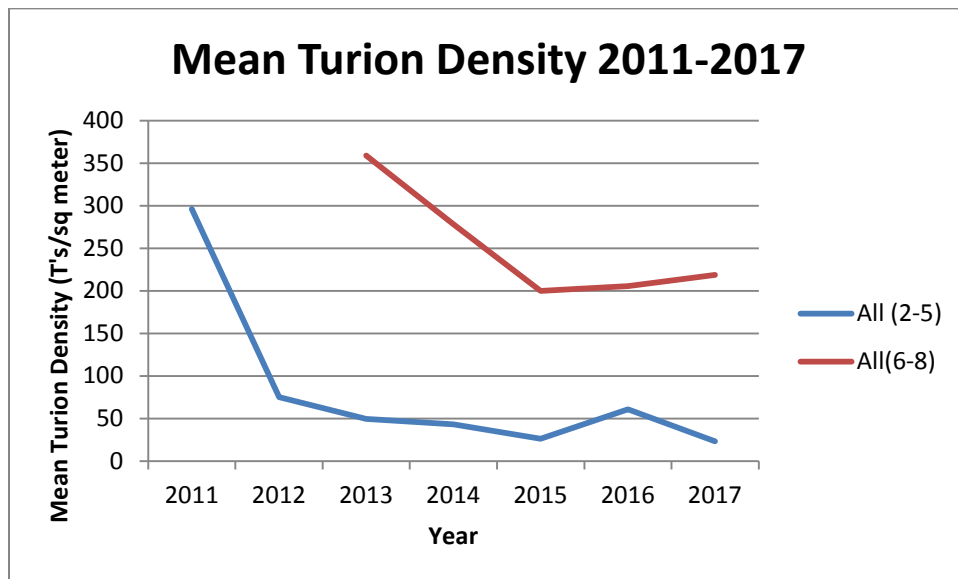
Figure 17 graphically shows the turion density that has been occurring in all beds. As successful treatments continue, the turion density should continue to decrease, resulting in less CLP growing each spring within these treatment beds.

Figure 17: Mean turion density change, 2011-2017.
