1.0 INTRODUCTION

[Big] Silver Lake, Waushara County, is a seepage lake with a maximum depth of 48 feet and a mean depth of 21 feet (Photo 1). The lake area as determined through a heads-up digitization of the lake from a 2015 aerial photograph is approximately 360.3 acres, whereas the WDNR website lists the lake as 328 acres. This mesotrophic lake has a relatively small watershed when compared to the size of the lake (3.5:1). Only when water levels are near full pool does water exchange occur with Irogami Lake via a culvert under State Hwy 21. Four exotic species are known to exist in Silver Lake: banded mystery snail, curly-leaf pondweed (*Potamogeton crispus*, CLP), Eurasian water milfoil (*Myriophyllum spicatum*, EWM), and zebra mussel. Genetic analysis confirms that the invasive milfoil population is comprised of both EWM and hybrid water milfoil (*M. spicatum x sibiricum*, HWM). Subsequent discussion using “HWM” will represent the collective invasive milfoil population of Silver Lake unless specifically referenced otherwise.

2.0 2014 HWM MANAGEMENT

3.0 CONTROL STRATEGY DEVELOPMENT

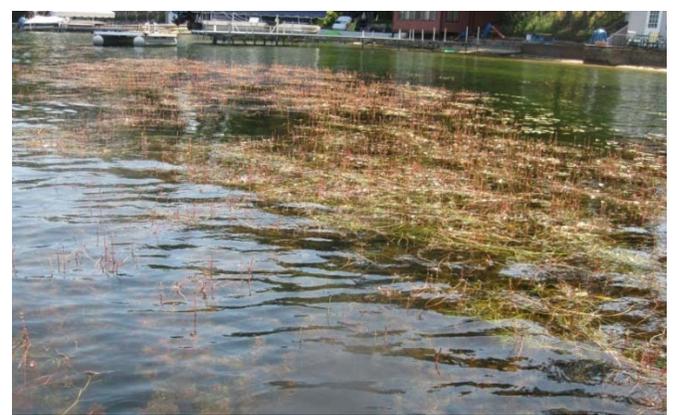
Photo 2. HWM Surface Matted colony on Silver Lake.

On August 12-13, 2015, Onterra ecologists conducted the HWM Peak-Biomass Survey on Silver Lake. During the survey, the HWM population was mapped using sub-meter GPS technology by using either 1) point-based or 2) area-based methodologies. Large colonies >40 feet in diameter are mapped using polygons (areas) and were qualitatively attributed a density rating based upon a five-tiered scale from *Highly Scattered* to *Surface Matting*. Point-based techniques were applied to HWM locations that were considered as *Small Plant Colonies* (<40 feet in diameter), *Clumps of Plants*, or *Single or Few Plants*.

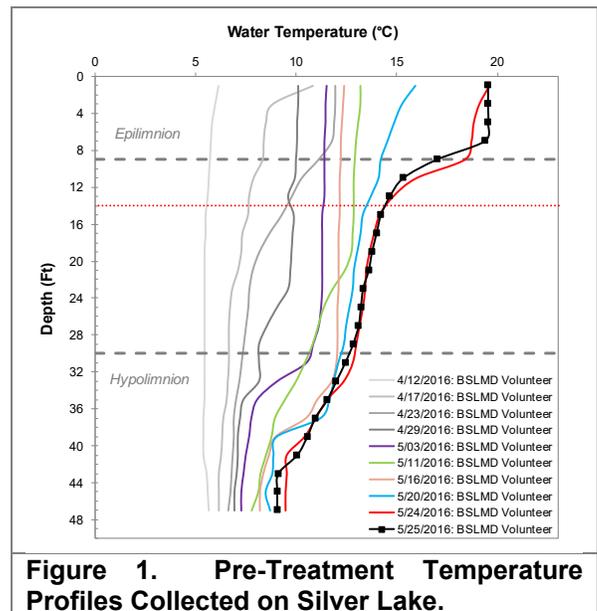
Figure 1. Pre-Treatment Temperature Profiles Collected on Silver Lake.

Volunteers from the SLMD provided numerous temperature profiles in the days and weeks leading up to the large-scale herbicide treatment on Silver Lake (Figure 1). During April and early-May, the lake was warming but not developing separate strata. Between May 20 and May 24, stratification parameters finally became apparent around 9 feet. The final dosing was based upon a mixing zone of the top 14 feet of the lake. The lake was also considered to be approximately 1 foot higher than when the early-September acoustic survey took place and was accounted for within the calculations.

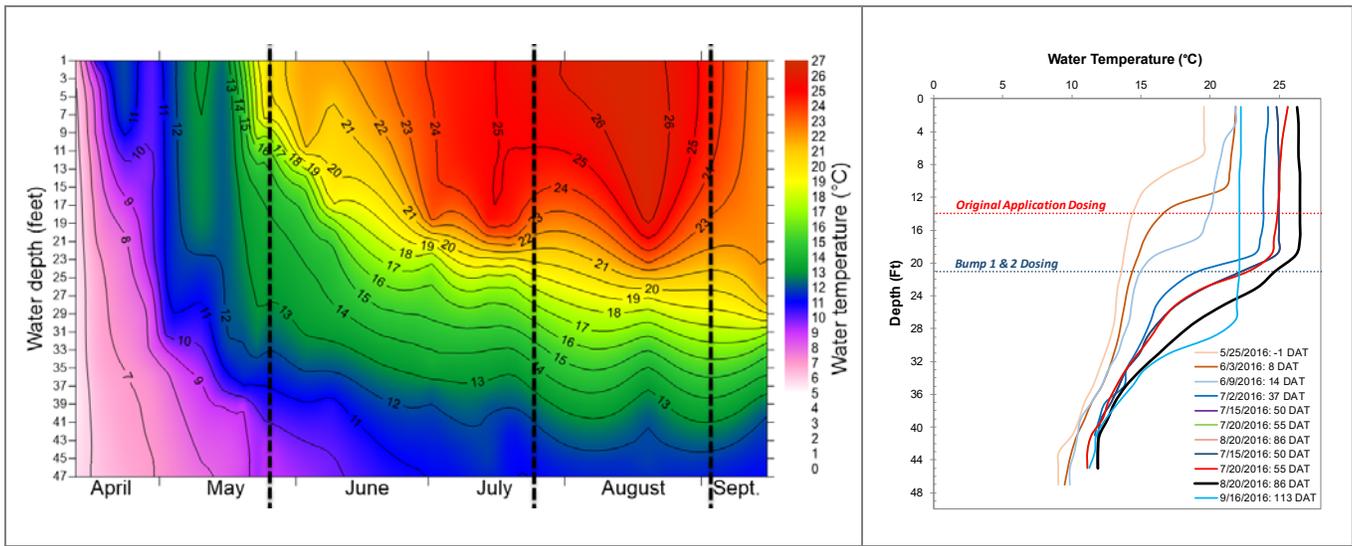
Figure 2. Temperature Isotherm (left) and Profiles (right) Collected from Silver Lake Following the 2016 Herbicide Treatment. Dashed line on isotherm represents treatment dates.

Temperature profiles collected before the treatment and at each herbicide concentration sampling interval indicate that the lake remained thermally stratified through mid-September when temperature profiles no longer were collected (Figure 2). Limnologists, scientists that study inland waters, understand thermal stratification as occurring when there is a change of 1°C within 1 meter. The closely spaced water temperature contours on the isotherm (Figure 2, left frame) indicate a thermal gradient separating the epilimnion and hypolimnion beginning at approximately 9 feet on the treatment date and extended to about 19-20 feet by the beginning of July. This can also be observed on the temperature profiles (Figure 2, right frame), where uniform temperatures were observed down to about 19-20 feet before getting much colder in a short amount of depth.

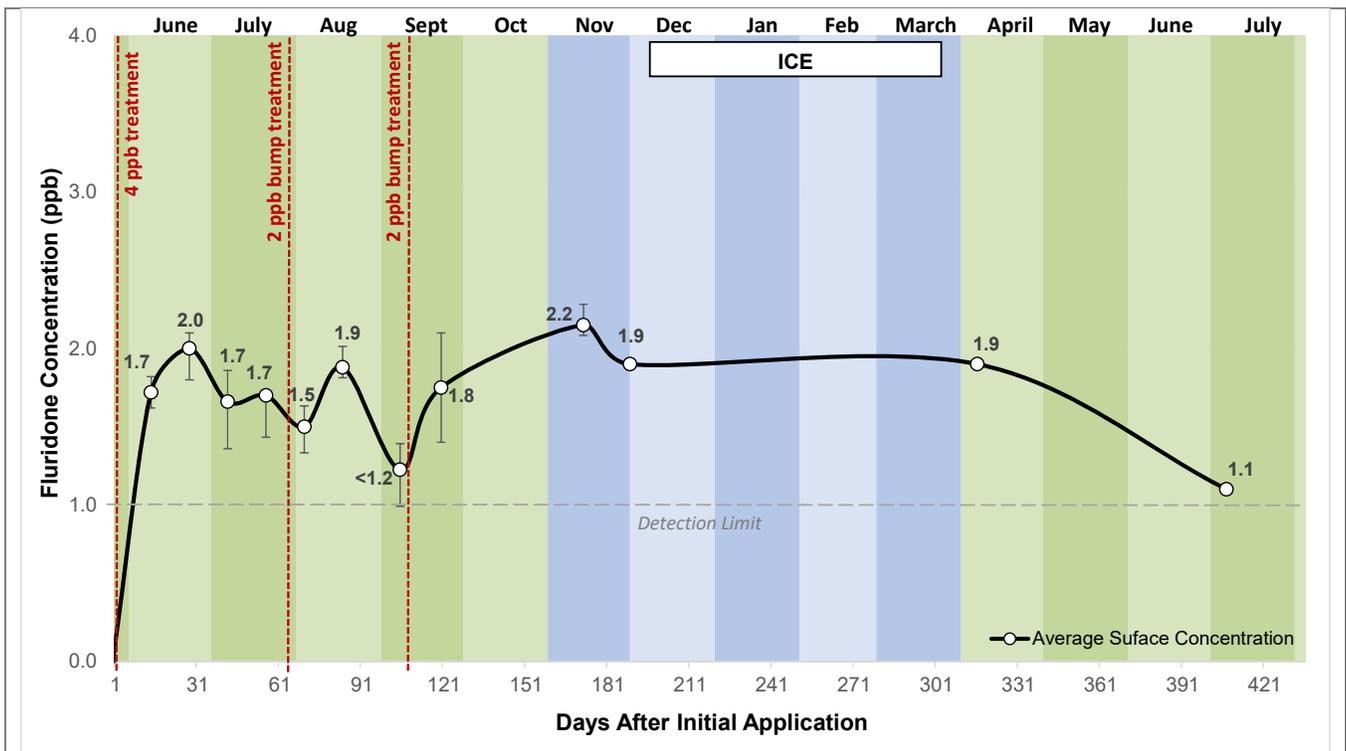
Figure 3. Silver Lake Herbicide Concentration Monitoring Results from five monitoring locations.

Based upon reviewing the measured herbicide concentration during the summer (Figure 3) as well as technical advice from SePRO, 2 ppb bump treatments of pelletized fluridone (Sonar One®) were conducted on July 21 and September 1 by Clean Lakes. The final dosing of these treatments was based on a mixing zone down to 21 feet (Figure 2, right frame) and includes application of 655.9 lbs of pelletized fluridone over the same 86.4 acres where the initial application occurred.

Figure 3 shows the results of the fluridone monitoring that occurred in association with the 2016 large-scale treatment on Silver Lake. Gauged by the size of the error bars (representing range of results), surface herbicide concentrations were fairly uniform between the five monitoring sites, indicating that horizontal mixing had occurred within the lake-wide epilimnion including at Site BS2 and BS4 where no herbicide was directly applied. Hypolimnetic samples were collected at each sampling interval into

September with no herbicide (i.e. below detection limits) being observed. Samples collected in November after the lake had likely mixed (i.e. fall turnover) indicated fluridone levels were just below 2 ppb. It was anticipated that herbicide degradation would be minimal over the winter as fluridone is primarily broken down by sunlight, specifically UV-B (300-320 nm), but also by UV-A (320-380) spectrums. These wavelengths are absorbed by ice and snow, not allowing much penetration to fluridone in the lake during the winter. Average surface herbicide concentrations following the ice-out event on Silver Lake were basically unchanged to before ice-on levels. Based upon discussions with SePRO, it is likely that fluridone concentrations within the lake will degrade to below detectable levels by late-spring. A July 7, 2017 herbicide concentration sample (407 days after initial application) confirmed that fluridone was still present within the lake, but only slightly above the detection levels (Figure 3).

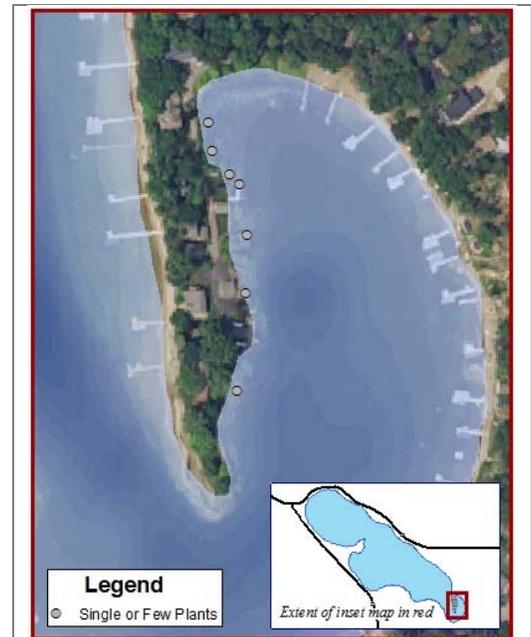
Figure 4. Early Season AIS Survey HWM mapping results. Survey conducted July 5, 2017 (Onterra). Area depicted locally known as Foxtail Bay.

During the ESAIS survey, a small amount of HWM was visible during the survey within the portion of the lake known as Foxtail Bay on the southeastern end of the lake (Figure 4). No HWM was visible from the surface within the main body of the lake. Field crews supplemented the visual survey by deploying a submersible camera along with periodically doing rake tows at locations in which dense HWM colonies were mapped in previous surveys. No HWM was found using these survey methods within the main body of the lake during the ESAIS survey.

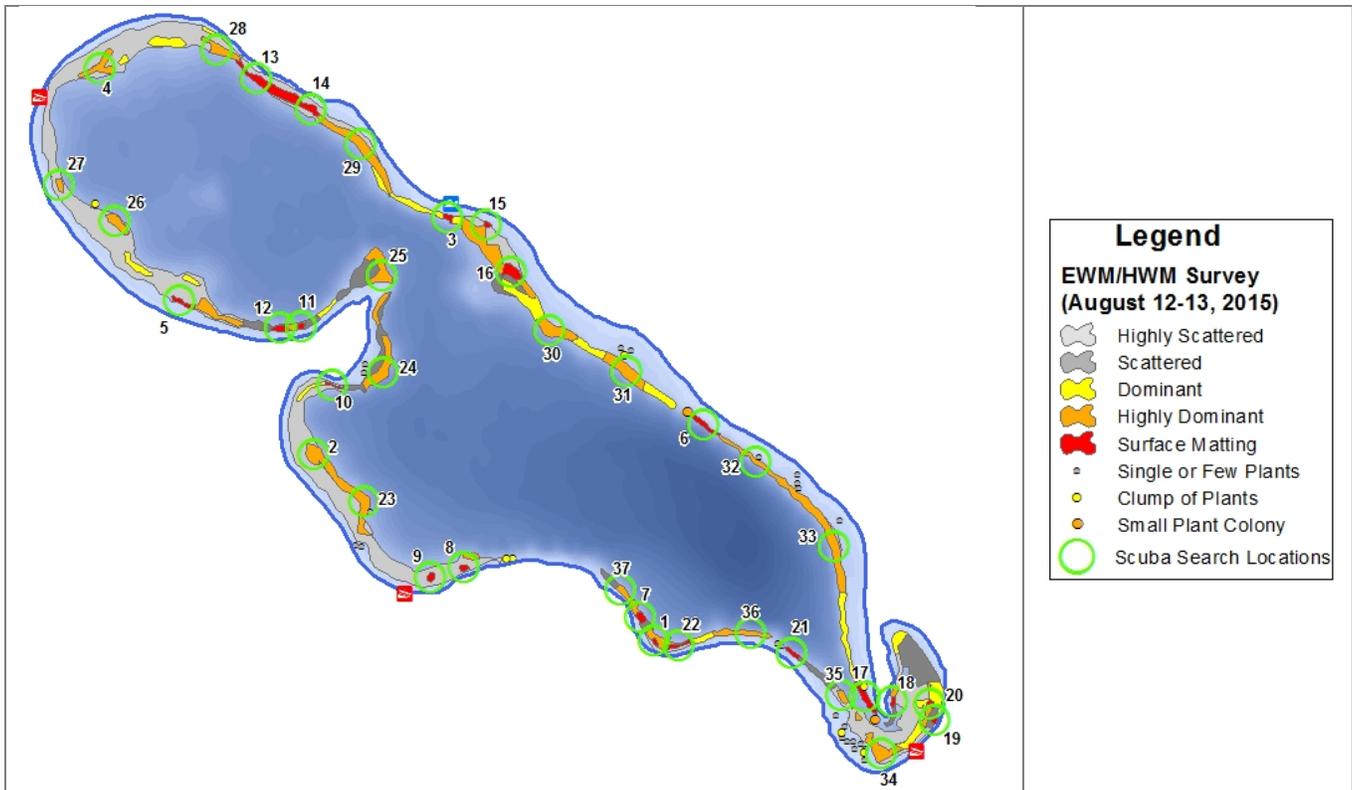
Figure 5. 2017 Professional scuba reconnaissance survey in Silver Lake. Thirty-six Search areas designated based on Onterra 2015 HWM mapping survey.

During the first visit to the lake (July 20, 2017), DASH, LLC conducted EWM hand-removal in Foxtail Bay that was discovered during the July 5th ESAIS Survey as well as started investigating the first scuba reconnaissance area. Six subsequent days of scuba reconnaissance (July 31, Aug 1, Aug 18, Aug 22, Aug 29, Sept 12) allowed DASH, LLC to visit all 36-designated search areas, spending a total of 38.95 hours underwater (Figure 5). Divers encountered varying amounts of milfoil (presumably all HWM but difficult identification at this growth stage is noted) at the different search areas and ranged from zero plants to several hundred plants at some locations. The number of plants harvested by DASH, LLC at each site are totaled and displayed on Figure 6. The hand-harvesting firm indicated the plants that they removed were typically small single-stalked plants that did not appear to be growing out of a large root crown. It is unclear if this represents plants that survived the treatment or was a result of germination from a seedbank or sprouting from asexual turions (i.e. winter buds).

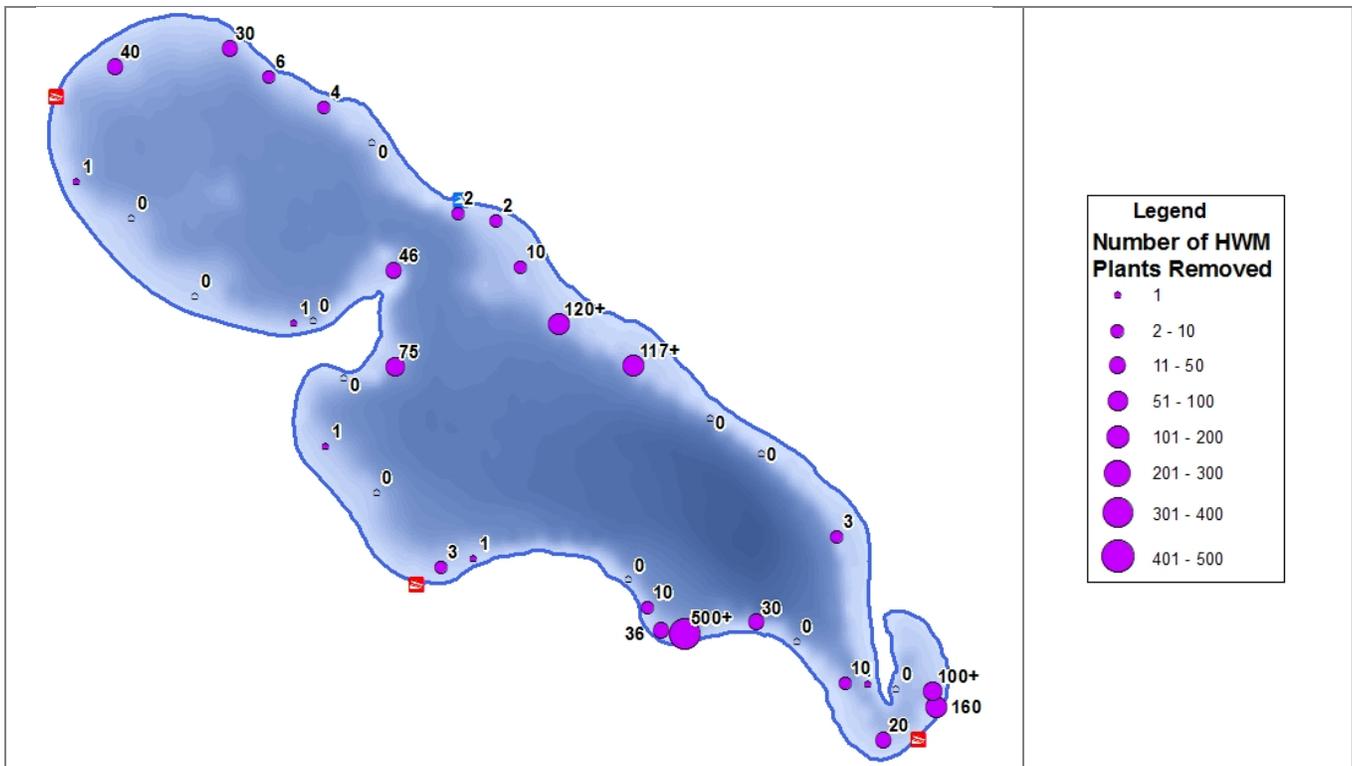
Figure 6. Professional hand-harvesting HWM yield from Silver Lake scuba reconnaissance survey in 2017. Data compiled from DASH, LLC dive summary.

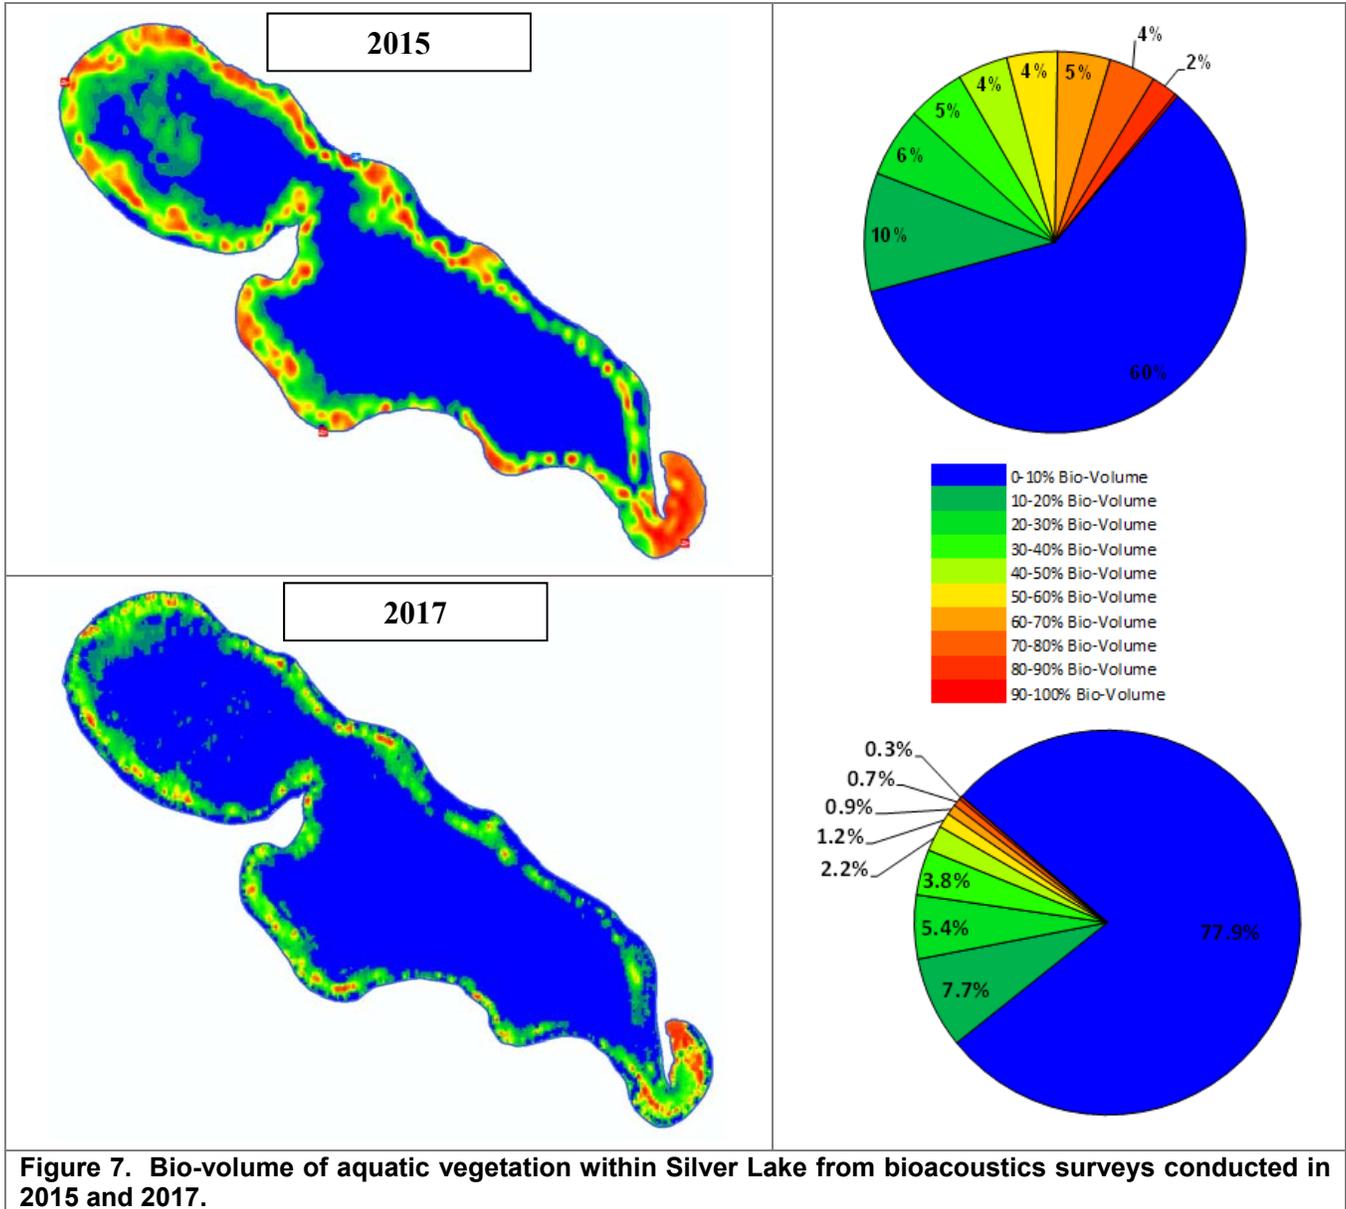
Aquatic plant bio-volume is measured as a percentage of the water column that is occupied by aquatic plants. The results of these surveys are displayed in Figure 7. Prior to treatment, approximately 15.2% of the lake area contained a bio-volume 50% or greater, compared to approximately 3.1% for the same parameters in 2017 (Figure 7). These high biovolume areas in 2015 corresponded with the dense colonies of HWM (Map 1) that were greatly impacted by the fluridone treatment.

The 2015 acoustic survey showed approximately 60% of the lake area contained between a 0-10% bio-volume compared to 77.9% in 2017 that had a bio-volume between 0 and 10% (Figure 7). These data indicate that the lake has more areas with no/low vegetation in 2017 than in 2015. A portion of this increase is caused by a reduction in deeper areas that contained vegetation in 2015 that were unable to support vegetation in 2017 now that the lake-levels were increased by 3-3.5 feet. For example, deeper areas of the northwestern lobe of the lake contained areas with greater than 10% biovolume in 2015 but not in 2017.

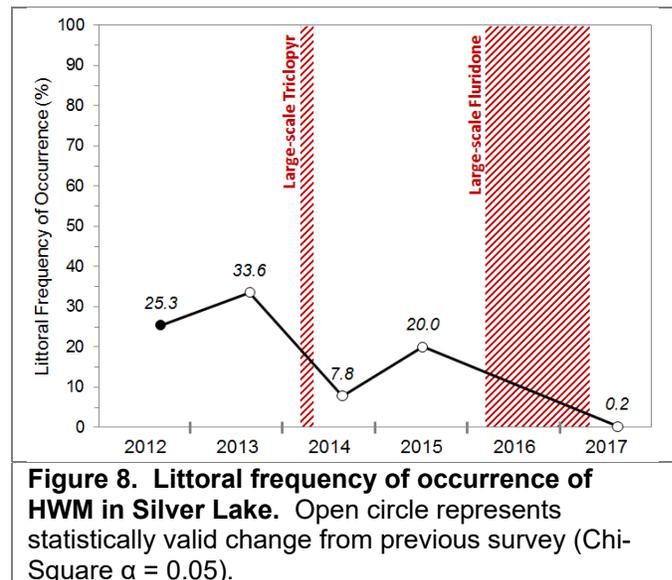
Figure 8. Littoral frequency of occurrence of HWM in Silver Lake. Open circle represents statistically valid change from previous survey (Chi-Square $\alpha = 0.05$).

One occurrence of HWM was recorded on the August 18 and August 21, 2017 point-intercept survey in Silver Lake, represented a littoral frequency of occurrence of 0.2%. The littoral frequency of occurrence of HWM exhibited a 99% decrease since the 2015 survey in which an occurrence of 20.0% was recorded (Figure 8). The 99% decrease in occurrence from 2015 (*year prior to treatment*) to 2017 (*year after treatment*) met lake managers expectation for successful control.

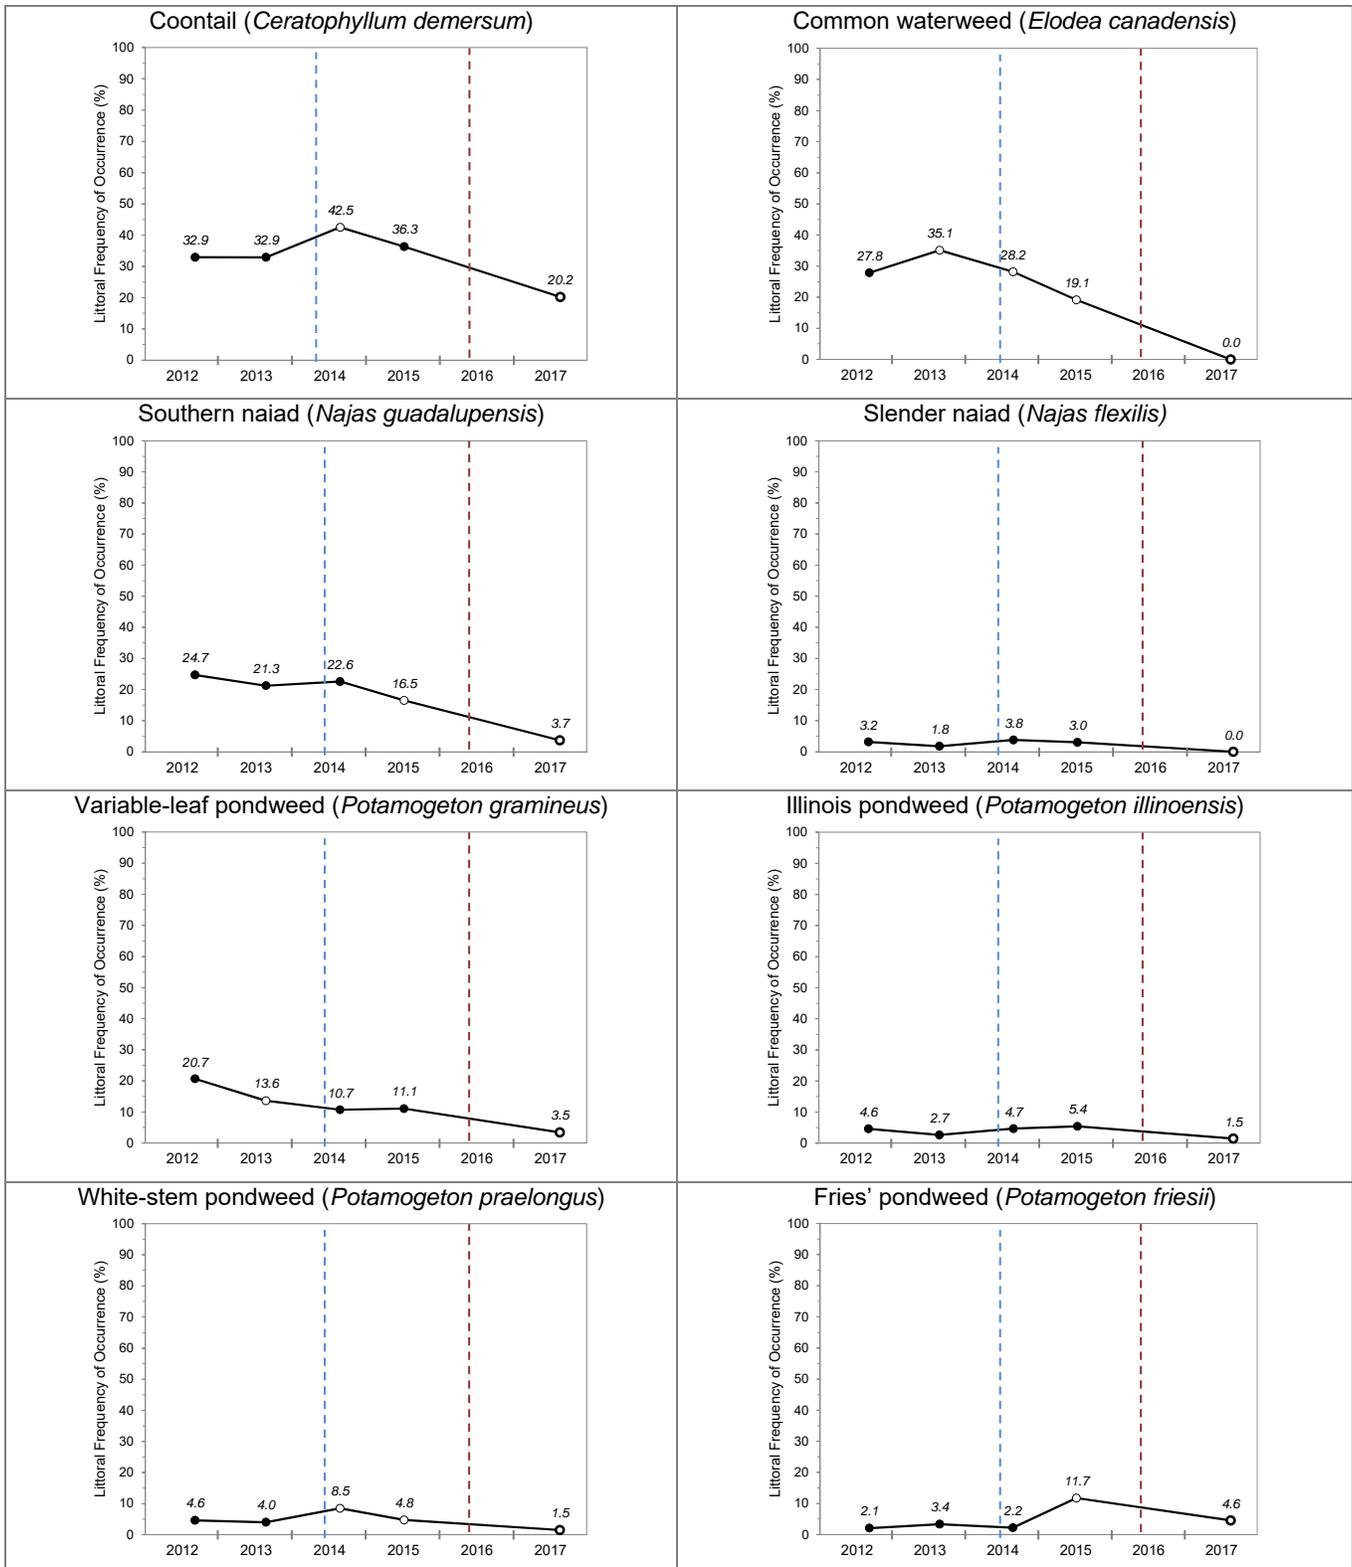
Figure 9. Littoral frequency of occurrence of native aquatic plant species that exhibited a statically valid decrease in occurrence from 2015-2017 in Silver Lake. Open circle represents statistically valid change from previous survey (Chi-Square $\alpha = 0.05$). Blue dashed line indicates initiation of large-scale tricopyr treatment, red dashed line indicates initiation of large-scale fluridone treatment.

Eight species exhibited a statistically valid decrease in occurrence from the 2015-2017 point-intercept surveys (Figure 9). The frequency of occurrence of common waterweed (*Elodea canadensis*, -100%) and coontail (*Ceratophyllum demersum*, -44.3%) represents a statistically valid decrease from 2015 to 2017. According to a fluridone susceptibility analysis completed by the WDNR Science Service Department, common waterweed and coontail were shown to be particularly sensitive to fluridone treatments. Both coontail and common waterweed are free-floating or loosely rooted plant species that can utilize the biomass of other plant species as a “substrate” in which they become entangled and grow. It is suspected that with the nearly complete loss of structural habitat previously being supplied by the robust HWM population, may have compounded the direct impacts from the herbicide treatment strategy. A relatively robust population of coontail remained present in the lake during the 2017 point-intercept survey in which coontail was the second most common species with a frequency of 20.2%.

The frequency of occurrence of southern naiad (*Najas guadalupensis*) decreased by a statistically valid 77.6 % in 2017, and slender naiad (*Najas flexilis*) decreased by a statistically valid 100% for (Figure 8, Photo 3). Southern naiad is a hardy perennial that can be a nuisance at times and is suspected of expanding in population following auxin treatments (e.g. 2,4-D, triclopyr), whereas slender naiad is an annual that relies on seed production and has been shown to be particularly susceptible to auxin herbicides. However, slender naiad has shown to rebound extremely quickly in most large-scale auxin treatments, often exceeding pretreatment levels during the *year after treatment*.

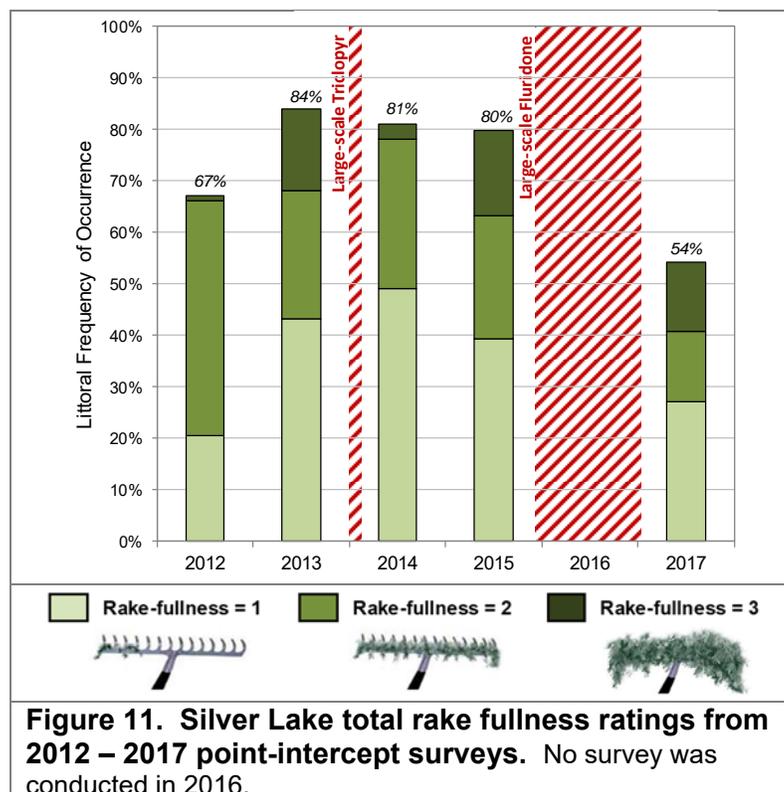
Figure 11 shows a semi-quantitative analysis of the abundance of natives through looking at total rake fullness ratings (i.e. how full of plants is the sampling rake at each location). The TRF data collected during 2017 shows an overall reduction in rake fullness as compared to previous surveys. In 2017, 54% of the sampling points contained aquatic vegetation compared to 80% in 2015. It is important to note that the aquatic plant fullness in 2017 is almost completely comprised of native plant species, whereas HWM was a large contributor to the aquatic plant biomass in past surveys.

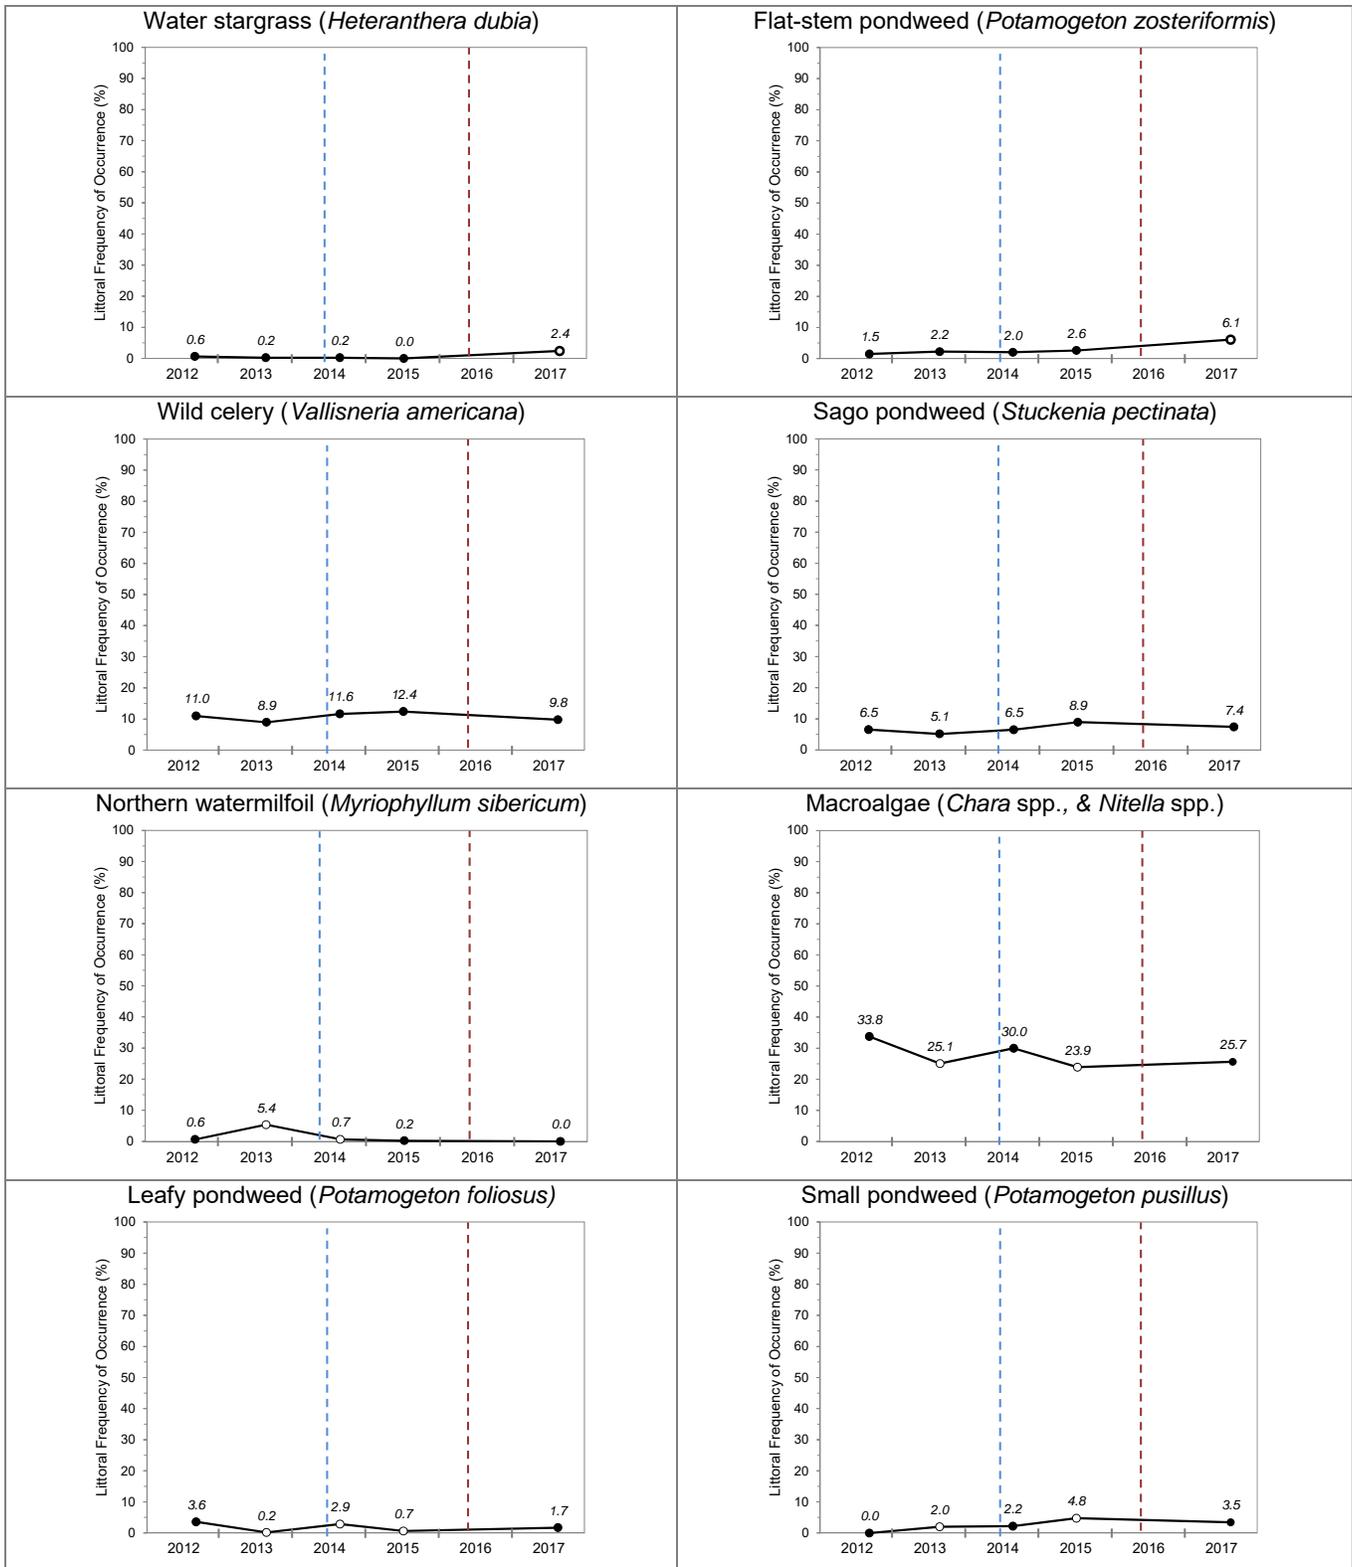
Figure 10. Littoral frequency of occurrence of native aquatic plant species that exhibited a statically valid increase in occurrence or no change in occurrence from 2015-2017 in Silver Lake. Open circle represents statistically valid change from previous survey (Chi-Square $\alpha = 0.05$). Blue dashed line indicates initiation of large-scale triclopyr treatment, red dashed line indicates initiation of large-scale fluridone treatment.

Eight species that had at least a 2% littoral frequency of occurrence in one or more point-intercept surveys and exhibited either no statistical change or an increase in occurrence between the 2015 and 2017 surveys on Silver Lake are displayed on Figure 10. The two species that exhibited a statistically valid increase in occurrence between 2015 and 2017 include water stargrass (*Heteranthera dubia*) and flat-stem pondweed (*Potamogeton zosteriformis*) (Figure 10). Onterra's experience is the flat-stem pondweed is particularly sensitive to endothall treatments and somewhat sensitive to auxin treatments.

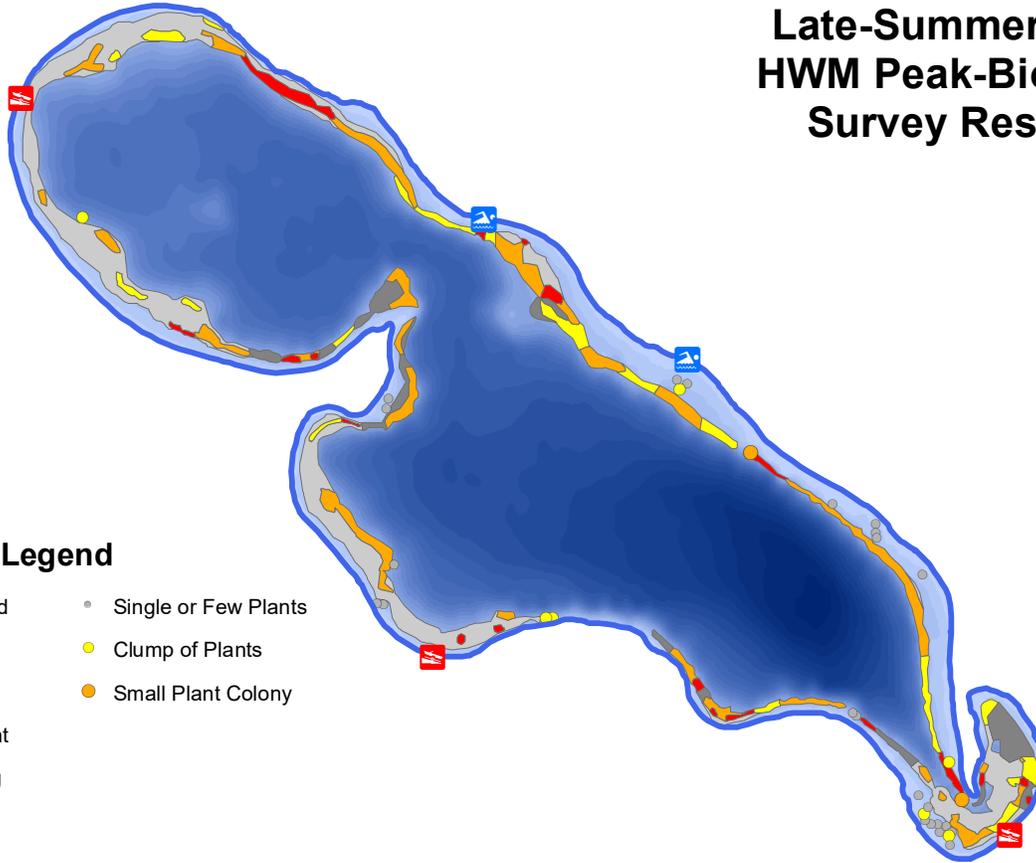
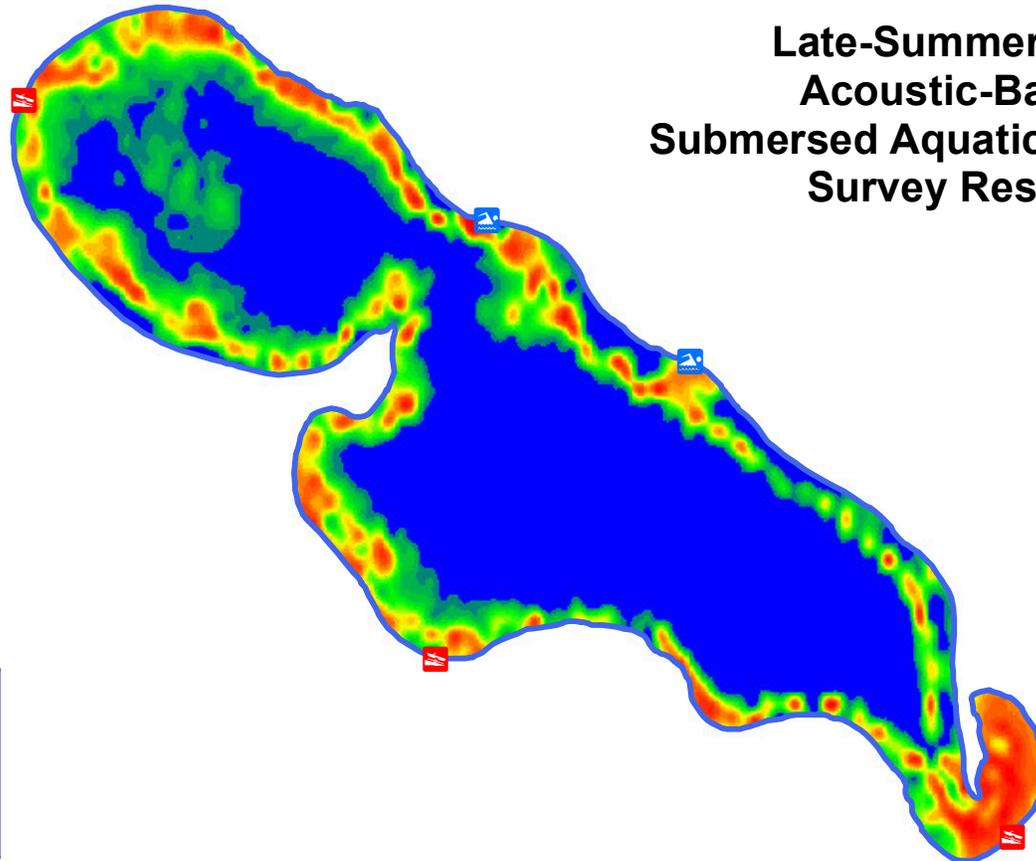
Map 1
Silver Lake
Waushara County, Wisconsin

Late-Summer 2015 HWM Peak-Biomass Survey Results

Late-Summer 2015 Acoustic-Based Submersed Aquatic Vegetation Survey Results

As discussed above, HWM of varying densities was located throughout the littoral zone of Silver Lake (Map 1). In total, 52 acres of colonized HWM were delineated with approximately 21 of the acres being comprised of *Dominant*, *Highly Dominant*, or *Surface Matted* HWM populations (Photo 2). The results of the 2015 HWM Peak-Biomass Survey guided where the herbicide application areas were constructed for the spring 2016 treatment. Replicate HWM mapping surveys conducted after the large-scale treatment occurs will allow an understanding of treatment efficacy and guide follow-up active management activities such as hand-harvesting or herbicide spot treatments. A HWM Peak-Biomass Mapping Survey was also not completed in 2016, as the lake was still in the process of being treated (i.e. had active herbicide concentrations).

The acoustic survey also created a baseline understanding of the submerged aquatic vegetation in Silver Lake (Map 1). While the map output does not differentiate between aquatic plant species, it indicates where high bio-volumes of vegetation exist in the lake. Conducting bio-volume surveys before and after herbicide treatments can also allow an understanding of how the macrophyte structure (aka lakescape) was influenced by the treatment, a set of data that have particular interest of fisheries managers.

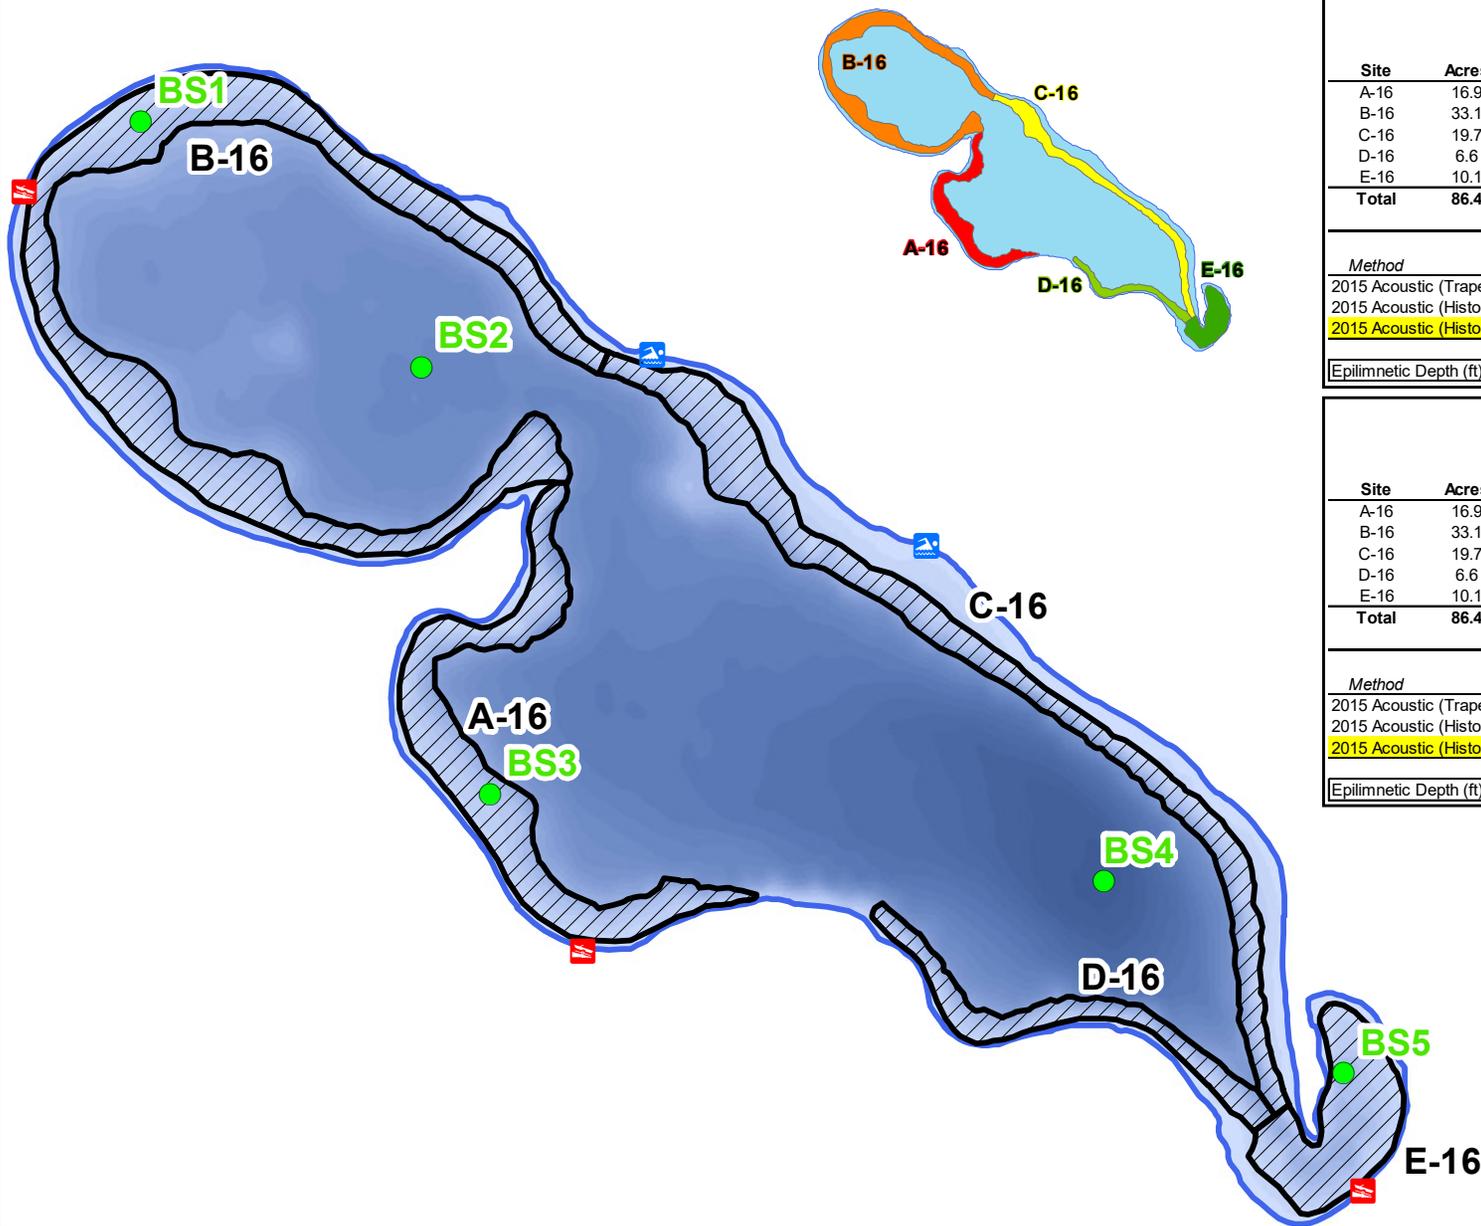
Map 2
 Silver Lake
 Waushara County, Wisconsin
**Final 2016
 HWM Control Strategy**

Site	Acres	Ave Depth	Total Volume (acre-feet)	Initial Application	
				Application Area Dose ppb	Pellitized Fluridone lbs
A-16	16.9	8.3	140.3	26	198.3
B-16	33.1	7.6	253.1	26	357.7
C-16	19.7	9.3	183.9	26	259.9
D-16	6.6	9.4	61.9	26	87.5
E-16	10.1	6.9	70.0	10	38.1
Total	86.4		709.2		941.5

Site	Acres	Ave Depth	Total Volume (acre-feet)	Bump Applications	
				Application Area Dose ppb	Pellitized Fluridone lbs
A-16	16.9	8.3	140.3	18	137.3
B-16	33.1	7.6	253.1	18	247.7
C-16	19.7	9.3	183.9	18	179.9
D-16	6.6	9.4	61.9	18	60.6
E-16	10.1	6.9	70.0	8	30.4
Total	86.4		709.2		655.9

Map 2 displays the final large-scale herbicide treatment design and dosing strategy for Silver Lake in 2016. The treatment includes application of 941.5 lbs of pelletized fluridone (Sonar One ®, SePRO)

over 86.4 acres of the littoral zone known to contain HWM (based on the 2015 HWM Peak-Biomass Mapping Survey (Map 1). The initial herbicide treatment was conducted by Clean Lakes on May 26, 2016 using a Vortex gas powered spreader system. The applicator reported a near-surface water temperature of approximately 68°F and west winds of 2-8 mph at the time of application. A representative from SePRO was at the lake during the application.
