The Lake Alice Stewardship Program Adaptive Management Plan (3rd Edition)

The Lake Alice Stewardship Program Adaptive Management Plan (3rd Edition) (Lincoln County, Wisconsin)

Cite as: *Premo, Dean, Angie Stine, Caitlin Hoenig and Kent Premo. 2017. The Lake Alice Stewardship Program Adaptive Management Plan (3rd Edition). White Water Associates, Inc.*

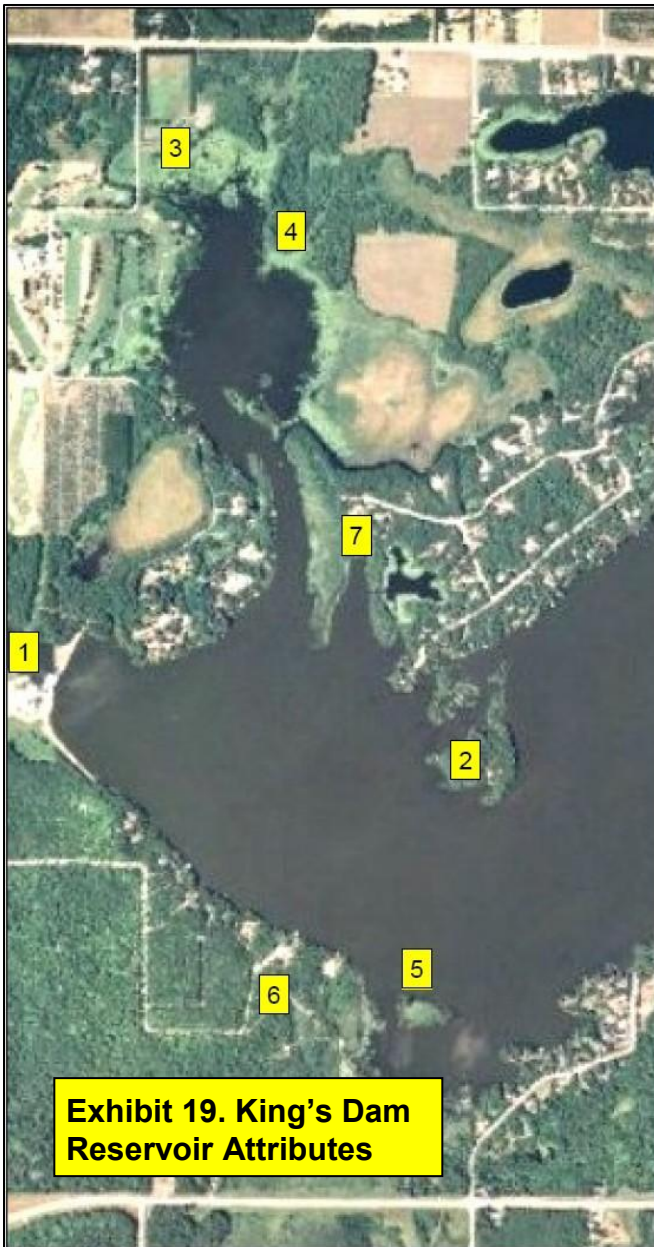
KING'S DAM (1, Exhibit 19) is owned and operated by the Tomahawk Power Company. The dam was built in 1910 creating Lake Alice, a 1,369 acre reservoir. Board members have obtained newspaper accounts and articles about the building of the dam, how Lake Alice got its name, description of the Pulp mill by the dam (Pulp Lake was a suggested name) and of the King family, who lived in this area. This information is contained in Appendix B). The river channel is the deepest from the dam to Generator Island.

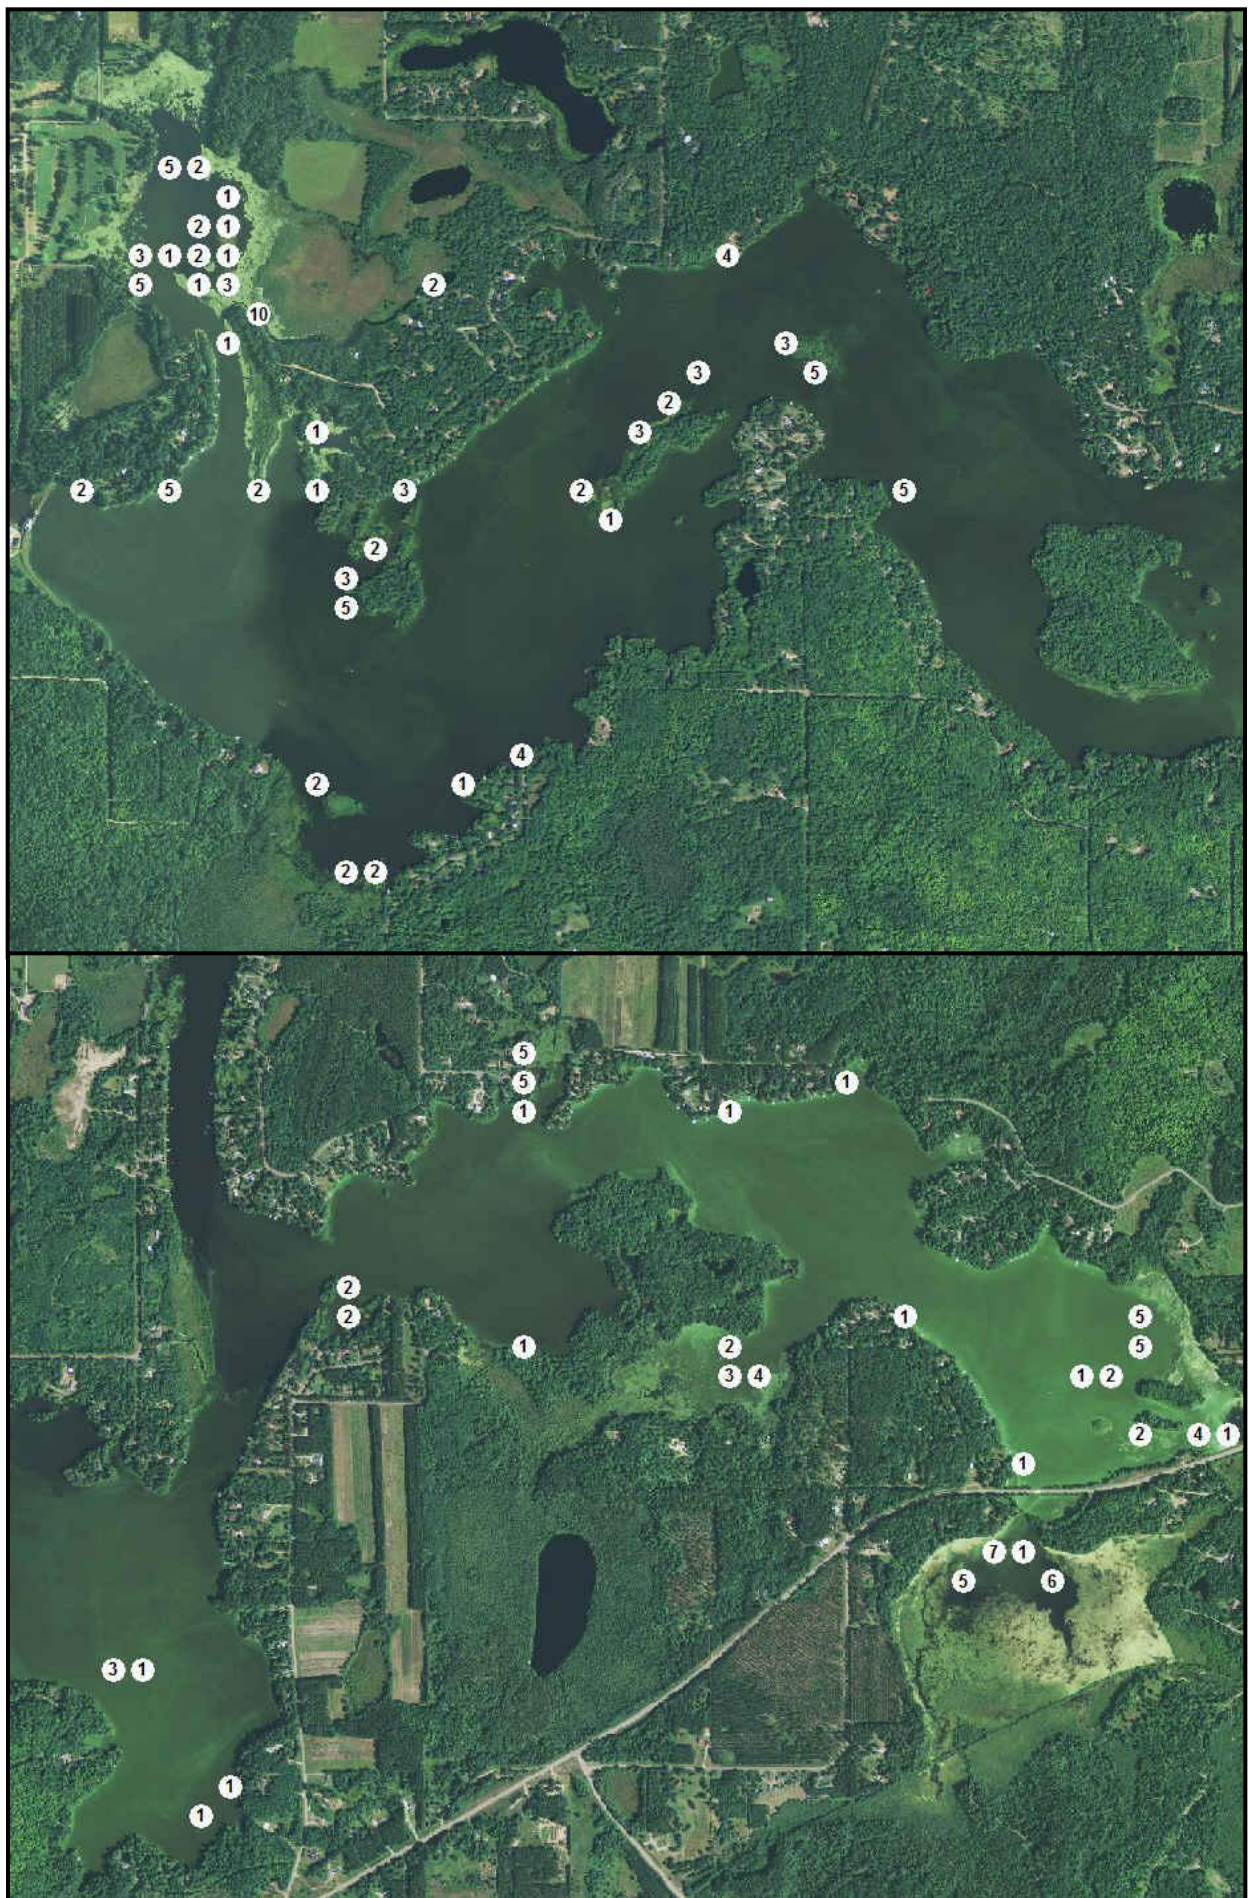
Figure 1. Number of plant species recorded at Lake Alice sample sites (2010).

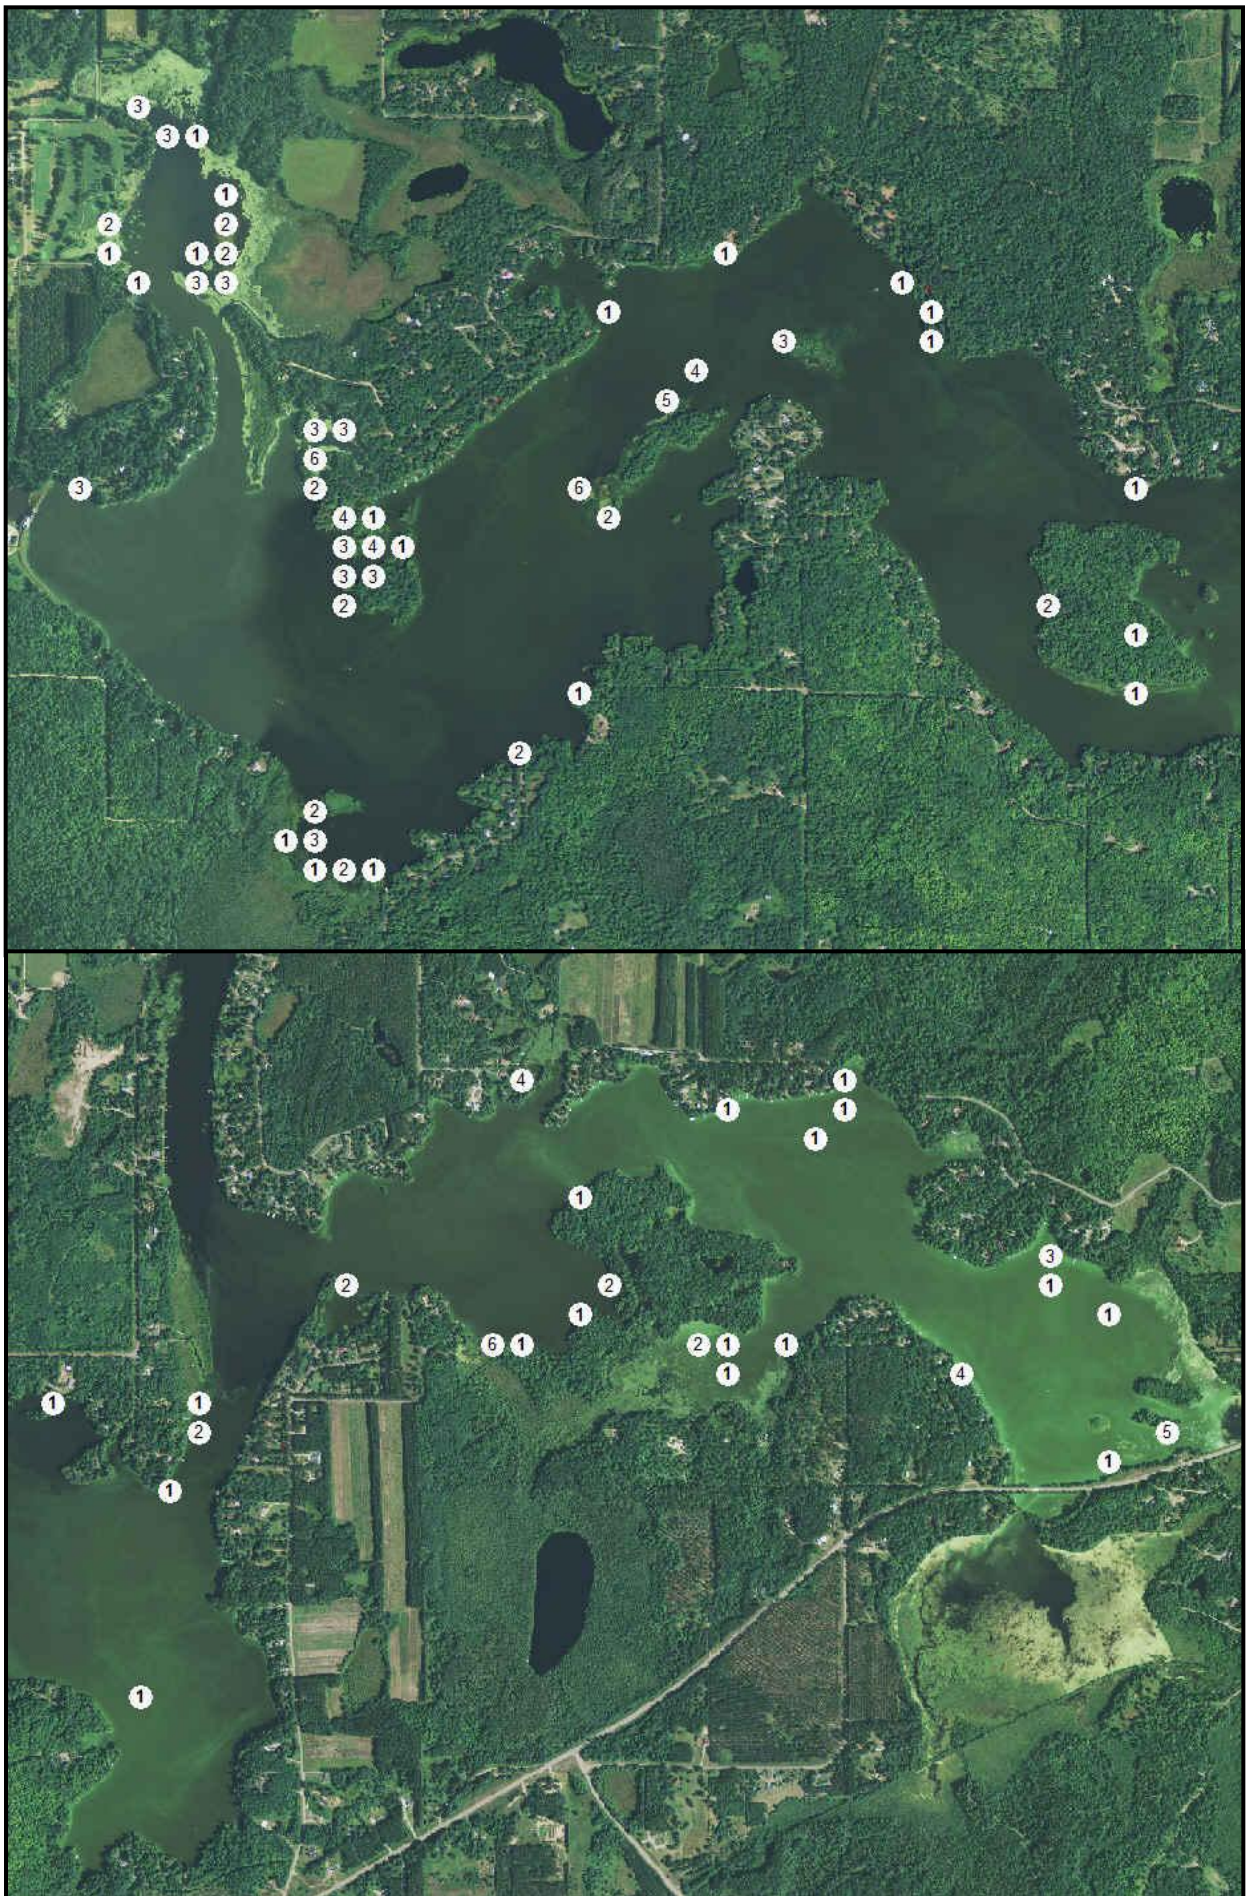
Figure 14. Number of plant species recorded at Lake Alice sample sites (2016).

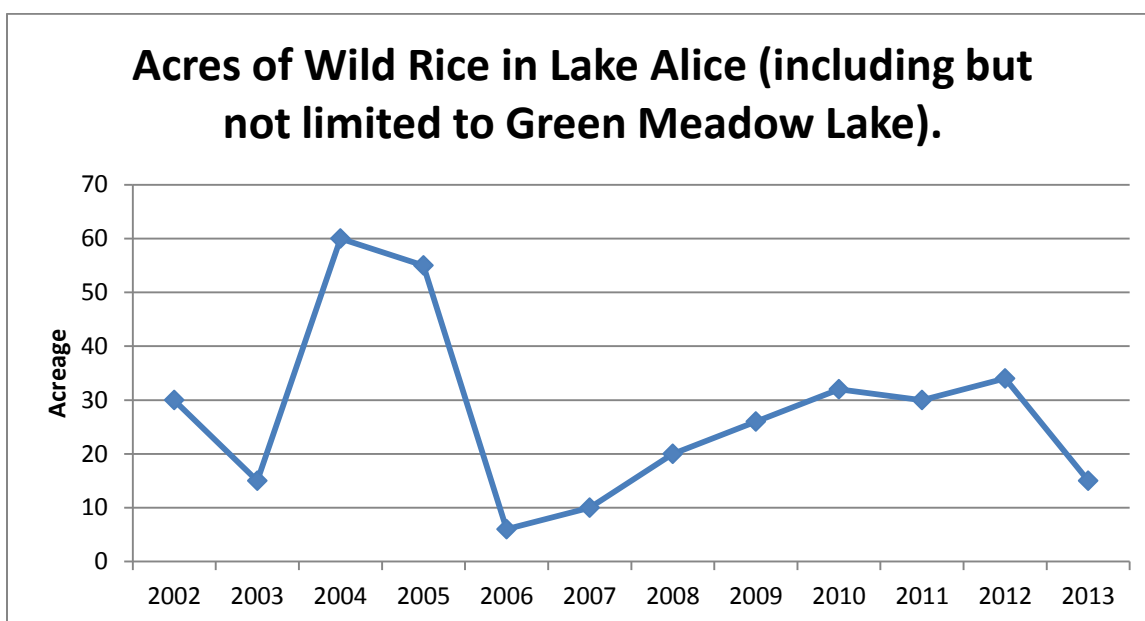
Shown below is a figure displaying the total acres of wild rice within Lake Alice (including but not limited to Green Meadow Lake) from 2002 to 2013. At the end of this report are aerial images of wild rice in Green Meadow Lake from 2004-2009. The sidebar provides a personal account of picking wild rice in Lake Alice.
