Warm Water Point/Intercept Macrophyte Survey Silver Lake (WBIC: 1881100) Barron County, Wisconsin

Project Initiated by:

The Silver Lake Association, Harmony Environmental, and the
Wisconsin Department of Natural Resources

Endangered Resource Services, LLC
Matthew S. Berg, Research Biologist
St. Croix Falls, Wisconsin
July 9-10, 2012

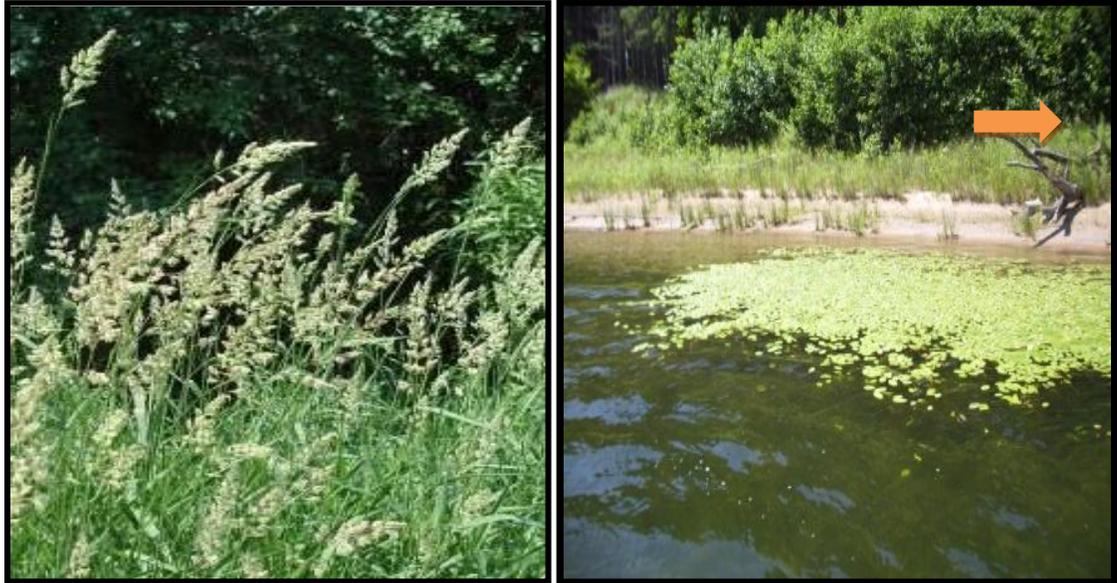
Figure 7: Reed Canary Grass on the Silver Lake Shoreline

We did NOT find any evidence of Curly-leaf pondweed, Eurasian water milfoil or Purple loosestrife (*Lythrum salicaria*) on Silver Lake. Reed canary grass (*Phalaris arundinacea*), a ubiquitous exotic grass species, was present in scattered patches along the eastern and western shorelines and near the public boat landing (Figure 7). (For more information on exotic invasive species, see Appendix VII).

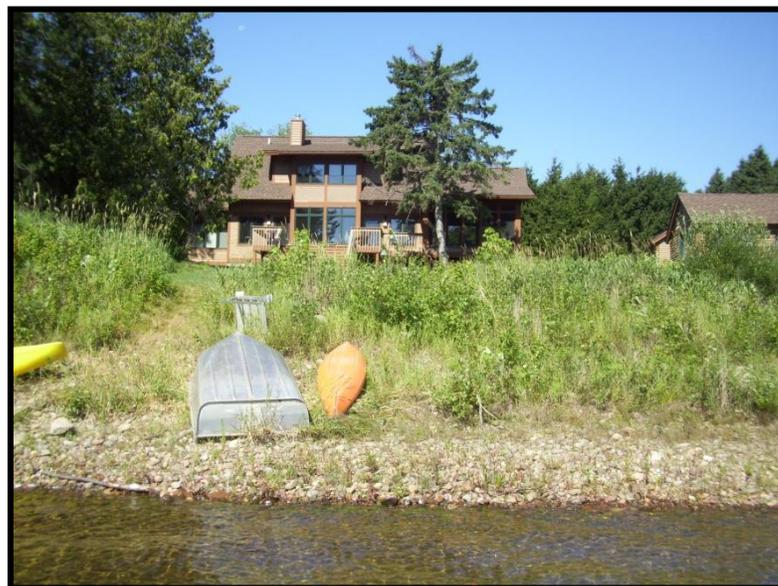
Figure 9: Model Natural Shoreline on Silver Lake's West Side

Because soil erosion and nutrient runoff promote algae growth, residents should evaluate how their shoreline practices may be impacting the lake. Simple things like establishing a buffer strip of native vegetation along the lake shore, bagging grass clippings, eliminating fertilizer near the lake, collecting pet waste, disposing of ash from fire pits away from the lakeshore, and avoiding stirring up sediments with motor start-ups in shallow water can all significantly reduce the amount of nutrients entering the lake's water column. We consistently noticed that residents who maintained their shorelines tended to have higher numbers of sensitive species in front of their residences and were much less likely to have filamentous algae coating the bottom and smothering these native plants. In general, Silver Lake's residents are to be commended for their shoreline conservation – especially in light of the current low water levels which are making it difficult to prevent erosion. In fact, many residences could serve as models for how to minimize human impacts along a lake (Figure 9). Hopefully, a greater understanding of how individual property owners can have lake-wide impacts will result in more people taking appropriate conservation actions to ensure continued water clarity and quality for all.
