***Calument County L & W
Conservation Dept***

**CalMan Lakes
Water Quality
April 13, 2017**

**Paul Garrison
Tim Hoyman
Onterra LLC
*Lake Management Planning***

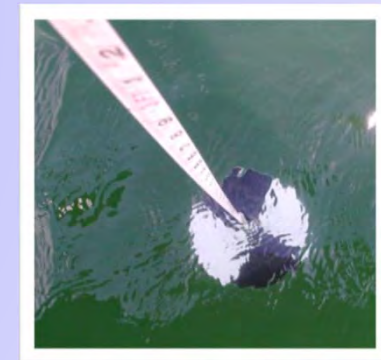
Secchi Disk Transparency

Measure of water clarity
Measured using a Secchi disk

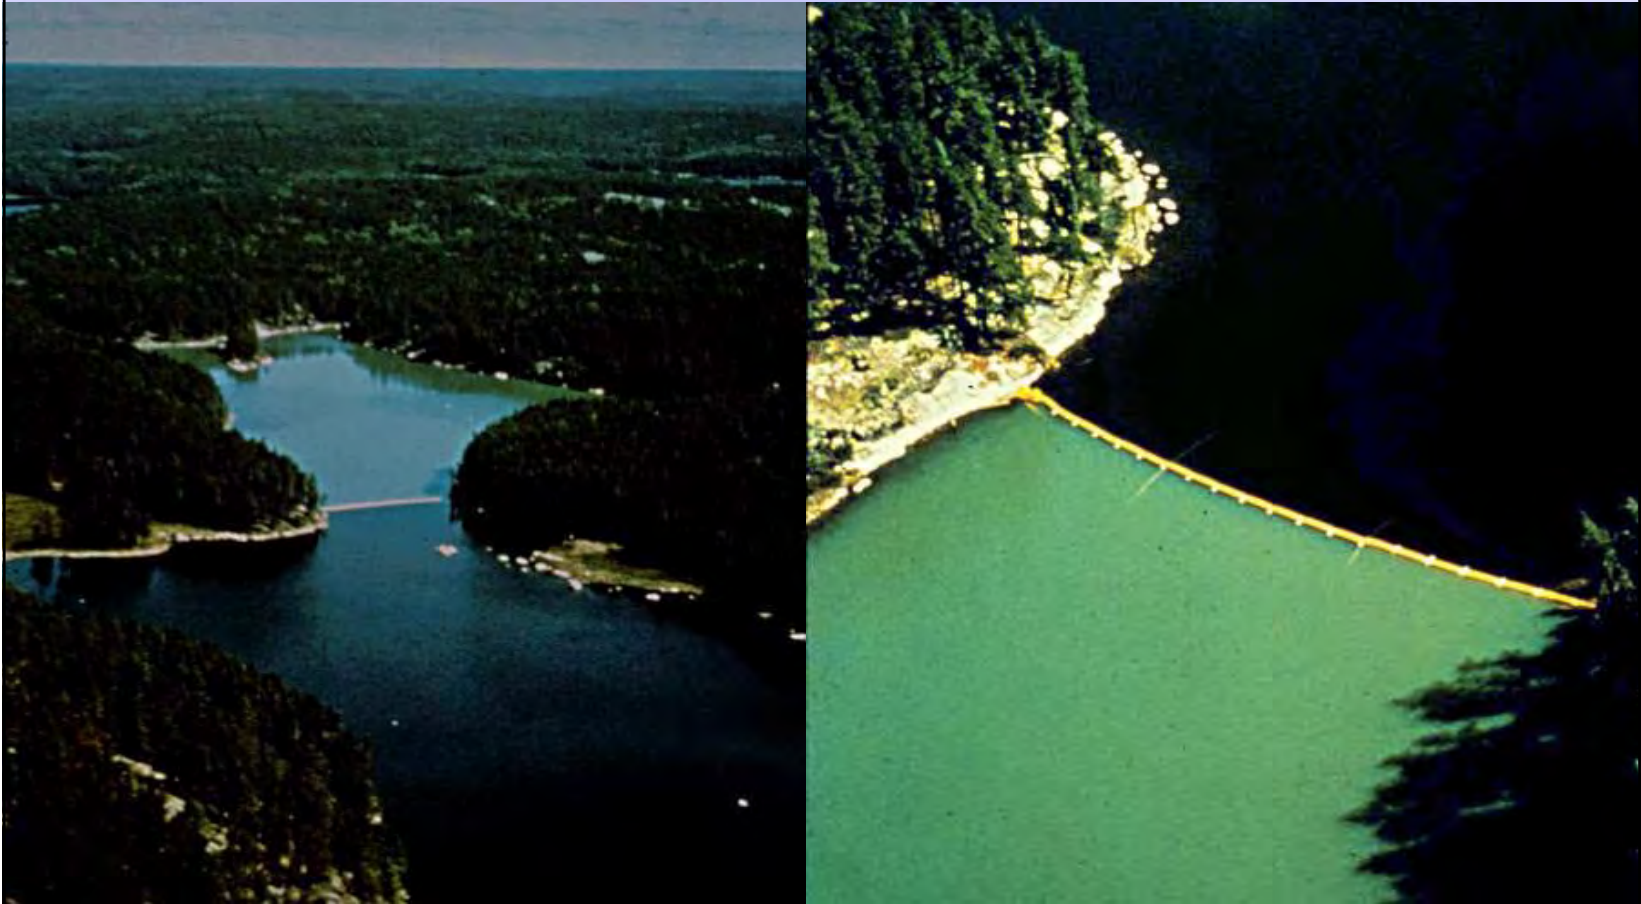
Phosphorus as Limiting Nutrient

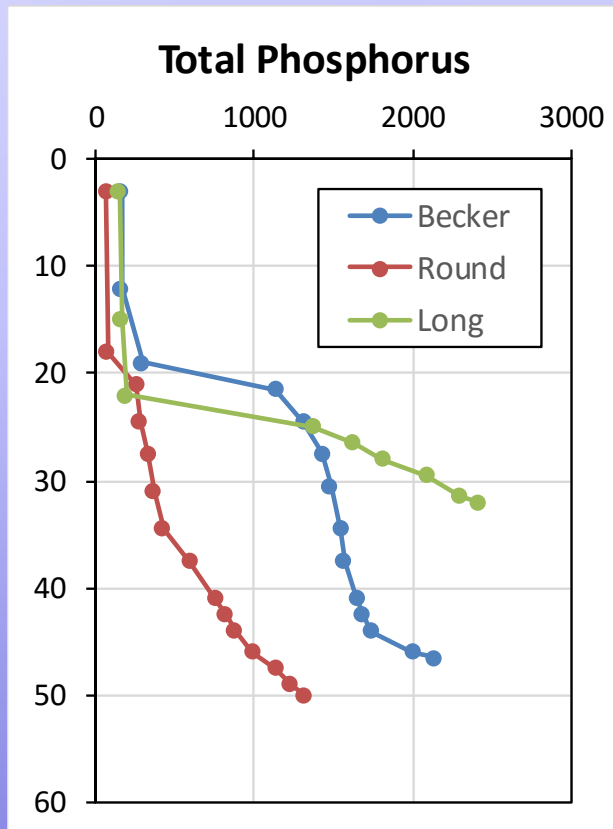
INTERNAL LOAD

PHOSPHORUS LOAD (lbs)
ROUND	92
BOOT	66
LONG	381
BECKER	334
