8.3 Birch Lake

An Introduction to Birch Lake

Lake at a Glance - Birch Lake

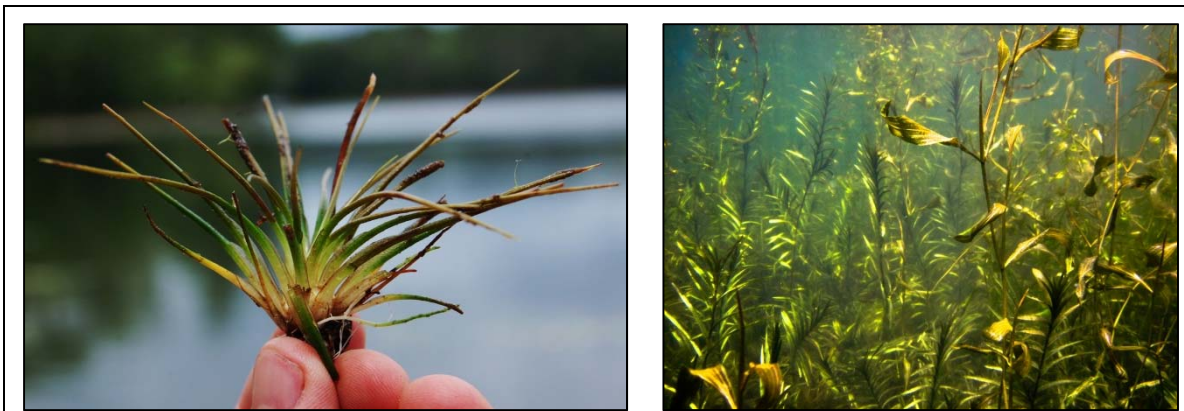
Photo 8.3.4-1. Lake quillwort (*Isoetes lacustris*) of the isoetid growth form (left) and variable pondweed (*Potamogeton gramineus*) and fern pondweed (*P. robbinsii*) of the elodeid growth form (right).

In contrast, aquatic plant species of the elodeid growth form have leaves on tall, erect stems which grow up into the water column, and are the plants that lake users are likely more familiar with (Photo 8.3.4-1). It is important to note that the definition of these two groups is based solely on morphology and physiology and not on species' relationships. For example, dwarf-water milfoil (*Myriophyllum tenellum*) found in Birch Lake is classified as an isoetid, while all of the other milfoil species in Wisconsin such as northern water milfoil (*Myriophyllum sibiricum*), also found in Birch Lake, are classified as elodeids.

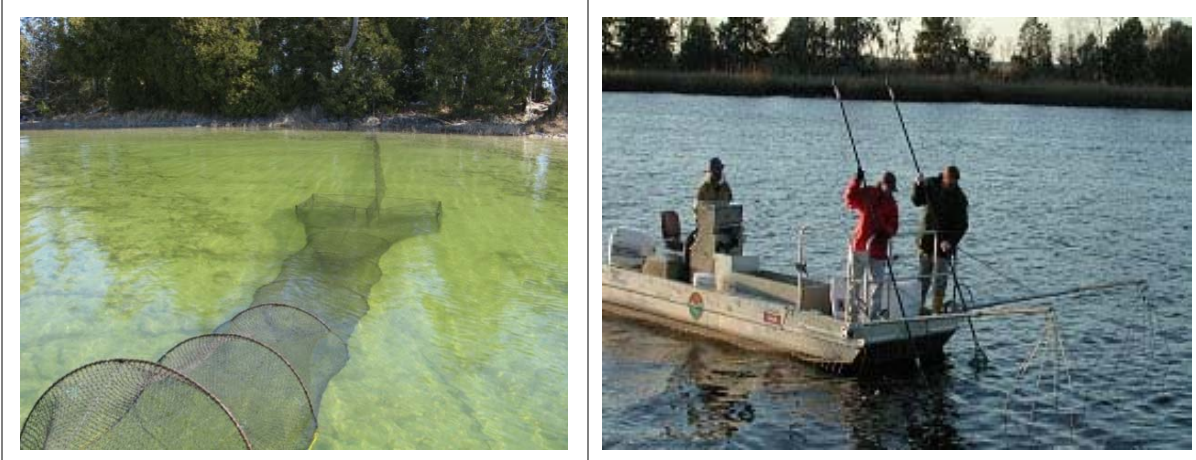
Photo 8.3.6-1. Fyke net positioned in the littoral zone of a Wisconsin lake (right) and an electroshocking boat (left).

The other commonly used sampling method is electroshocking (Photo 8.3.6-1). This is done, often at night, by using a specialized boat fit with a generator and two electrodes installed on the front touching the water. Once a fish comes in contact with the electrical current produced, *galvanotaxis* stimulates their nervous system and involuntarily causes them to swim toward the electrodes. When the fish are in the vicinity of the electrodes, they undergo *narcosis* (stunned), making them easy for fisheries technicians to net and place into a livewell to recover. Contrary to what some may believe, electroshocking does not kill the fish and after being placed in the livewell, fish generally recover within minutes.

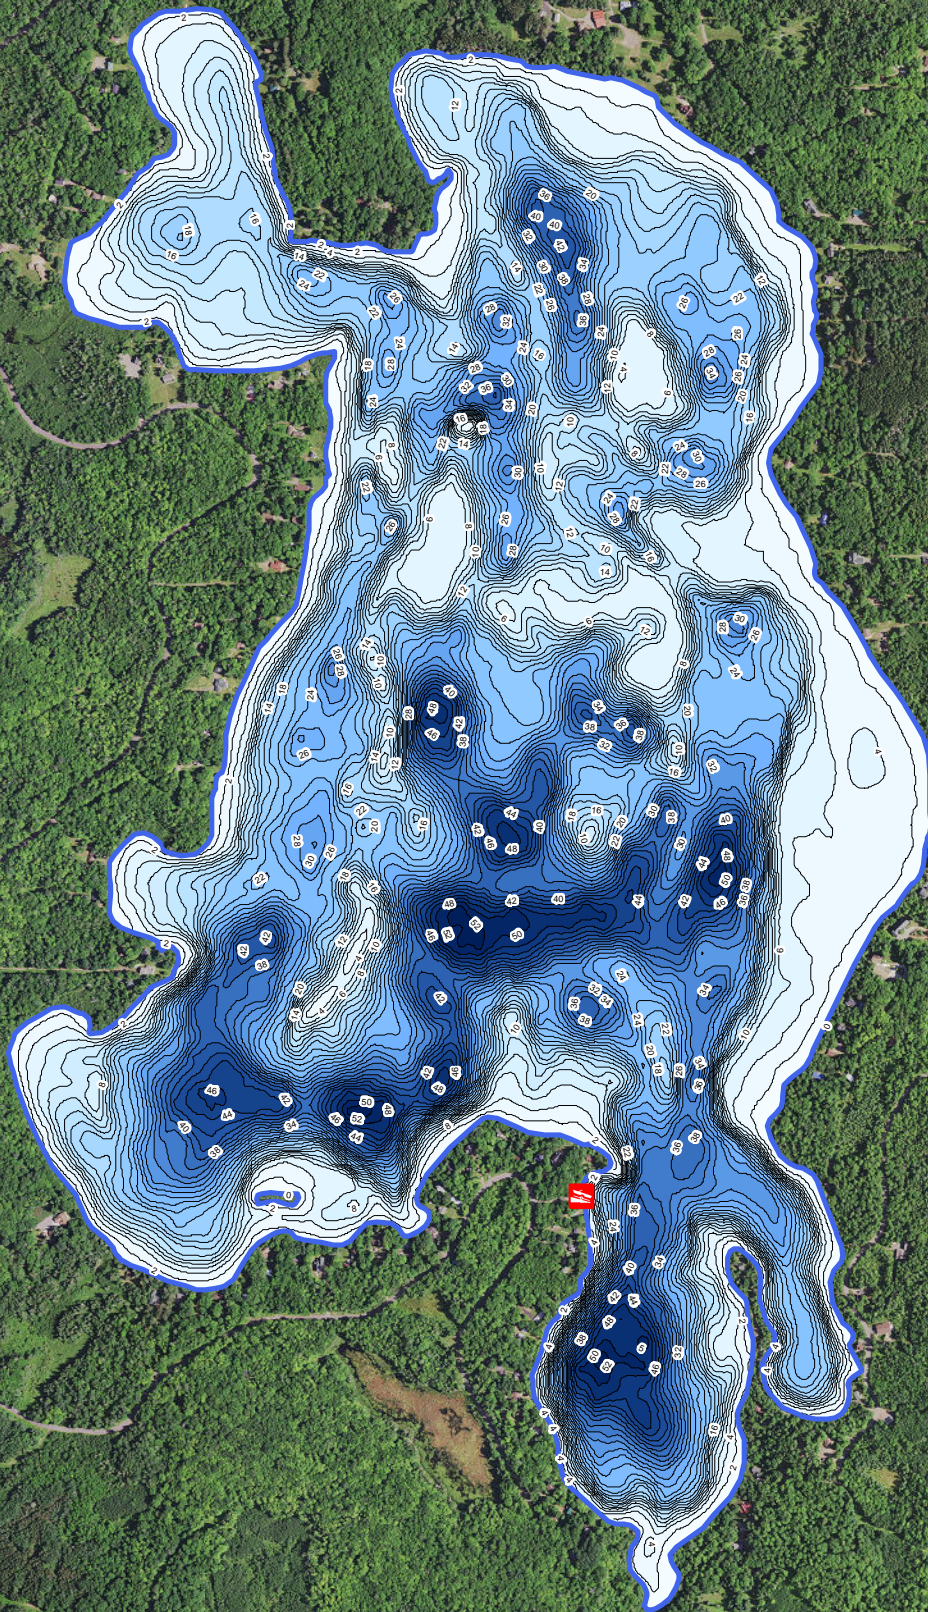
Sources:
 Orthophotography: NAIP 2015
 Bathymetric Survey: Onterra 2016
 Map Date: March 6, 2017
 Filename: Map1_Birch_Location.mxd

Birch Lake, Vilas County, is a 528-acre deep lowland, brown-water, mesotrophic drainage lake with a maximum depth of 52 feet and mean depth of 18 feet (Birch Lake – Map 1). Its surficial watershed encompasses approximately 4,178 acres and is comprised mainly of intact forests and wetlands. Birch Lake is a headwater lake within the Flambeau River Watershed, and water from Birch Lake flows out through Tambier Creek northwest into downstream Tamarack Lake. In 2016, 36 native aquatic plant species were located within the lake, of which wild celery (*Vallisneria americana*) was the most common. No non-native, invasive aquatic plant species were located during the 2016 surveys. However, the lake is known to harbor populations of the non-native wetland plant aquatic forget-me-not and non-native invertebrates including the Chinese and banded mystery snails and rusty crayfish.
