Wisconsin Department of Natural Resources
Surface Water Grants Program
Aquatic Invasive Species
Grant # AIRR-216-17

Buckatabon Lakes Eurasian Watermilfoil Control and Prevention Rapid Response Project (2015-2017)

Upper and Lower Buckatabon Lakes - Vilas County, WI

Final Reporting

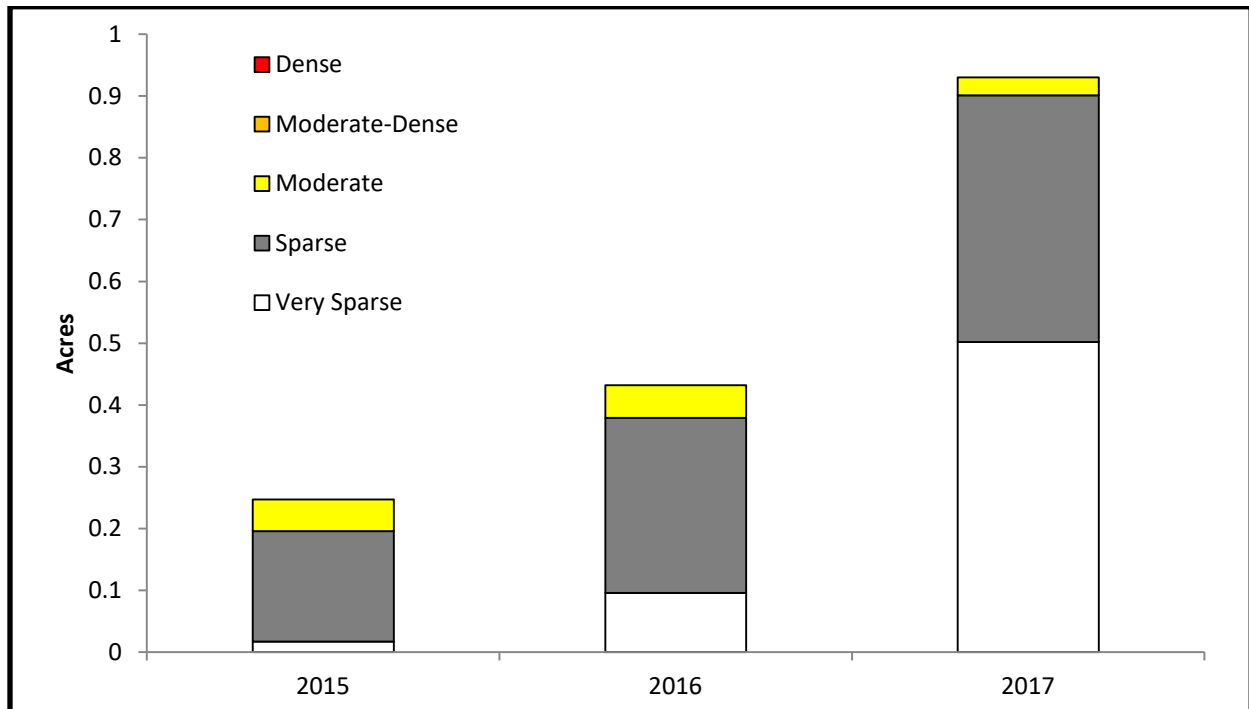
Figure 1: Change in EWM point based mapping acreage categorized by estimated abundance 2015-2017 – Upper and Lower Buckatabon Lakes Combined. Note: This is a visual estimate of exact extent, not total footprint.

Seasonal monitoring and post management evaluations have shown over the course of three years a slight increase in the overall distribution of point based gps mapping of EWM across the Buckatabon Lakes and a slight decrease in overall abundance. However, since 2016, no larger polygon based mapped beds were detected on either of the Buckatabon Lakes. Overall, the present status of EWM on Buckatabon Lakes is at a low, non-nuisance level. Annual variations in the population of native and invasive plants will occur, regardless of management or chosen no management, however, a maintained reduction to point based mapping and mainly sparse to very sparse EWM abundance can be positively attributed to seasonal EWM management.
