Prepared by: EOR

For the Muskellunge Lake Association

## 2017 EWM Monitoring and Harvesting Assessment Report

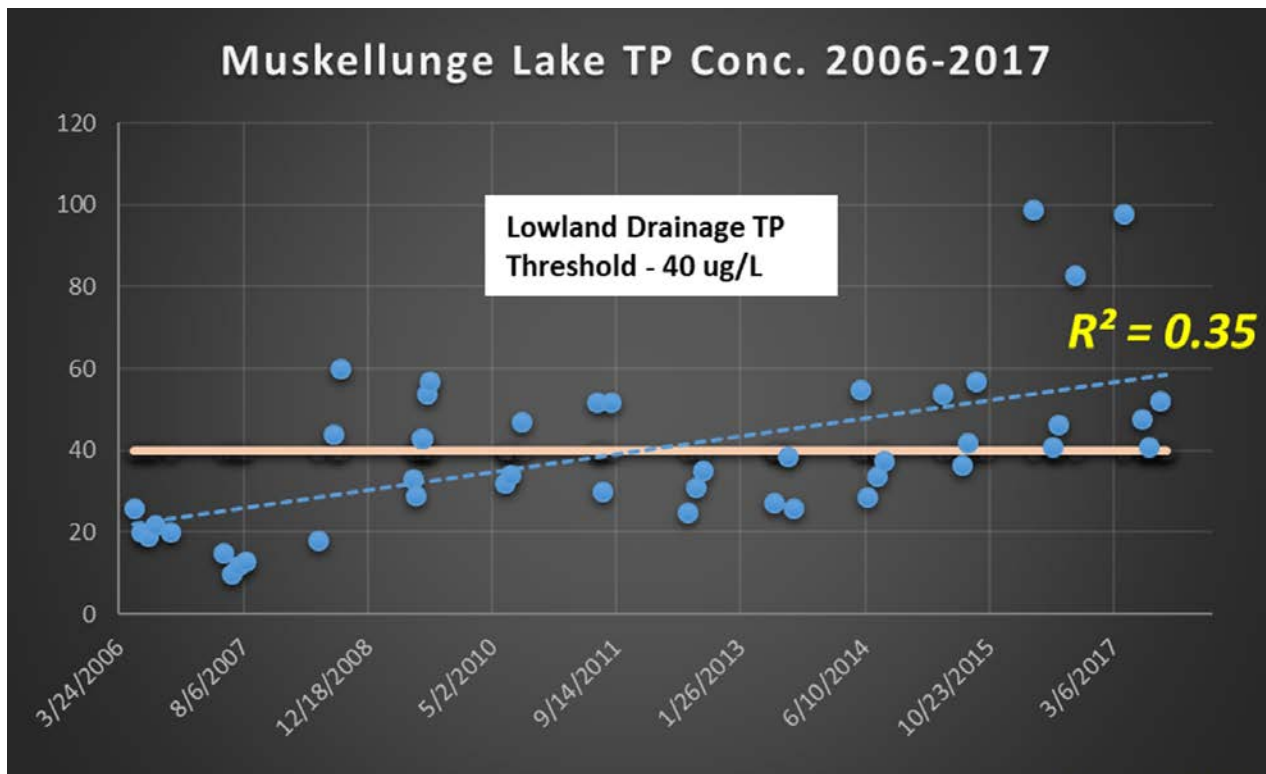
Figure 1. Muskellunge Lake Total Phosphorus (TP) concentrations 2006-2017.

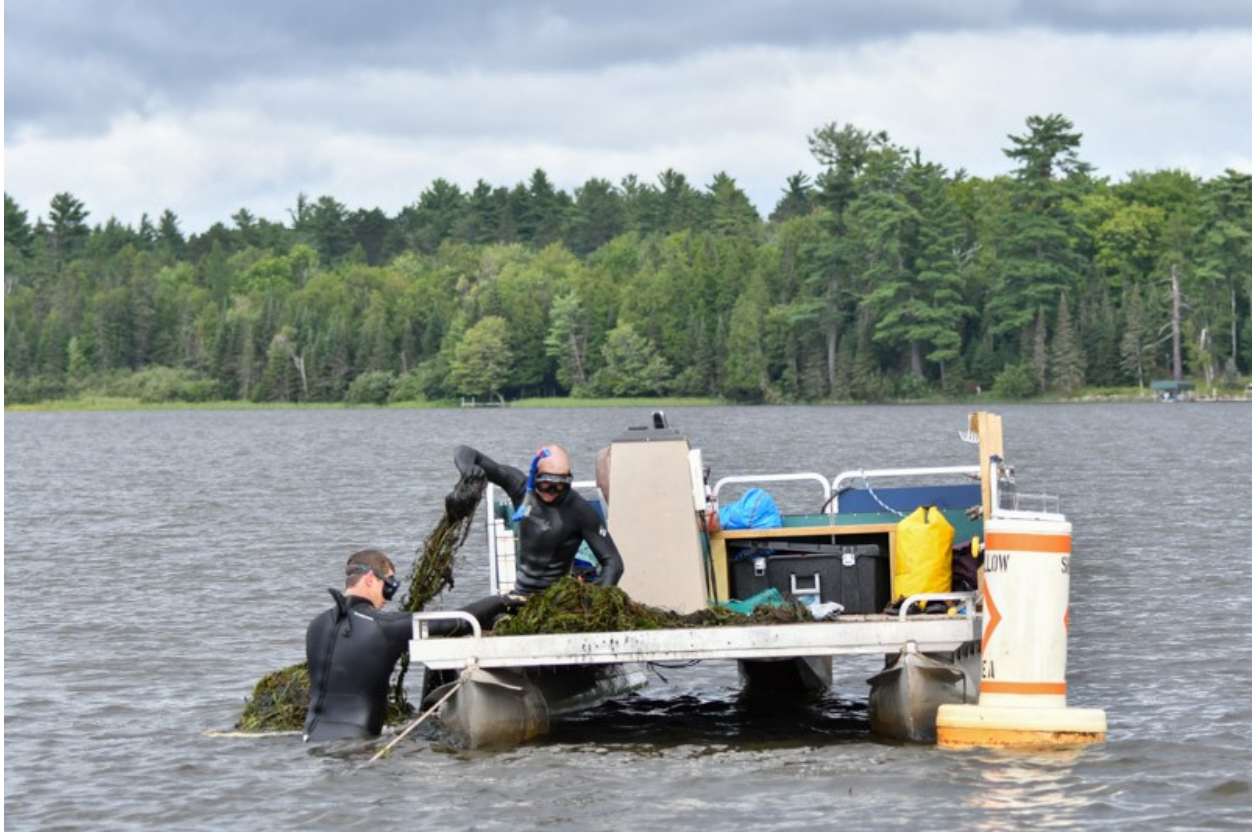
Figure 6. Aquatic Plant Management, LLC conducting professional hand-harvesting near center buoy.

Divers from APM spent a combined total of 47.65 hours on the water during which they successfully removed 31.1 cubic feet of EWM from the lake. Members of the MLA directed divers to the treatment areas and collected pictures to document progress. The majority of the time spent on 8/17/2017 was focused on targeting the areas near the rock bar at the center buoy where EWM was matted to the surface (Figure 5). Divers then moved off the rock bar, targeting single plants adjacent to the main bed within the 0.43 acre treatment area (Figure 6). The remainder of time spent on 8/17 was spent removing EWM within the 0.08 acre treatment area near the public access. The EWM was growing in approximately 3 feet of water in this area, however, most of the EWM was less than 2 feet tall. Dive conditions on 8/17 were ideal for hand-harvesting; however, secchi disk readings of 3.0 feet indicated water clarity was poor which may have obscured some smaller plants.

Professional hand removal efforts on 8/18 focused on the 0.40 acre treatment area on the south side of Muskellunge Lake. Plants within the treatment area were growing to the surface in 3.5 to 4.5 feet of water. Hand-removal efforts concluded with a revisit to the center buoy which focused on further removing individual plants from the deeper areas around the perimeter of the treatment area. Weather conditions on 8/18 were not as ideal with high winds and rain making diving more difficult. Water transparency remained the same.

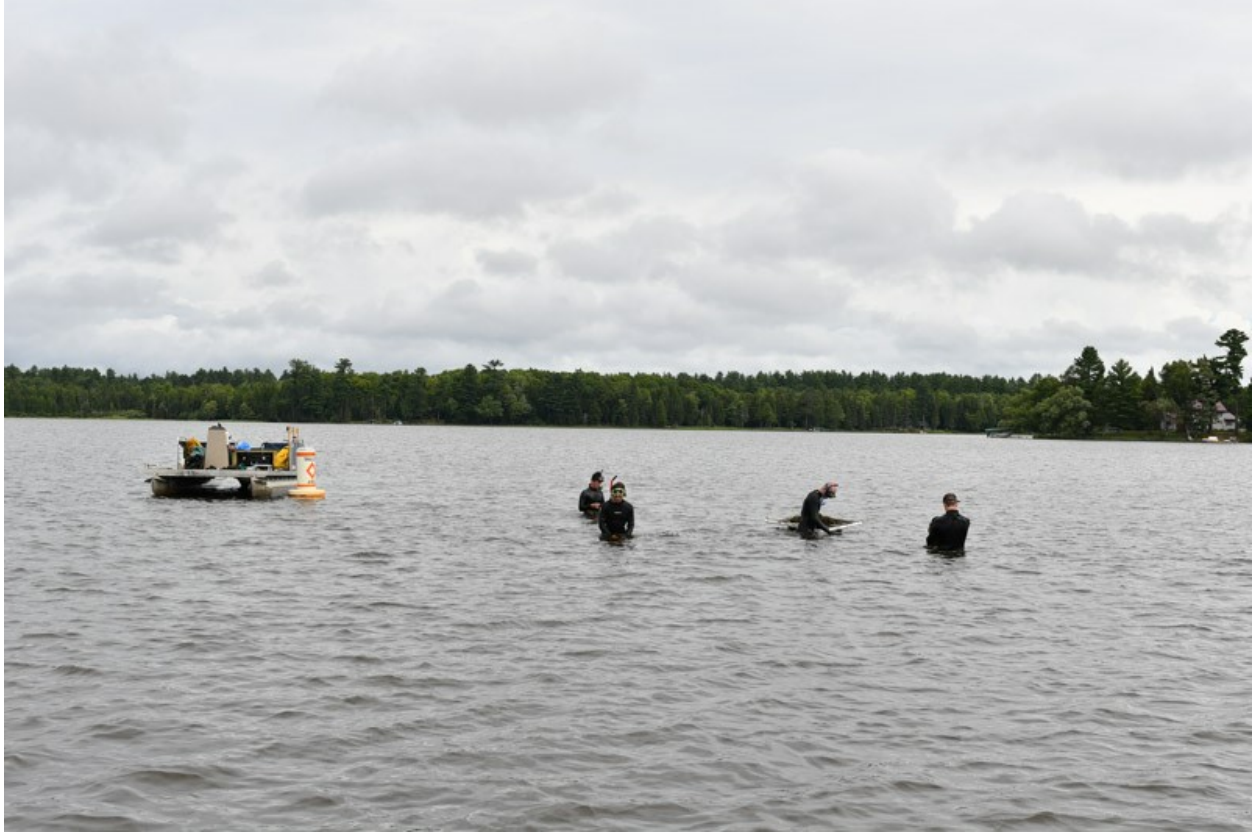
**Figure 7. Aquatic Plant Management, LLC conducting professional hand-harvesting adjacent to the center buoy.**
