# Red Cedar River Erosion and Habitat Assessment Report

**RED CEDAR RIVER EROSION AND HABITAT ASSESSMENT  
DRAFT REPORT**

Inter-fluve, Inc.  
301 S. Livingston St., Suite 200  
Madison, WI 53703  
608-441-0342

March 24, 2014

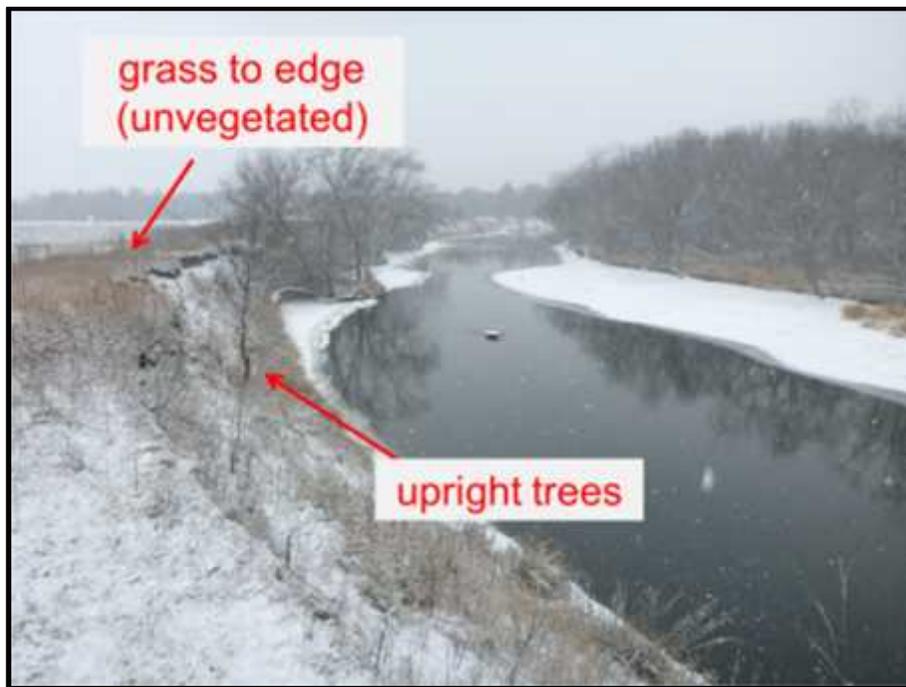
Figure 13. Red Cedar River looking downstream along the wastewater treatment facility (left). The terraces are relatively high with sparse vegetation and the floodplains (right) are relatively low and well vegetated.

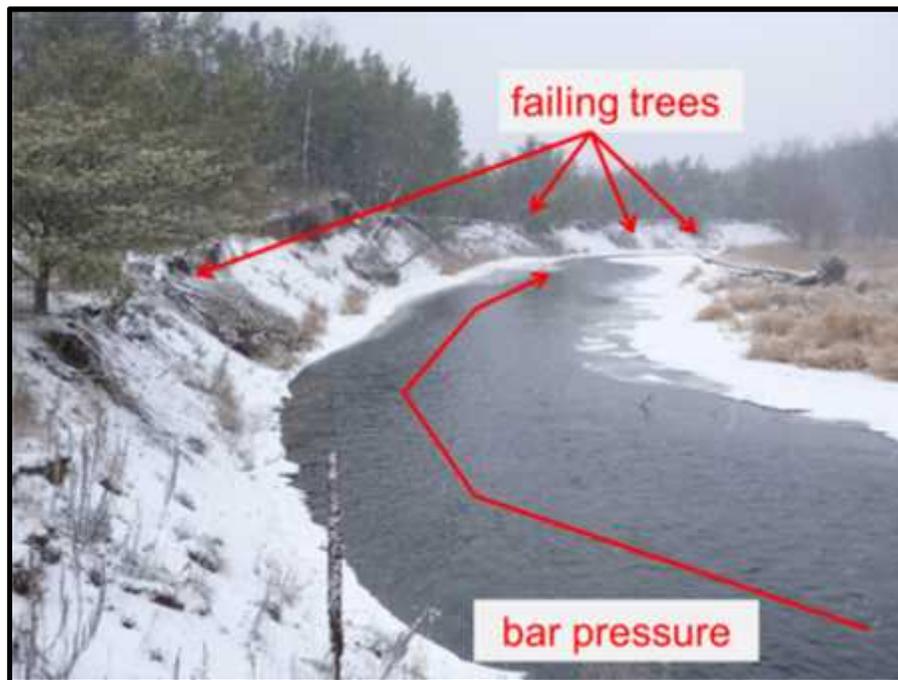
Figure 14. Red Cedar River looking downstream below the wastewater treatment facility. The terrace/bluff slopes are relatively high with sparse vegetation. The conifers on the left provide little bank protection and are being left along the bank and the opposing bar (right), which is forcing flow against the left bank.

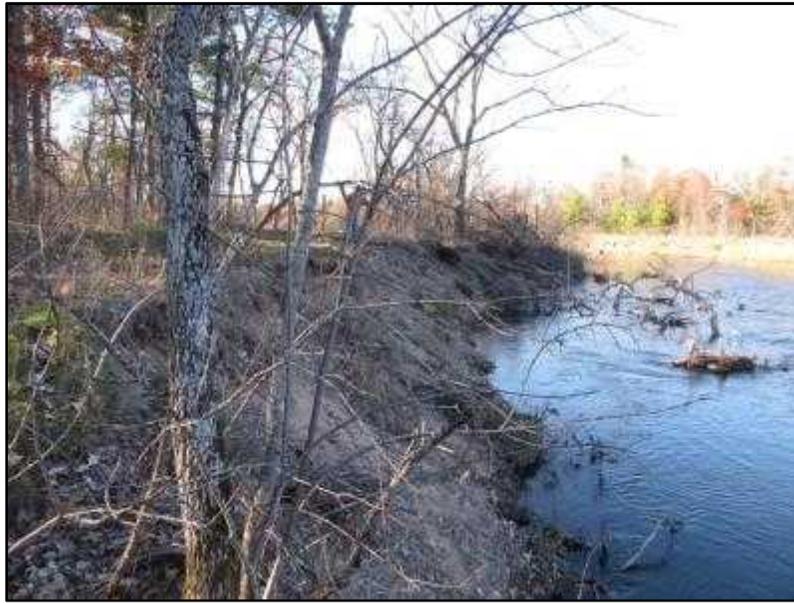
Figure 20. Red Cedar River at the gravel pit location downstream of the Dobb's Landing Bend (Site 54). The channel is undercutting woody riparian vegetation along the sandy floodplain bank on both sides of the river.

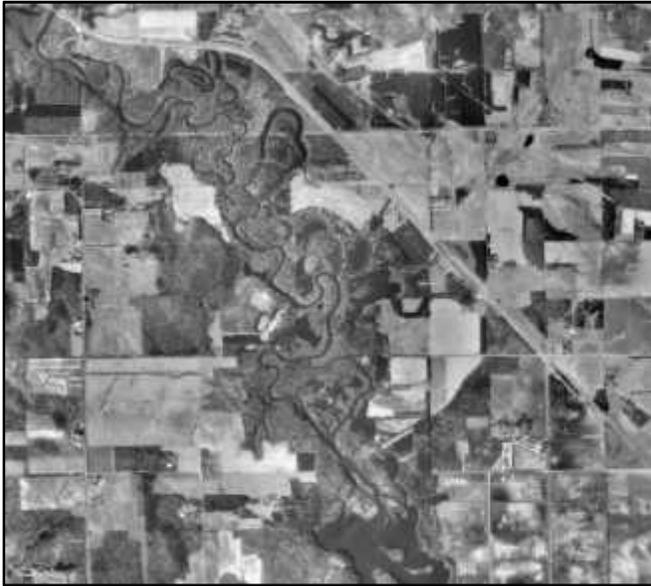
**Figure 22. The lower reach of the Hay River also appears to be active as it enters the Tainter Lake valley.**

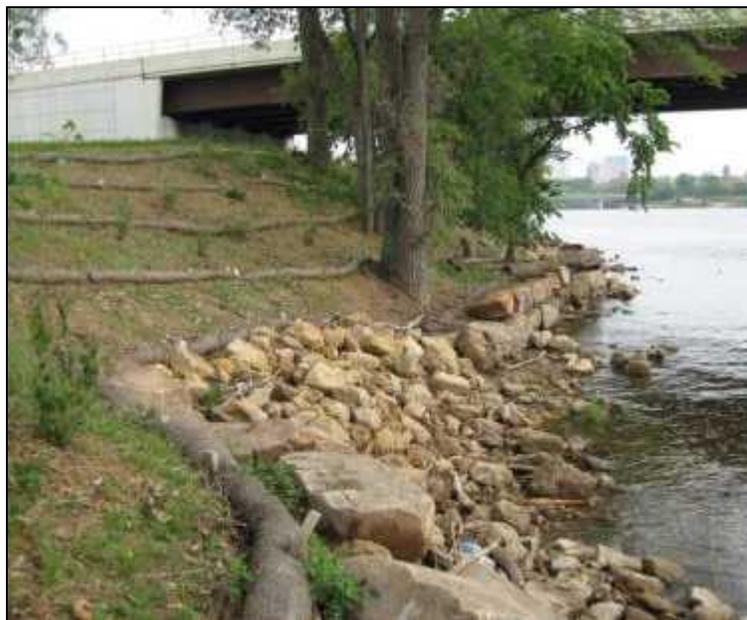
**Figure 26. Riprap here was placed carefully from the bottom of the slope to preserve the existing trees. This may be possible at some sites where access is permits**

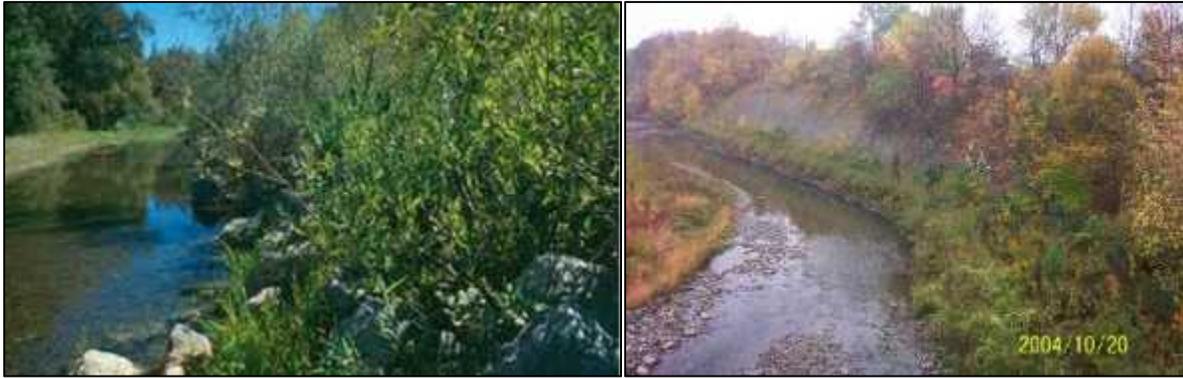
**Figure 17: Examples of established vegetative riprap.**

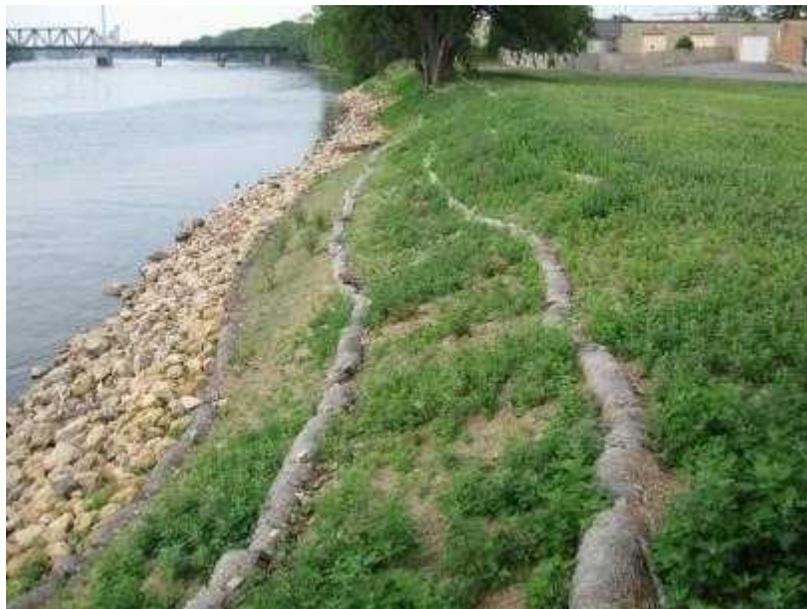
**Figure 28: Water levels move up and down frequently at this site, keeping vegetation from developing among the riprap.**

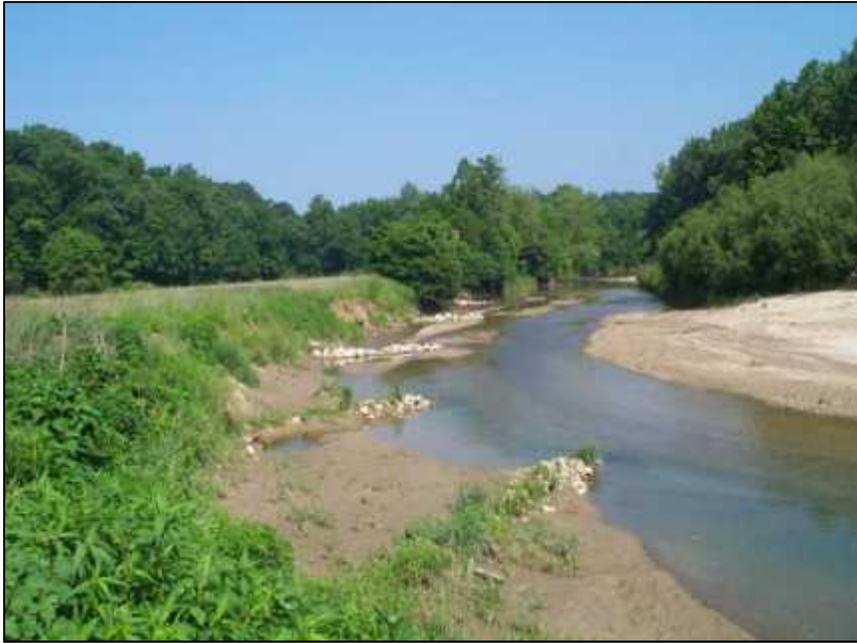
**Figure 29: Rock/riprap barbs forcing the flow to the right and catching sand on their downstream sides.**

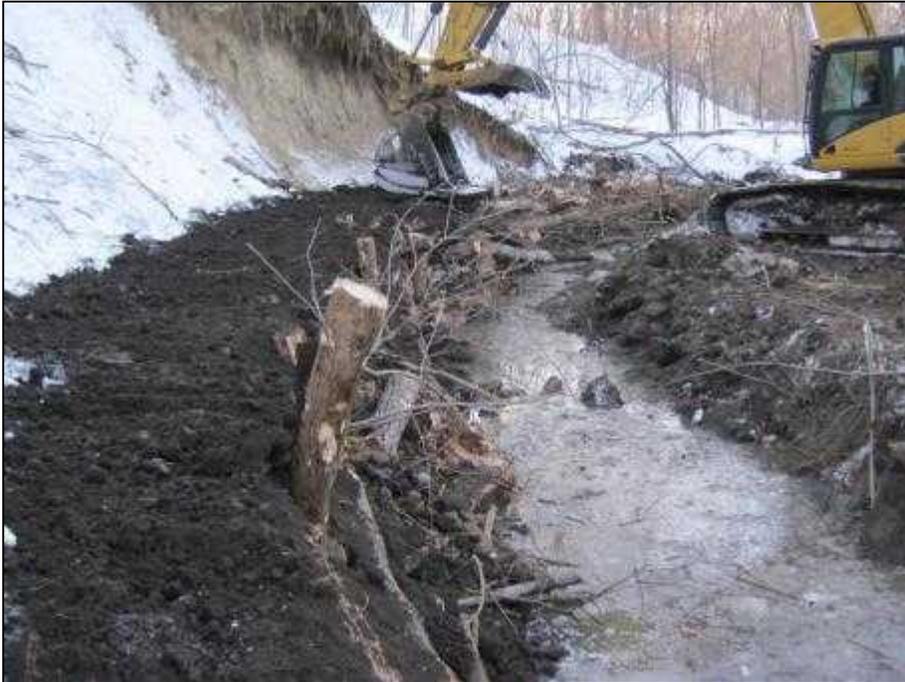
**Figure 32. Example of a large wood cribwall under construction at the toe of a failing sand bluff in Minnesota. The space between the interlocking logs was filled by additional wood and rock, before being covered with soil. After construction, the bench will be planted with native vegetation.**

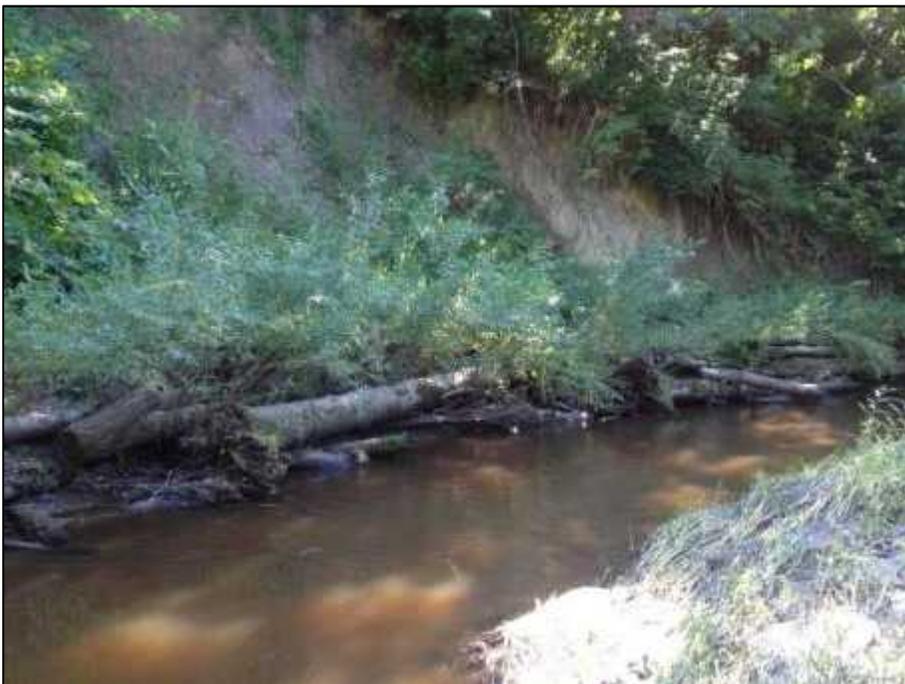
**Figure 33. Vegetation established on the bench and slope face behind the cribwall noted above.**

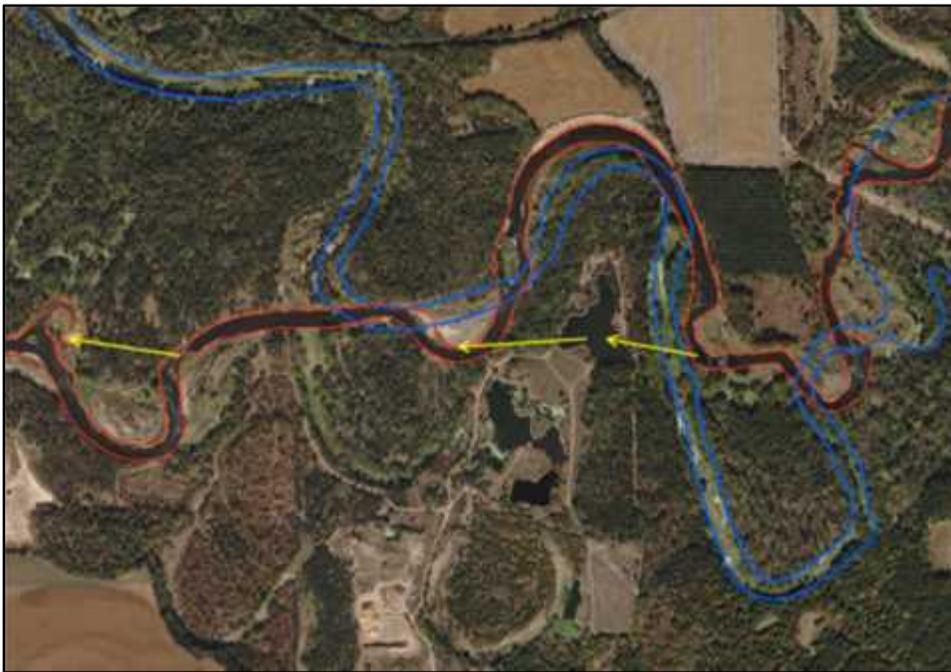
**Figure 35. Potential avulsion/chute cutoff path along the existing channel. The gravel pits on the south side of the channel provide preferential pathways for floodwaters to cut a new position.**
