Bass Lake
Eastern Marathon County Lake Study

Final Study Results 2013

*University of Wisconsin-Stevens Point
and
Marathon County Staff and Citizens*

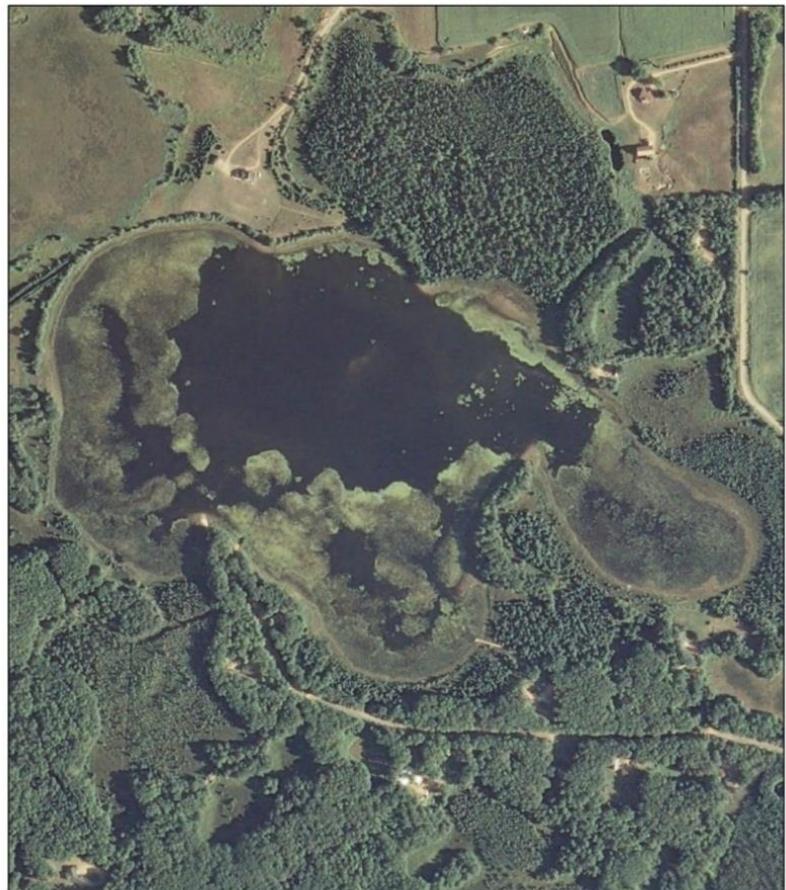
Water Flow

- ◆ Bass Lake is a seepage lake with most of the water entering the lake from groundwater.
- ◆ Surface water runoff and direct precipitation also contribute water, but to lesser extents.
- ◆ Water exits Bass Lake through groundwater.

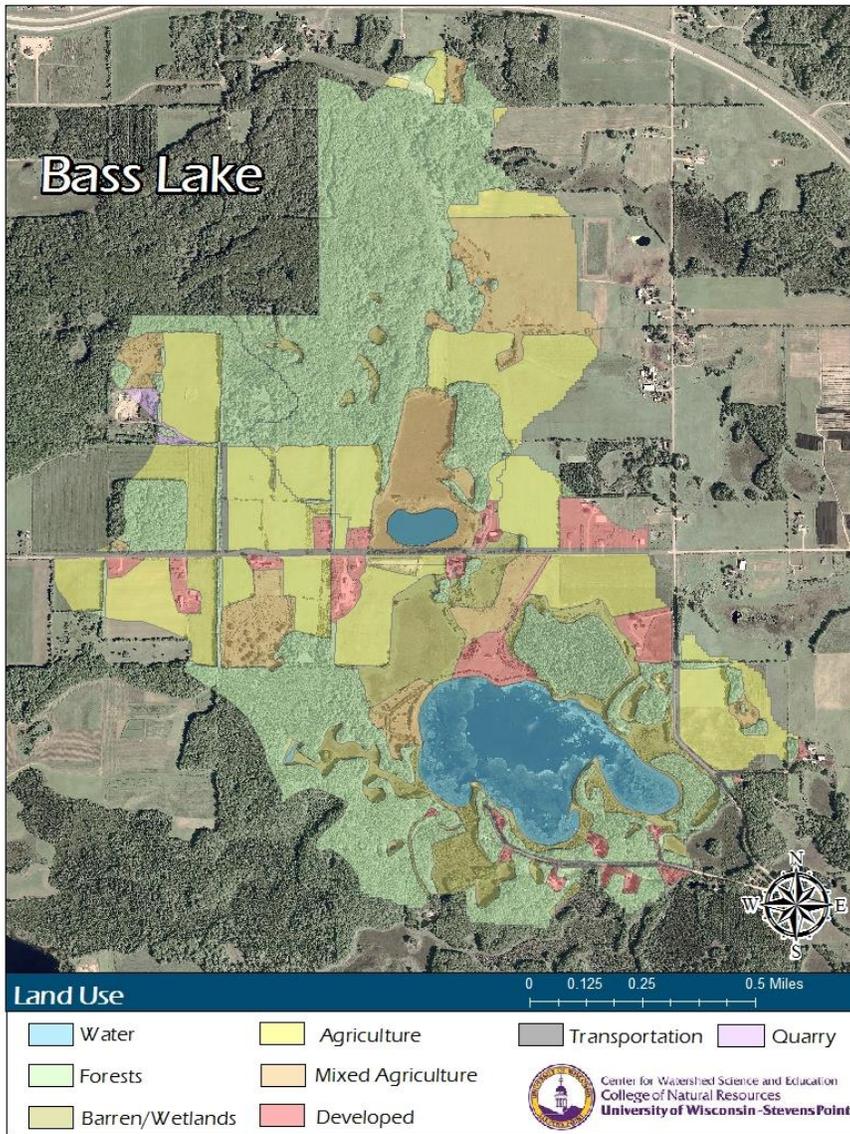
Bass Lake – Surface Watershed

Surface Watershed: The area where water runs off the surface of the land and drains toward the lake.

- Land uses and land management practices occurring in the watershed affect the water quality in the lake.
- Land uses and land management also play major roles in how water moves across the landscape and how much water soaks into the ground (for long-term storage) or quickly runs off the land.
- The surface watershed of Bass Lake is 1,083 acres.
- The primary land uses in the Bass Lake watershed are agriculture and forests.
- Bass Lake has residential development around part of its perimeter. In general, the land closest to the lake has the greatest immediate impact on water quality.

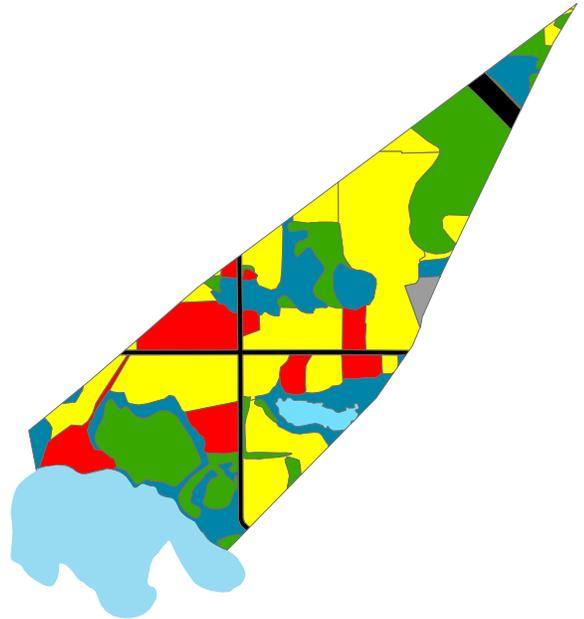
Bass Lake – Groundwater Watershed

Groundwater Watershed: The area where water soaks into the ground and travels below ground to the lake.

- ◆ The groundwater watershed for Bass Lake is 384 acres.
- ◆ The primary land uses in the Bass Lake groundwater watershed are agriculture and forests.
- ◆ In general, the land adjacent to the lake where groundwater is flowing into the lake has the greatest immediate impact on water quality. Residential development, forests and wetlands are adjacent to Bass Lake where most of the groundwater enters.

Land Use	Acres
Agriculture	142
Developed	46
Forested	86
Quarry	3
Roads	16
Water	28
Wetland	63

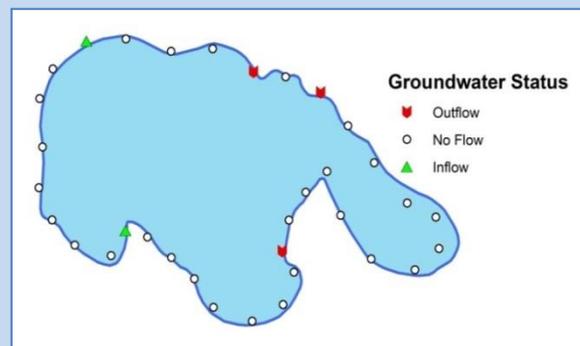
Looking at Groundwater Up Close:

Most of the groundwater enters Bass Lake from the north and exits at various points around the lake.

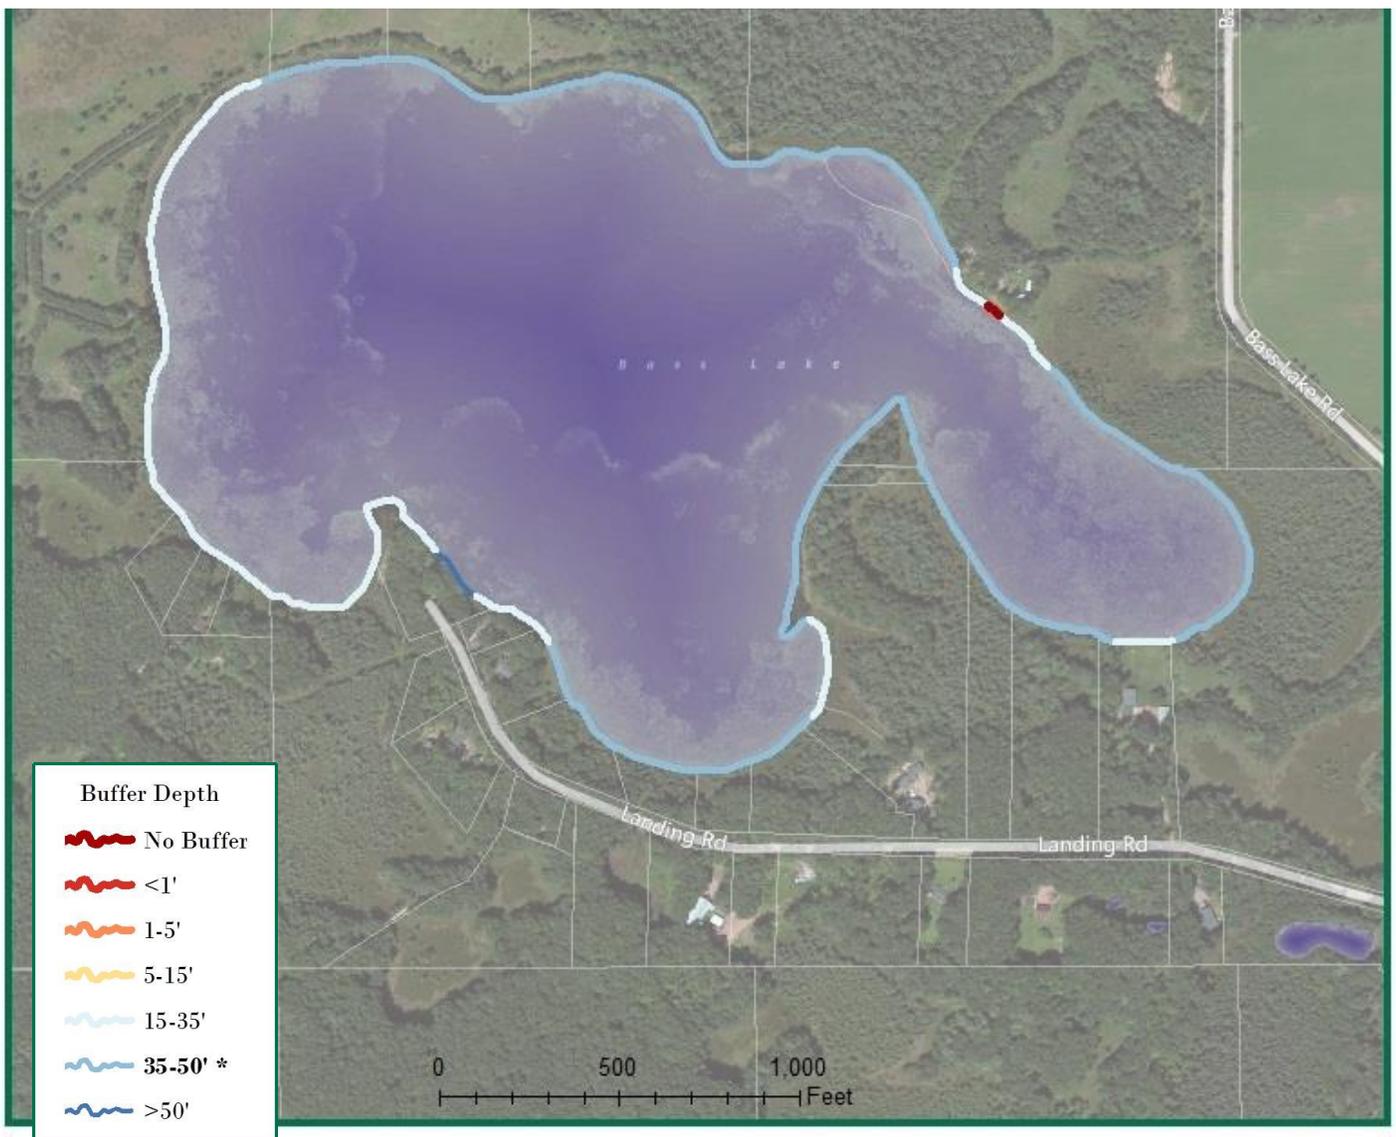
Bass Lake – Shoreland Vegetation

The map below shows how far the 0.5 to 3 foot tall vegetation extends landward from the edge of Bass Lake. A greater vegetative buffer produces more habitat and better water quality.

*NR 115 requires at least a 35 foot wide shoreline buffer

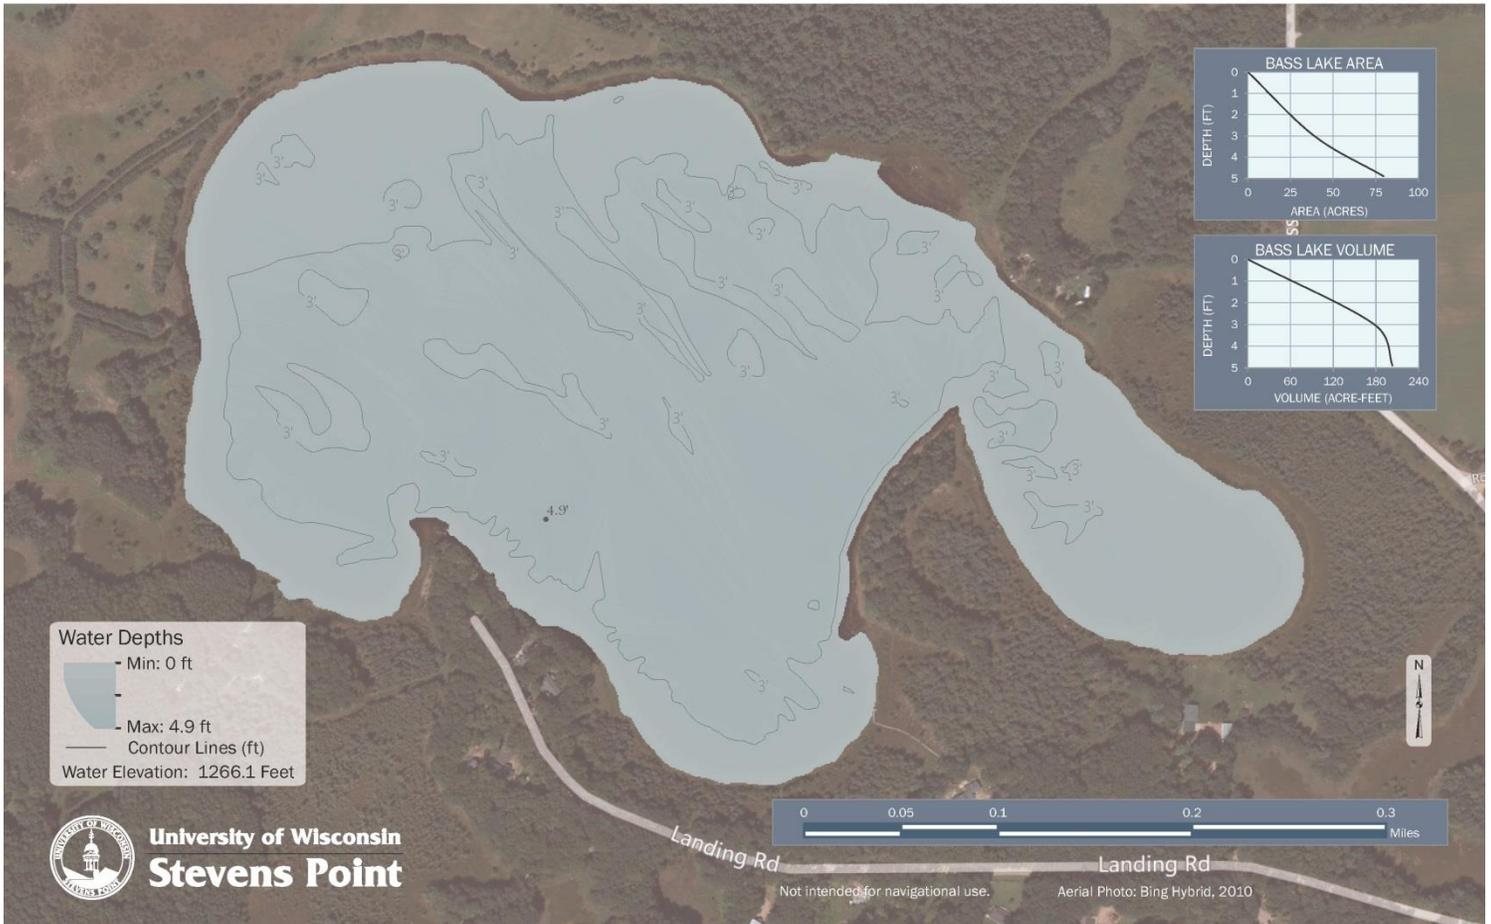
BATHYMETRIC MAP

LAKE AREA	79.7 Acres
Under 3 Feet	38.9 Acres (48.8%)
Over 20 Feet	0 Acres (0%)

VOLUME	203 Acre-feet
SHORELINE	1.9 Miles
MAX DEPTH	4.9 Feet
GPS and Sonar Survey	June, 2012

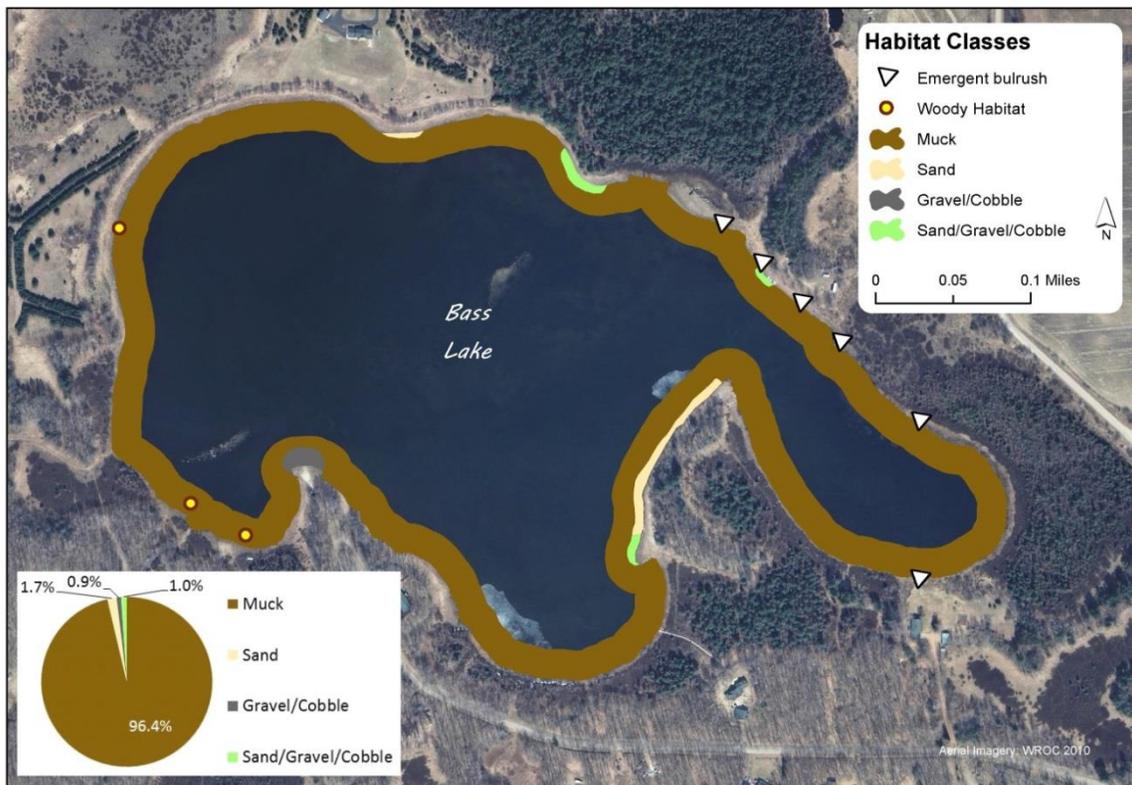
**Bass Lake Habitat
Marathon County, WI 2012**

- ◆ Coarse woody habitat (CWH) is sparse in Bass Lake; the fish community may benefit from the addition of CWH.
- ◆ Substrate in Bass Lake primarily consists of a soft bottom, muck (96.4%); however, harder substrates including gravel/cobble and sandy areas also exist.
- ◆ Wisconsin DNR files document a proposal to dredge areas of Bass Lake in 1969. Dredging was proposed again in 1988, but was denied due to historic use of chemicals in the lake and because then-current lake levels supported a variety of wildlife.
- ◆ Average lake depth remains low; maximum depth in Bass Lake was less than five feet in the 2012 survey.

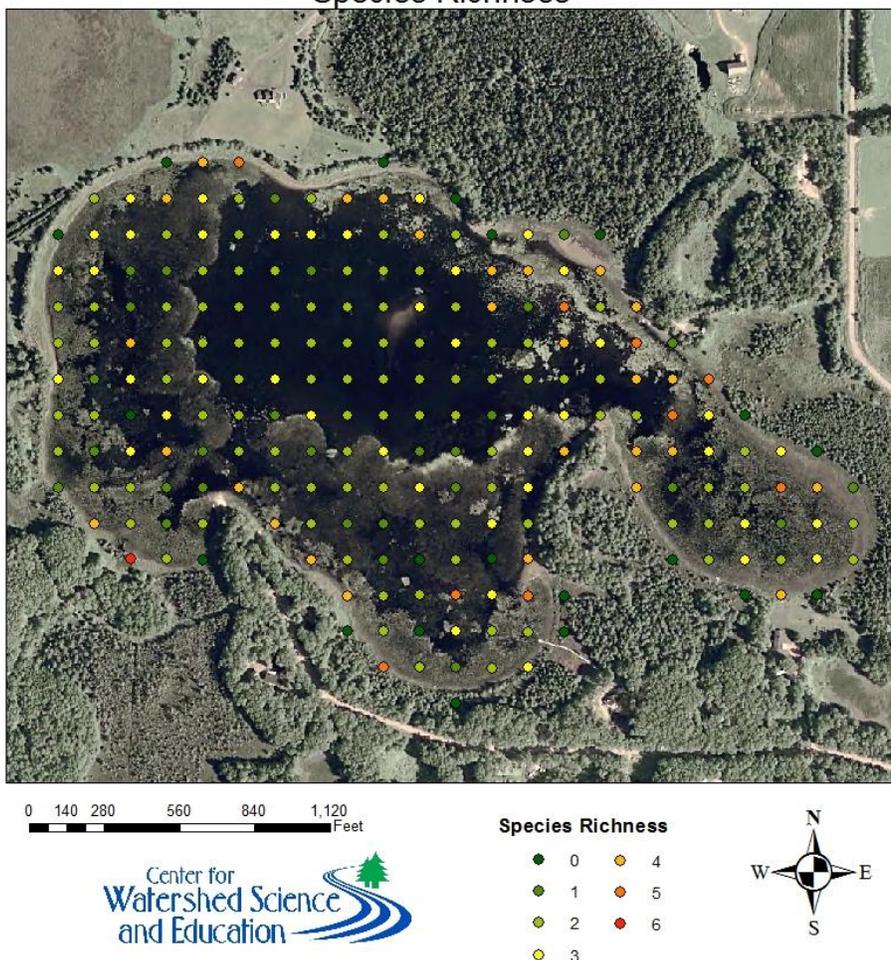
Bass Lake Aquatic Plant Survey 2011:
Species Richness

Species Richness is a count of the number of plant species found at a survey point. A greater number of species in a lake helps to make the aquatic plant community more resilient to year-to-year changes and aquatic invasive species. More plant species means more diverse habitat and food sources are available.

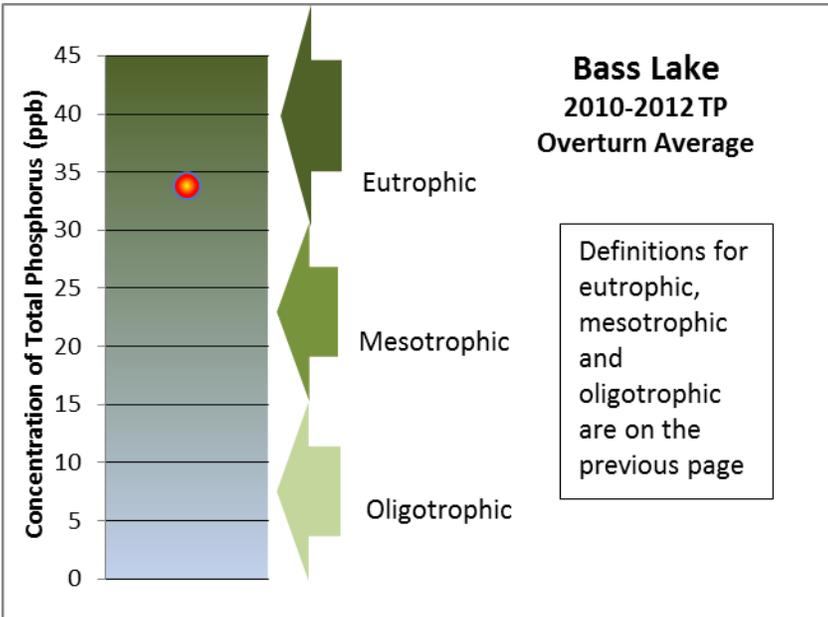
- ◆ Total phosphorus levels measured when Bass Lake was well-mixed (overturn) are displayed in the graph to the left.
- ◆ Overturn sampling during the 2010-2012 monitoring period indicate that Bass Lake is a eutrophic lake with a high average total phosphorus level.

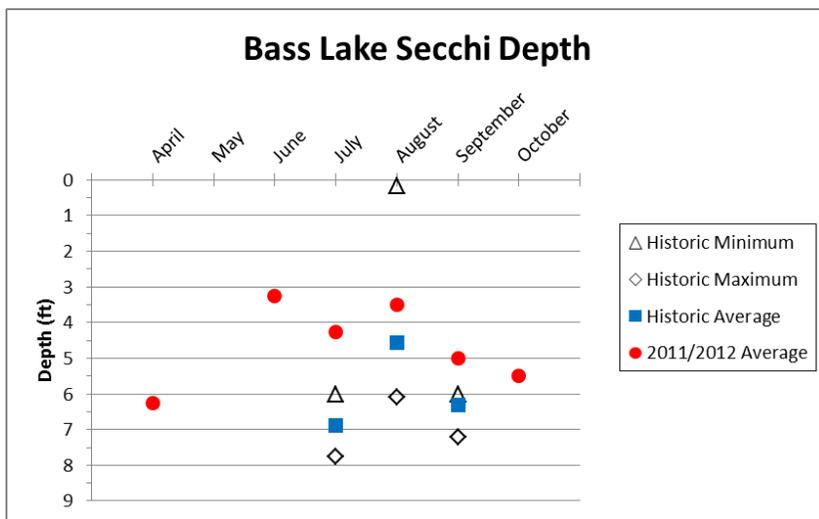
- ◆ The graph to the left shows water clarity data collected during the growing seasons in 2011 and 2012. It is typical for water clarity to vary throughout the year.
- ◆ The 2011/2012 average Secchi depth readings were slightly shallower than historic averages, suggesting a possible recent decline in water clarity.

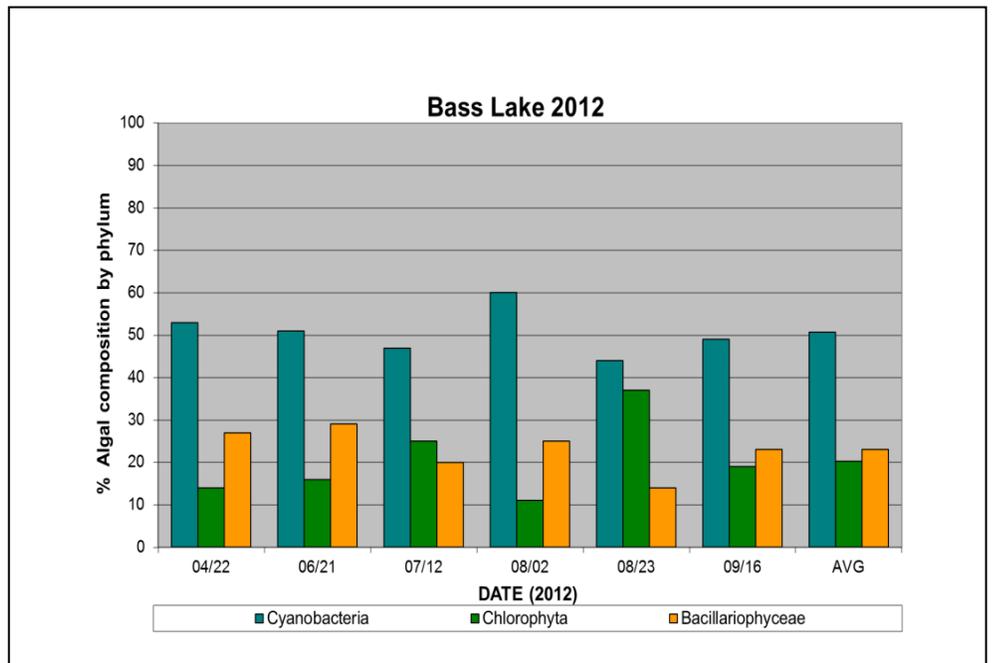
PERCENT ALGAL COMPOSITION FOR BASS LAKE IN 2012

- The algal community of Bass Lake was similar in 2011 and 2012, dominated by blue-green algae, which is characteristic of eutrophic lakes. The blue-greens dominated early in both years with a small mid-summer depression before a dominating fall rebound.
- The diatoms displayed a typical early and late season distribution in Bass Lake. They are the most common species associated with eutrophic waters.
- The green algae made up a small percentage of the algal community. These species are typically present under high nutrient conditions.
- The high nutrient load, shallow depth, decreasing water clarity, and an algal community dominated by species historically associated with eutrophic lakes suggest the lake has transitioned into a eutrophic state and may continue to decline. These conditions could lead to oxygen depletion and possible fish kills.
