Mayflower Lake

Eastern Marathon County Lake Study

Final Study Results 2013

University of Wisconsin-Stevens Point
and
Marathon County Staff and Citizens

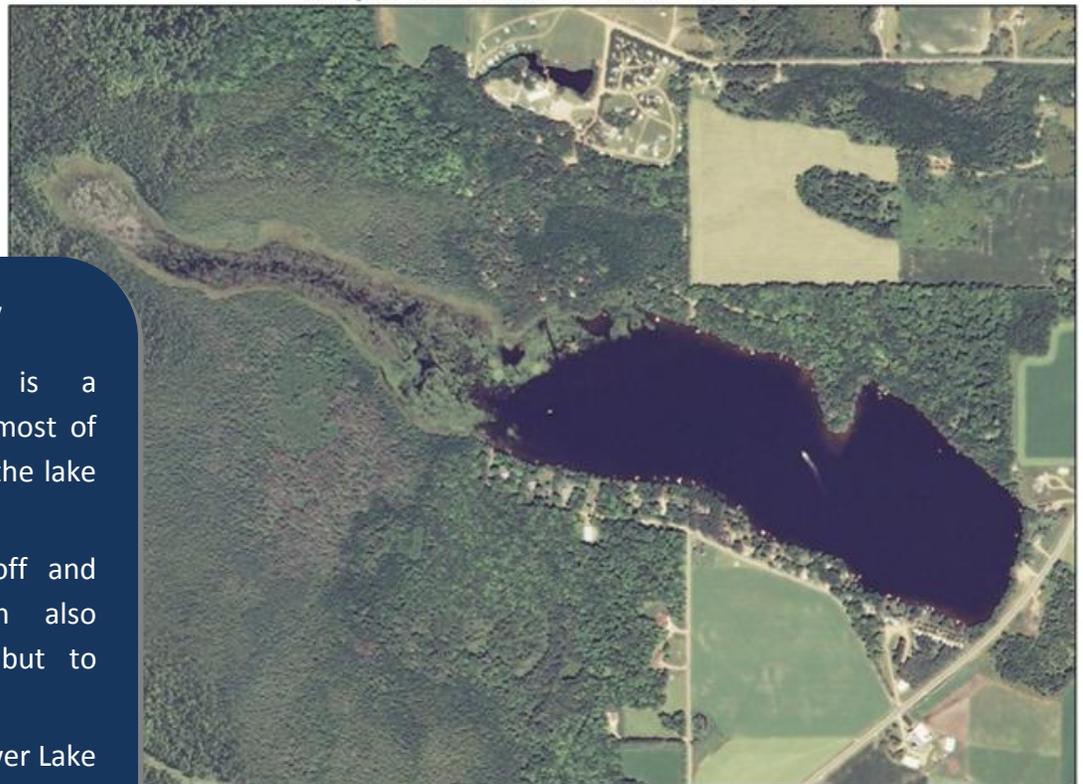
Water Flow

- ◆ Mayflower Lake is a seepage lake with most of the water entering the lake from groundwater.
- ◆ Surface water runoff and direct precipitation also contribute water, but to lesser extents.
- ◆ Water exits Mayflower Lake through groundwater.

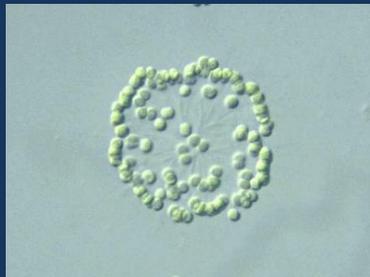
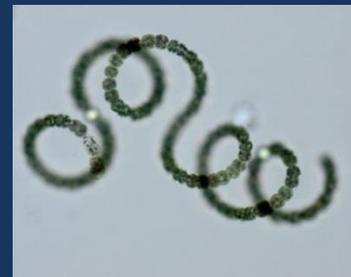
Mayflower Lake – Sediment Core Analysis

Lake sediment can help to tell the history of a lake and changes that may have affected the lake related to water quality, the abundance of aquatic plants, and sedimentation or land use changes in the watershed. These changes are assessed by evaluating the content of the upper layer of the sediment versus lower layers. This information can help to guide management decisions for a lake.

- Analysis of Mayflower Lake’s sediment core suggests increased disturbance in the lake basin since the time of European land clearing.
- The increase in ragweed pollen found deeper in the sediment core likely accompanied the onset of logging in the early 1880's, and peaked a decade or two later as agricultural fields replaced logged-over areas, especially around the eastern end of the lake.
- Diatom species communities as well as sediment properties reflect an increase in phosphorus and in aquatic plants and filamentous algae in the top of the sediment core.
- Changes in color and substance of upper sediment layers suggest stabilization and a slight decline in shoreline erosion and aquatic plant growth in the very recent past.

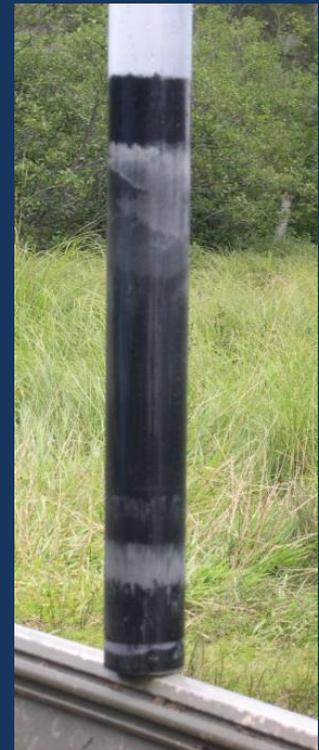
This is an example of a sediment core collected from the bottom of a Wisconsin lake. The darker layers indicate organic-rich sediments that are often due to abundant aquatic plants and/or soil erosion from the landscape. Additional analysis of these layers can help to confirm the source(s).
