# Mission Lake

## Eastern Marathon County Lake Study

# Final Study Results 2013

University of Wisconsin-Stevens Point  
and  
Marathon County Staff and Citizens

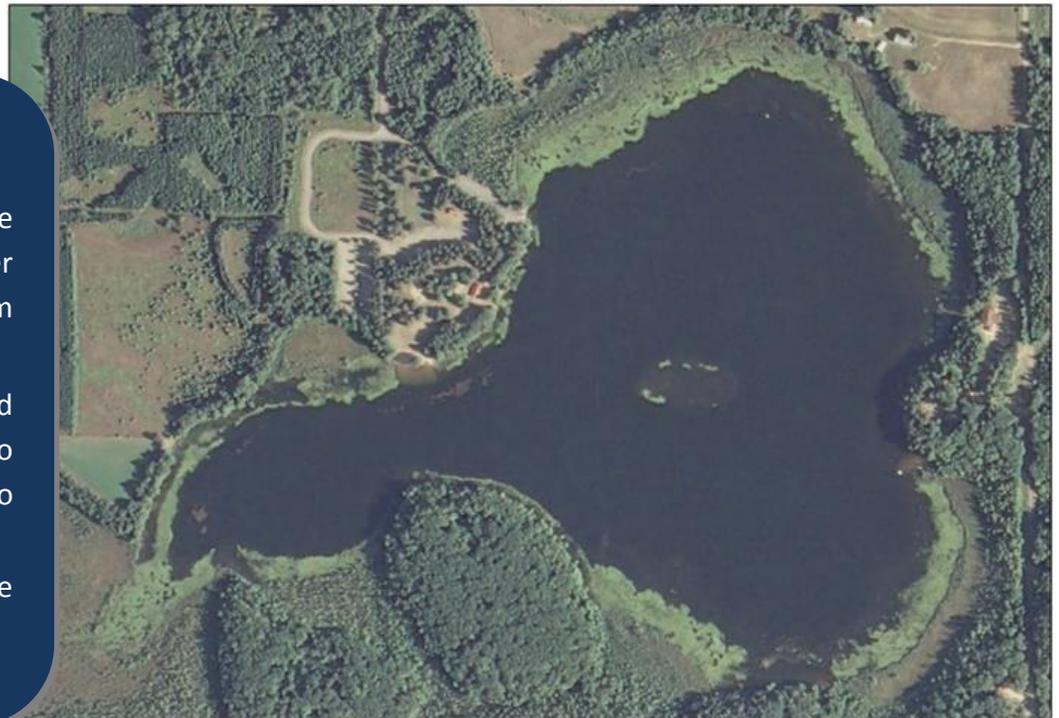
# Mission Lake – Surface Watershed

**Surface Watershed:** The area where water runs off the surface of the land and drains toward the lake.

- Land uses and land management practices occurring in the watershed affect the water quality in the lake.
- Land uses and land management also play major roles in how water moves across the landscape and how much water soaks into the ground (for long-term storage) or quickly runs off the land.
- The surface watershed of Mission Lake is 1,592 acres.
- The primary land uses in the Mission Lake watershed are agriculture and forests.
- Residential development is scattered throughout the watershed and is adjacent to part of the lake. In general, the land closest to the lake has the greatest immediate impact on water quality.
- Primary land uses adjacent to Mission Lake are wetlands, forests and recreation.

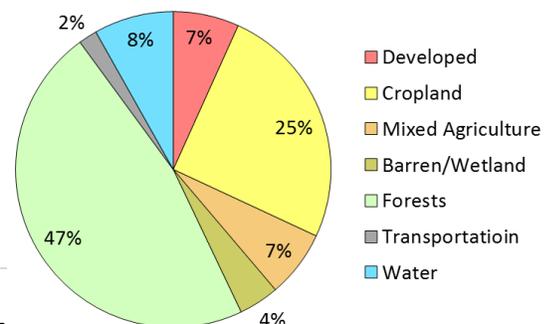
# Mission Lake – Groundwater Watershed

**Groundwater Watershed:** The area where water soaks into the ground and travels below ground towards the lake.

- ◆ The groundwater watershed for Mission Lake is 368 acres.
- ◆ The primary land uses in the Mission Lake groundwater watershed are agriculture and forests.

- ◆ In general, the lands adjacent to the lake where groundwater is entering have the greatest immediate impact on water quality. Wetlands and forest are adjacent to Mission Lake where most of the groundwater enters.

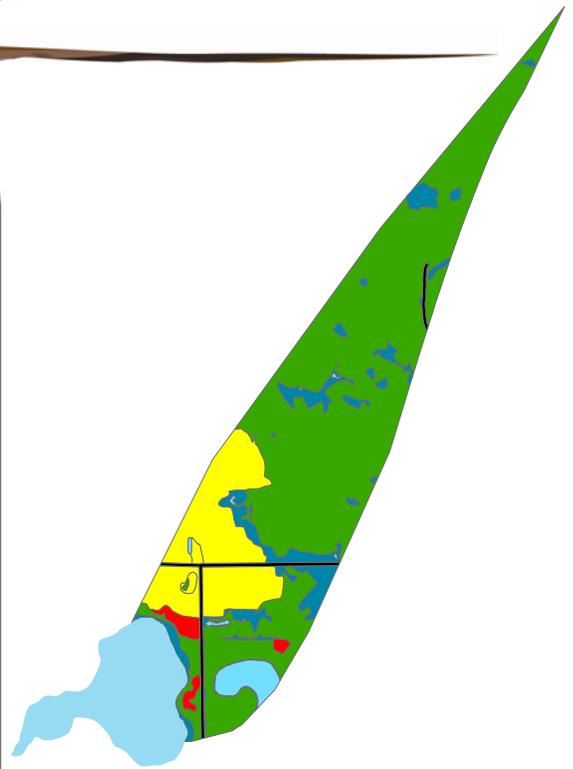
Land Use	Acres
Agriculture	84
Developed	14
Forested	241
Roads	5
Water	19
Wetland	5

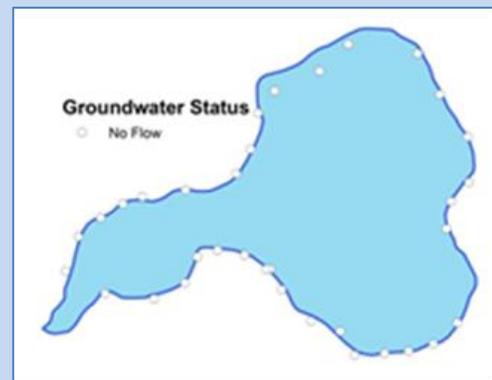
Groundwater enters Mission Lake from the northeast.

There were no groundwater connections identified at the sites sampled during the groundwater survey.

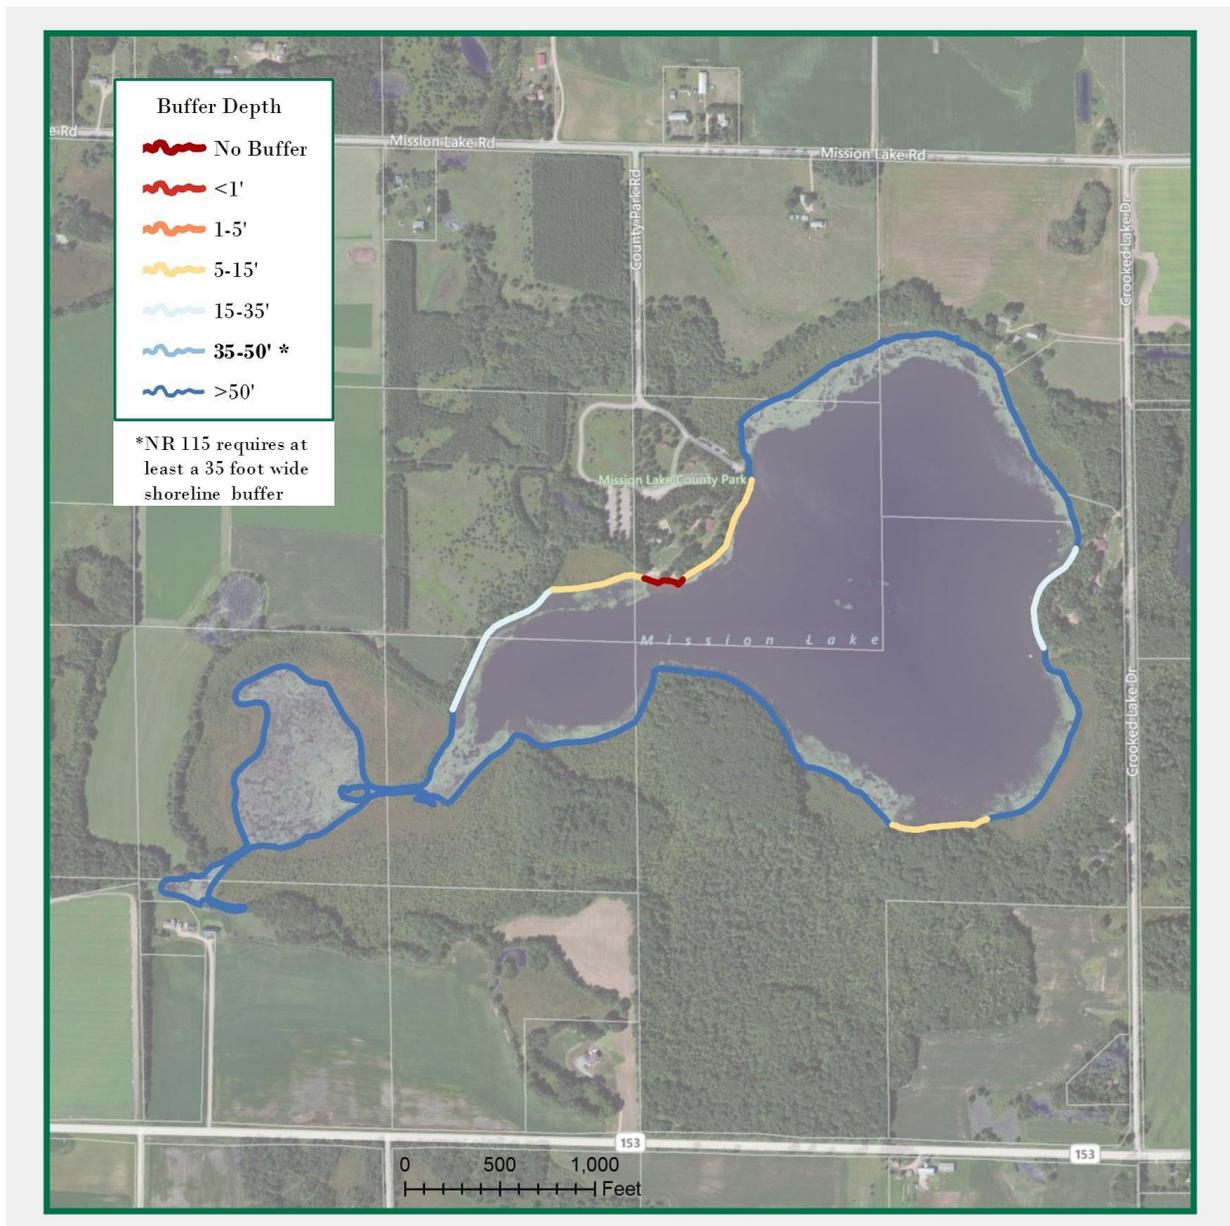
# Mission Lake – Shoreland Vegetation

The map below shows how far the 0.5 to 3 foot tall vegetation exists landward from the edge of Mission Lake. A greater vegetative buffer provides more habitat and better water quality.

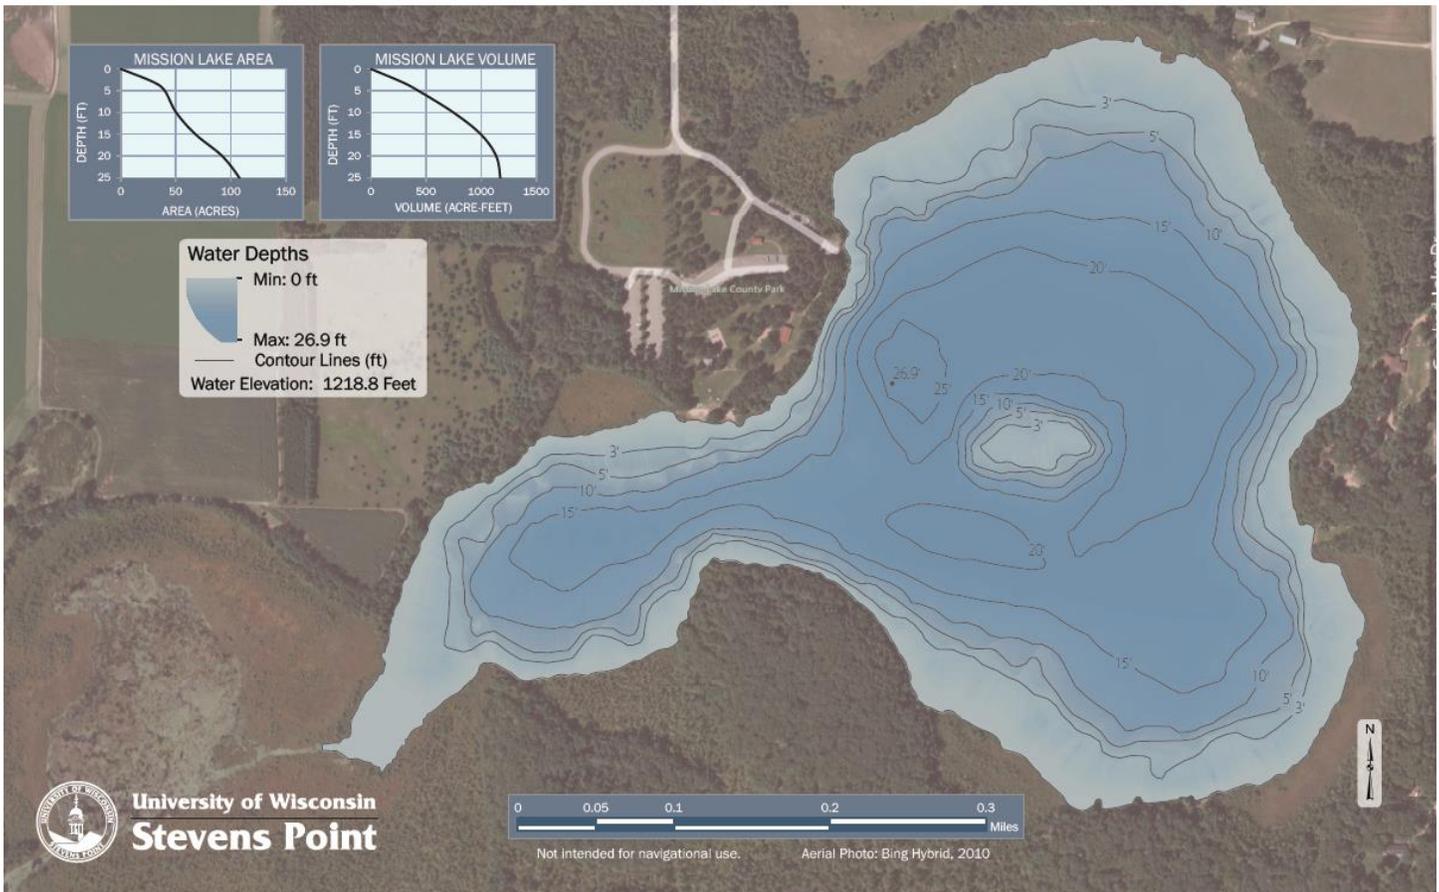
## MISSION LAKE BATHYMETRIC MAP

LAKE AREA	108.8 Acres
Under 3 Feet	29.42 Acres (27%)
Over 20 Feet	16.8 Acres (15.5%)

VOLUME	1174 Acre-feet
SHORELINE	2.3 Miles
MAX DEPTH	26.9 Feet
GPS and Sonar Survey October, 2012

Mission Lake’s shape and depth play large roles in determining:

- 💧 Where aquatic plants can and cannot grow
- 💧 Species of fish and where they live
- 💧 How fast water in the lake warms up and cools down
- 💧 The water quality of the lake
- 💧 Abundance of habitat for species living in the water and on the land

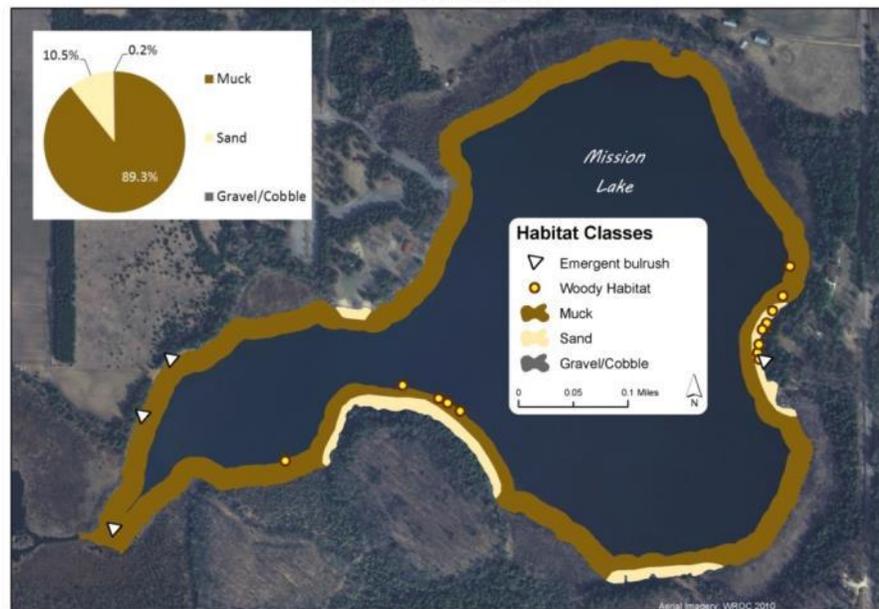
Mission Lake Habitat  
Marathon County, WI 2012

Coarse woody habitat (CWH) is present in Mission Lake – the fish community would benefit from the addition of CWH in areas where it is sparse.

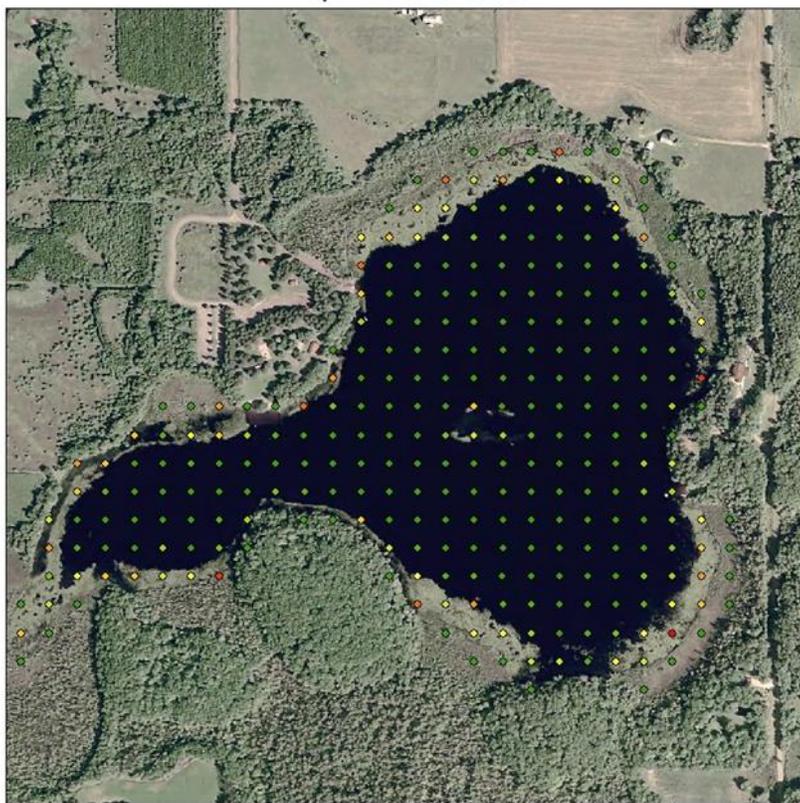
Mission Lake 2012 Aquatic Plant Survey:  
Species Richness

**Species Richness** is a count of the number of plant species found at a survey point. A greater number of species in a lake helps to make the aquatic plant community more resilient to year-to-year changes and aquatic invasive species. More plant species means more diverse habitat and available food sources.

- 0
- 1
- 2
- 3
- 4
- 5
- 6
- 7
- 8
- 9
- 11

- During the 2012 aquatic plant survey of Mission Lake, 36 percent of the sample sites had vegetation.
- The average depth of sampled sites was 10 feet, with a maximum rooting depth of 16 feet.
- The three most frequently occurring species were slender naiad, white water lily and muskgrass (*Chara* spp.).

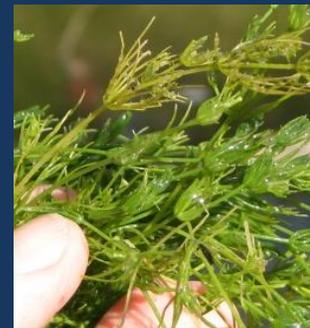
**Chara** is a form of algae which resembles higher plants. It often grows in low, dense mats and is identified by its musky odor and rough texture. The water is often clear where Chara grows densely because of its ability to filter nutrients from water.

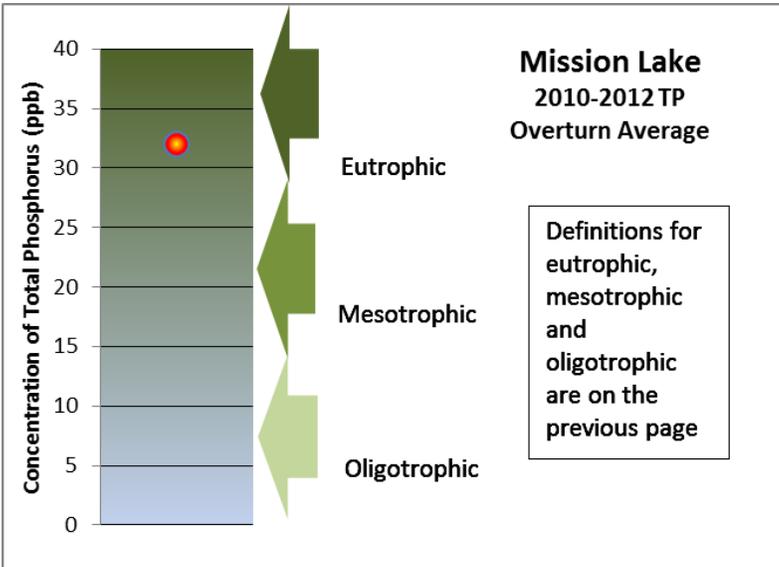
- Total phosphorus levels measured when Mission Lake was well-mixed (overturn) are displayed in the graph to the left.
- Overturn sampling during the 2010-2012 monitoring period indicated that Mission Lake is a eutrophic lake with a high average total phosphorus level.

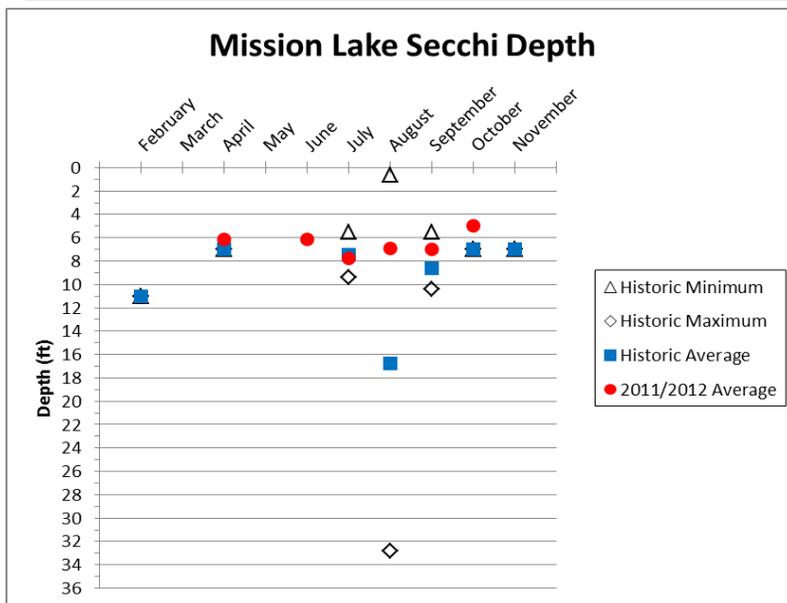
- The graph to the left shows water clarity data collected during the growing seasons in 2011 and 2012. It is typical for water clarity to vary throughout the year.
- The 2011/2012 average Secchi depth readings were relatively consistent with historic averages.

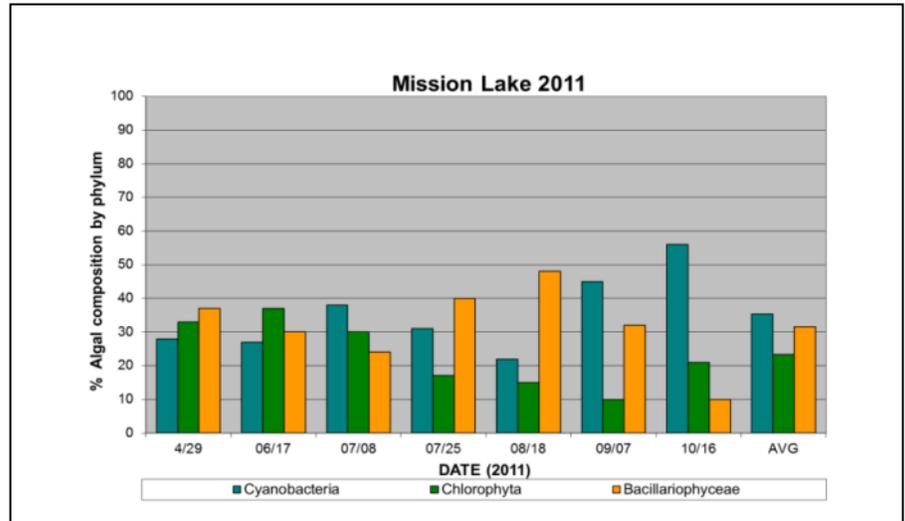
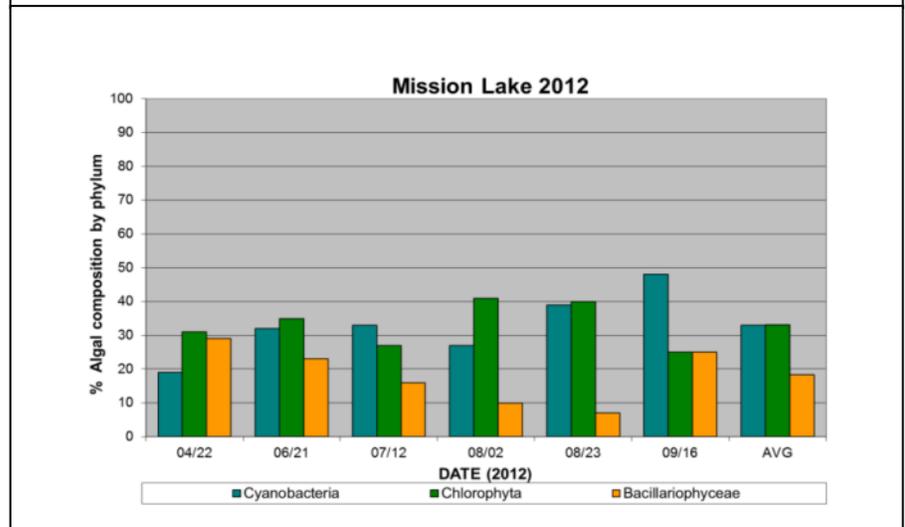
PERCENT ALGAL COMPOSITION FOR MISSION LAKE IN 2011 AND 2012

- ◆ During 2011 and 2012, the algal community in Mission Lake was characteristic of a lake tending towards eutrophic status. The early presence of the blue-green algae was followed by a tendency to dominate as the seasons passed.

- ◆ The heavy, early-season green algal populations fell as 2011 progressed, but stayed high during 2012.
- ◆ Diatom populations bloomed in late 2011, but their abundance in 2012 dropped relative to 2011.

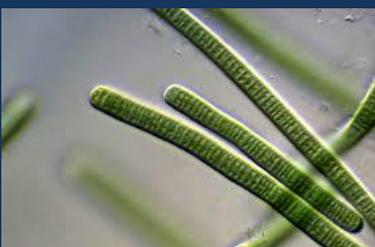
**Blue-green algae** have the widest tolerance range for temperatures and nutrient concentrations.

A few varieties of blue-greens can produce toxins that are potentially harmful to livestock, pets and humans.

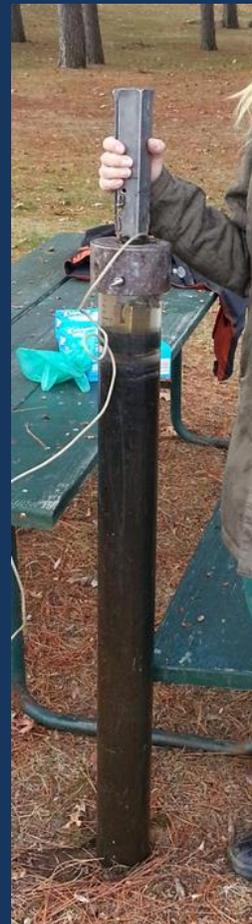
This sediment core was collected from Mission Lake. The darker layers indicate organic-rich sediments often due to increased growth of aquatic plants and/or soil erosion. Additional analysis of these layers can help to confirm the source(s).

- Analysis of Mission Lake’s sediment core suggests increased disturbance in the lake basin since the time of European land clearing.
- Over this time period, there have been increases in nutrients to the lake, including phosphorus, and substantial habitat changes.
- Ragweed generally increases with logging and land clearing. High ragweed pollen counts at 28-30 cm suggest that disturbance was already occurring prior to this point in the core and peaked with agricultural expansion in the first decade or two of the 20th century.
- Diatom species communities as well as sediment properties reflect an increase in phosphorus and in aquatic plants and filamentous algae found in the top of the sediment core.
