Pike Lake

Eastern Marathon County Lake Study

Final Study Results 2013

University of Wisconsin-Stevens Point

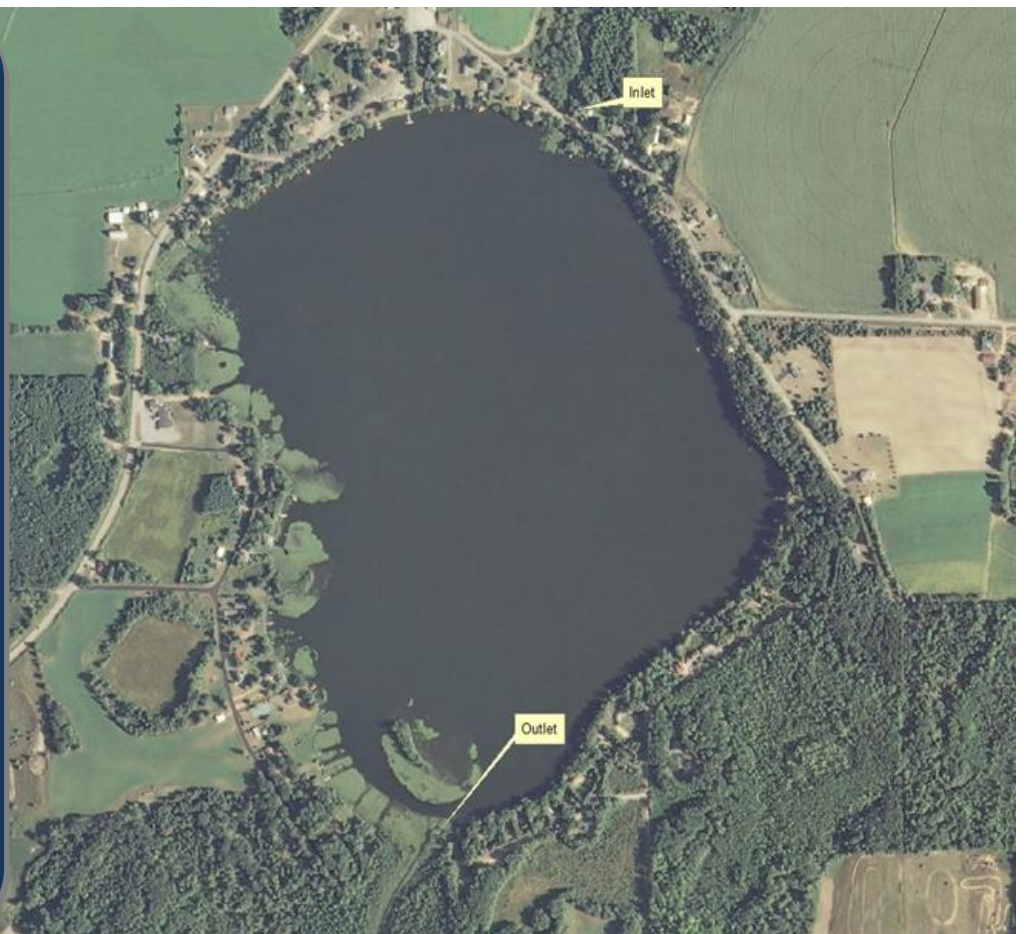
Pike Lake – Surface Watershed

Surface Watershed: The area where water runs off the surface of the land and drains toward the lake.

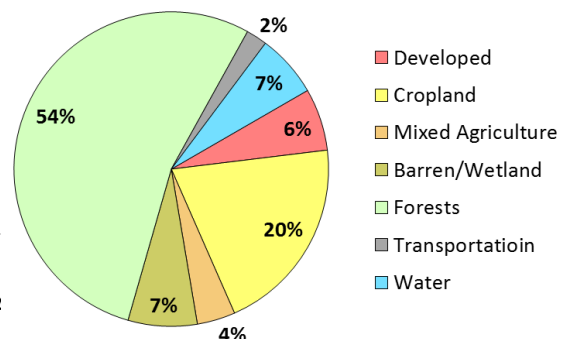
Pike Lake – Land Use in the Surface Watershed

- ◆ **Land uses** and land management practices occurring in the watershed affect the water quality in the lake.
- ◆ Land uses and land management also play major roles in how water moves across the landscape and how much water soaks into the ground (for long-term storage) or quickly runs off the land.
- ◆ The surface watershed of Pike Lake is 2,359 acres.
- ◆ The primary land uses in the Pike Lake watershed are agriculture and forests.
- ◆ In general, the lands closest to the lake have the greatest immediate impact on water quality. The lake has development around much of its perimeter.
- ◆ Land use that affects Rice Lake and the stream that drains it also have a direct impact on the quality of water in Pike Lake.

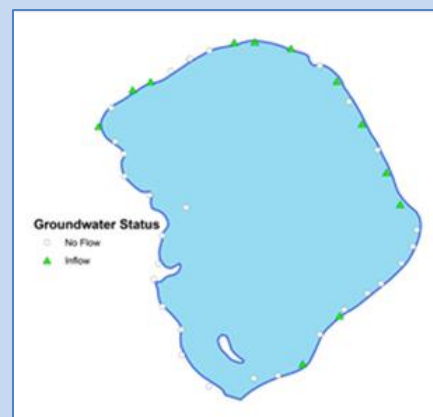
Pike Lake – Groundwater Watershed

Groundwater enters Pike Lake primarily from the north with some groundwater entering in the southeast.

No groundwater outflow sites were identified during the groundwater survey.

- ◆ The groundwater watershed for Pike Lake is 2,929 acres.
- ◆ The primary land uses in the Pike Lake groundwater watershed are agriculture and forests. In general, the lands adjacent to the lake where groundwater enters the lake have the greatest immediate impact on water quality. Residential development and agriculture are nearest the lake in the areas of groundwater inflow.

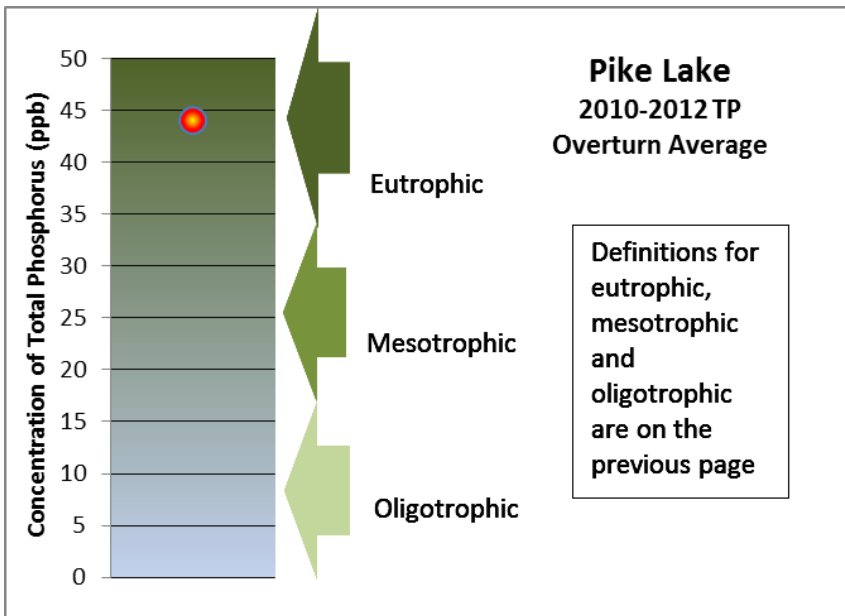
- Total phosphorus levels measured when Pike Lake was well-mixed (overturn) are displayed in the graph to the left.
- Overturn sampling during the 2010-2012 monitoring period indicated that Pike Lake is a eutrophic lake with a high average total phosphorus level.

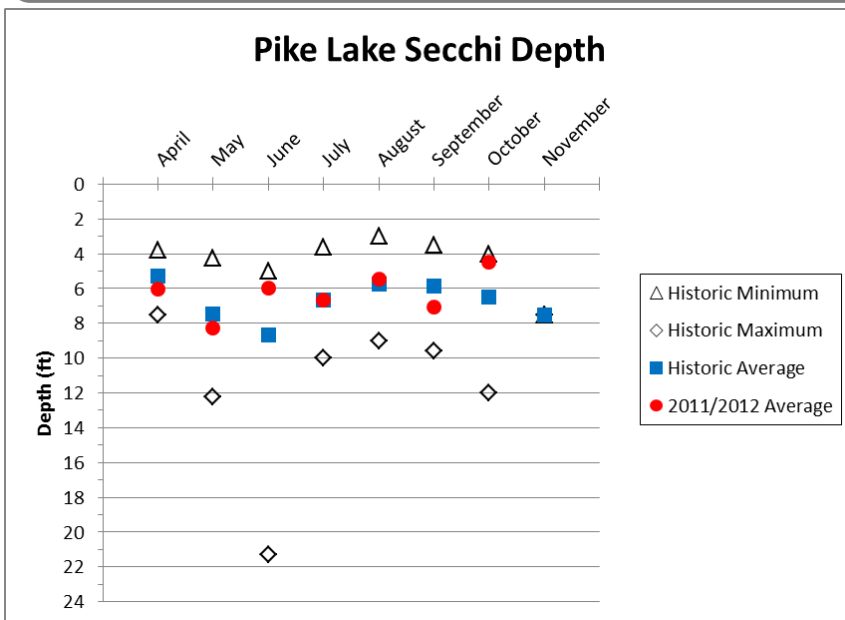
- The graph to the left shows water clarity data collected during the growing season in 2011 and 2012. It is typical for water clarity to vary throughout the year.
- The 2011/2012 average Secchi depth readings were relatively consistent with historic averages.

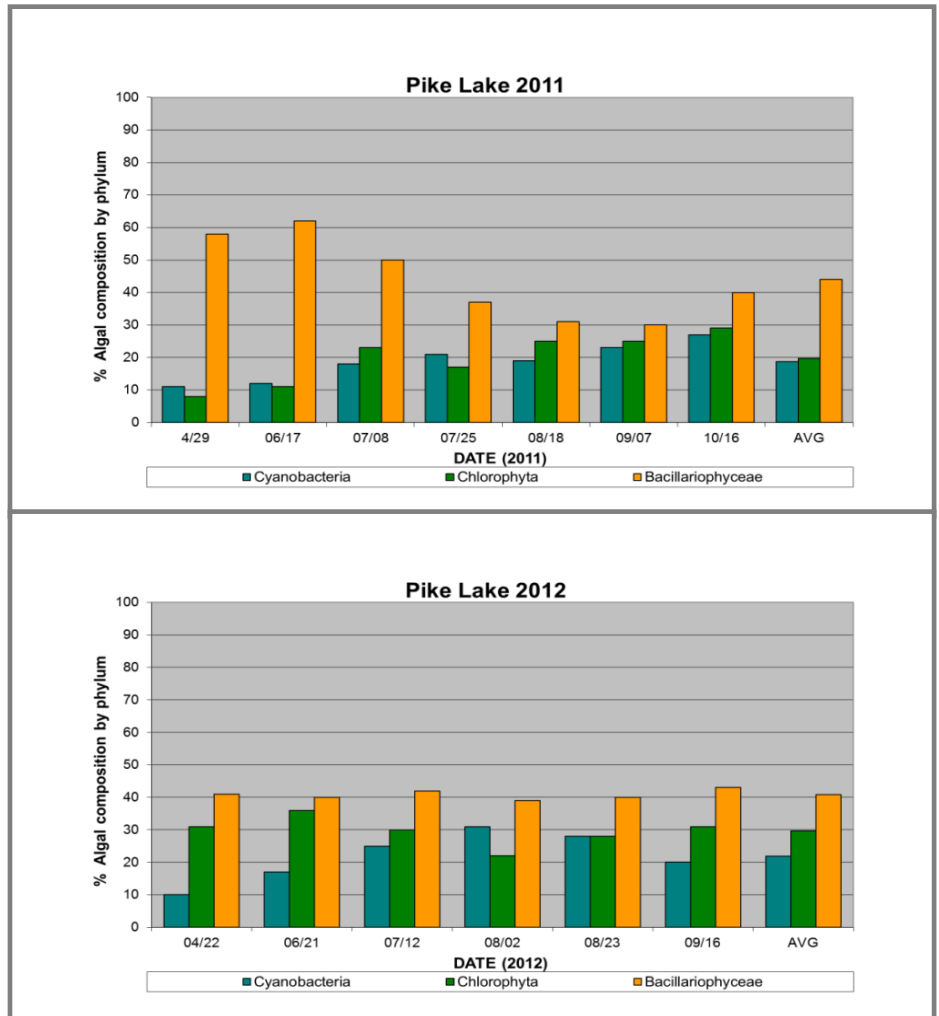
PERCENT ALGAL COMPOSITION FOR PIKE LAKE IN 2011 AND 2012

- Despite some variation in the seasonal patterns of the algal community, diatoms were the dominant algal group in Pike Lake during both 2011 and 2012.
- The diatoms were represented by a rich species mixture; most are associated with eutrophic waters. These plankton species grow quite densely in colonies and likely contributed to the very low water clarity observed in 2011 and 2012.
- The remaining components of the algal community, green algae and blue-green algae, were minor and like the diatoms are typical of eutrophic lakes.
- The high total phosphorus value, the low water clarity, and the dense and dominating diatom community found in Pike Lake are typical of a stable eutrophic lake.

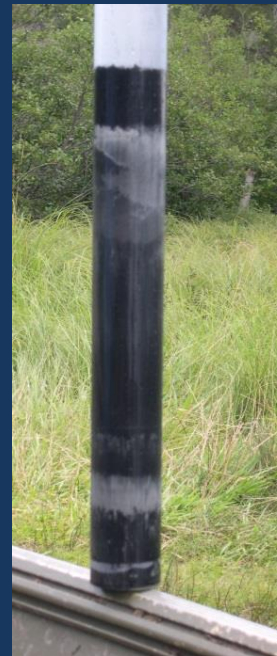
This is an example of a sediment core collected from the bottom of a Wisconsin lake. The darker layers indicate organic-rich sediments often due to increased growth of aquatic plants and/or soil erosion. Additional analysis of these layers can help to confirm the source(s).

- ◆ Analysis of Pike Lake’s sediment core suggests increased disturbance in the lake basin since the time of European land clearing.
- ◆ Over this time period, there have been increases in nutrients to the lake, including phosphorus, and substantial habitat changes.
- ◆ Ragweed generally increases with logging and land clearing but does not peak until the land is prepared for agriculture, which became widespread around the turn of the century. High levels of ragweed pollen between 10 and 12 inches deep probably represent this period. A high ragweed index deeper in the sediment suggests earlier disturbance due to logging or agricultural clearing by Native Americans.
