# Eastern Marathon County Lakes Study

# Mission Lake

Spring 2014

University of Wisconsin-Stevens Point

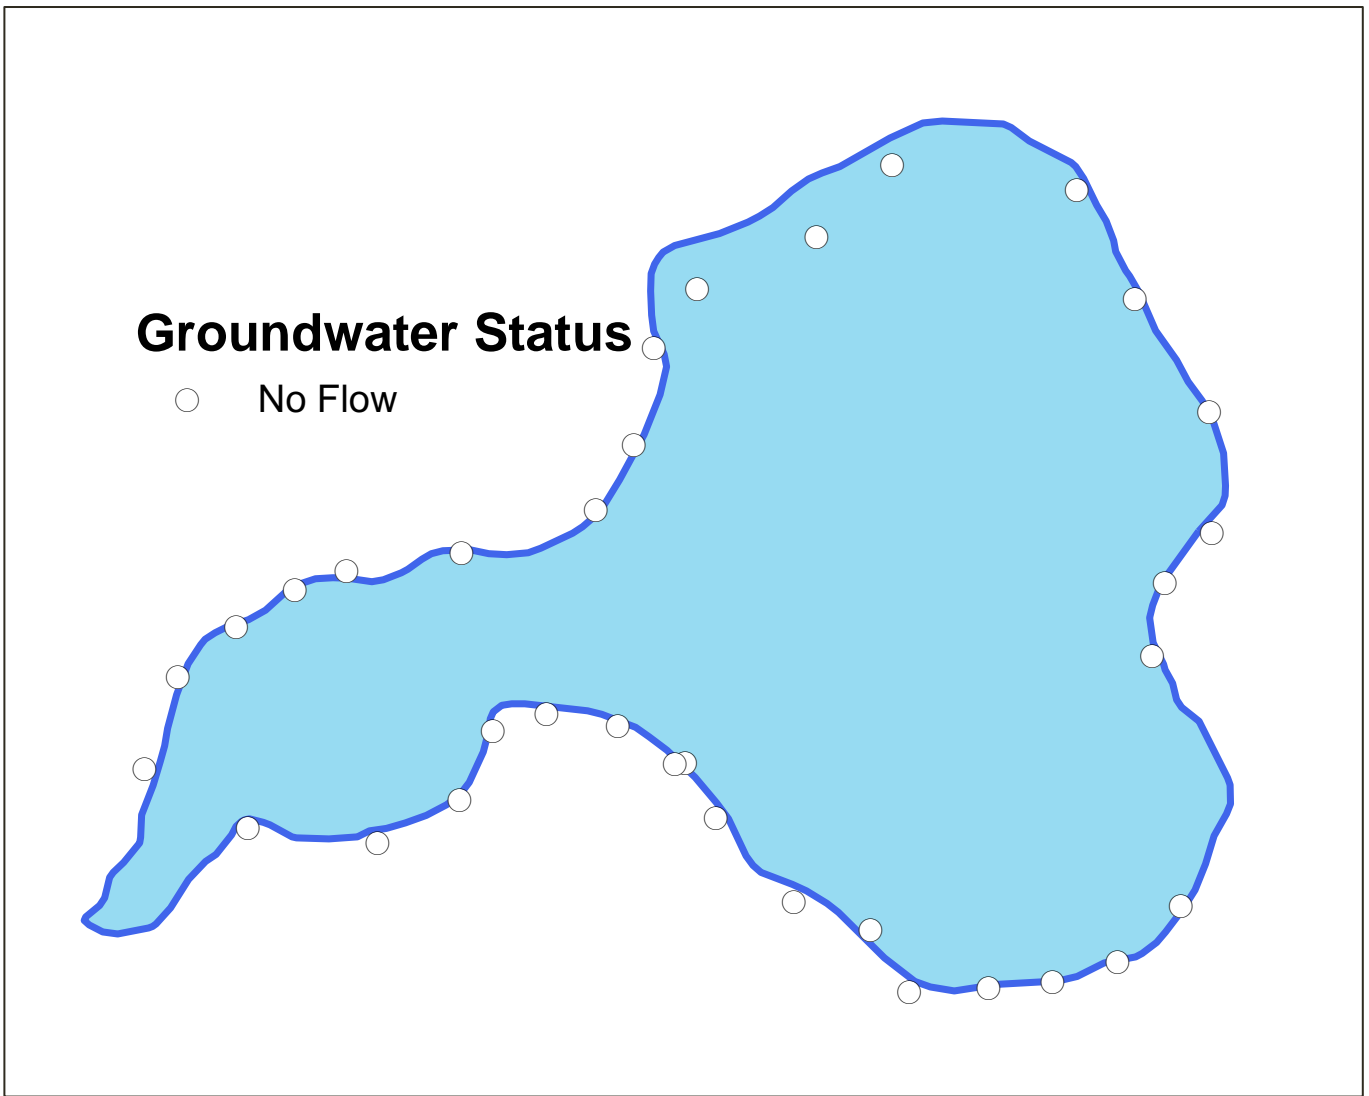
FIGURE 4. GROUNDWATER INFLOW AND OUTFLOW AROUND MISSION LAKE, 2011.

Near shore, mini-wells were installed in the lakebed approximately every 200 feet around the perimeter of Mission Lake (Figure 4). In many lakes, this type of survey can help to identify the location of groundwater inflow or outflow. In Mission Lake, no connection between groundwater (inflow and/or outflow) and the lake was observed during this survey (gray circles). Groundwater may be entering the adjacent wetlands or in parts of the lakebed that were deeper than the groundwater survey. It should be noted that the survey was conducted in 2011, which was a dry year with lower than normal groundwater levels. These conditions would result in less groundwater entering Mission Lake.

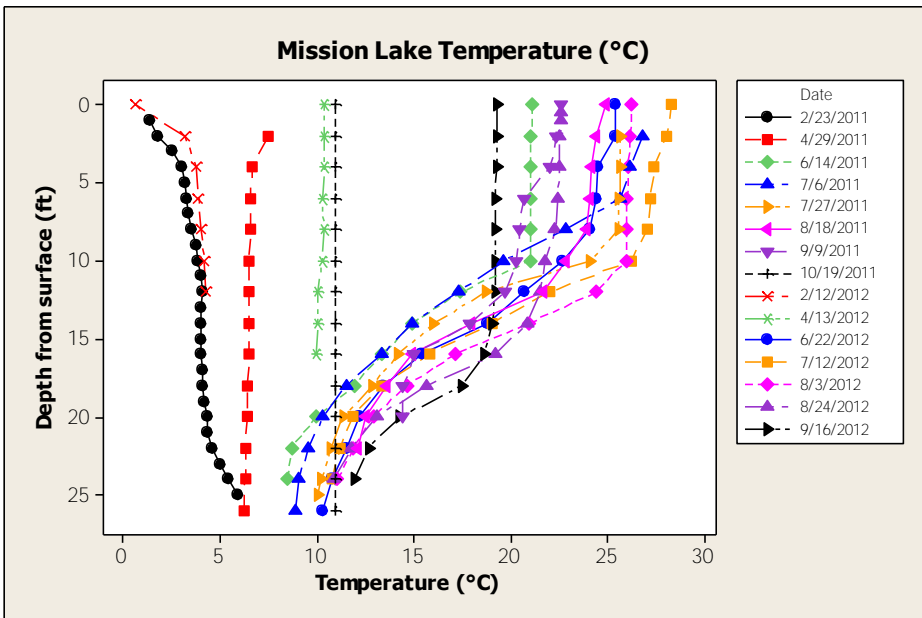
FIGURE 6. TEMPERATURE PROFILES IN MISSION LAKE, 2011-2012.

Water temperature and dissolved oxygen were measured in Mission Lake from the surface to the bottom at the time of sample collection during the 2010-2012 study. The temperature in Mission Lake follows a classic pattern for deeper lakes in Wisconsin. The lake water mixes thoroughly in spring and summer and stratifies during the summer and winter (Figure 6). As would be expected, late winter profiles (February 2011 and February 2012) showed colder (freezing) temperatures near the surface with slight gradual warming with depth. Spring (April 2011 and April 2012) and fall (October 2011) data showed nearly uniform temperature with depth. June to September data from both years shows a classic profile of thermal stratification with warmer temperatures near the surface and the coolest temperatures towards the lake bottom. Temperatures in Mission Lake ranged from 1°C (34°F) at the surface in February 2012 to 28°C (82°F) at the surface in July 2012.

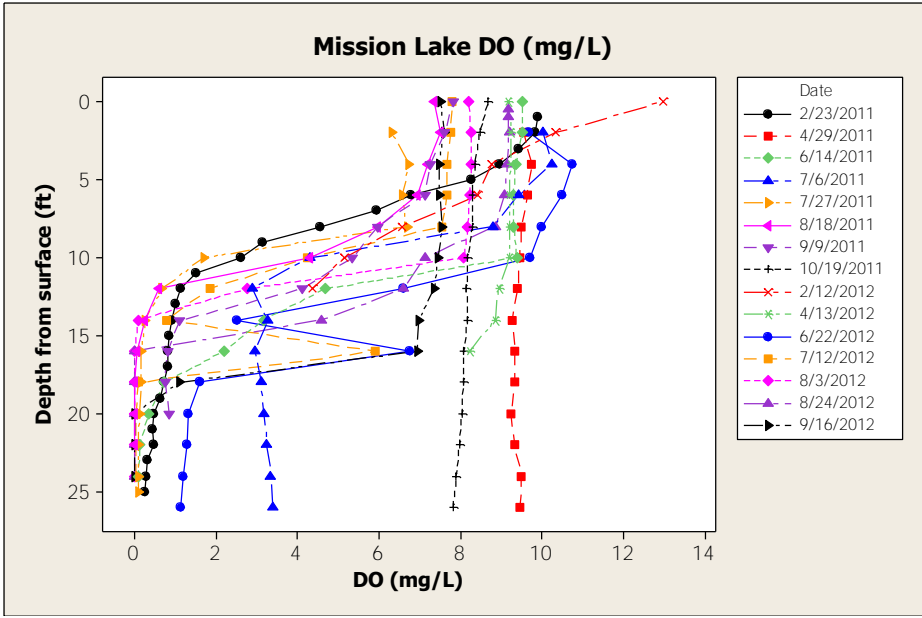
FIGURE 7. DISSOLVED OXYGEN PROFILES IN MISSION LAKE, 2011-2012.

Dissolved oxygen concentrations in Mission Lake were always plentiful in at least the upper 9 feet of water (Figure 7). Like temperature, dissolved oxygen was mixed from the surface to the bottom during spring and fall. With ice cover during the winter, dissolved oxygen was sufficient in the upper 9 feet of water; below that depth, concentrations were not sufficient to support many fish. Dissolved oxygen was replenished throughout the lake in the spring, and during the summer the lake once again stratified. Algal blooms produced periodic spikes in dissolved oxygen concentrations at depths typically below 10 feet. This was particularly noticeable in the measurements taken in June and July 2012.

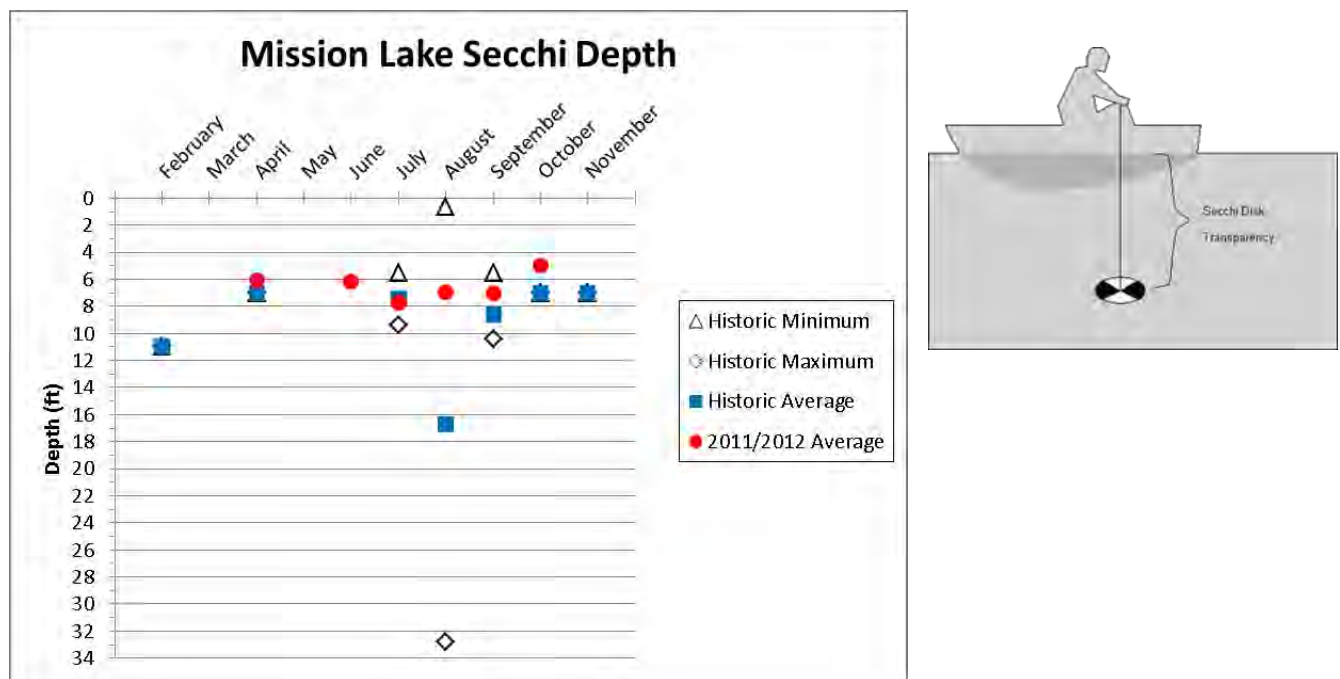
FIGURE 8. AVERAGE MONTHLY WATER CLARITY IN MISSION LAKE, 2010-2012 AND HISTORIC.

In Mission Lake, the color index was moderate (Table 1). Brown staining from tannins in surrounding wetlands and forest is the natural source of the slightly elevated color index. The variability in water clarity throughout the year in Mission Lake was primarily due to fluctuating algae concentrations and re-suspended sediment following storms. The water clarity in Mission Lake was considered fair. The average water clarity measurements in Mission Lake during the study were poorest in October and best in July (Figure 8). Water clarity data was submitted sporadically between 1999 and 2007. When compared with this historic data, the average water clarity measured during the study was poorer in August.

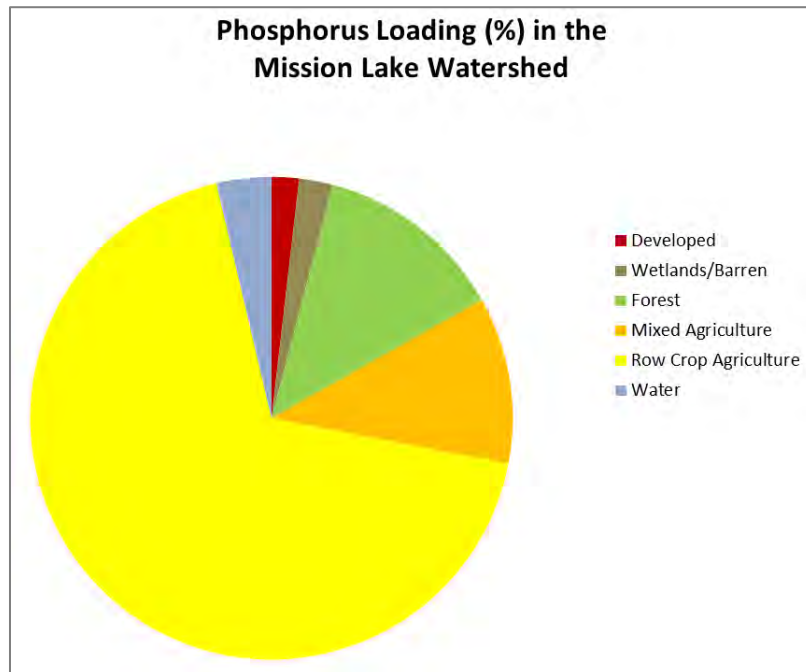
FIGURE 9. ESTIMATED PHOSPHORUS LOADS FROM LAND USES IN THE MISSION LAKE WATERSHED.

Estimates of phosphorus from the landscape can help to understand the phosphorus sources to Mission Lake. Land use in the surface watershed was evaluated and used to populate the Wisconsin Lakes Modeling Suite (WILMS) model. In general, each type of land use contributes different amounts of phosphorus in runoff and through groundwater. The types of land management practices that are used and the distance from the lake also affect the contributions to the lake from a parcel of land. While forests comprised the greatest amount of land in the watershed, modeling results indicated agriculture had the greatest percentage of phosphorus contributions from the watershed to Mission Lake (Figure 9). The phosphorus contributions by land use category, called phosphorus export coefficients, are shown in Table 4. The phosphorus export coefficients have been obtained from studies throughout Wisconsin (Panuska and Lillie, 1995).

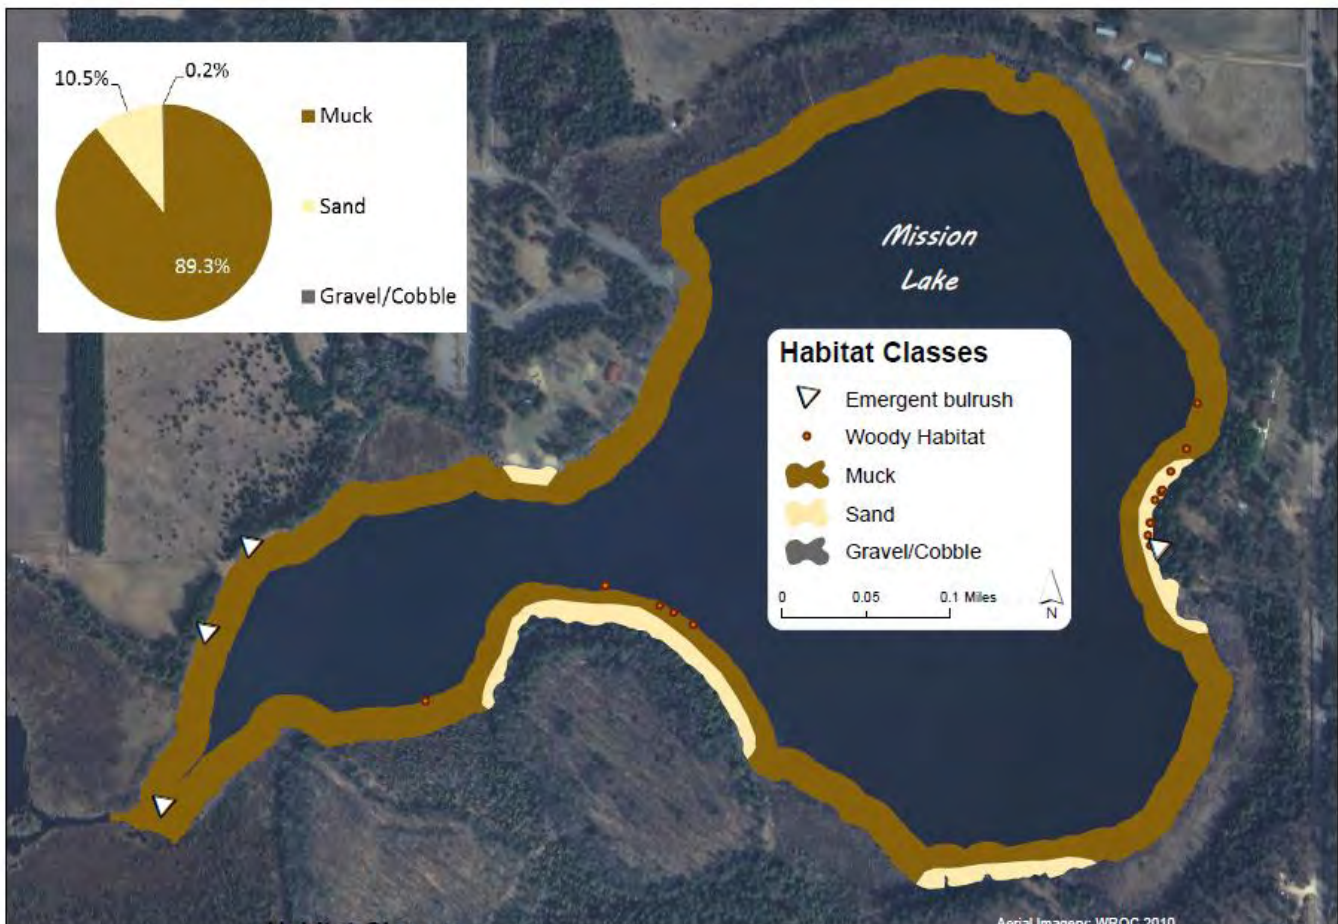
FIGURE 14. DISTRIBUTION OF SUBSTRATE AND COARSE WOODY HABITAT IN MISSION LAKE, 2012.

Coarse woody habitat (CWH), including downed trees and logs, are present in Mission Lake (Figure 14); however it is mostly limited to the southern and eastern shorelines. This structure is utilized by young prey fish and other aquatic organisms for spawning, foraging, and protective cover. The fish community would benefit from the addition of CWH in areas where it is sparse.

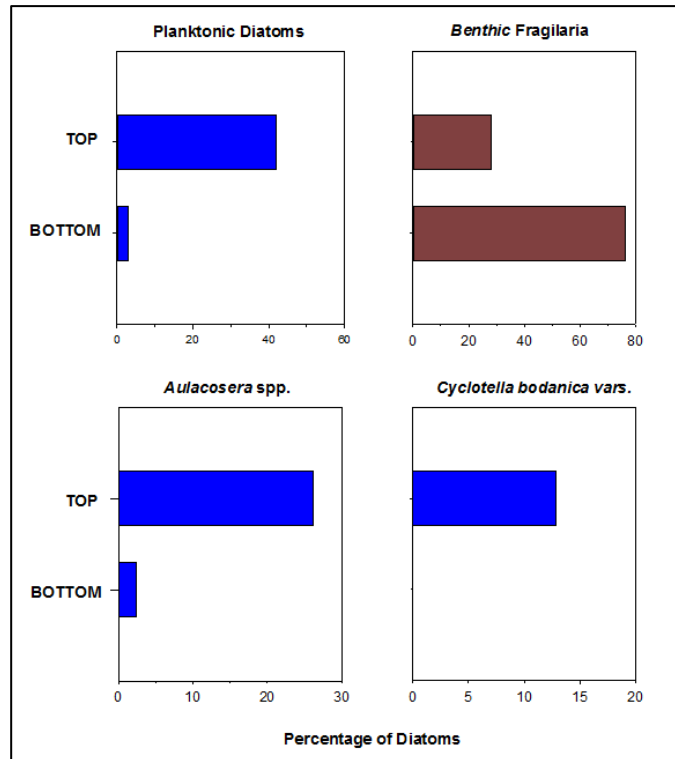
FIGURE 17. ABUNDANCE OF IMPORTANT DIATOMS FOUND AT THE TOP AND BOTTOM OF THE SEDIMENT CORE FROM MISSION LAKE, 2012.

The diatom community was analyzed in top and bottom samples of the Mission Lake sediment core (Figure 17). The bottom of the core was dominated by *S. pinnata* and *Staurosira construens*, which are both benthic (bottom-feeding) species of diatoms. These species are associated with sediments, submerged aquatic plants, and filamentous algae. In contrast, the top of the core was dominated by planktonic species of diatoms, which are most commonly found floating on top of open water and are associated with higher nutrient levels. Often, as nutrients increase, the water clarity decreases, which reduces the depth that light can penetrate. This decreases the area of the lakebed that could be occupied by benthic diatoms. Species richness and diversity were greater at the top of the core. This indicated that there are currently more submerged aquatic plants in Mission lake than in the past, and that lake productivity is also greater.

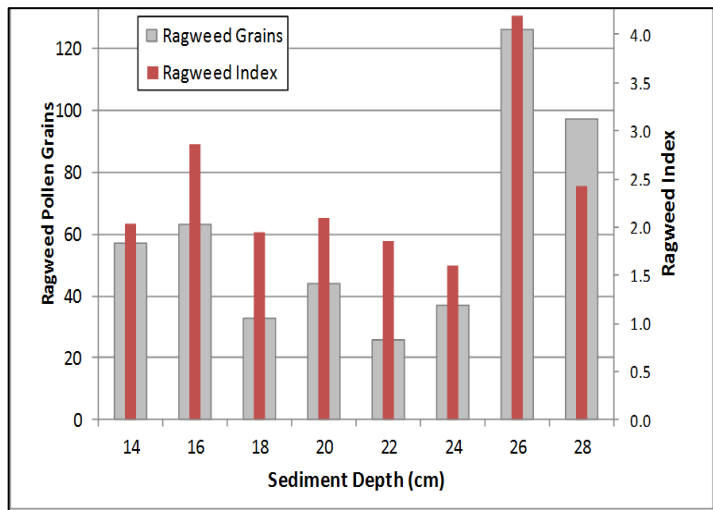
FIGURE 18. RAGWEED POLLEN IN THE MISSION LAKE SEDIMENT CORE.

Ragweed pollen was high throughout the core, but was remarkably high between 10-11 inches (Figure 18). Ragweed typically increases with increased logging and land clearing. Its pollen peaks when the remaining undergrowth is cleared or burned for agricultural use later on. The increase in ragweed pollen between 10-11 inches indicated an increase in agricultural expansion of the land around Mission Lake during the first two decades of the 20th century. This dramatic spike in ragweed pollen towards the top of the core indicated the land was cleared sometime long after logging.

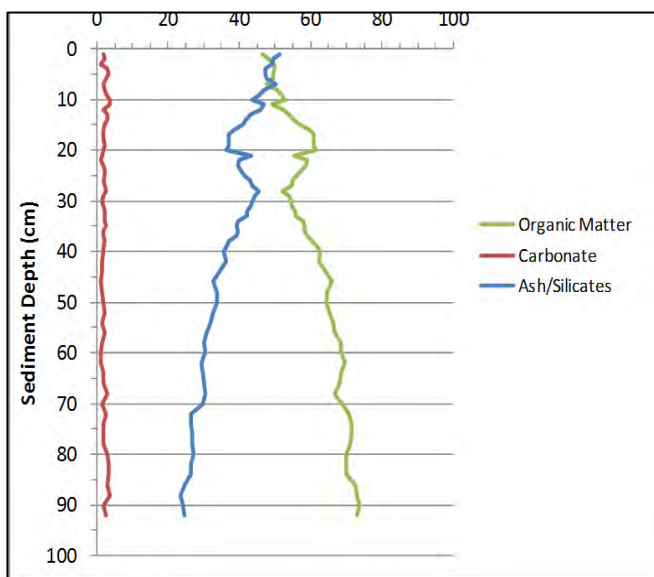
FIGURE 19. LOSS ON IGNITION RESULTS FOR MISSION LAKE.

In order to further understand the composition of Mission Lake’s sediment core, a test called loss on ignition (LOI) was conducted. To provide more specifics about the core’s composition, various components of a lake’s sediment core are burned off, including organic matter, marl (carbonate), and silica (sand, silt, and clay) (Figure 19). The LOI results for Mission Lake indicated that silica was abundant in the upper 7 inches of the core and again at 11 inches. The upper occurrence of increased silica was a result of shoreland disturbance such as erosion from land clearing and development around the lake in more recent years, and the lower spike of silica correlated to the logging that occurred around Mission Lake in the past.
