# West Branch Sugar River Water Quality Monitoring Report, 2017

*The Contemporary Condition of the  
West Branch Sugar River  
15 Years After Stream Rehabilitation  
Dane County, WI  
WBIC 886100*

EGAD #3200-2018-84  
Water Quality Bureau  
Wisconsin DNR

**May 2018**

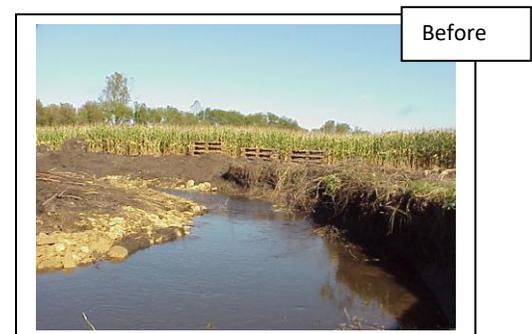
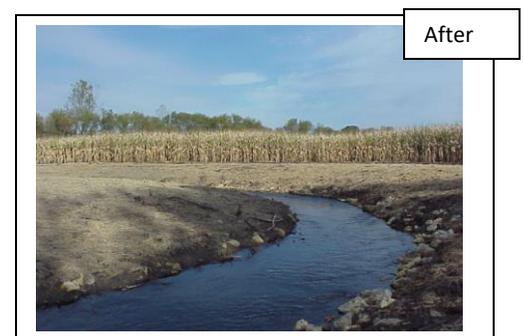
In 1999, work began to improve the riparian corridor and habitat of the stretch of the West Branch Sugar River above State Highway 92. From 1999 to 2002, the Dane County Land Conservation Department worked with landowners along 12 miles of the stream to install riprap and fencing as well as shaping, seeding, and stabilizing the banks of the river. The rehabilitation project removed most of the undesirable trees. The banks were sloped back at a 3:1 ratio to allow the river to over-top onto its floodplain during high water events. The banks were ripped at the toe (edge) and seeded, thus establishing grasses with good root structure to preserve bank integrity. This also provides a buffer to help mitigate runoff from the surrounding agricultural fields. The river was narrowed in appropriate places to increase flow, flushing the soft sediment out of the channel and reestablishing a gravel bottom which is essential to trout reproduction. Habitat structures such as Little Underwater Neighborhood Keepers Encompassing Rheotactic Salmonids (LUNKERS) were placed in bends on the stream and rock weirs were used on straight sections to create plunge pools for generating deeper water areas.

Post-rehabilitation monitoring of the fishery and habitat was conducted in 2002 and 2003. The monitoring showed a dramatic increase in overall habitat scores and an improvement in the fish assemblage (WDNR, 2004b). Overall, the stream improved to the point it was meeting its attainable use. In 2004, the Department was granted approval from EPA to remove the West Branch Sugar River from the impaired waters list. In February 2005, the stream suffered a fish kill due to runoff of manure. While hundreds of trout died, it was not a complete kill and the stream was able to recover. In 2008, fisheries management extended the Class II trout water designation from STH 92 up to the headwaters.

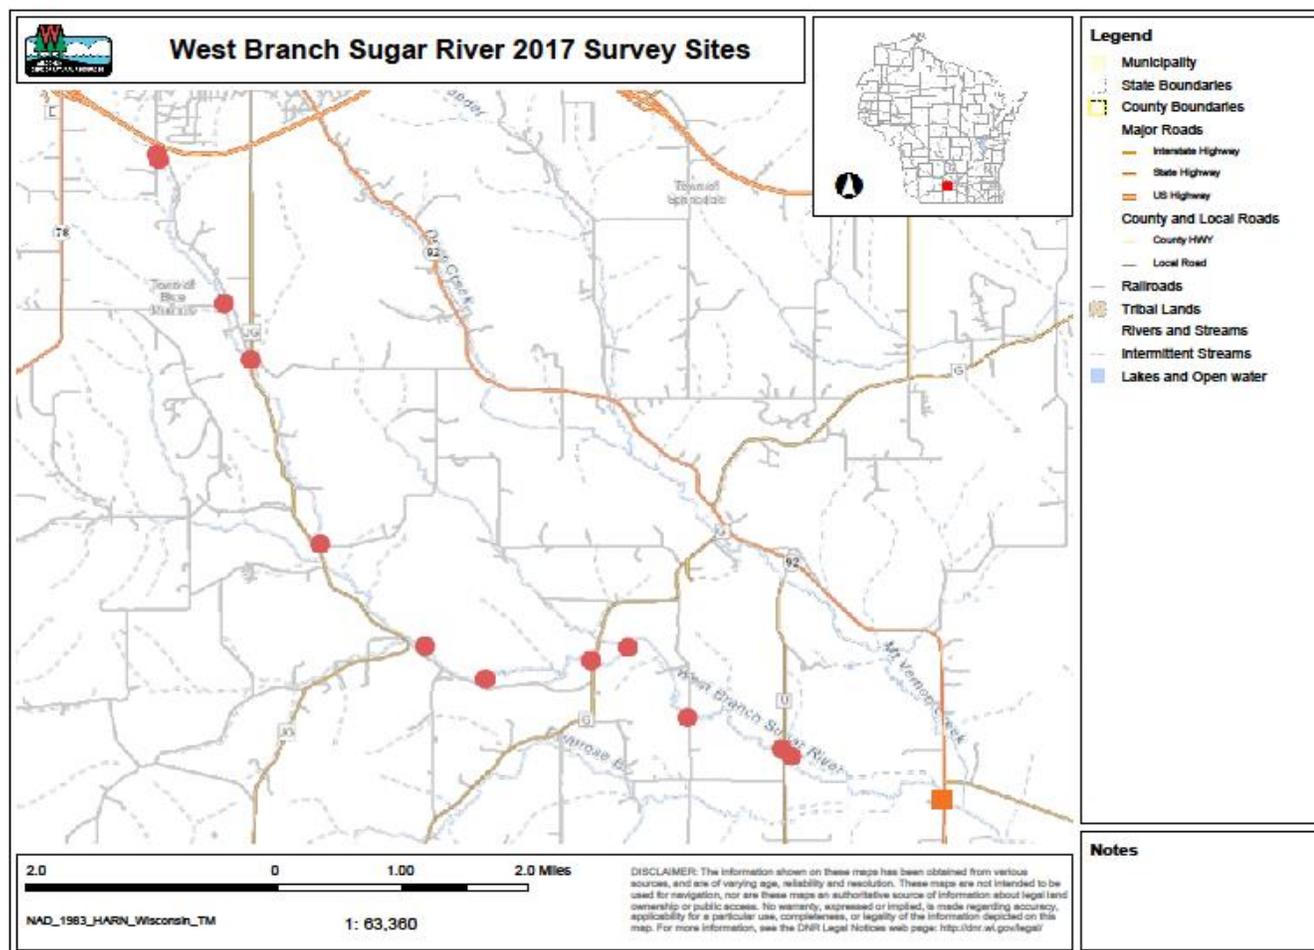
Figure 1: West Branch Sugar River 2017 Survey Sites

The 2017 survey was conducted on 12 sites along the stream (Figure 1). Sites were selected based on previous studies. Biologists were unable to conduct sampling at STH 92 due to high water levels that existed throughout the field season. The fisheries assemblage was determined by electroshocking a section of stream with a minimum station length of 35 times the mean stream width (Lyons, 1992) or based on previous station lengths. A stream tow barge with a generator and two probes was used at most sites. A backpack shocker with a single probe was used at sites generally less than 2 meters wide. All fish were collected, identified, and counted. All gamefish were measured for length. At each site, qualitative notes on average stream width and depth, riparian buffers and land use, evidence of sedimentation, fish cover and potential management options were also recorded. A qualitative habitat survey (Simonson, et. al., 1994) was also performed at each site. Four sites were chosen to conduct a quantitative habitat analysis (Ibid) for comparison with previous studies.

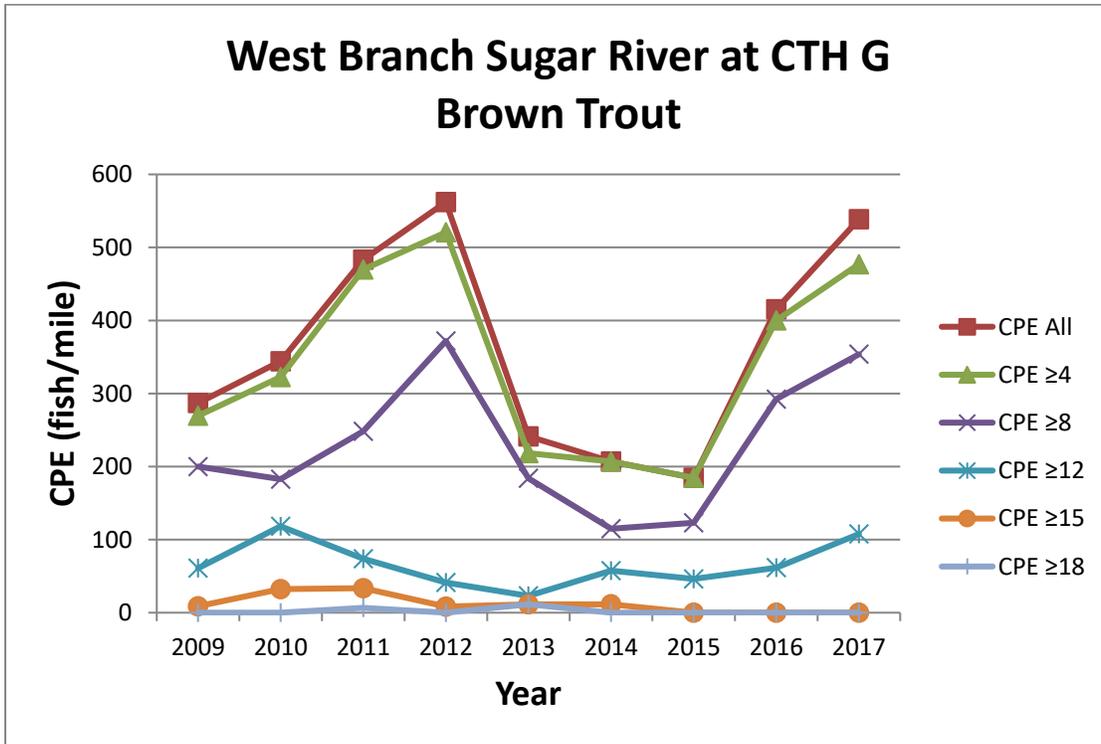
**Figure 2: Brown Trout at CTH G - Catch per Unit Effort Based on Size Class**

Weather conditions, angler harvest, and stocking rates can all play a role in determining fish populations and size structure. The trend site at CTH G shows that brown trout numbers as normalized for catch per unit effort (trout/mile) for most size classes fluctuate annually. Beginning in 2013, trout numbers dropped substantially and remained lower through 2015 (Figure 2). This trend may have resulted in the anecdotal reports of lower trout numbers in the stream. The reduction in population was likely due to drought conditions in 2012 followed by unusually cold winters in 2012/13 and 2013/14 and was noted in other trout streams throughout the region (David Rowe, fisheries supervisor, personal communication). In the past 2 years, numbers have rebounded to pre-2013 levels.

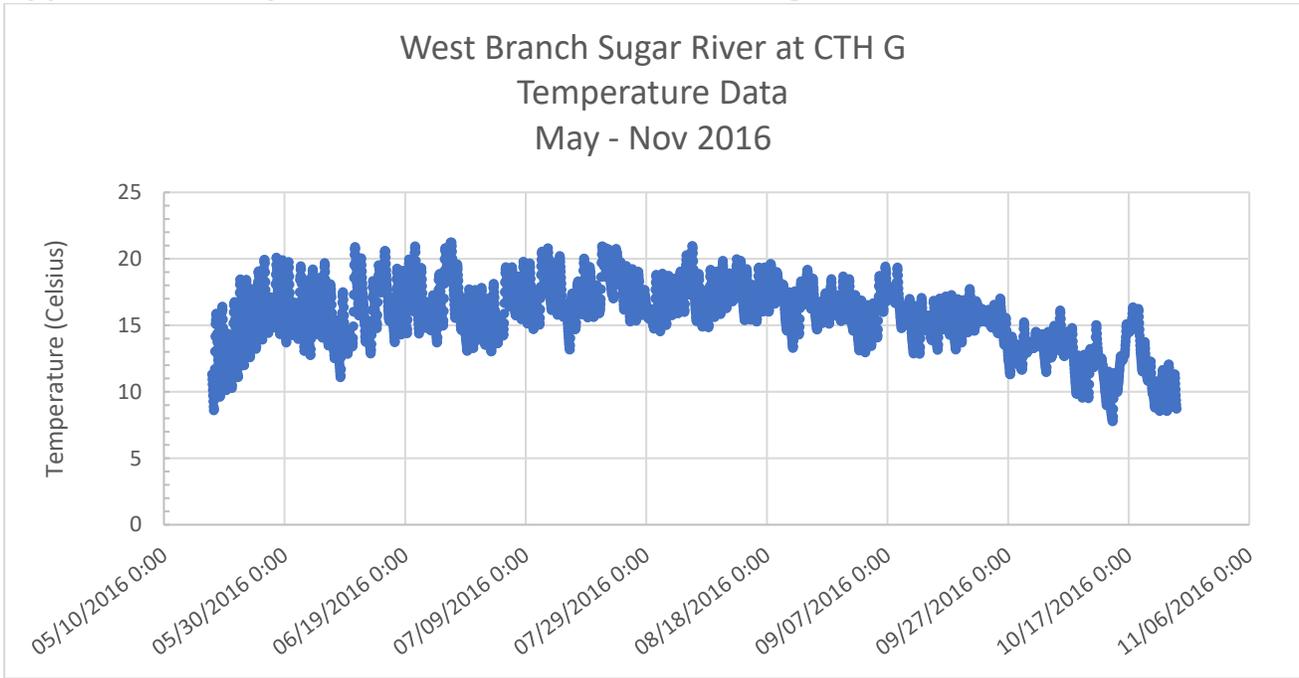
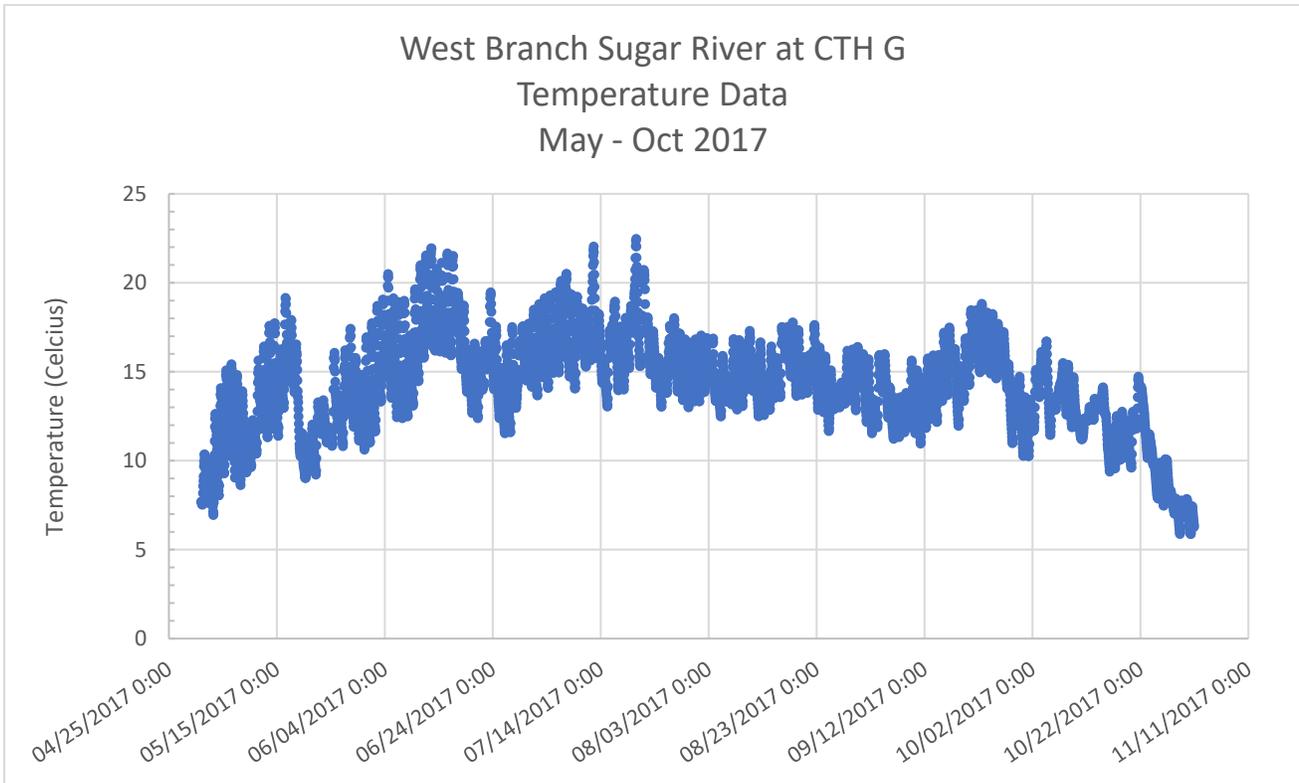
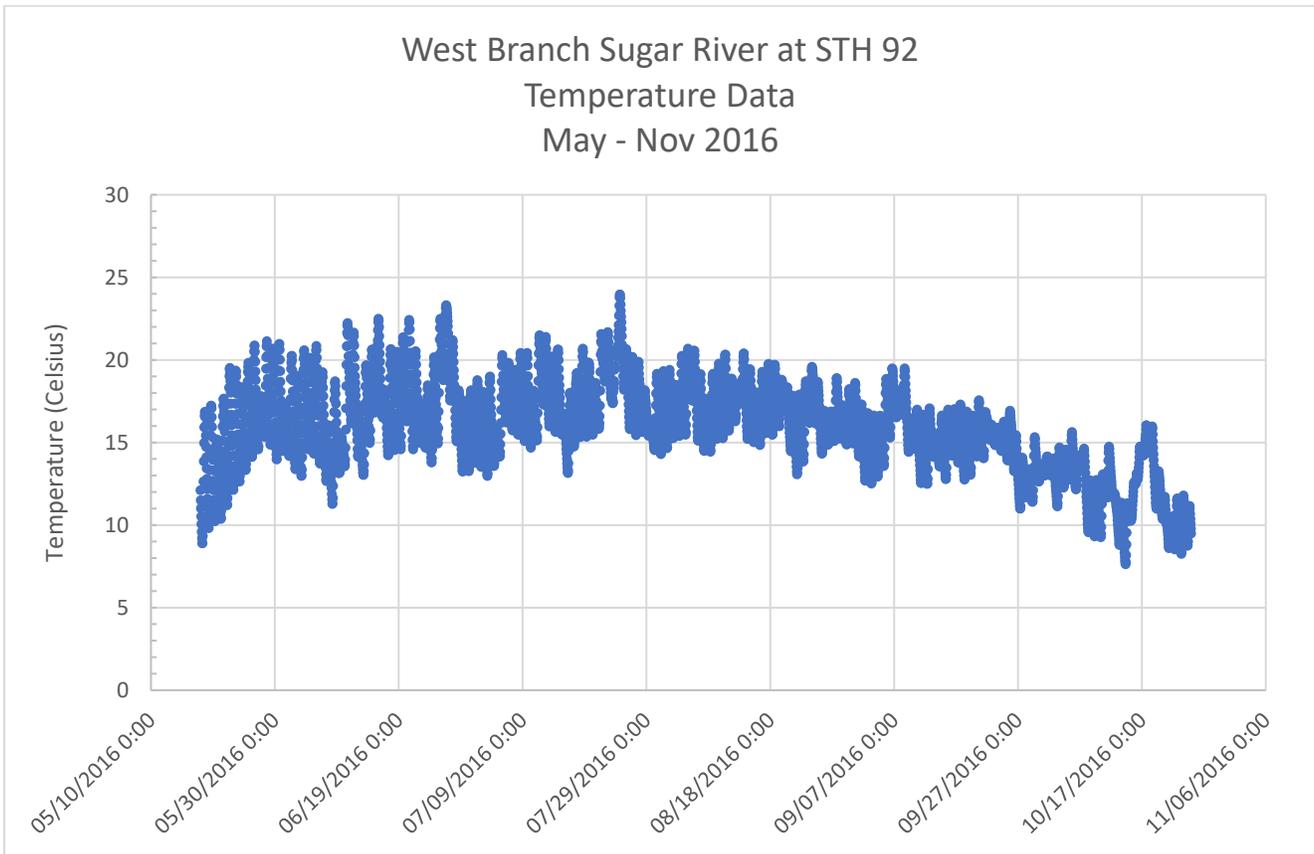
### Appendix B: Temperature Data for West Branch Sugar River

Temperature data was collected hourly at CTH G in 2016 and 2017 and at STH 92 in 2016 by fisheries management. Table 5 shows water temperatures at CTH G fall into the cold range as defined by the maximum daily mean, summer (June-August) mean, and the July mean (Lyons, et. al., 2009). The site at STH 92 shows temperatures to be in the low end of the cold transitional range. This is similar to the natural communities found at these 2 sites (note: STH 92 was not surveyed for this study due to high water levels, but past data has confirmed this site as cool-cold).

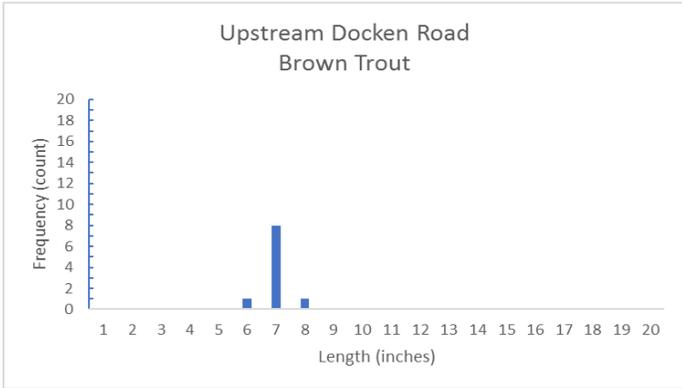
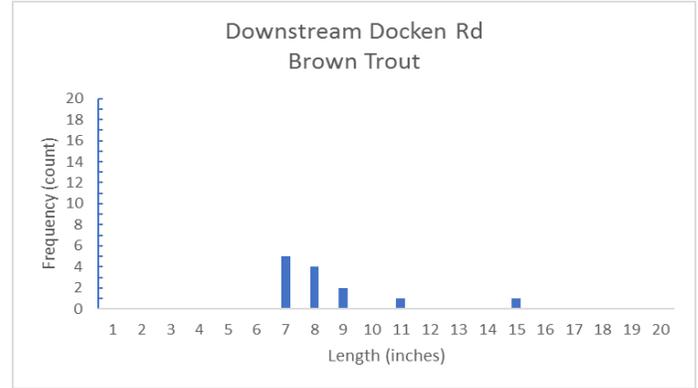
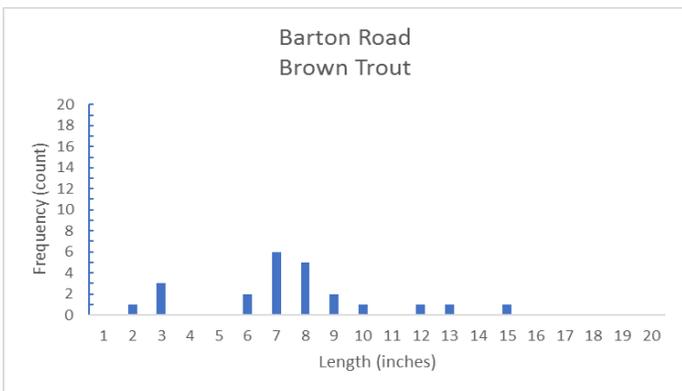
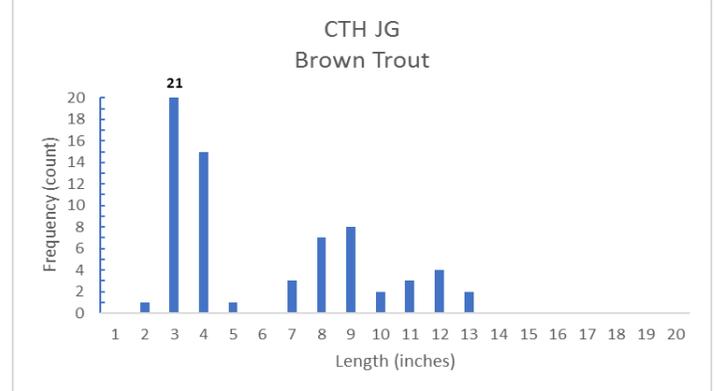
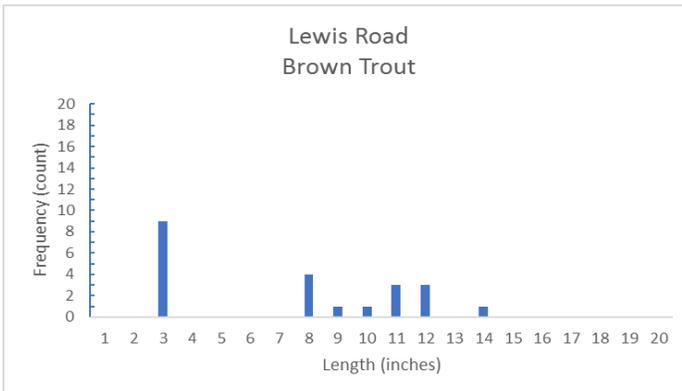
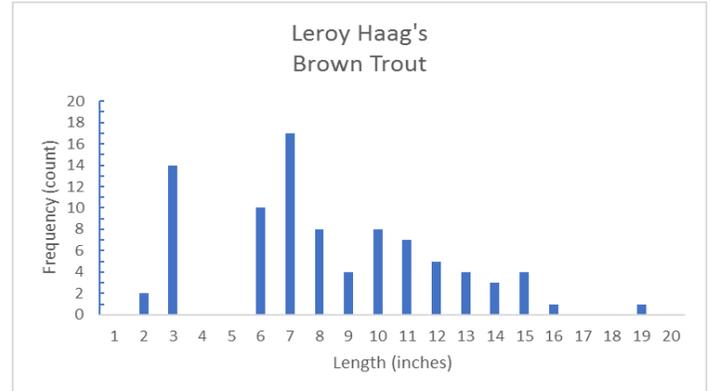
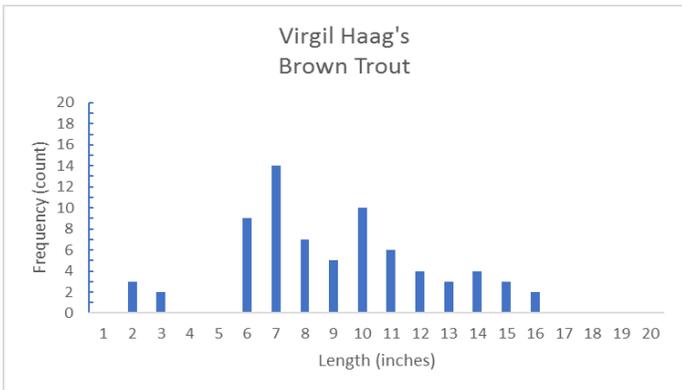
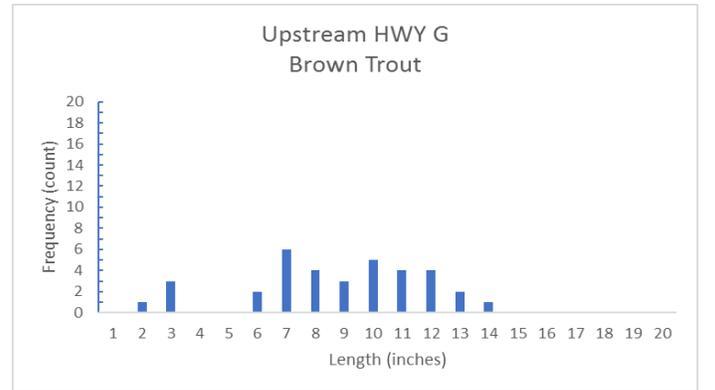
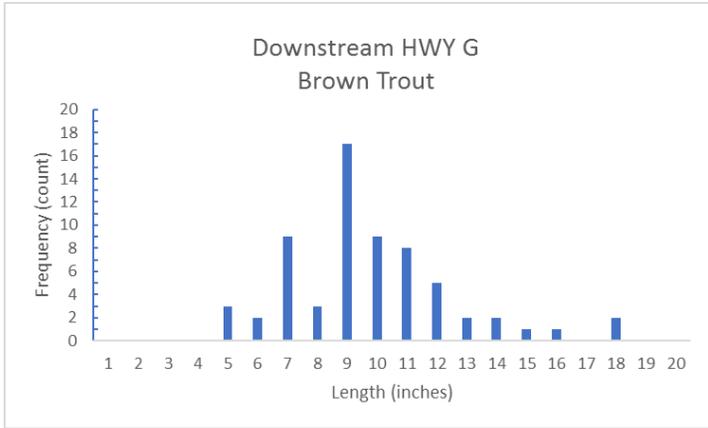
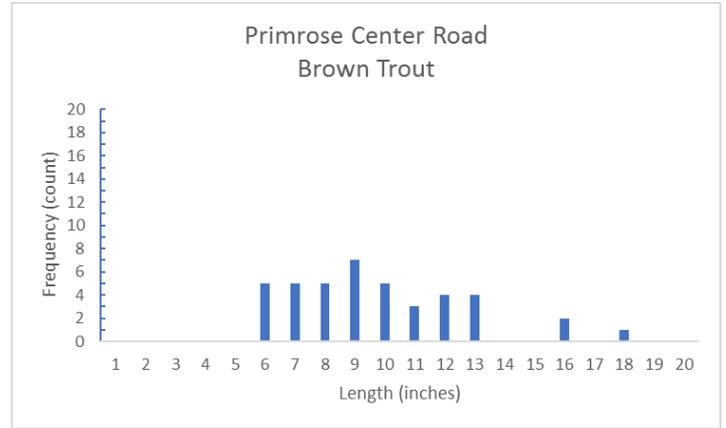
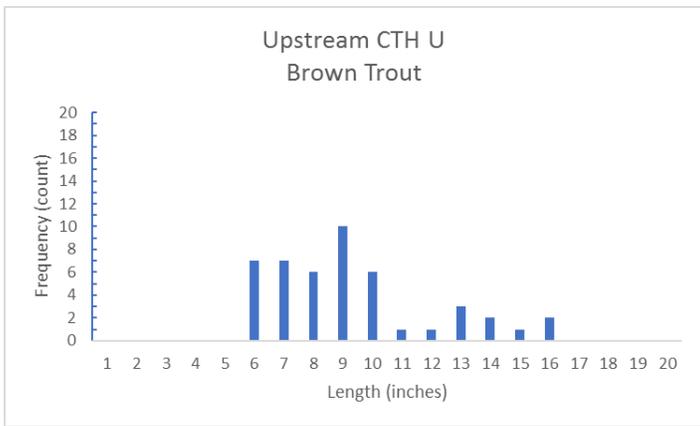
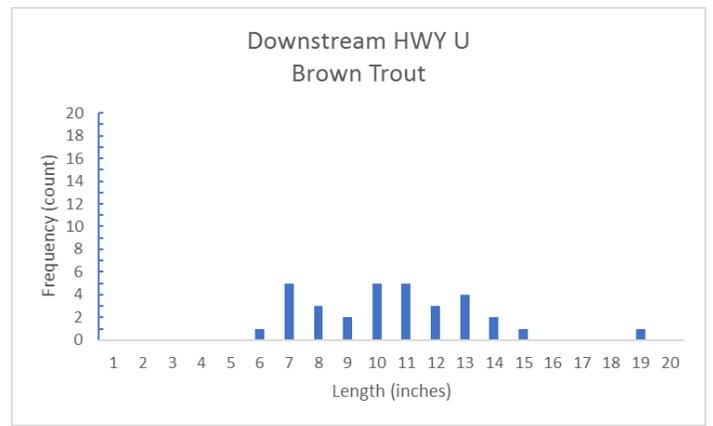
### Appendix D: West Branch Sugar River 2017 Brown Trout Frequency by Site

Length/Frequency data for the surveys conducted in 2017 show multiple year classes present at most sites (Appendix 4). As is typical for most waters, there are more 2-3-year-old fish than others. The size distribution then gradually declines as older fish are taken out of the system either by angling or natural mortality. The West Branch Sugar River has been stocked periodically with brown trout, but has not received browns since 2015. This survey showed the presence of 2-4-inch specimens, which are typically sizes of young-of-the-year fish. This would indicate that some natural reproduction is occurring in the stream, primarily at upstream sites and presumably because habitat favorable for brown trout spawning is more prevalent at these sites. Fisheries management believes the West Branch Sugar River is now functioning as a Class 1 brown trout stream (David Rowe, personal communication).
