Final Report on Kimes Rain Garden
Healthy Lakes Grant LPT 56217.1
Little Arbor Vitae Lake

Addendum A

Addendum B

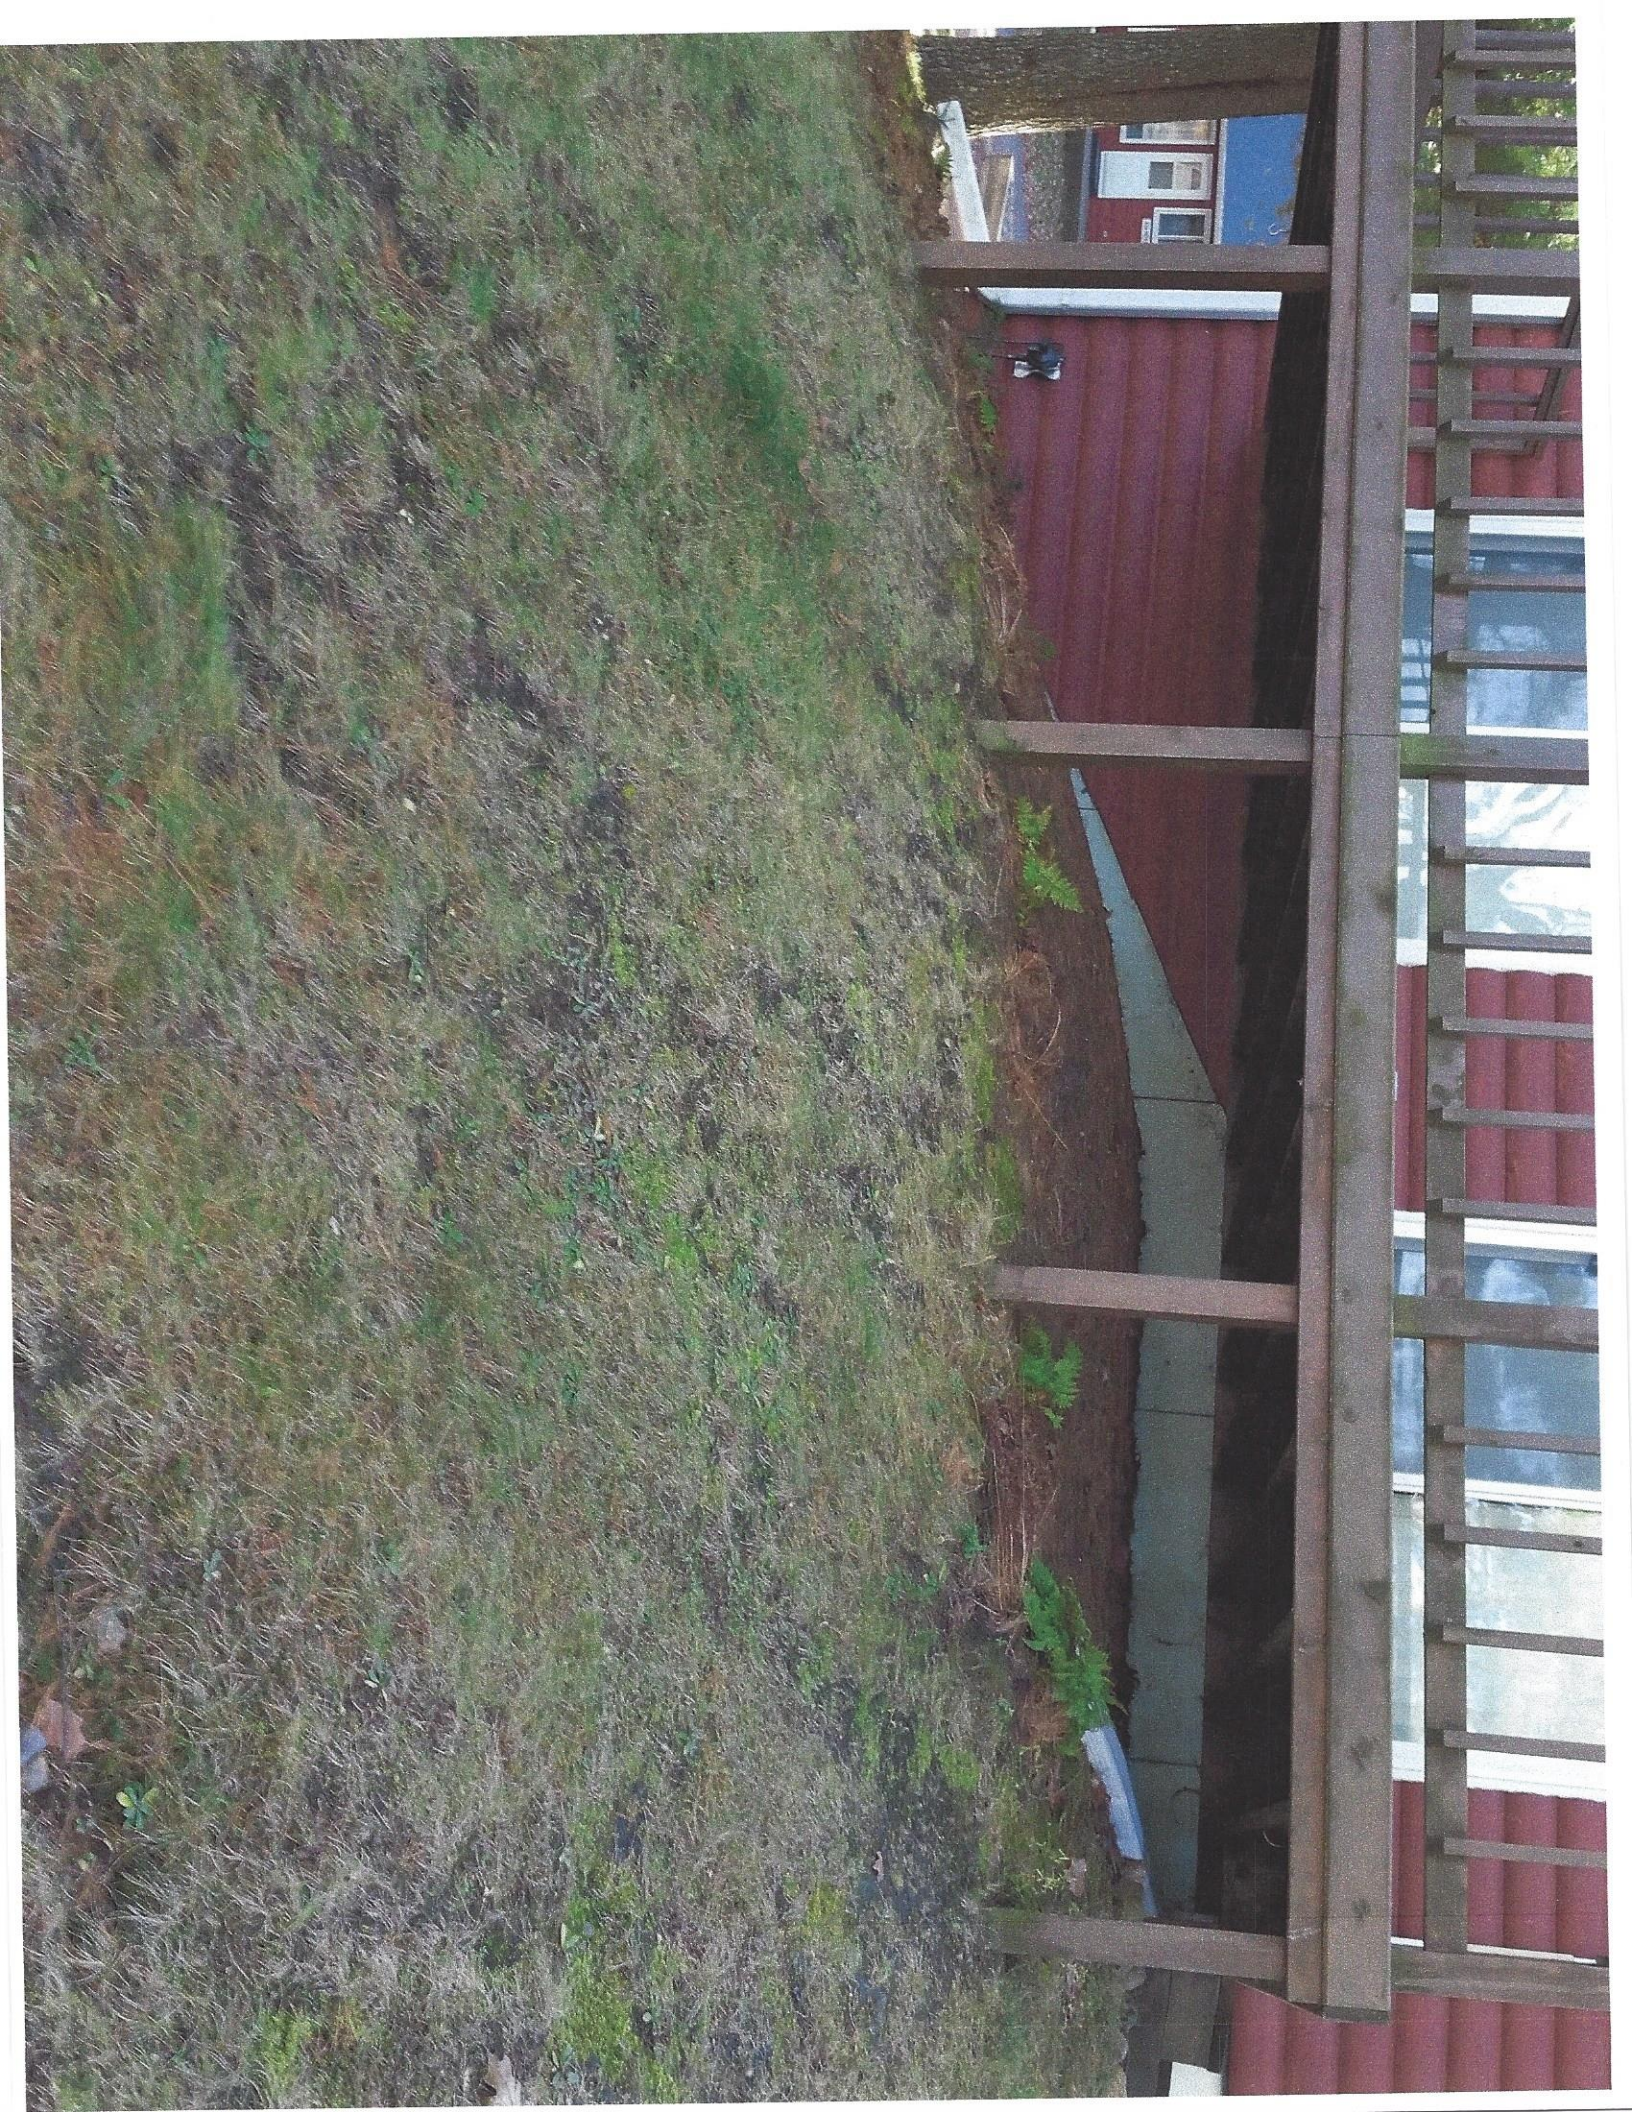
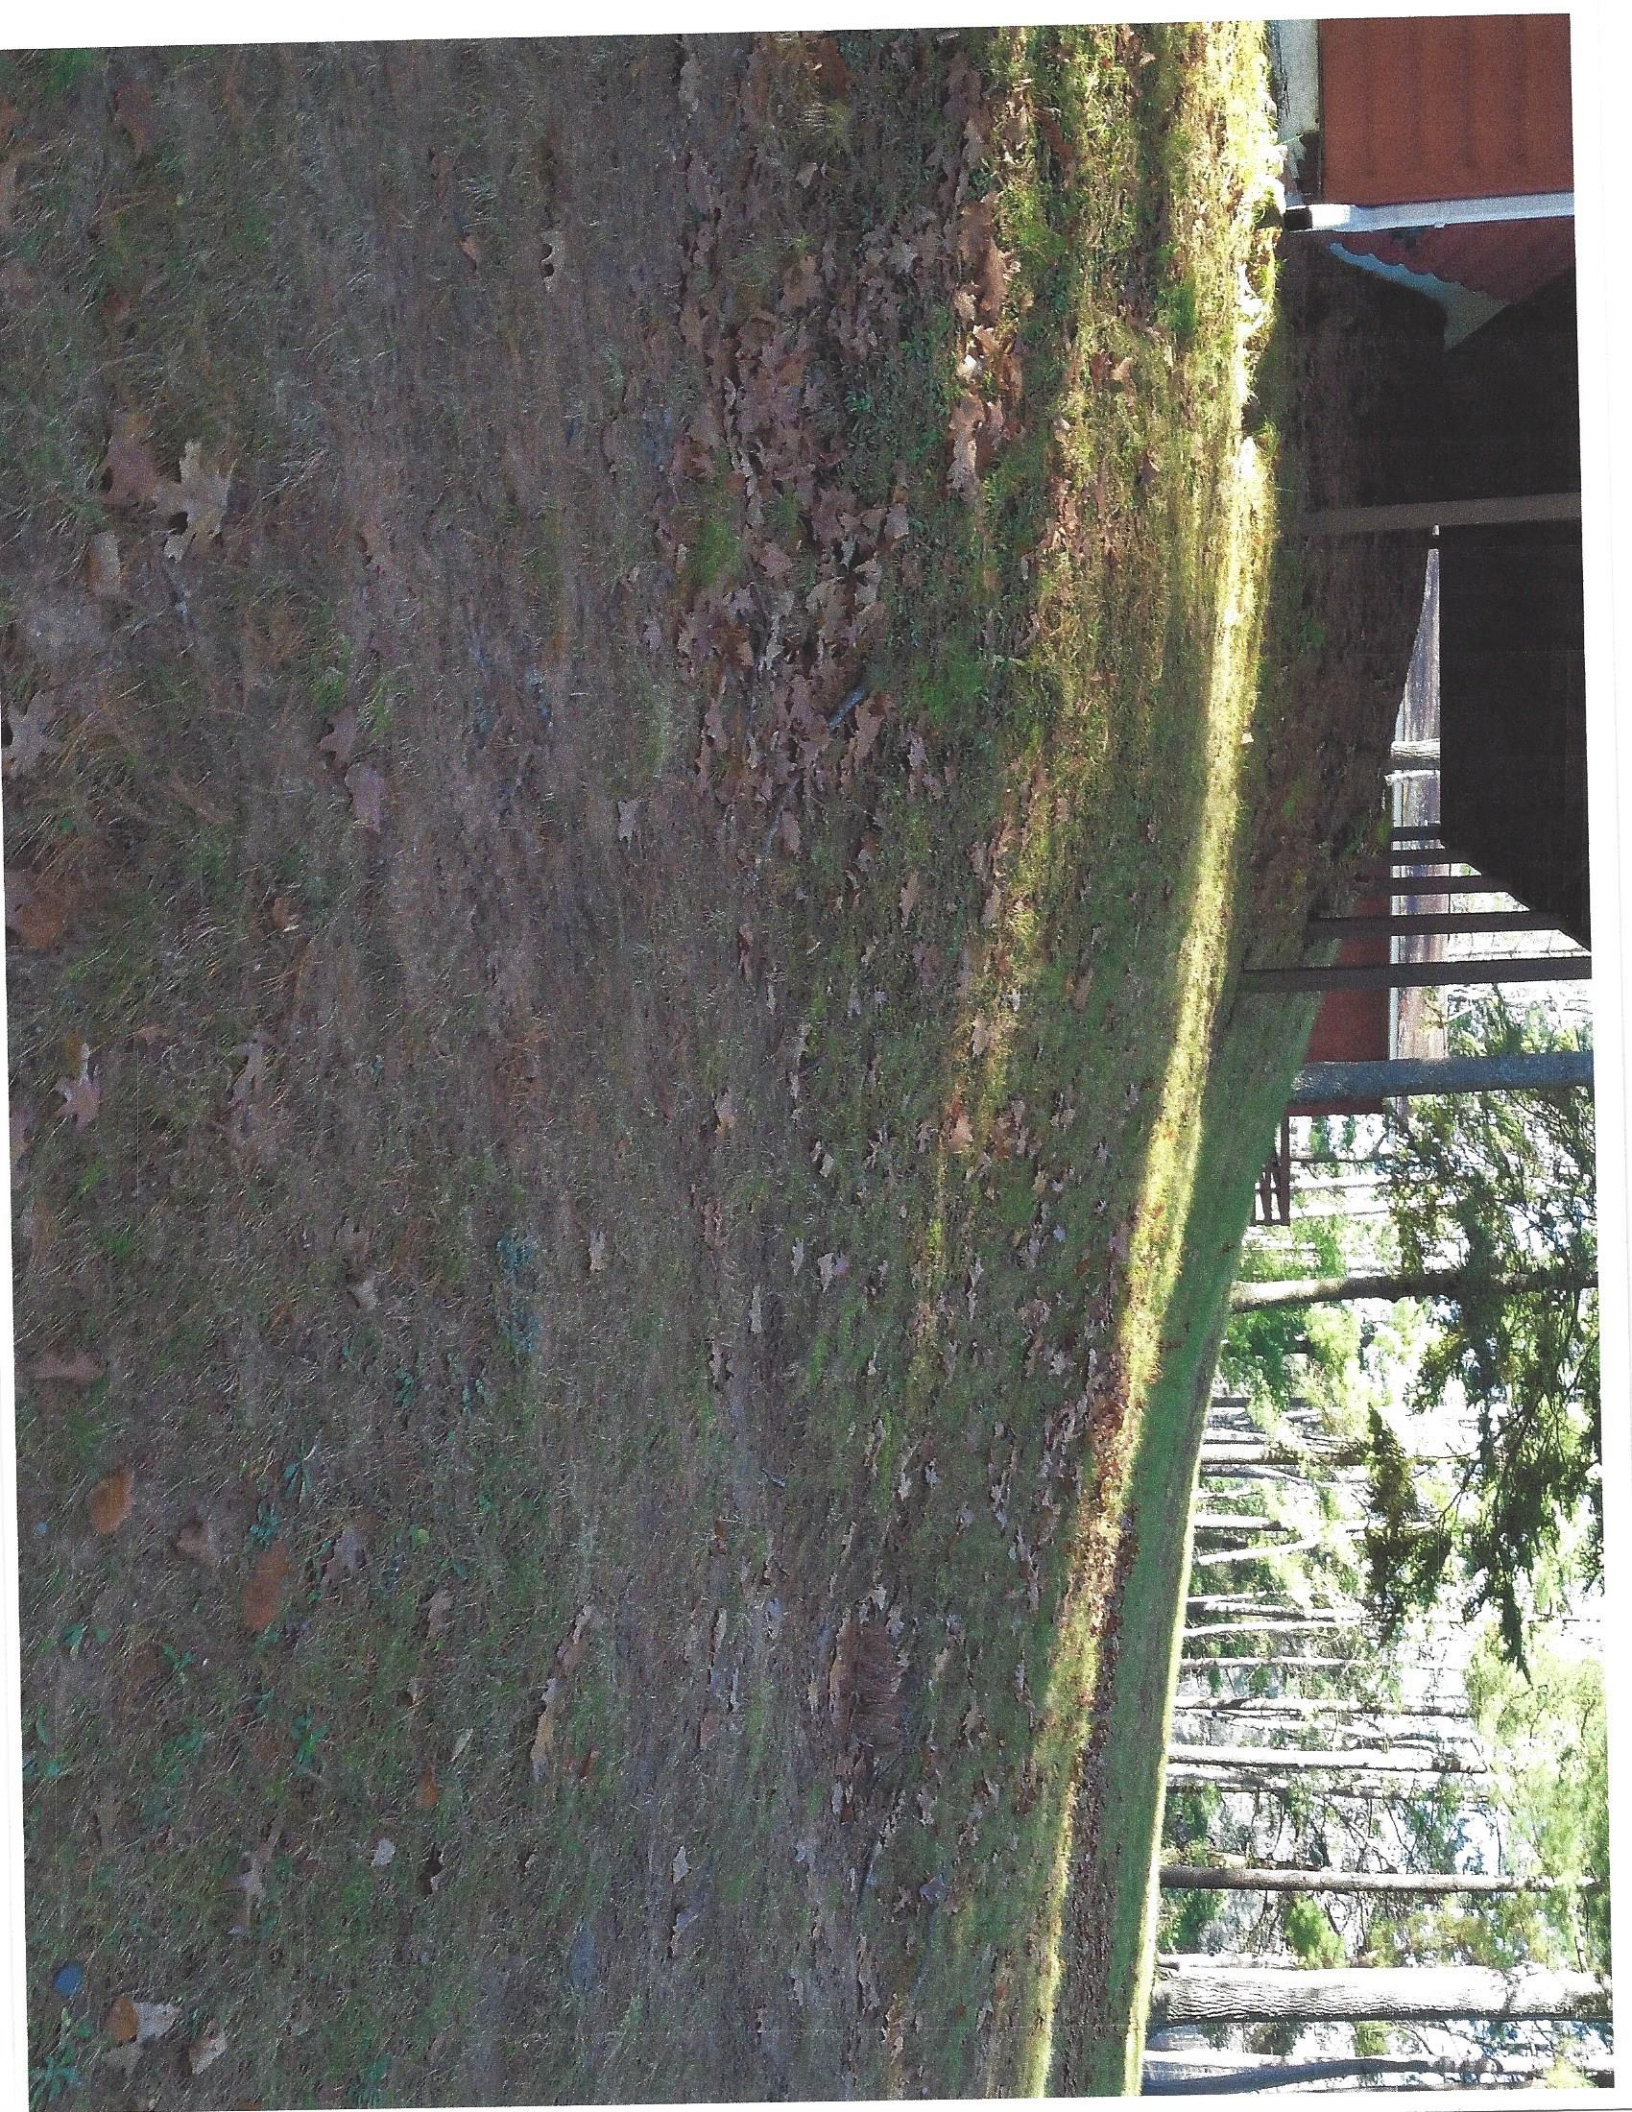
The Kime rain garden was built to correct two issues; one was the roof run off from Kimes house and some of the roof water from the Terlep house, second was the lawn run off adjoining the Kime house and lake ward from the Terlep house. See addendum A for the site plan, run off computations and the before pictures.

The runoff calculations said that an area of 100 square feet would be needed to handle the average storm in this area. The soil is sandy so a factor of .03 for infiltration was selected based on the slope above the rain garden. Due to the terrain a main rain garden

was built west of the Kime house to handle $\frac{1}{2}$ of the roof water and the runoff up hill from the garden and the run off contribution from the Terlep garage. A smaller secondary rain garden was built east of the Kime house to handle just the roof water from that side. See addendum A for calculations. See addendum B for photos of the completed gardens.

WATER CALCULATIONS

TOTAL AREA = $2232 \times .03 \text{ FACTOR} = 67 \text{ SF}$

#1 RAIN GARDEN USE $10 \times 8 = 80 \text{ SF}$

$732 \text{ SQ FT} \times .03 = 22 \text{ SQ FT}$

USE 25 SQ FT

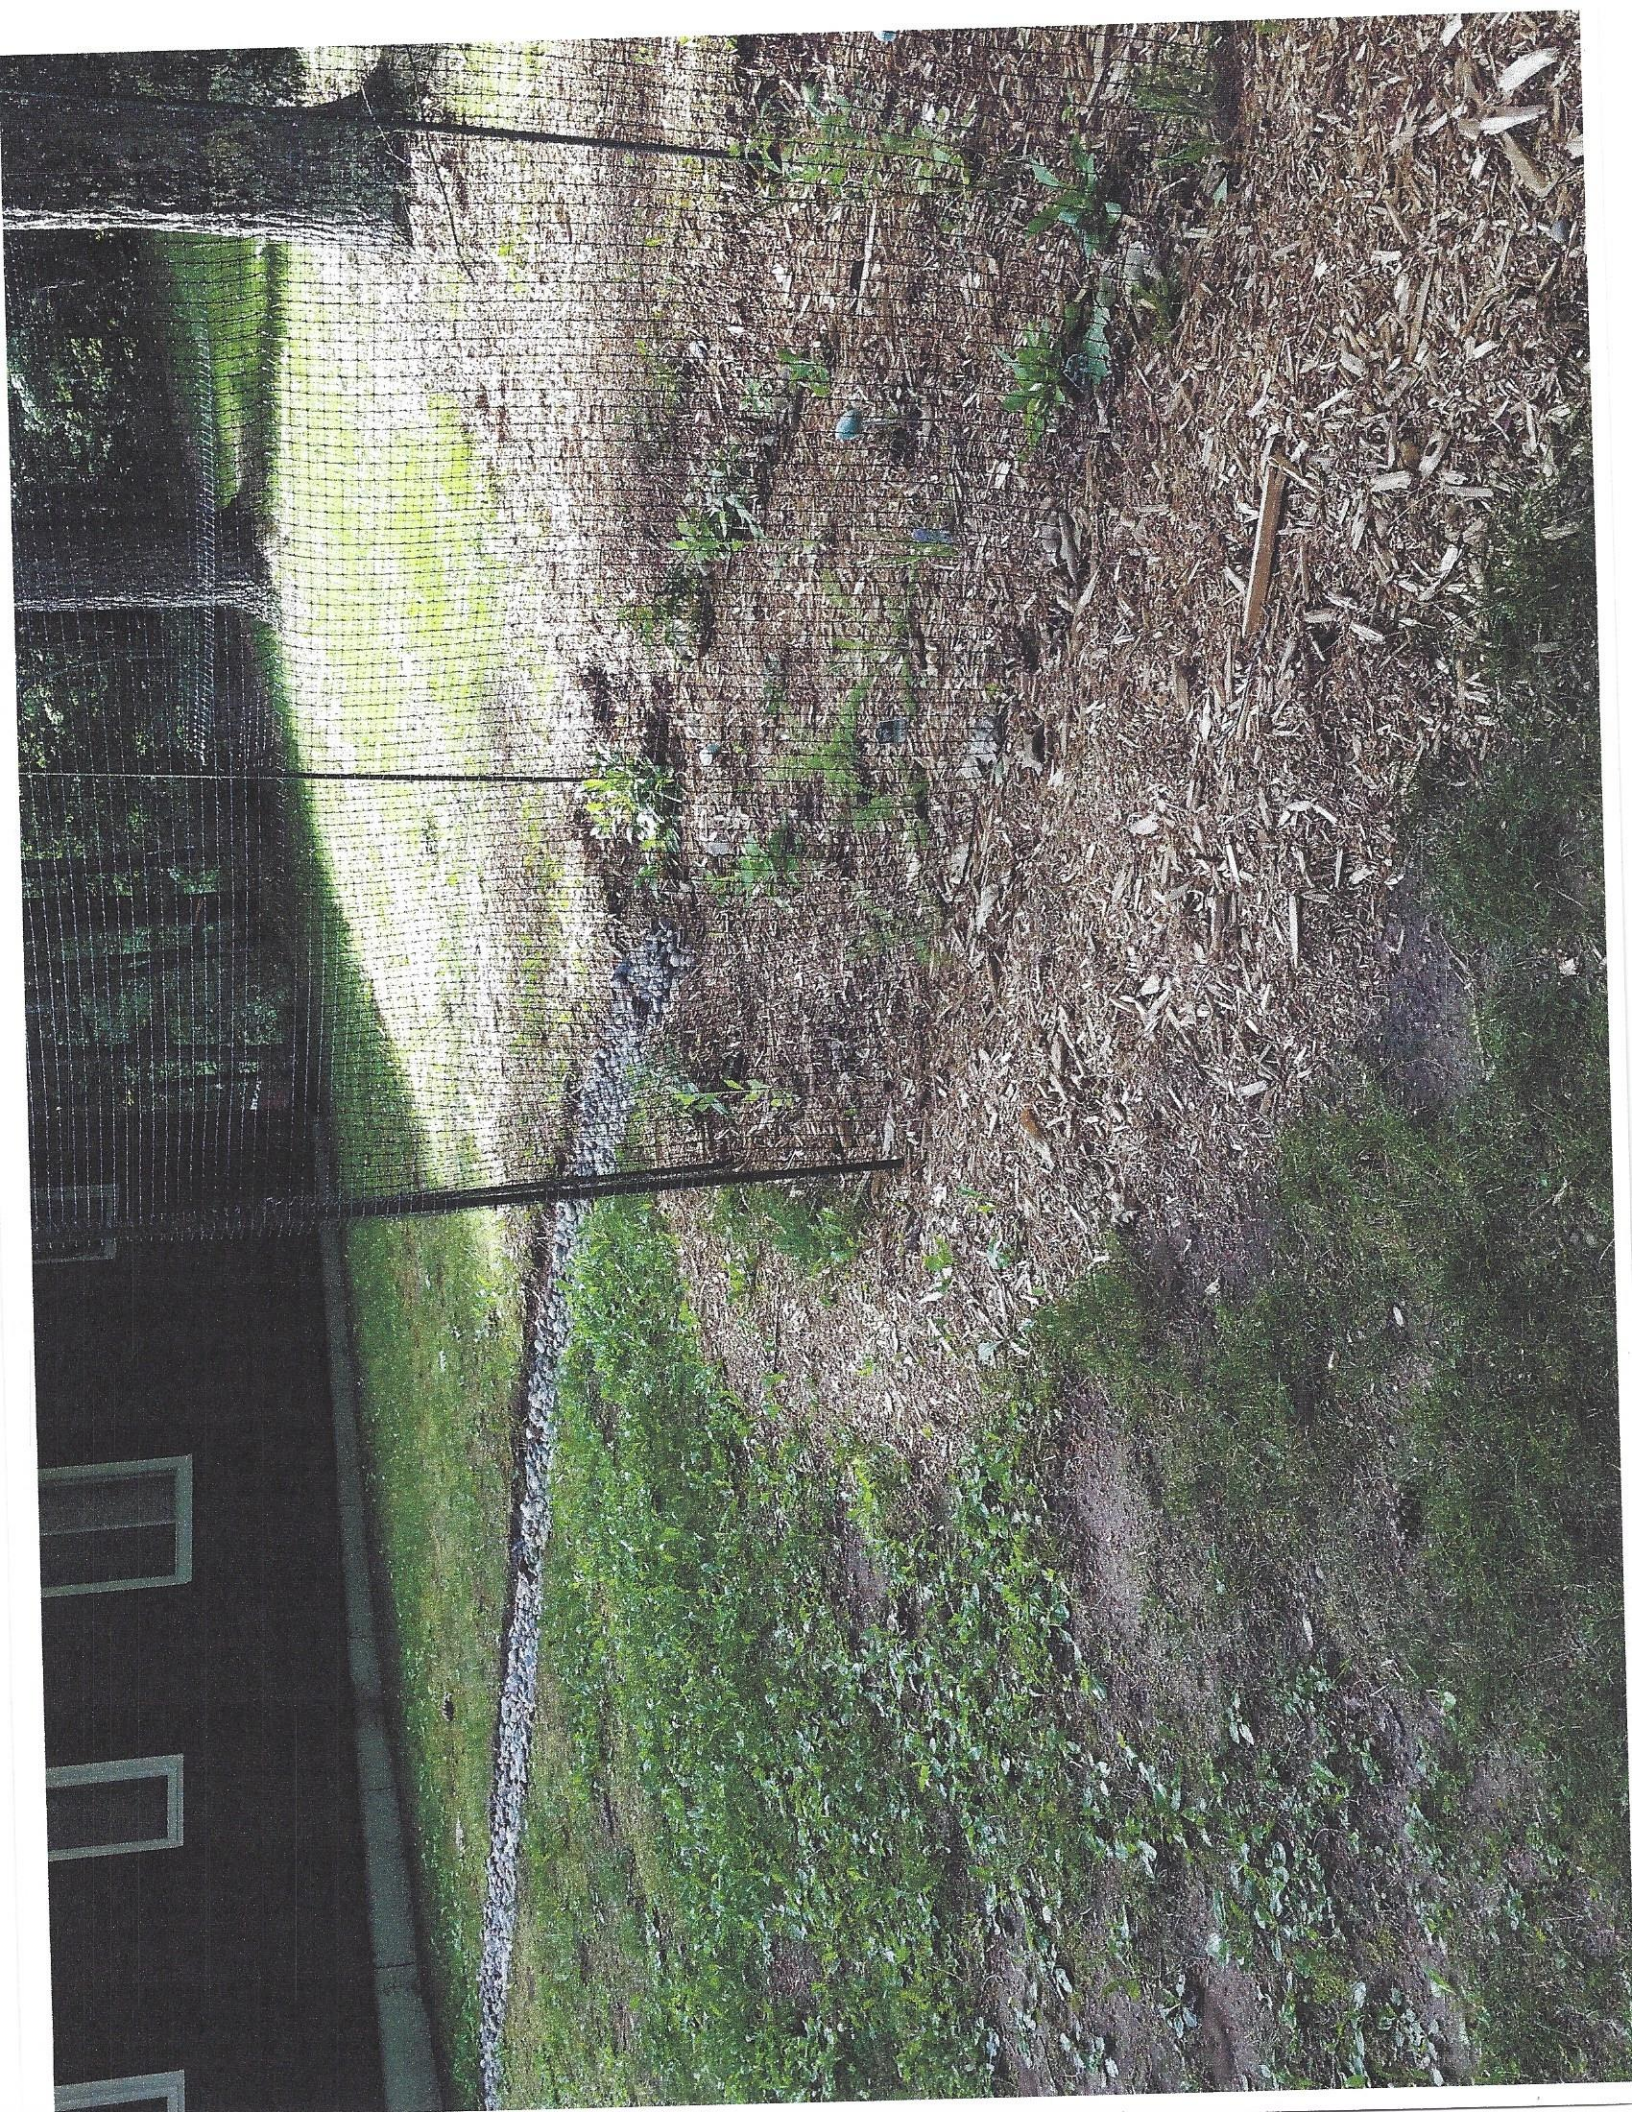
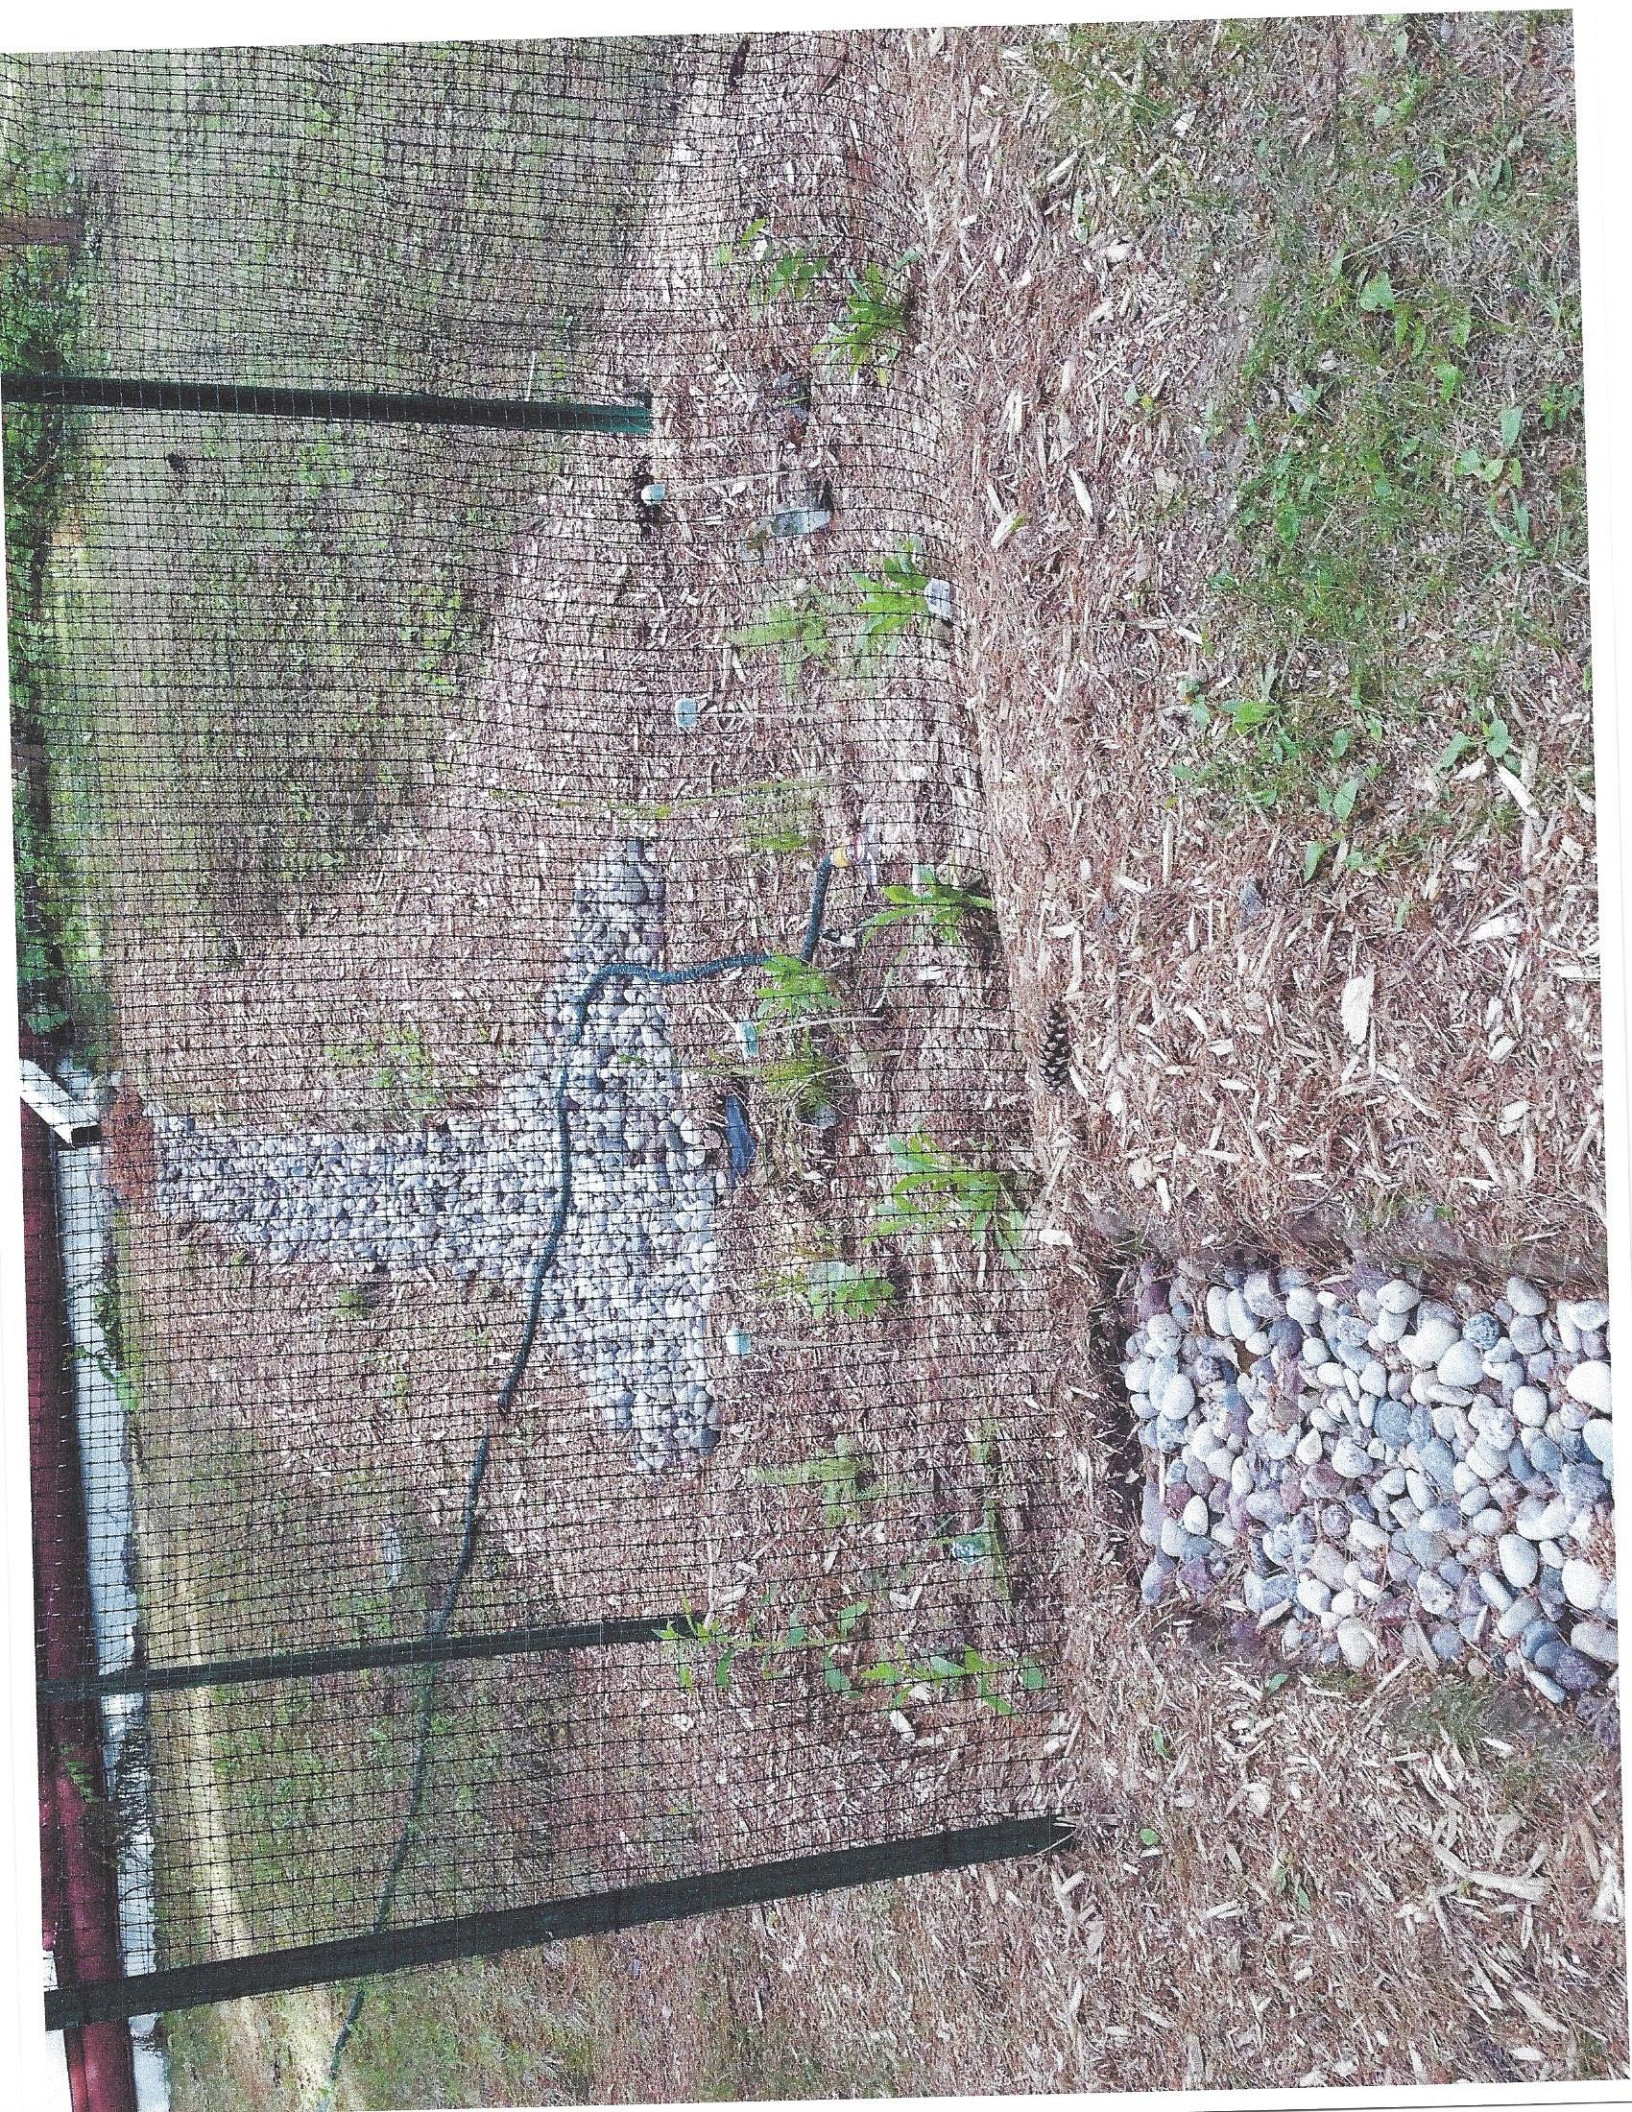
We had one 3 day storm event in June that totaled 7 inches that caused a significant over topping several times over the 3 days. The cedar mulch used performed well in keeping the lower side of the garden from eroding away. The plants stayed rooted and when the water soaked in the garden was mostly intact. The use of straw mulch with netting kept the run off in sheet form rather than rivlets forming, this lessened the potential damage. Within a day the area was restored. A temporary small rock over flow was added to prevent further damage should another such event occur. It should be able to be removed in year 2 after the plants emerge the 2nd year and the grass area around the rain garden has taken hold. A second major event happened September 26th with 1 inch of rain in 40 minutes. The garden filled and had sheet flow over the down hill side with no damage of any kind. The garden has the capacity to handle normal rain with minimal overtopping. It is important to keep the top of the down hill side of the garden as level as possible so the over flow is spread out across the garden so a rivlet does not get started and become a wash out. A quality mulch around the plants and edges is necessary to hold soil in place until the plants fill in years 2 and 3.

The sizing and the factors used appear to be appropriate for the site. There maybe room to direct some additional runoff to this garden. It would cause over topping more often but the garden seems to be able to handle that, The down hill and side berms could be built up. There is some concern on how often we would want to flood the plants to that extent. The gardens will be left as built for at least another growing season and see what type of storms come in 2018. To be able to see the gardens during the September storm provided a good chance to evaluate the project.
