Final Report On Tychsen Rain Garden
Healthy Lakes Grant LPT 56217.1
Little Arbor Vitae lake
Vilas County

Project Cost Rain Garden 3 Grant LPT 56217.1

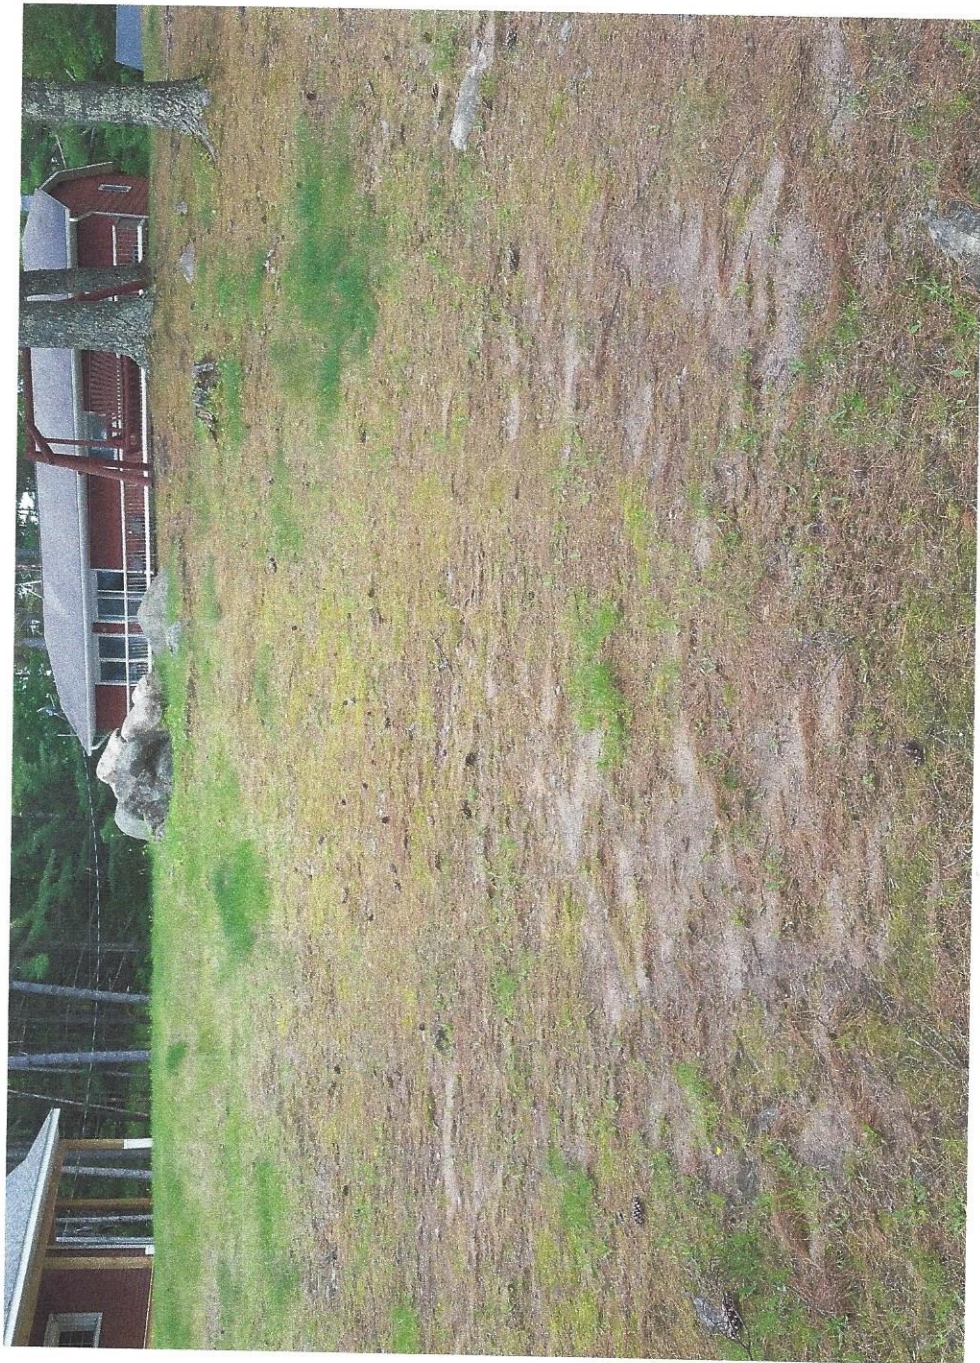
Before

Blue Island Resort and Condominiums was a resort converted to condominiums. It dated from the 1930s The terrain is rolling and rises from the shore line upward toward Blue Island Road. Some road drainage and a majority of the lawn area slopes to the lake. From years of removing leaves by blowers and little effort to rejuvenate the lawn it had lost most of it's top soil and became a sandy type lawn subject to erosion.

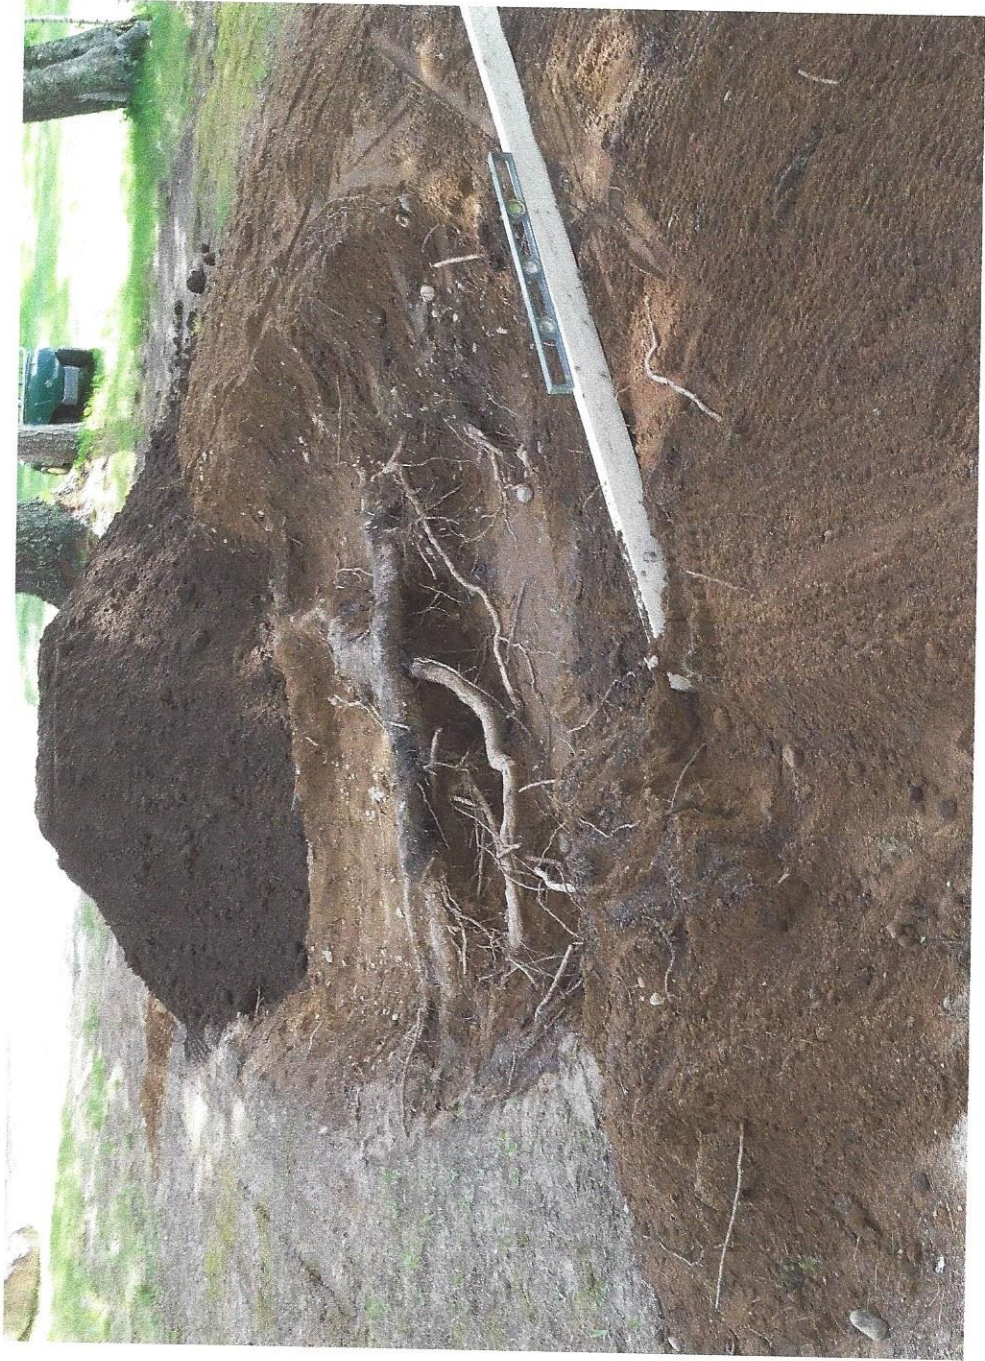
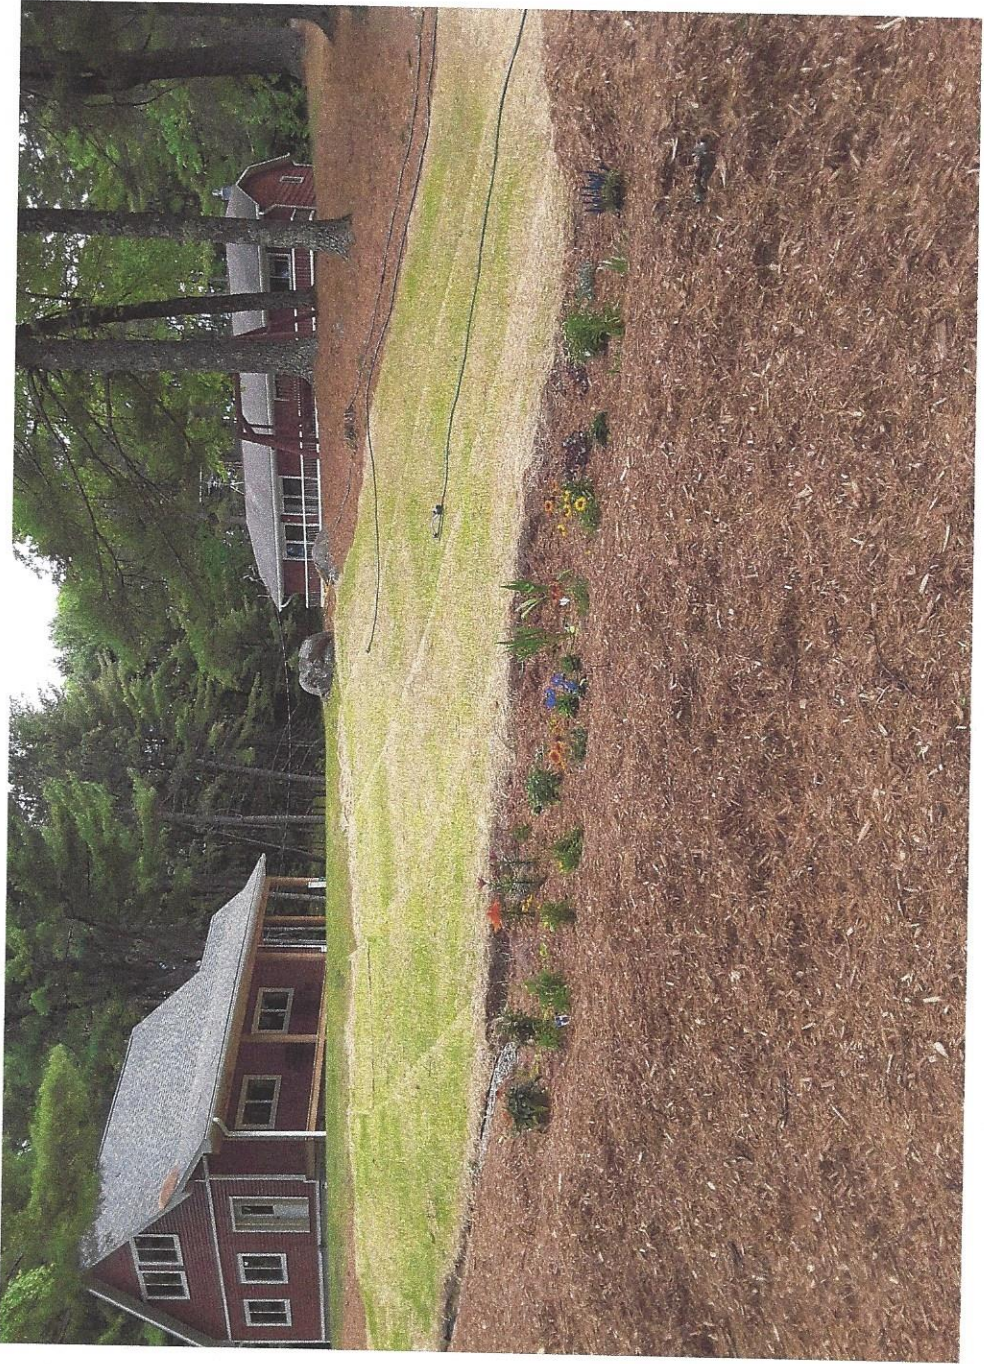
Ran into a few roots
slow digging during the Hot week in
May

The excavation was done by hand due to the numerous roots and stones . Two large roots cross through the garden as they are important anchor roots. There are several photos of the construction in the appendix A.

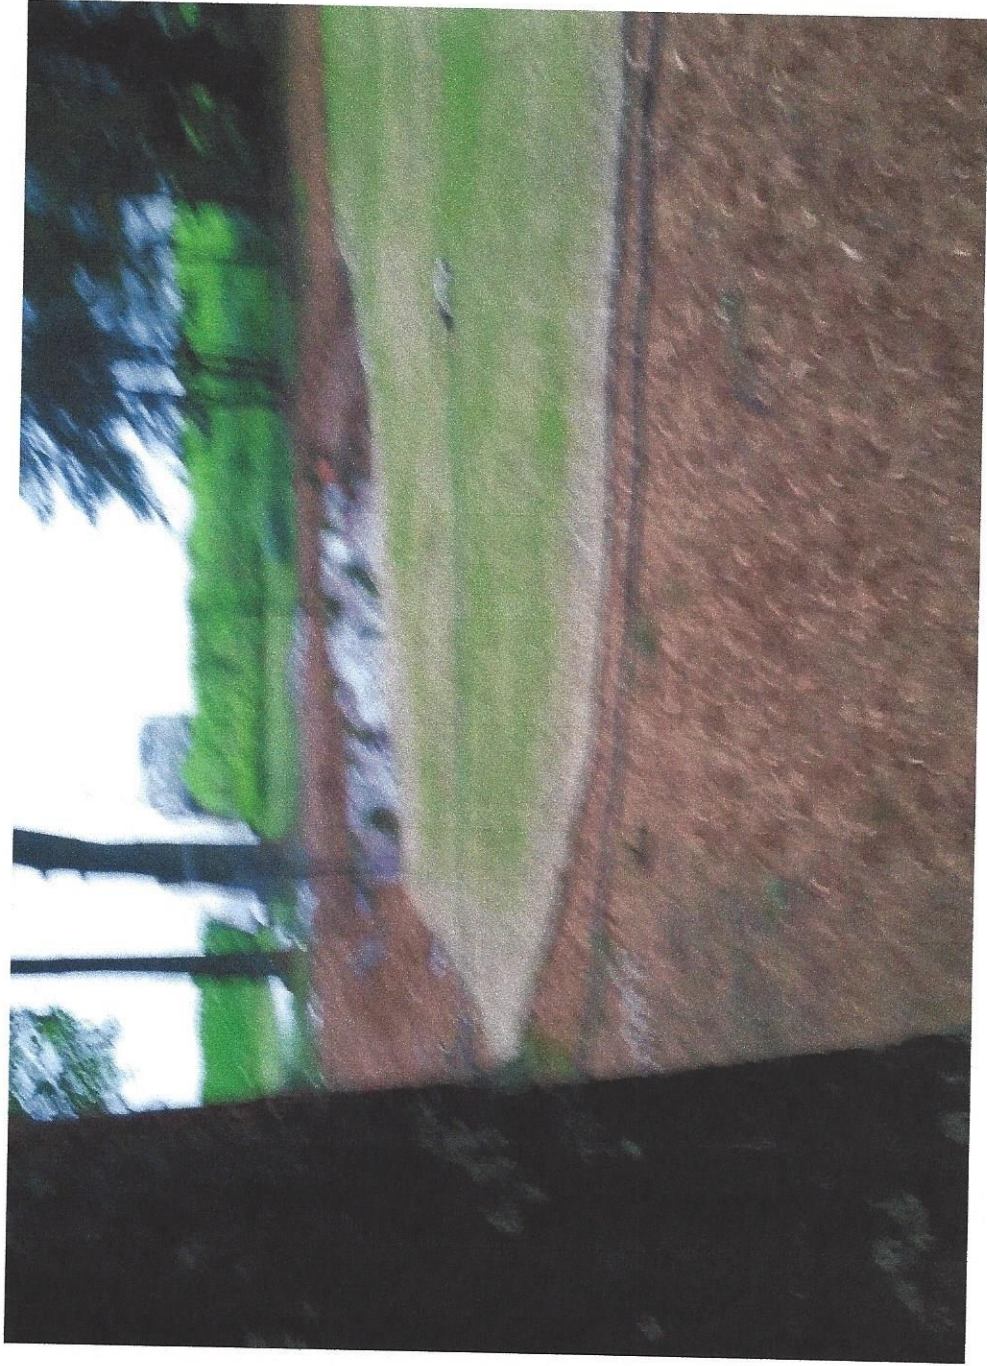
First test - early morning June 15, 2018

The garden was completed on June 12. On June 15,16 and 17 the garden received 6.6 inches of rain coming in a series of heavy down pours each day. The garden remained intact during the Friday storms but the lower berm was breached Saturday morning. A quick trip to Walmart and 8 bags of river pebbles the breached area was turned into a stone spillway that allowed the garden to fill with water but not overflow the fresh berm.
