RICE LAKE, BARRON COUNTY

2016 LAKE MANAGEMENT SUMMARY REPORT

Prepared by: Dave Blumer, Lake Educator March 23, 2017

RICE LAKE-LAKE PROTECTION
AND REHABILITATION DISTRICT

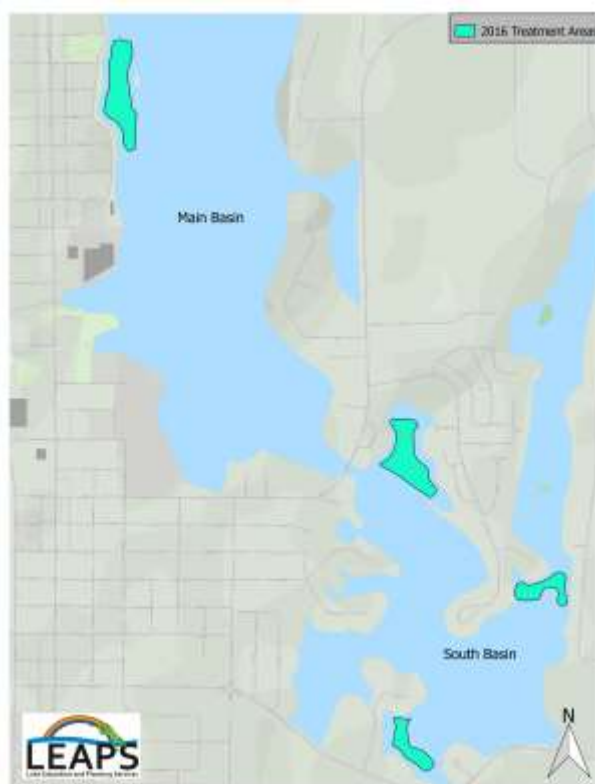
Figure 1 – 2016 Final Treatment Areas in Rice Lake (LEAPS, 2017)

A chemical treatment proposal for three CLP beds in the South Basin was prepared in early 2016 that targeted the same three areas of CLP that were targeted in 2015. In the preliminary proposal for 2016, the three beds in the south basin totaled 11.78 acres. Also as a part of the preliminary 2016 CLP chemical treatment proposal, two additional beds in the main basin totaling 10.42 acres were included. After the pretreatment survey, one bed in the main basin was removed, and Bed B in the south basin was modified slightly giving the final treatment plan which included four treatment areas, three in the south basin, and one in the main basin (Figure 1). Aquathol K, a liquid formulation with the active ingredient endothall, was recommended at 2.0 ppm in the larger areas and at 2.25 pm in the smaller areas (Table 1).

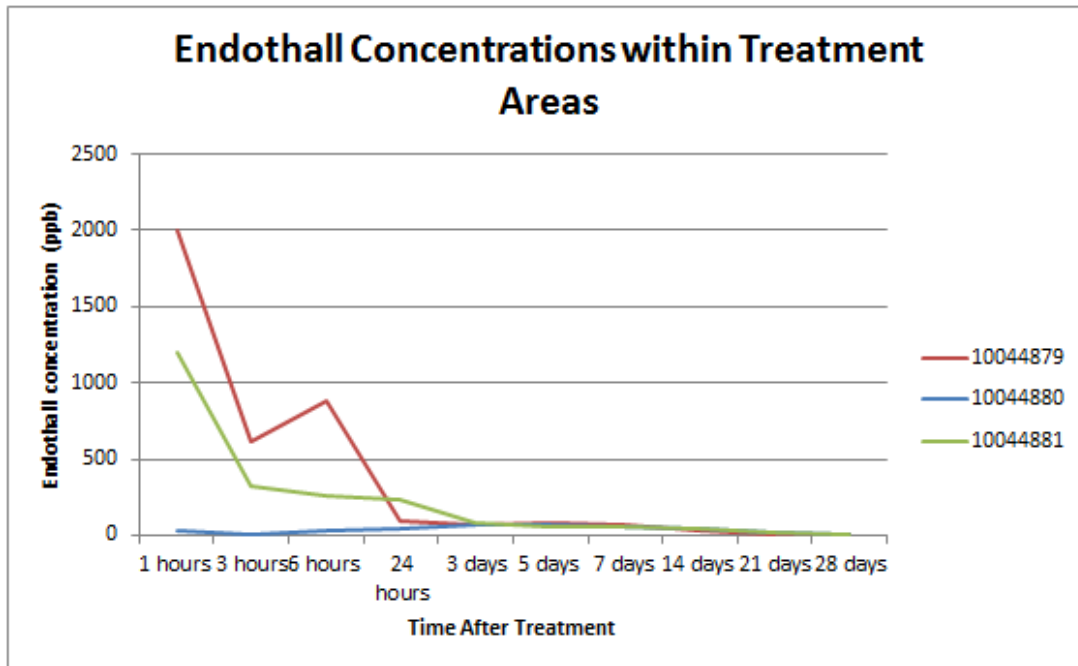
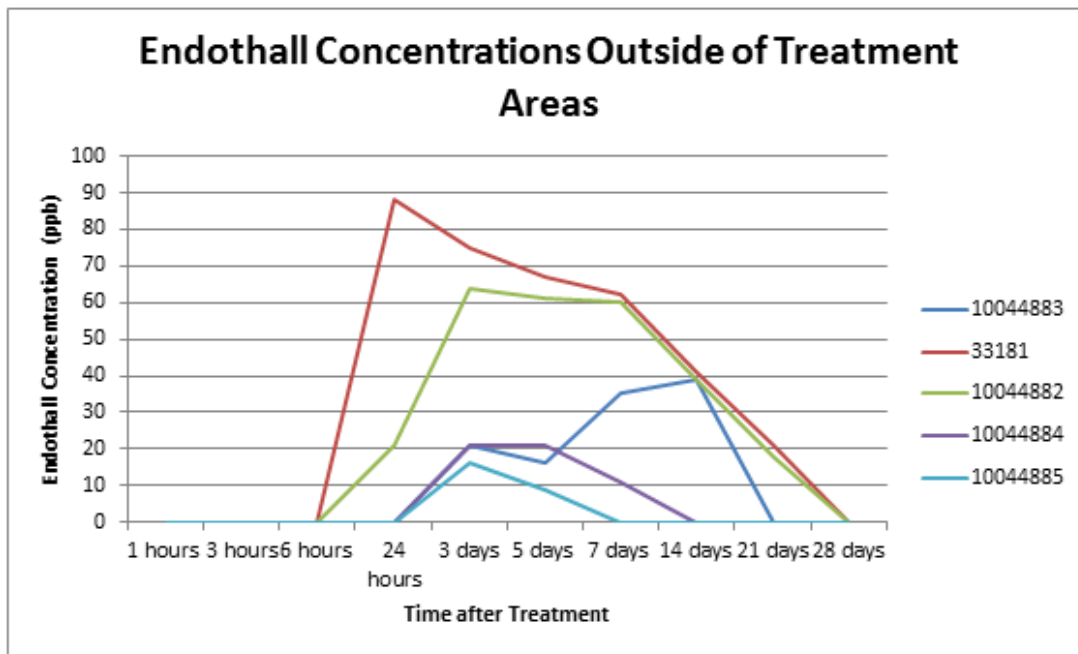
Figure 5 – Endothall Concentration Testing Results in Rice Lake

Herbicide concentrations in two of the treatment areas (SiteA-CC-16 (10044879) & SiteC-CC-16 (10044881)) reached high levels of herbicide concentration within an hour of application, with SiteA-CC-16 actually reaching the concentration that the herbicide was applied at (2.0 ppm). The third treatment site (SiteB-CC-16) did not reach as high levels of herbicide concentration. Two native plant species (*Elodea nutallii* & *Potamogeton robbinsii*) suffered significant declines post-treatment in 2016. It is possible that the declines in these two species were most prevalent in Treatment Area A (BedA-2016).

Herbicide concentration testing also revealed some interesting data about the movement of the herbicide in the lake once applied. Site CWBay-CC-16 (10044883) is located a substantial distance into Clearwater Bay. It has been the assumption in the past that water is mostly moving out of Clearwater Bay into the south basin, but concentration data shows that the herbicide applied in the south basin moved into Clearwater Bay about three days after

application, reaching its peak at two weeks after application, albeit still at very low concentrations (0.039 ppm). The exact mechanism for carrying the herbicide into Clearwater Bay is not known, but could include wind speed and direction, currents, and movement of boats into the Bay.

Herbicide did not reach the outlet of Rice Lake at the dam until 2-3 days after application. The herbicide that did arrive there was not entirely from the south basin treatment areas, as there was a fourth herbicide application area along the west shore of the lake north and upstream of the dam. But again, the concentration of herbicide was very low, well below any thresholds of potential negative impact. All herbicide concentrations at the 8 sites were essentially gone by 3-4 weeks after application. After 24 hours herbicide concentrations at all sites except one were below 100 ppb or 0.001 ppm.

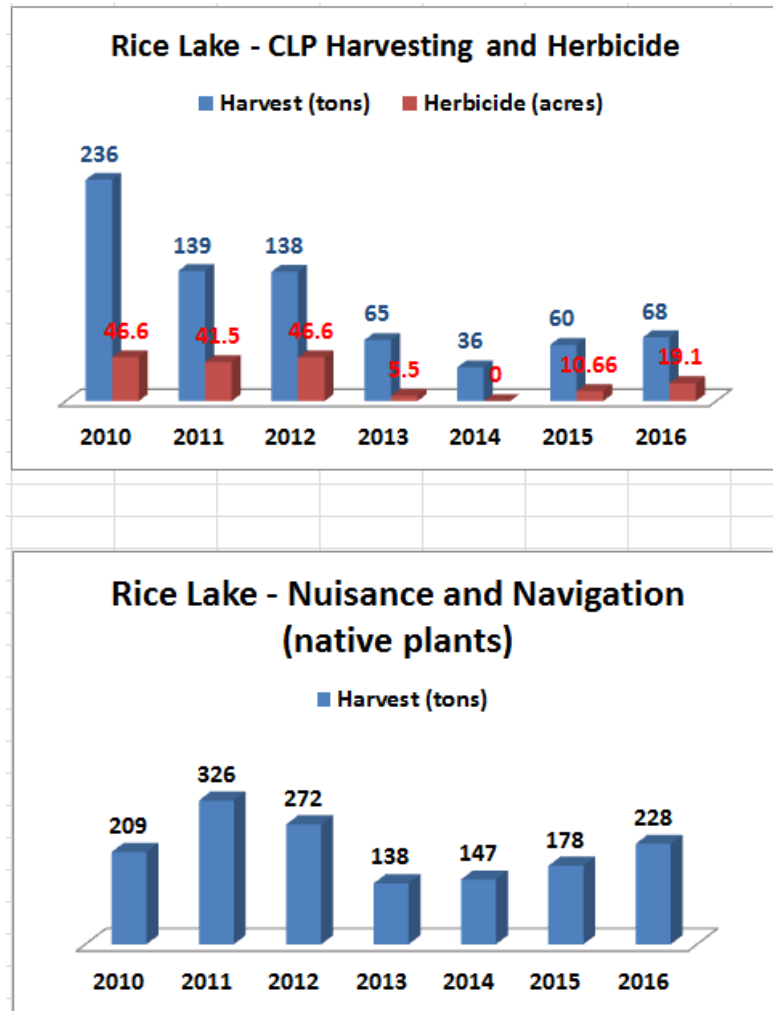
Figure 6 – Changes in CLP and Native Aquatic Plant Harvesting Results from 2010-2016

Improving water clarity seems to be having an effect on aquatic plant growth in Rice Lake. The amount of CLP harvested each year is going down, but the amount of native vegetation harvested is going up (Figure 6). According to visual estimates by harvester operators, the amount of water celery picked up by the harvesting operators in 2016 was much higher than normal, even when compared to what was harvested in 2015. In 2016, the average summer total phosphorus and chlorophyll a were just slightly worse than the average from 2010-2015. However, Secchi disk readings of water clarity were slightly better than the 2010-2015 average. Slightly worse than average phosphorus and chlorophyll readings and slightly better water clarity readings coupled with greater native aquatic plant harvest suggests more of the available phosphorus is being used by aquatic plants, and less is being used by algae.

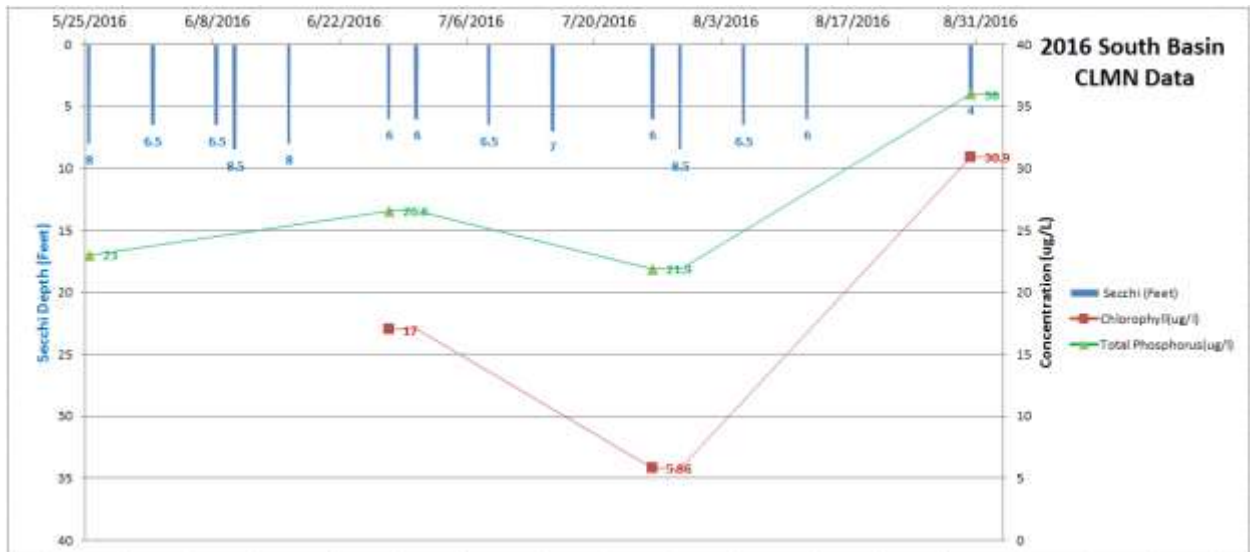
Figure 7 – 2016 Citizen Lake Monitoring Network Data for the South Basin of Rice Lake – Secchi, TP, and ChlA

Water quality data through the CLMN program was collected by Lake District Employees in 2016 from three locations on the lake: North Basin, Central Basin, and South Basin. Total phosphorus, chlorophyll, water clarity, and dissolved oxygen/temperature profiles were collected from the South Basin and the Central Basin. Only water clarity and dissolved oxygen/temperature profiles were collected from the North Basin. The results of CLMN monitoring for 2016 in the South Basin and Central Basin are shown in Figures 7 & 8.

Total phosphorus and chlorophyll values in the south basin typically spike in late August - early September, while Secchi readings of water clarity tank, due to an influx of phosphorus from the bottom waters. The south basin of the lake normally stratifies in the early summer creating a layer of warm oxygen-rich water at the surface separated from cooler water in the bottom by the thermocline. With a thermocline in place, oxygen in the surface waters cannot mix with the cooler water, setting up the opportunity for the bottom waters to become anaerobic or devoid of oxygen in the mid to late summer. When this happens, phosphorus formally locked up in the sediments is released back into the water column and becomes available for algae growth, turning the south basin green. Because the main basin of the lake is continually mixed by the influx of water from Bear Creek and the Red Cedar River, it does not stratify. However, both of these tributaries carry in a lot of phosphorus attached to suspended solids in the river water and may cause spikes in phosphorus like what is seen in the late June sample from the central basin. Chlorophyll values

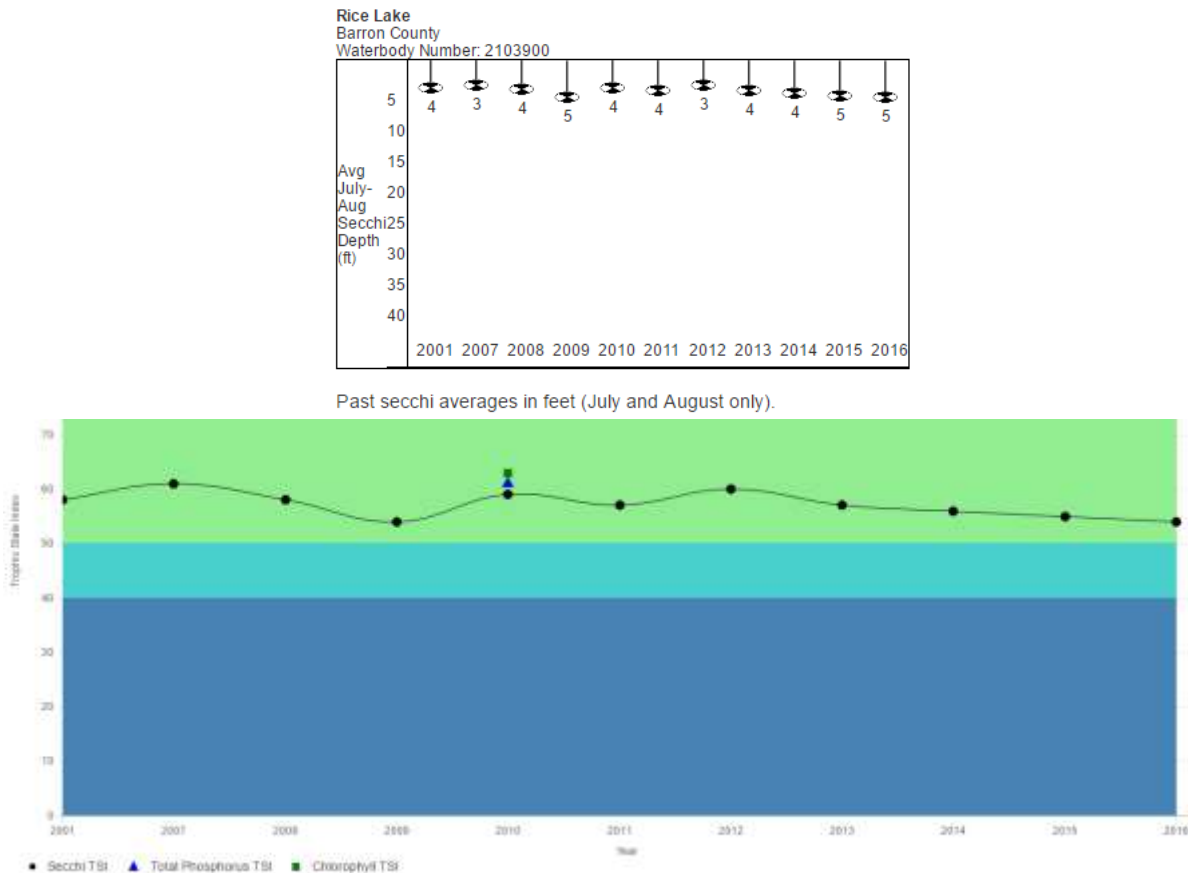
Figure 9 – North Basin Average Summer Water Clarity and Trophic Status (CLMN, 2016)

As previously stated, average summer water clarity in 2016 was slightly lower than what was recorded in 2015, but slightly higher than the average summer readings from 2010-2015. Total phosphorus and chlorophyll a values for 2016 are lower than those recorded in 2015, but slightly higher than the average from 2010-2015. Figures 9-11 shows the summer averages for water clarity (Secchi disk), total phosphorus, and chlorophyll a.

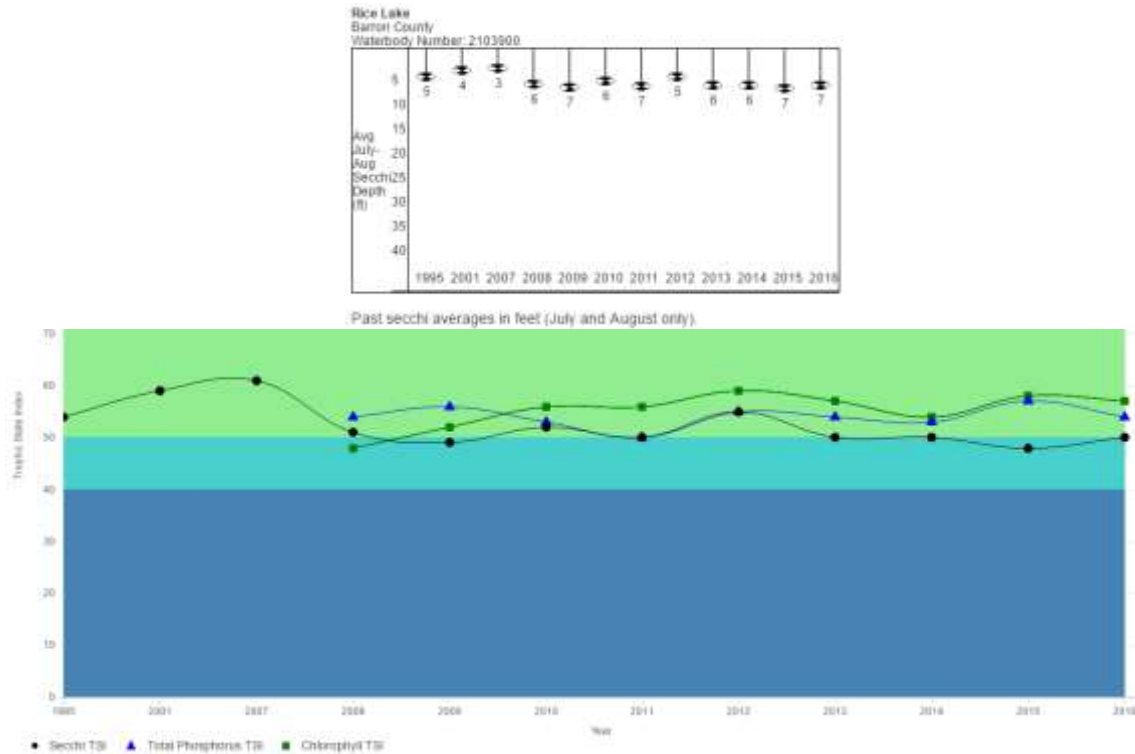
Figure 11 – South Basin Average Summer Water Clarity, Total Phosphorus, and Chlorophyll; and Trophic Status (CLMN, 2016)

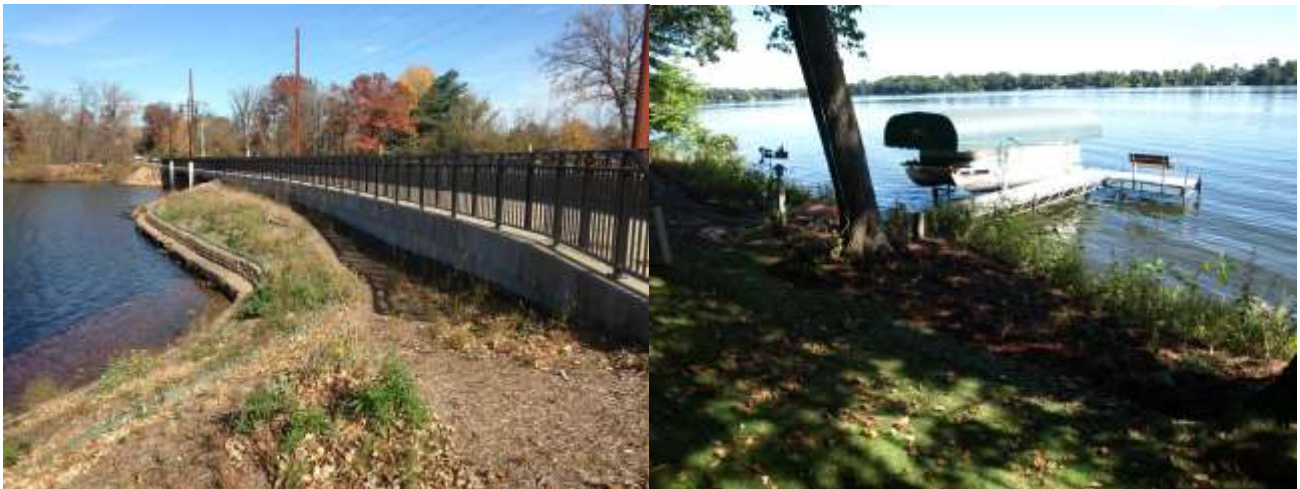
Figure 12 – Left: Narrows Park Native Plant Restoration (Blumer, 2016); Right: Storm Shoreland Improvement (Green Frog Co, 2016)

- Preparation and planting of the Narrows Park Native Plant Restoration
- Grinders Bike Shop Rain Garden
- Arnolds Landing Rain Garden
- Invasive Plant Control/Native Planting – Storm
- Establish a no-mow area/remove invasive species/native planting at Lake Shore Park Band Shelter
- Signage and weeding at City Hall

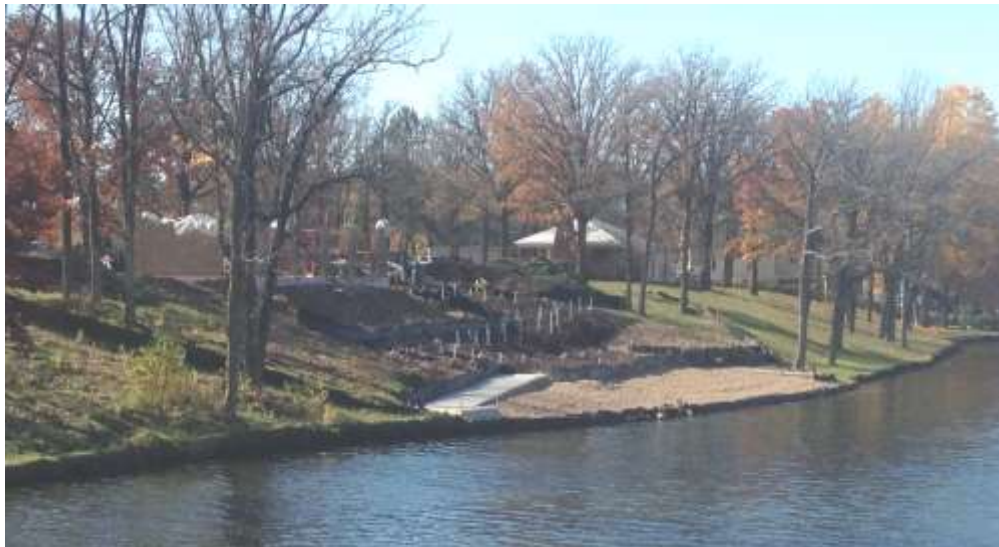
Figure 14 – New City of Rice Lake Swimming Access (Blumer, 2016)

While not directly tied to the actions of the Lake District, the City of Rice Lake began construction of a new swimming access point on Rice Lake at the Narrows Park. Construction includes a new shelter, bathrooms, and changing rooms, a tiered sidewalk/ramp to the waters' edge, placement of sand, and space to put two access piers. The concept of this project was first pitched by the Lake District several years ago, but the final design and construction was taken over by the City (Figure 12).

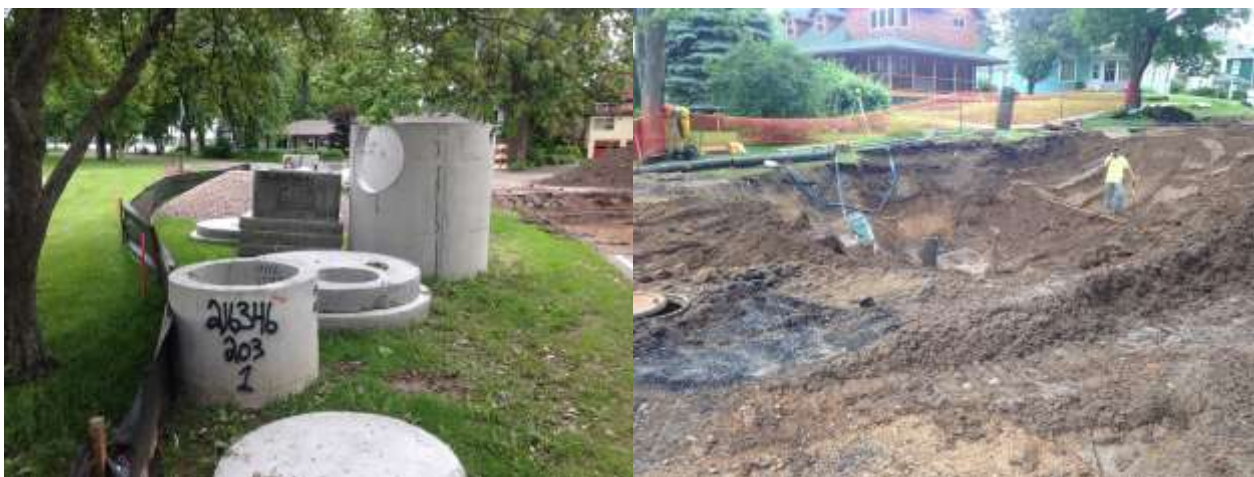
Figure 15 – Humbird Street Grit Chamber Installation

The City of Rice Lake redid a stretch of Humbird Street between Main Street and Lakeshore Drive in 2016. This project included the installation of a grit chamber at the lake side of the storm water sewer system. The actual grit chamber was paid for by the Lake District to the sum of \$15,000.00. Design work and installation was completed by the City of Rice Lake. The installation of a grit chamber was approved and added to the project. This project was completed over the summer (Figure 12).

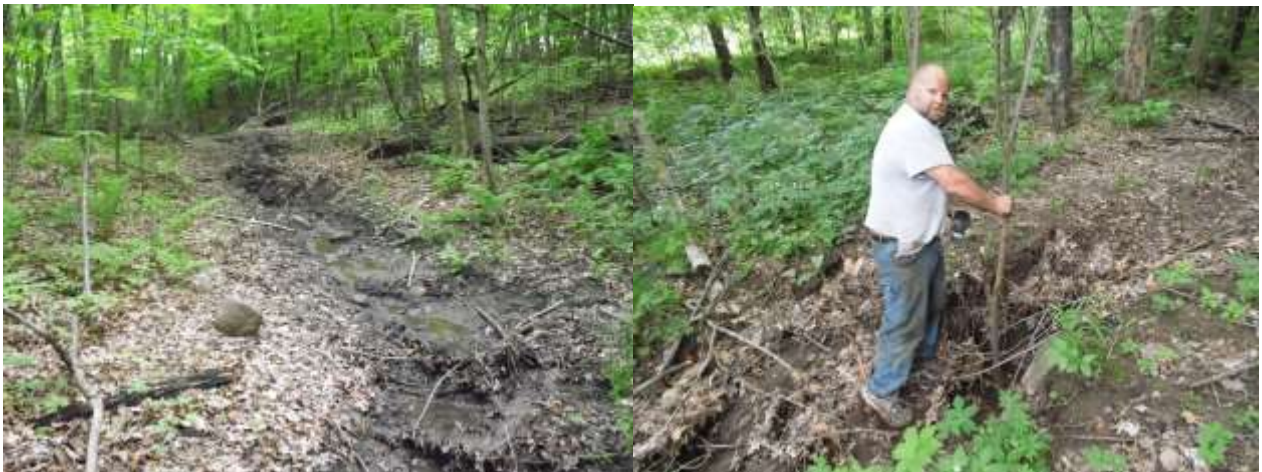
Figure 17 – Washout between the top of the 53 & V field and Bear Creek in June 2016 (Blumer, 2016)

Discussion continues to take place between the property owner, renter, Lake District, Barron County, and the WDNR about what to do with the agricultural field on top of the waste pile at the V & 53 intersection. Currently the renter has been planting corn on top of the hill. The corn crop was not very good in 2016, and the renter is willing to consider other options on the hill top. Severe erosion continues to occur in the gully between the top of the hill and the Bear Creek flat below. Options are limited, and the renter is not entirely willing to give up the ground for enterprises that may not provide income. But as was stated, the conversation continues.
