# RICE LAKE, BARRON COUNTY

## 2017 LAKE MANAGEMENT SUMMARY REPORT

# 2017 LAKE MANAGEMENT SUMMARY REPORT

PREPARED FOR THE RICE LAKE – LAKE PROTECTION AND REHABILITATION DISTRICT

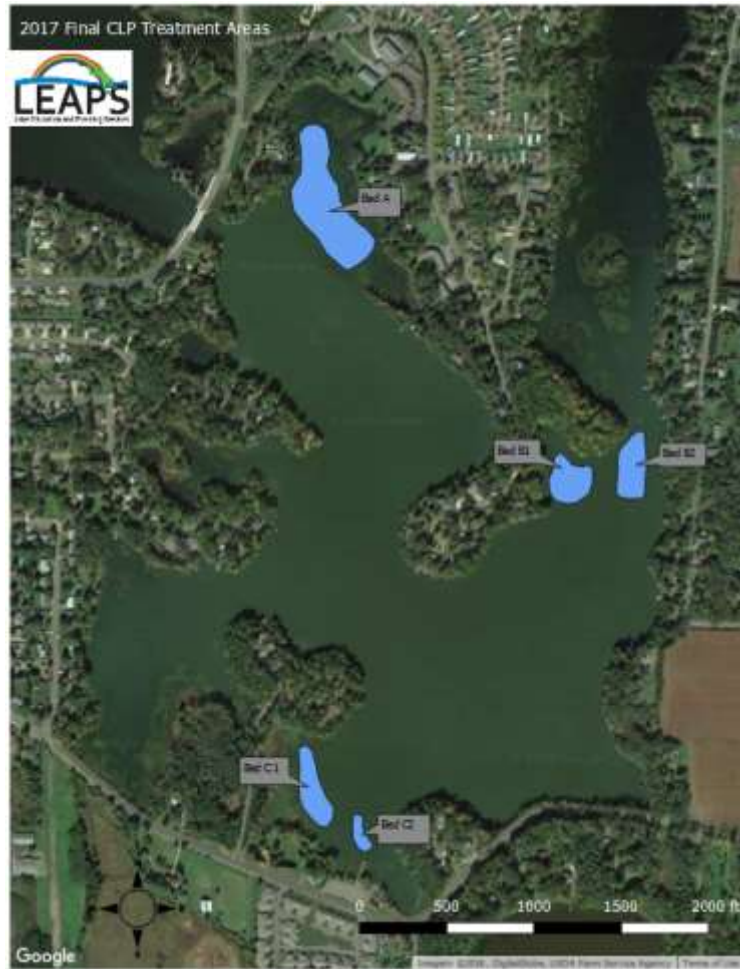
Figure 1 – 2017 Final Treatment Areas in Rice Lake

A chemical treatment proposal for three CLP beds in the South Basin was prepared in early 2017 that targeted the same three areas of CLP that were targeted in 2016. In the preliminary proposal for 2017, the three beds in the south basin totaled 13.46 acres. After the pretreatment survey, Beds B and C were split into two different beds and bed A was modified a little giving the final treatment plan which included five treatment areas (Figure 1). Aquathol K, a liquid formulation with the active ingredient endothal, was recommended at 1.5 ppm in bed A and at 2.0 pm in the other areas (Table 1). It was decided to use a lower concentration in 2017 than was used in 2016 because despite resulting in near 100% reduction in CLP, the higher concentration used in 2017 also caused significant decline in two native species.

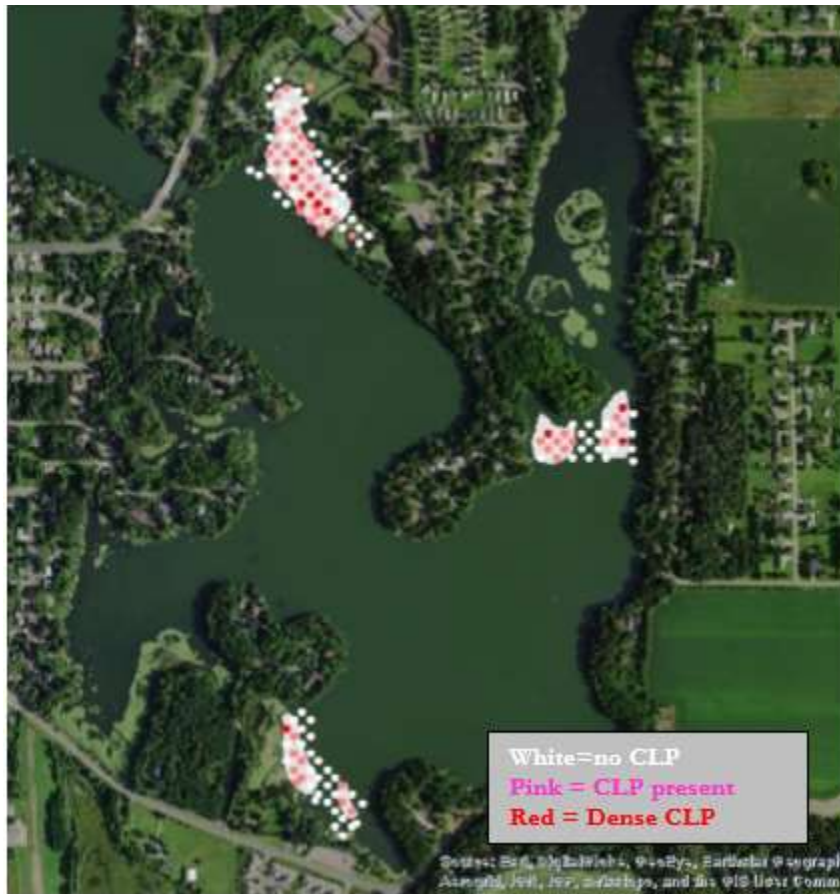
Figure 2 – April 9, 2017 Pre-treatment Survey Results (Schieffer, 2017)

A pre-treatment survey of just the proposed treatment areas in the south basin was conducted on April 9, 2017. Figure 2 shows the presence/absence of CLP during the pretreatment survey of the proposed treatment areas in the south basin. Pre and posttreatment survey in the south basin is required in the 3-yr AIS Control grant. As a result of the pre-treatment survey slight modifications from the preliminary CLP treatment proposal were made, specifically, Bed C at the transition from Clearwater Bay to the south basin, was split into two beds as was bed B near the Veteran’s boat landing. Treatment was completed on April 25<sup>th</sup> by Northern Aquatic Services. Water temperature was 53°F, and air temperature was 63°F. Winds were variable from 2-4 mph out of the south southeast, nearly perfect conditions for the treatment. A post-treatment survey was completed on June 7<sup>th</sup> approximately 7 weeks after treatment. At this time, CLP would normally still be very prevalent in the water column. Figure 3 shows the presence of CLP during the post-treatment survey, there was very little CLP in the treatment areas. Table 2 shows the frequency and density data from pre to post treatment survey. Almost all of the CLP in the treatment areas was killed by the 2016 spring treatment.

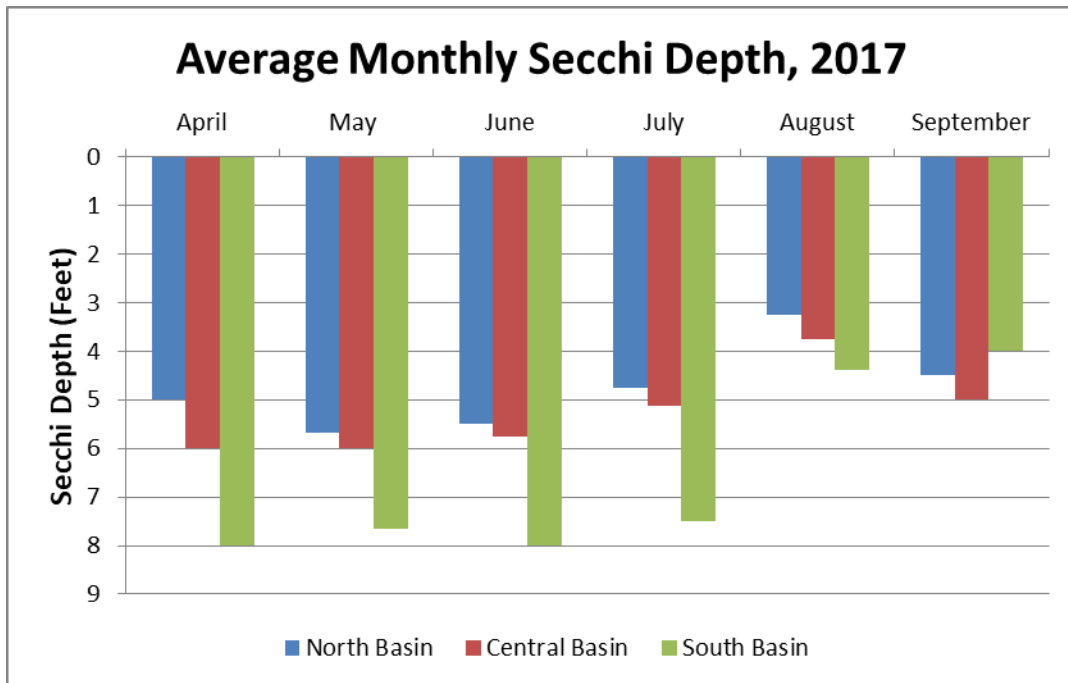
**Figure 4: Average Monthly Secchi Depth Readings, April- September 2017**

Water quality data through the CLMN program was collected by Lake District Employees in 2017 from three locations on the lake: North Basin, Central Basin, and South Basin. Total phosphorus, chlorophyll, water clarity, and dissolved oxygen/temperature profiles were collected from the South Basin and the Central Basin. Only water clarity and dissolved oxygen/temperature profiles were collected from the North Basin. Temperature/ dissolved oxygen profiles were taken on almost on a weekly basis for all three sites. Secchi readings were also taken almost weekly at all three sites throughout the season. Figure 5 shows a comparison of the monthly average Secchi depth readings for each site. With the exceptions of April and September, four Secchi readings were taken each month of the season in 2017. There was only one reading taken in both April and September. The best water clarity was found in the south basin which averaged a Secchi depth of 6.7 feet from April to September. Conversely, the north basin had the poorest water clarity with the April-September Secchi depths averaging 4.7 feet. The central basin fell in the middle of these two averaging 5.2 feet. As with most lakes, each of these basin's average Secchi depth is slightly lower for the summer (June-August) averages though this pattern remained in place with the south basin averaging 6.6 feet, the central basin was 4.9 feet, and the north basin was the lowest at 4.5 feet for the summer. This is the same trend shown in 2016, but overall clarity was lower in 2017 than it was in 2016. This is especially true for the north basin which was almost a foot lower than the 5.3 feet summer average seen in 2016. The central basin was 0.5 feet lower in 2017 than in 2016, and the south basin was only 0.2 feet lower. It is possible that the heavy rainfalls seen in 2016 essentially flushed the system resulting in higher water clarity than was seen in 2017 which had significantly less rain than 2016.

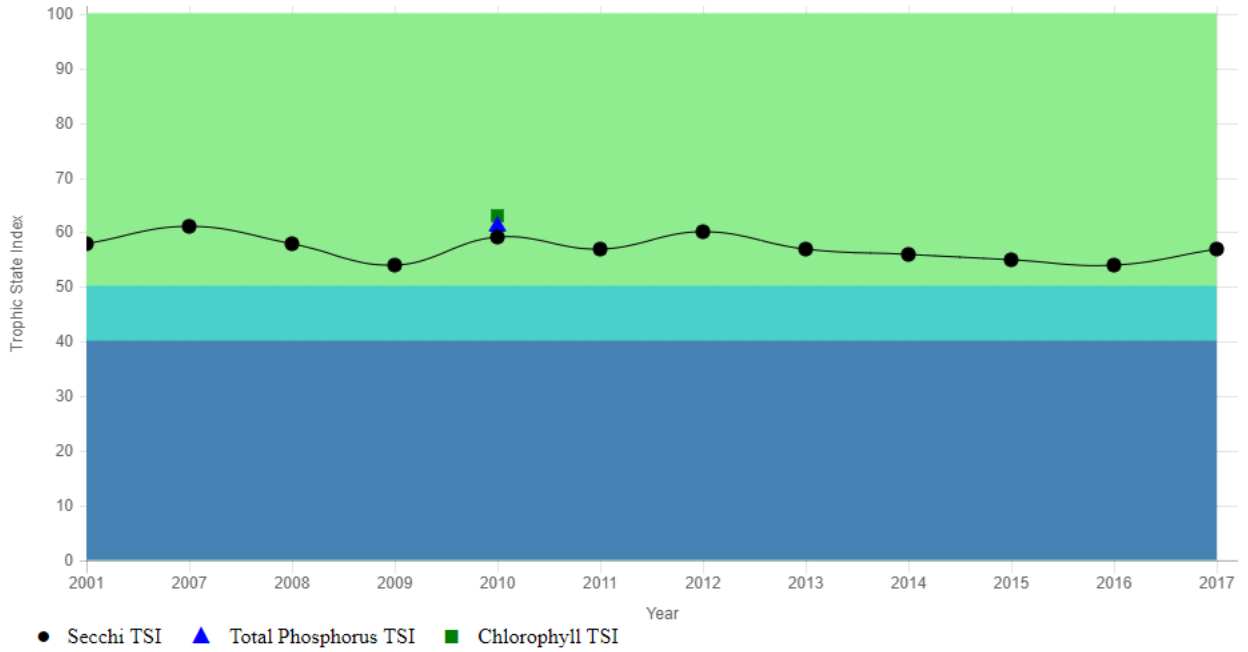
Figure 5: Average Yearly TSI- North Basin

While the overall water quality was lower than has been seen in recent years, it was not the worst year on record. Figures 6-8 show the average yearly TSI for Secchi depth, and total phosphorus, and chlorophyll (when this data was collected) since 2001. The TSI values for the central and south basins were derived from the chlorophyll data while the north basin TSI was derived from the Secchi readings. The north and south basins both had an average TSI of 57 in 2017 this was no change in the south basin and a slight increase in the north basin. The highest TSI value was found in the central basin which had an average of 60 for 2017. This was also the largest increase which was likely due to the decrease in rain which would have the strongest impact on the central basin due to the location of the outlet at the Red Cedar River.

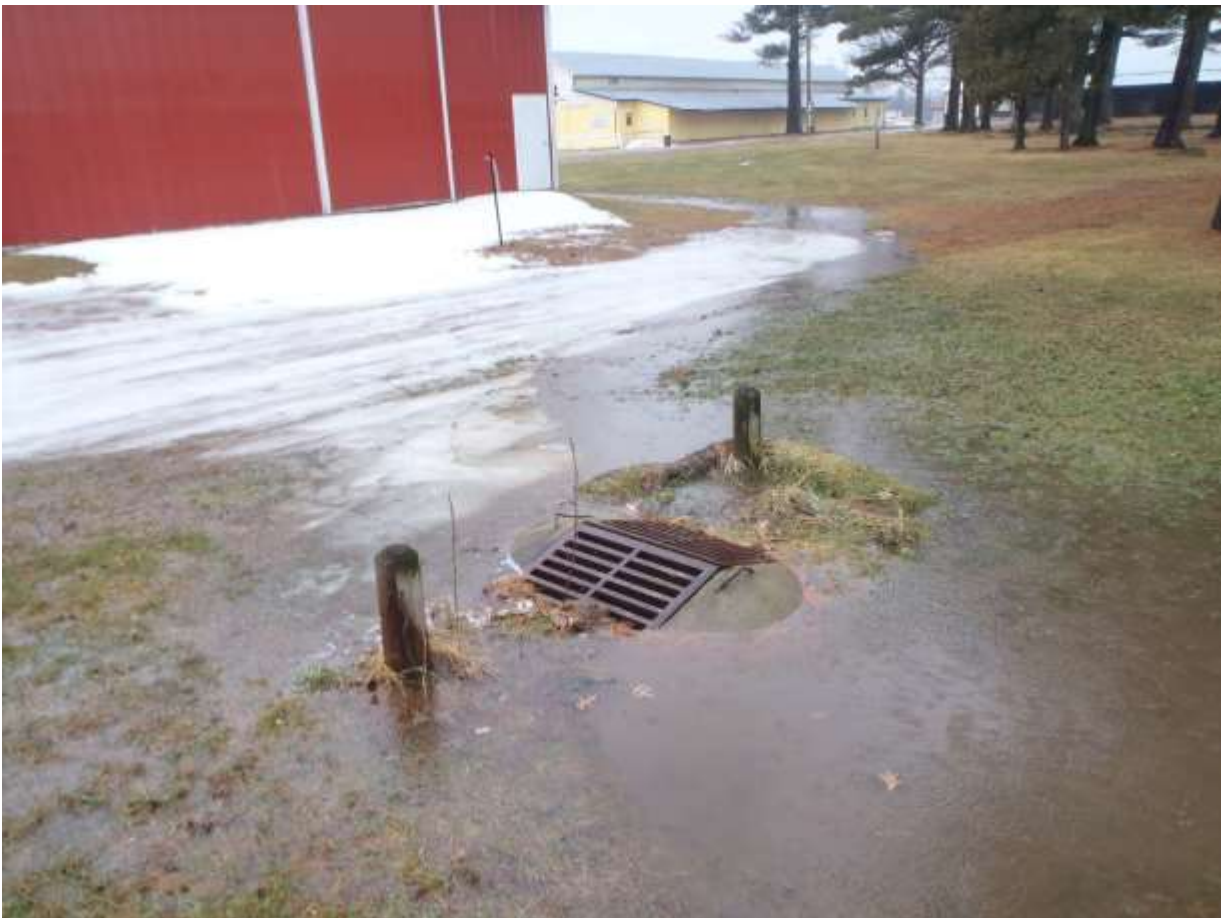
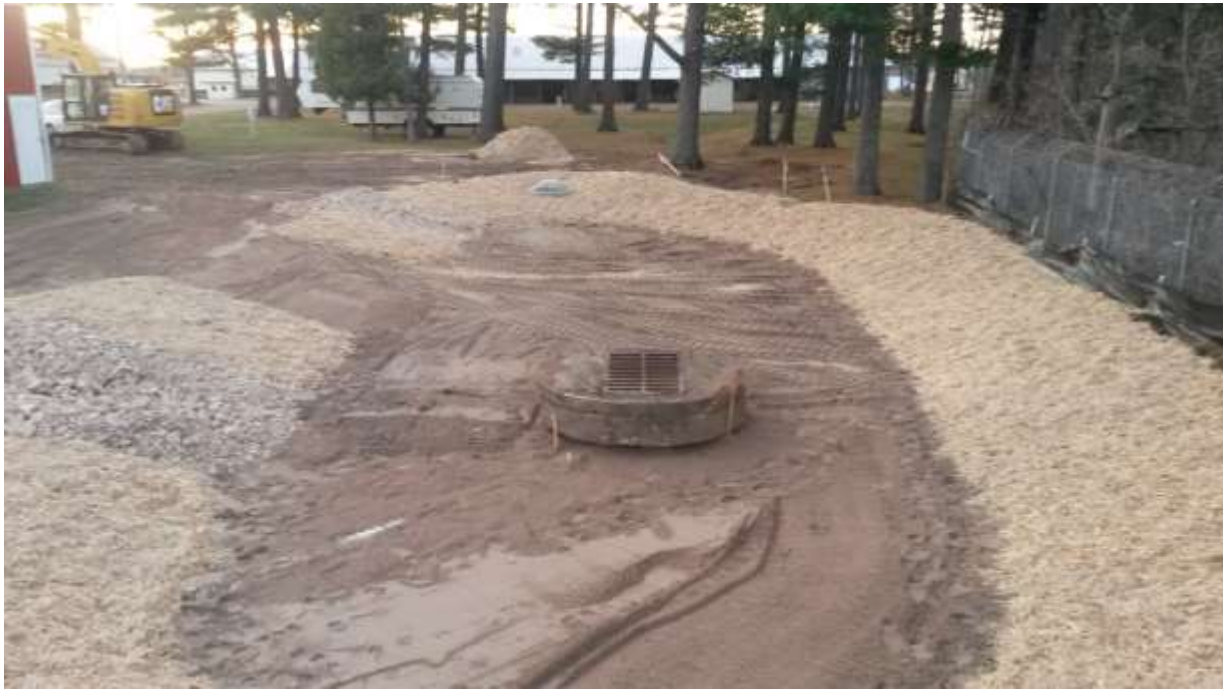
**Figure 9 - Barron County Fairgrounds Stormwater Retention Basin**

A lake management planning grant was submitted and awarded in early 2017 to develop a storm water management plan for the Barron County Fairgrounds. Initially it was expected that a large infiltration trench would be installed along the Poultry Barn, and Barron County had begun preliminary planning for its construction. After review by a Cedar Corp, and engineer retained by the Rice Lake Protection and Rehabilitation District and Barron County Soil and Water Conservation Department, a new plan for the installation of a large stormwater retention basin/rain garden behind the Poultry Barn was developed. This plan was approved by Barron County, the Lake District, and the Barron County Fair Board. Construction of this project was completed in November of 2017 (Figure 9). The Lake District will be adding rain garden plants to the site in 2018. Public education signs will also be installed in 2018.
