**Evaluation of *Myriophyllum spicatum* (EWM)  
Management Using Diver Assisted Suction  
Harvest (DASH)**

***Cedar Lake, Polk/St. Croix Counties, Wisconsin***

Sept. 2018

*Data collection and analysis provided by: Ecological Integrity Service, LLC-Amery, Wisconsin*

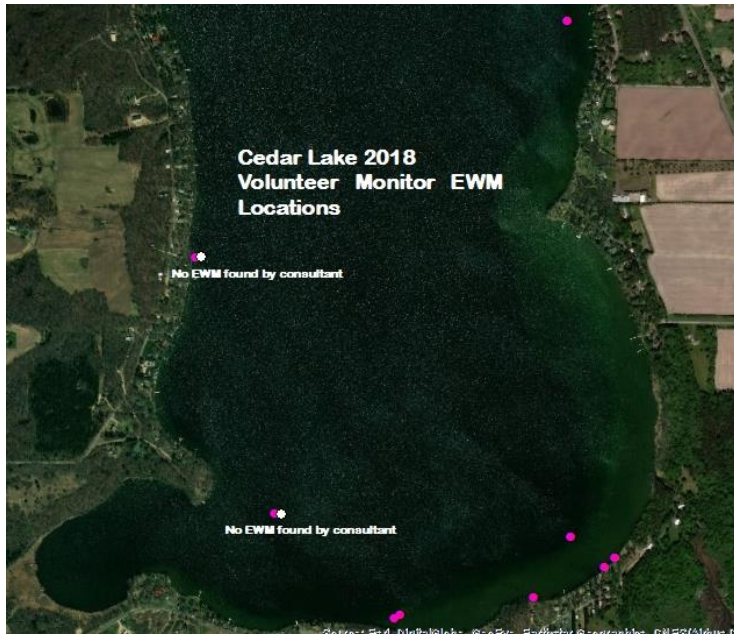
Figure 5: Volunteer monitoring EWM locations, July and August 2018.

Volunteer monitors assisted with finding EWM in other locations around Cedar Lake. Figure 5 shows the map of those locations (pink dots). The two locations on the western side have white dots adjacent to indicate that the professional surveyor could not locate the EWM at these locations, which indicate that it was likely only a plant or two and not a clump. These locations can be used to help make future management decisions and areas that need to be added to the professional monitoring.

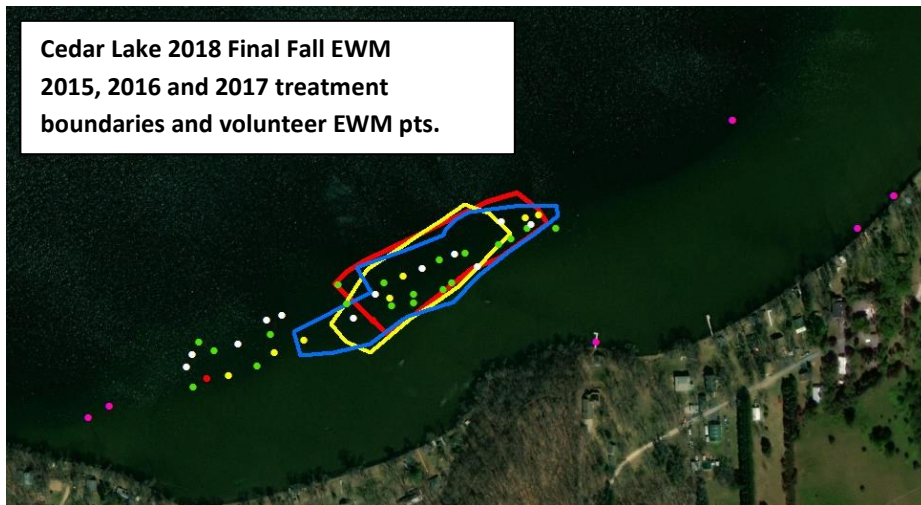
Figure 6: Fall 2018 EWM density in southern bed with previous herbicide application borders for reference.

Figure 6 shows the final density of EWM and the volunteer EWM sites along with previous treatment borders in the southern area of EWM (original discovery). This was used to evaluate future management recommendations. As this map shows, this area has spread to the west of the original treatment area.
