Lake Management Plan for VanVliet Lake, Vilas County, Wisconsin

June 2005
Updated April 2006

Prepared by Steve McComas, Blue Water Science
with contributions from Wisconsin Department of Natural Resources
and the VanVliet Lake Association

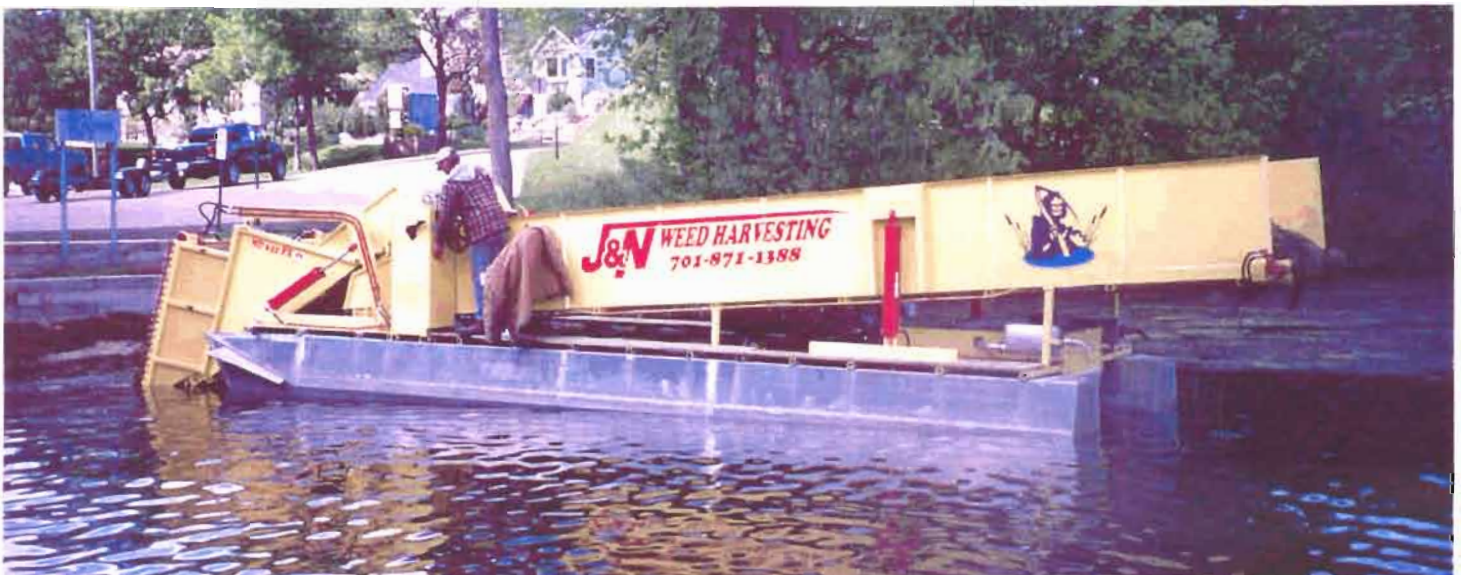
A mechanical harvester could be used to create cruising lanes through several areas of dense growth in VanVliet Lake.

If plant management is considered, a mechanical harvester is recommended because it will pick up the plant material. However, because of the soft sediment, there will be some sediment resuspension and a turbid condition will persist for a few days after harvesting is completed.

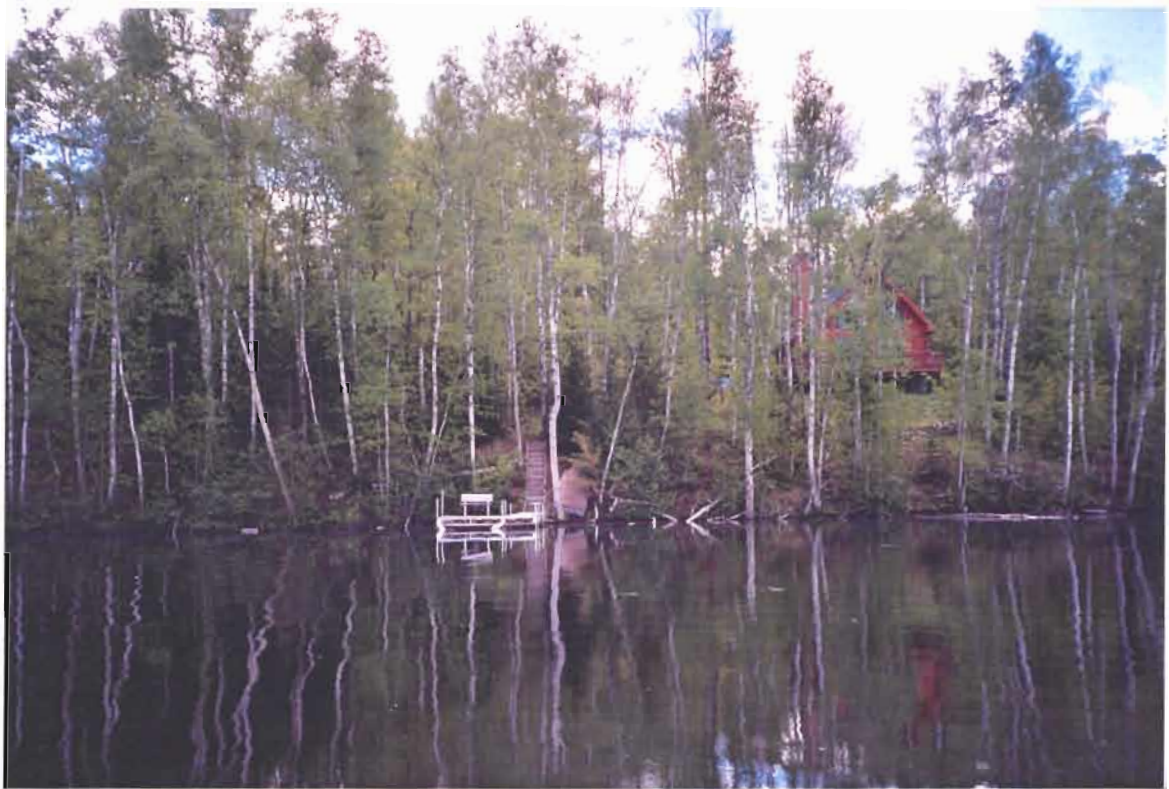
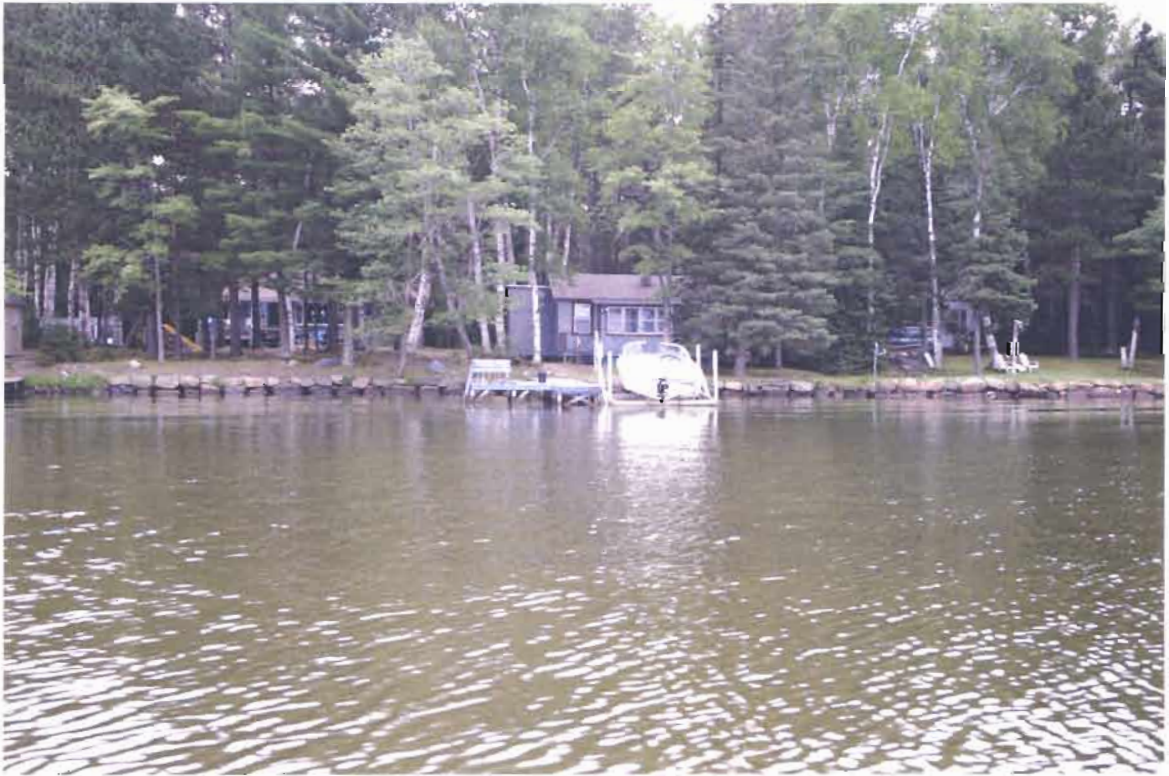
Figure 5. [top] This parcel would rate as having a shoreline with a buffer greater than 50% of the lot width and an understory with greater than 50% natural cover. [bottom] This is an example of a parcel from another lake that would not qualify as having a natural shoreline buffer greater than 50% of the lot width. Also understory in the upland area would be rated as having less than 50% natural cover.

For analysis, each photograph was evaluated by Blue Water Science staff for shoreline and upland conditions. Our criteria for natural conditions were the presence of 50% native vegetation in the understory and at least 50% natural vegetation along the shoreline in a strip at least 15 feet deep. Although the shoreline recommendations for new development is a 35-foot deep buffer, a 15-foot deep buffer is about the minimum needed to achieve some degree of runoff water quality treatment. We evaluated shorelines and uplands at the 75% natural level as well (Figure 5 illustrates the methodology).

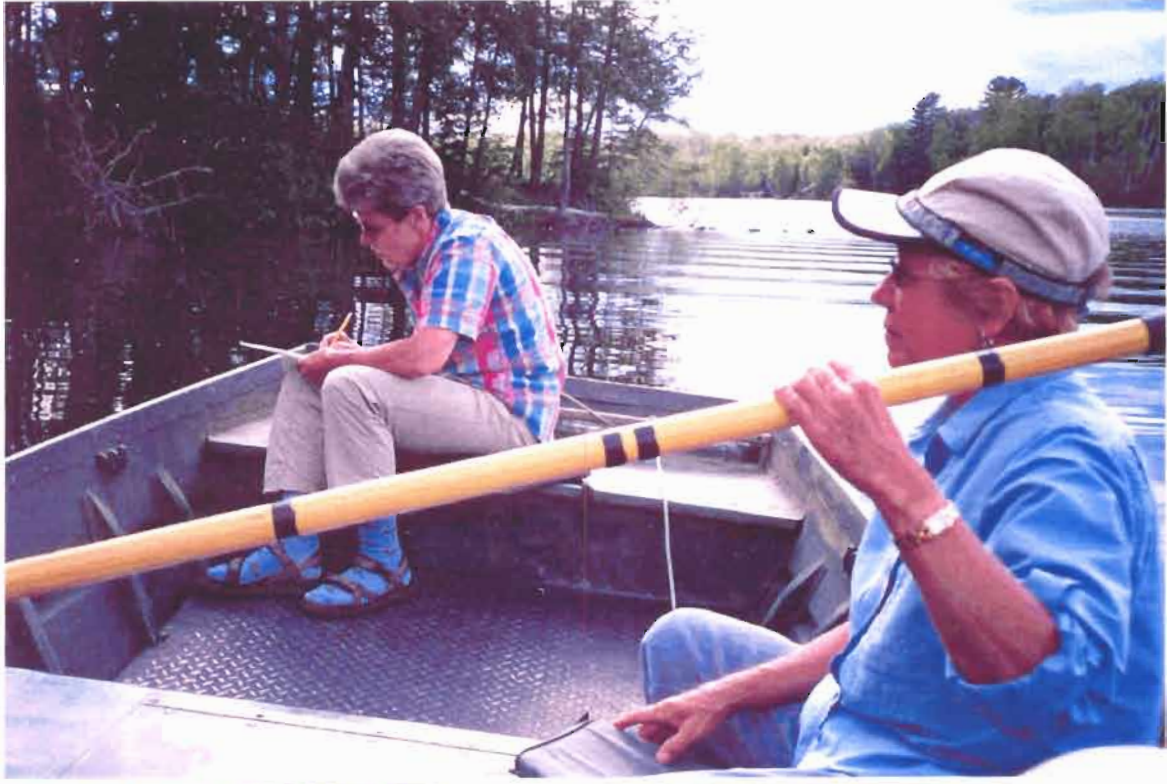
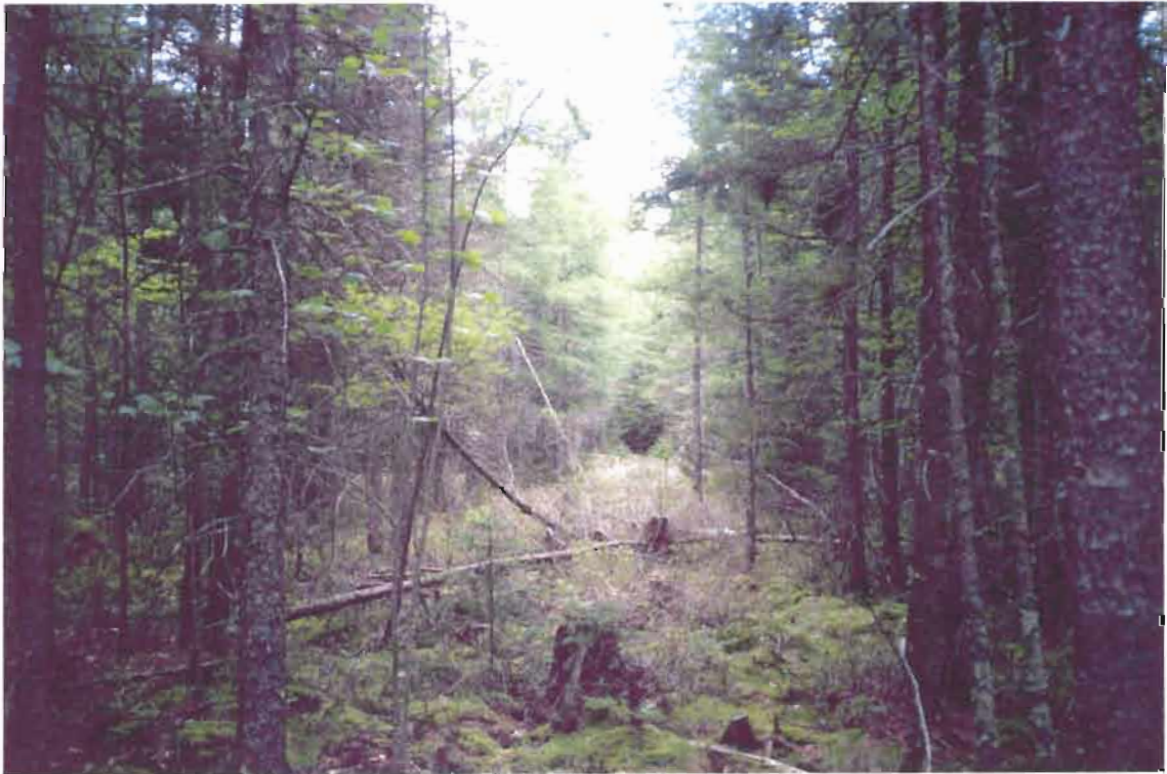
Figure 8. [top] VanVliet Lake Association volunteers assisted with collecting data for the conductivity survey. [bottom] Much of the water input to VanVliet Lake is from groundwater flow. Water infiltrates in areas like this, in the southern end of the lake, and travels to the lake through the peat and sand in the subsurface.

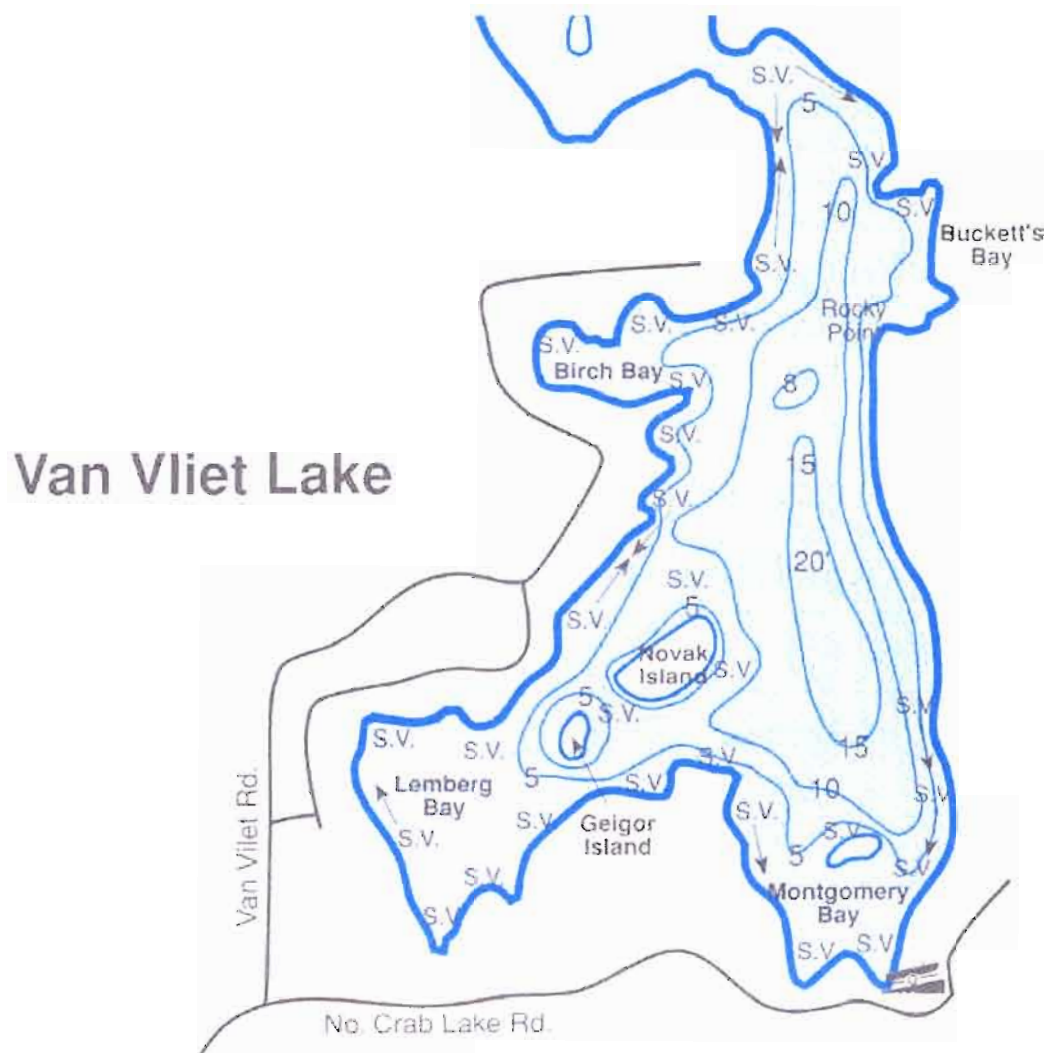
Figure 10. VanVliet Lake, Vilas County, Wisconsin.

VanVliet Lake is approximately 220 acres in size, with a watershed of 1,370 acres. The average depth of VanVliet Lake is 3 meters (9 feet) with a maximum depth of 6 meters (20 feet) (Table 7). A lake contour map is shown in Figure 10. VanVliet Lake is located in an area of Wisconsin that is dominated by forests.

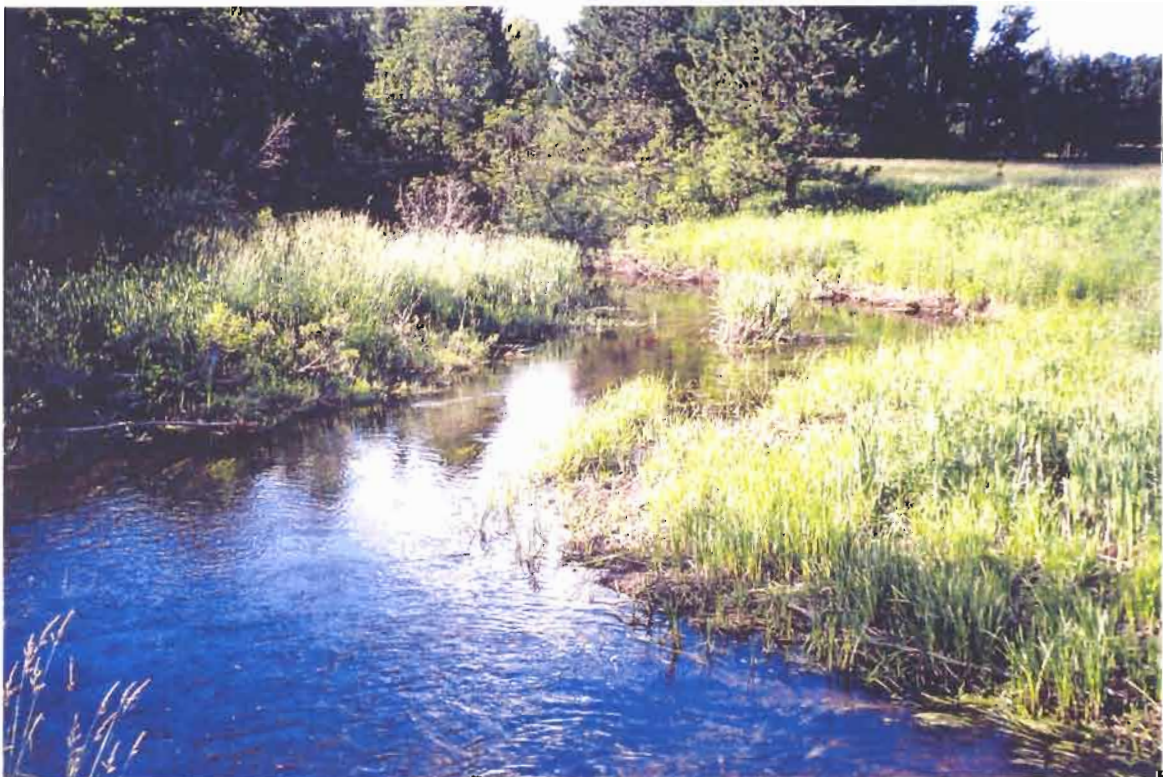
Figure 11. Presque Isle outlet area, July 2004. The water level of Presque Isle will influence the water level of VanVliet Lake.

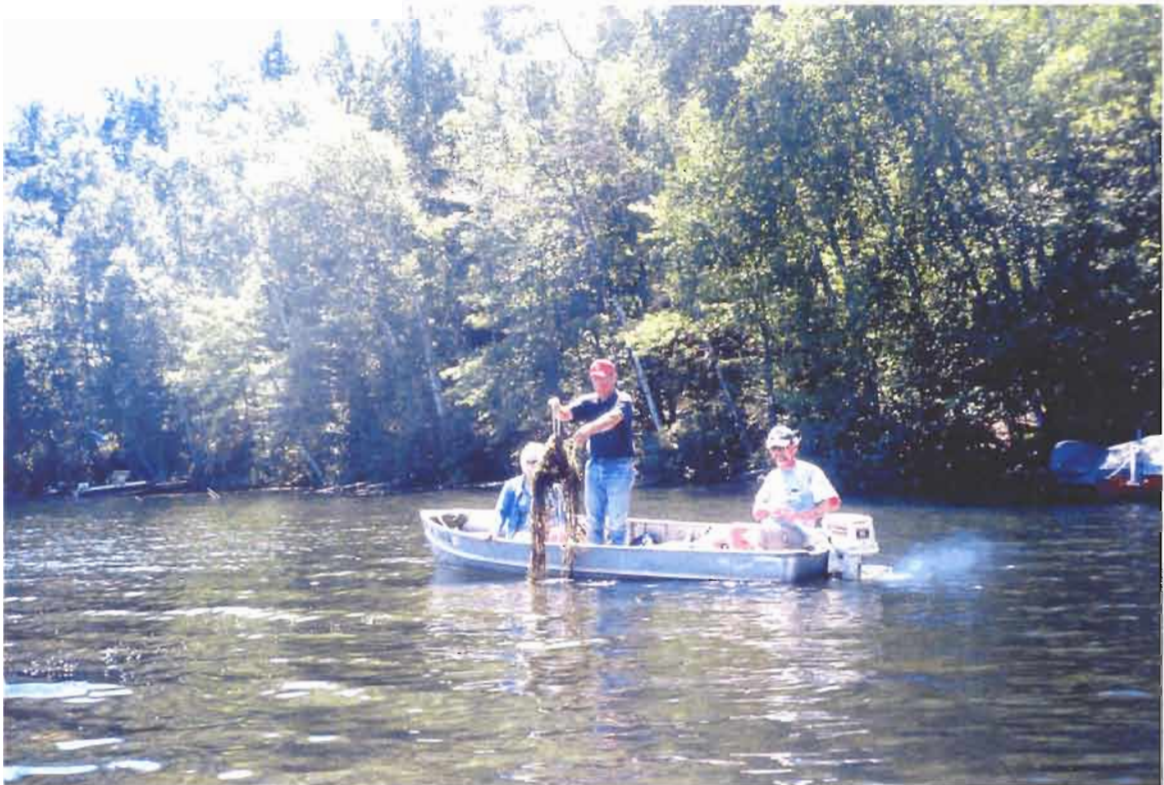
Figure 19. Fern pondweed is sampled at this location on VanVliet Lake.

Fern pondweed (*Potamogeton Robbinsii*) is found in water depths to 12 feet.

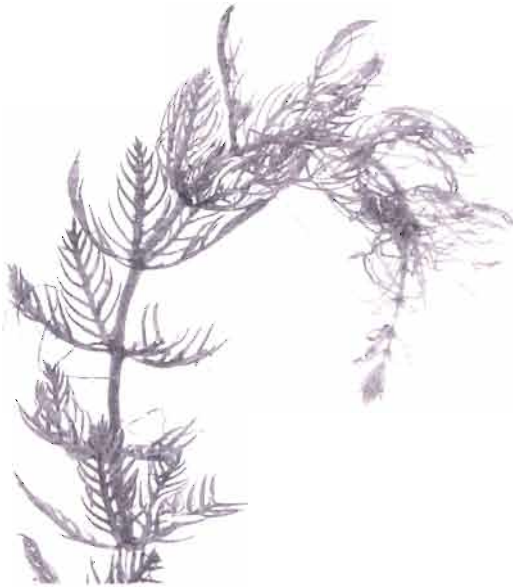
Northern watermilfoil (*Myriophyllum sibiricum*) is found in water depths to 10 feet.

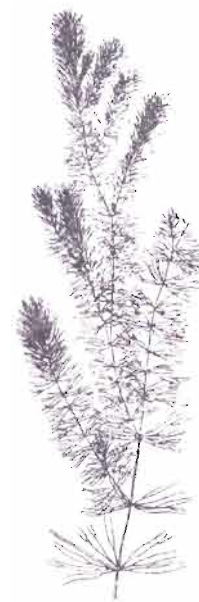
Coontail (*Ceratophyllum demersum*) is dominant in all water depths.

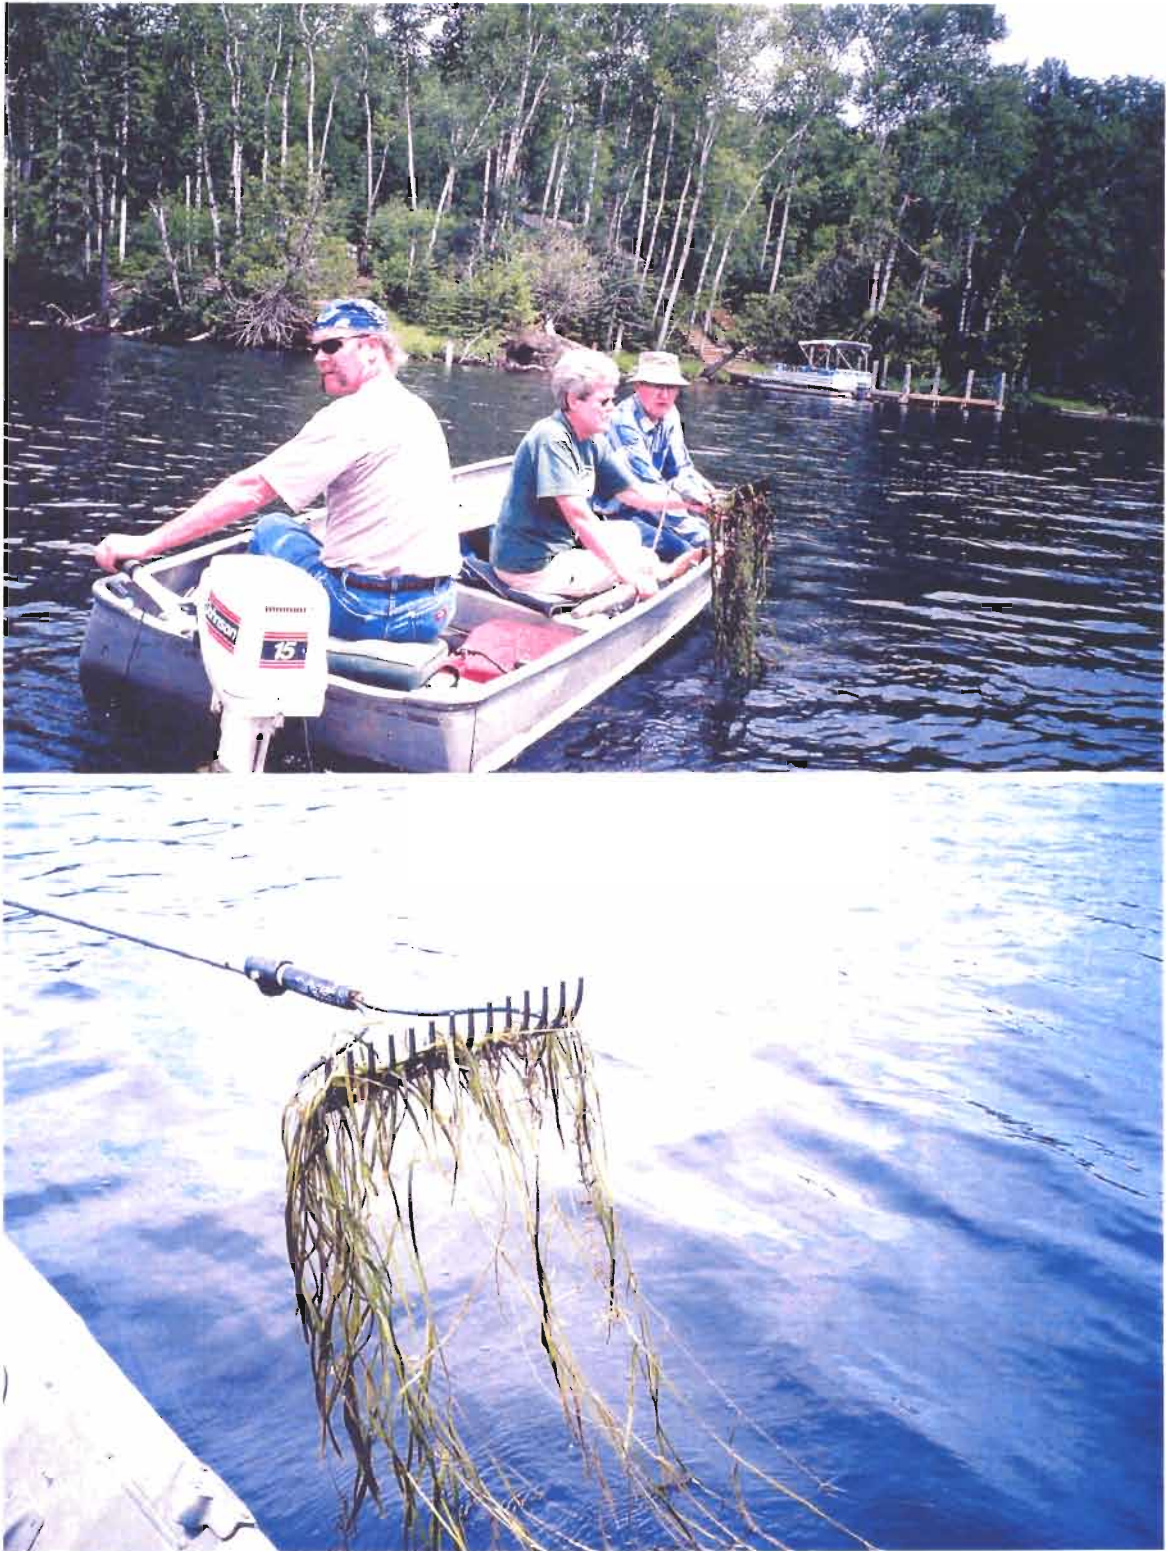
Figure 20. [top] VanVliet Lake residents, assisted with the aquatic plant survey. [bottom] Flatstem pondweed was a common aquatic plant found in the VanVliet Lake aquatic plant survey.

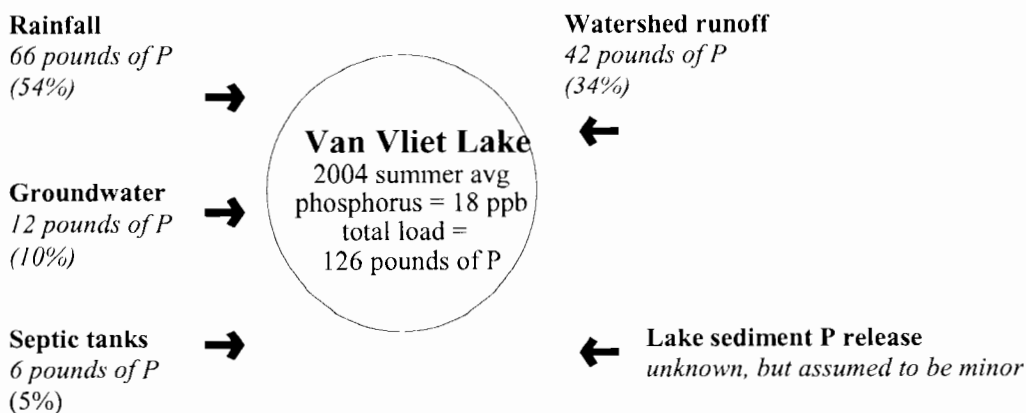
Figure 23. Sources of watershed phosphorus (P) that feed into VanVliet Lake are shown above. It is estimated that approximately 126 pounds of phosphorus enter VanVliet Lake on an annual basis.

The total estimated annual watershed phosphorus load to VanVliet Lake is estimated at 123 pounds.

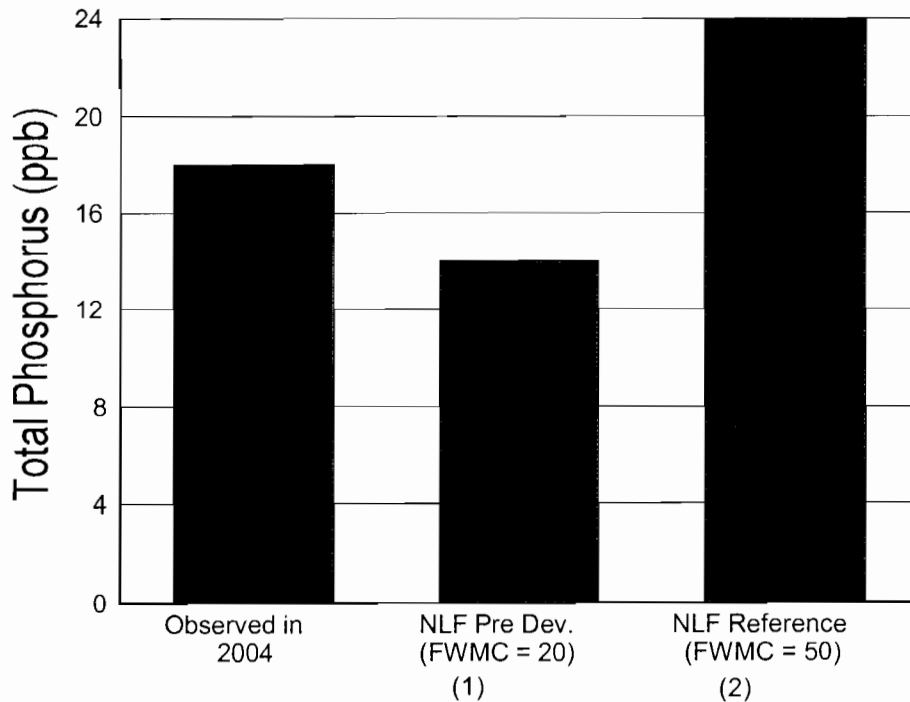
Figure 24. Comparison of total phosphorus conditions for VanVliet Lake in 2004 (red bars) to predicted conditions for a lake the size of VanVliet Lake situated in the Northern Lakes and Forest (NLF) ecoregion under two runoff conditions (blue bars)(FWMC = Flow weighted mean concentration in ppb)..

1. Phosphorus loading under ecoregion pre-development conditions (run-off phosphorus concentration at 20 ppb).
2. Phosphorus loading from relatively unimpacted lakes under current ecoregion conditions (runoff phosphorus concentration at 50 ppb).

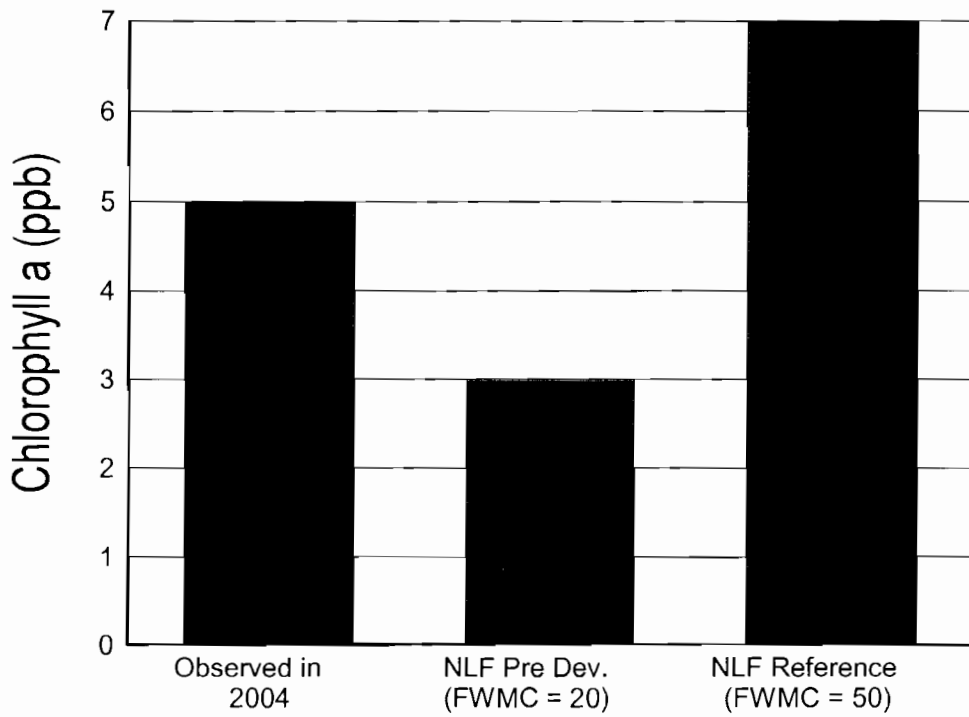
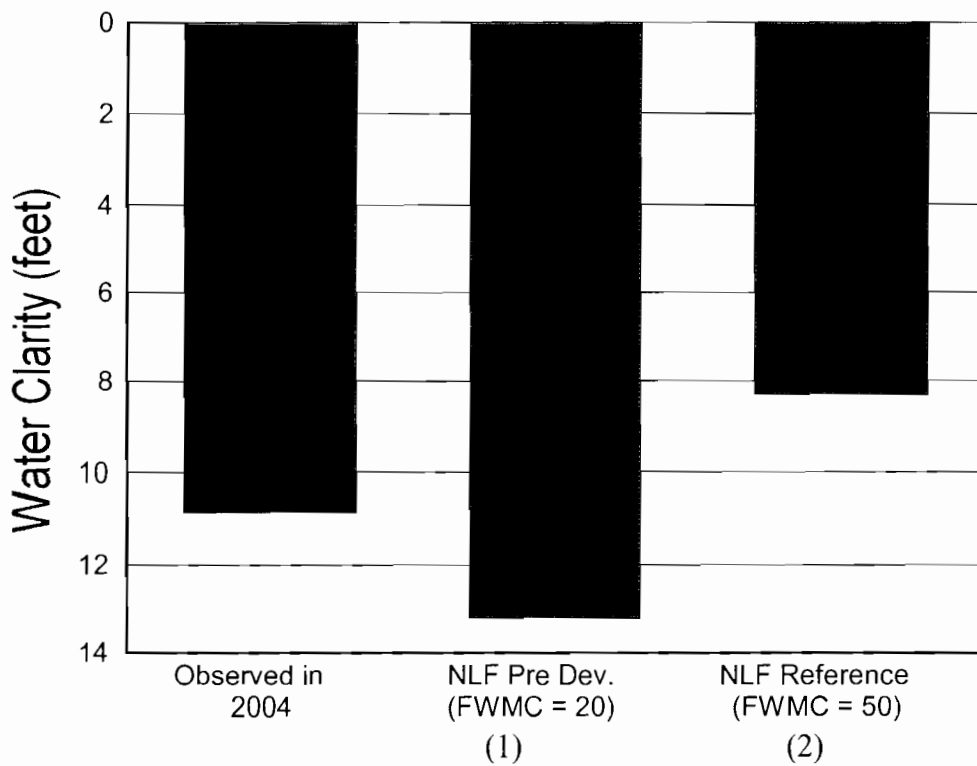
Figure 24. Comparison of chlorophyll *a* and water clarity conditions for VanVliet Lake in 2004 (red bars) to predicted conditions for a lake the size of VanVliet Lake situated in the Northern Lakes and Forest (NLF) ecoregion under two runoff conditions (blue bars).

Lake Goals: Based on lake modeling considerations it appears VanVliet Lake has water quality conditions that would be expected for a lake in this watershed setting.

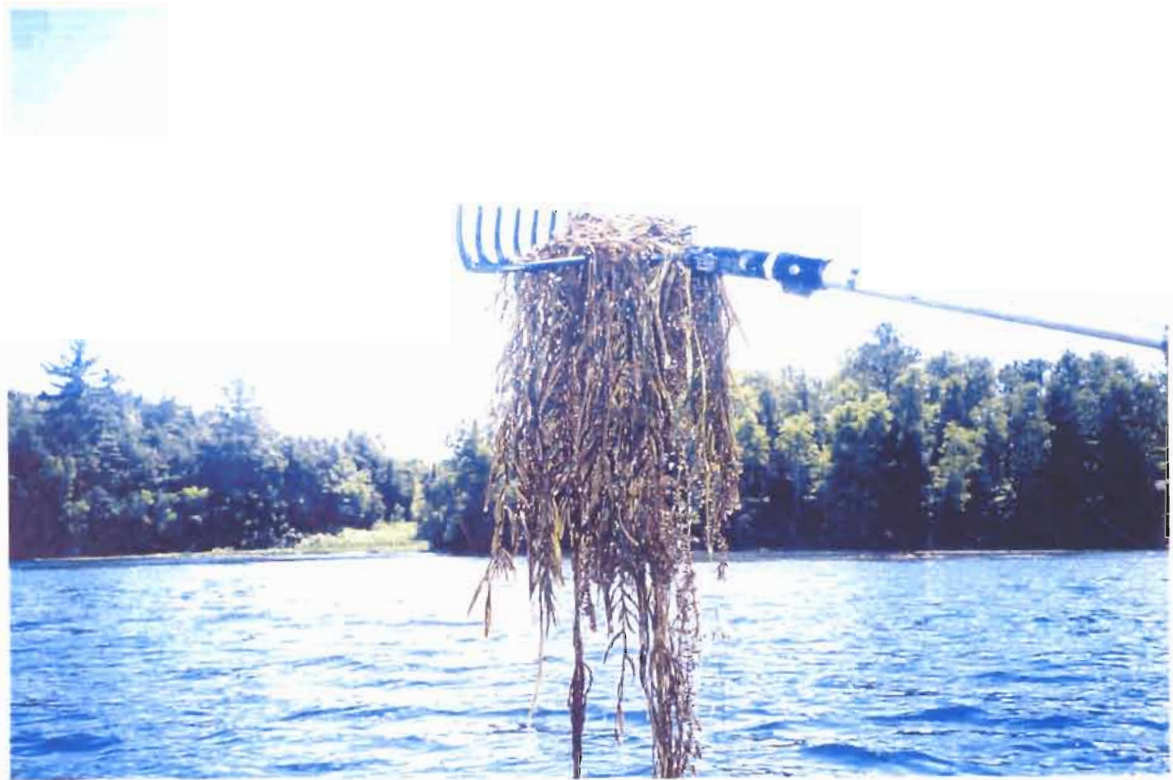
Figure 29. Fern pondweed is a weakly rooted plant and is the dominant plant in the soft mucky sediment in the southwest bay.

In the southwest bay, fern pondweed is found either floating at the surface or weakly anchored in the soft sediment and extending into the water column. Because the bay is only 2 to 3 feet deep, it does not take much plant material to produce nuisance conditions.

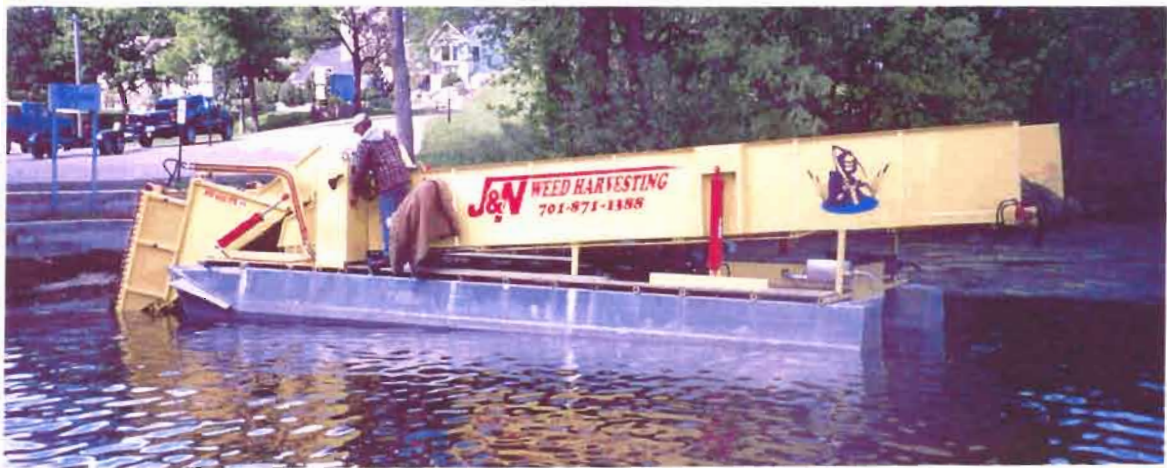
Figure 30. A mechanical harvester is recommended for picking up fern pondweed in the shallow southwest bay if plant management is considered.

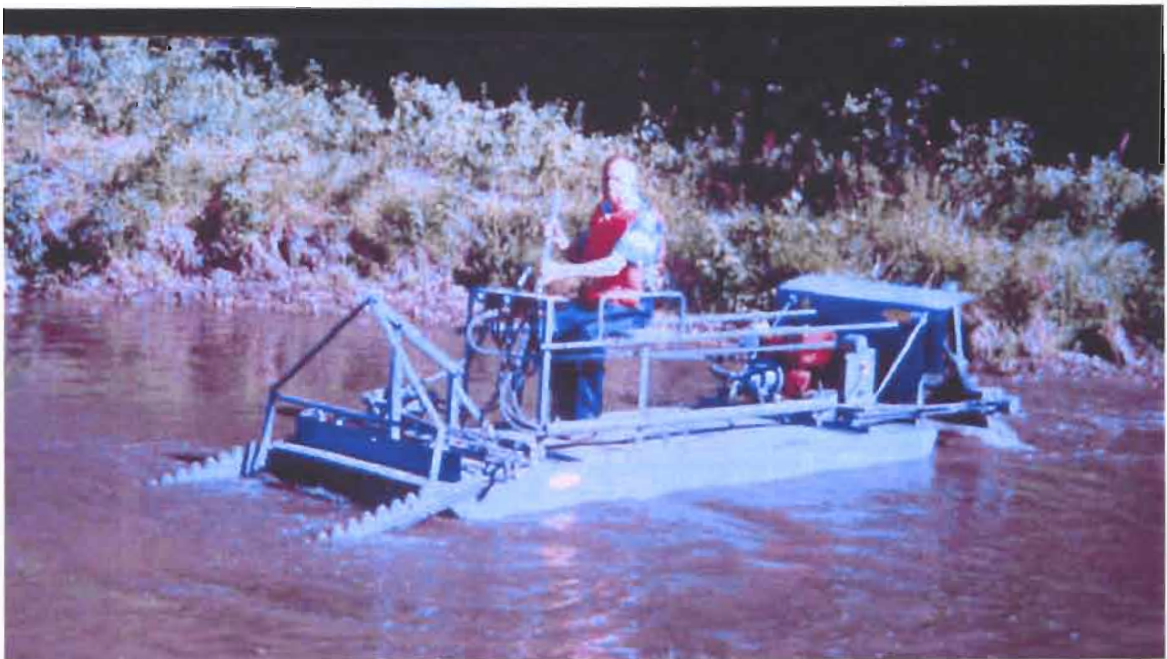
Figure 31. Hockney-type weed cutter or a mechanical harvester could be used to cut one or two channels through the cabbage on the west side of VanVliet Lake.

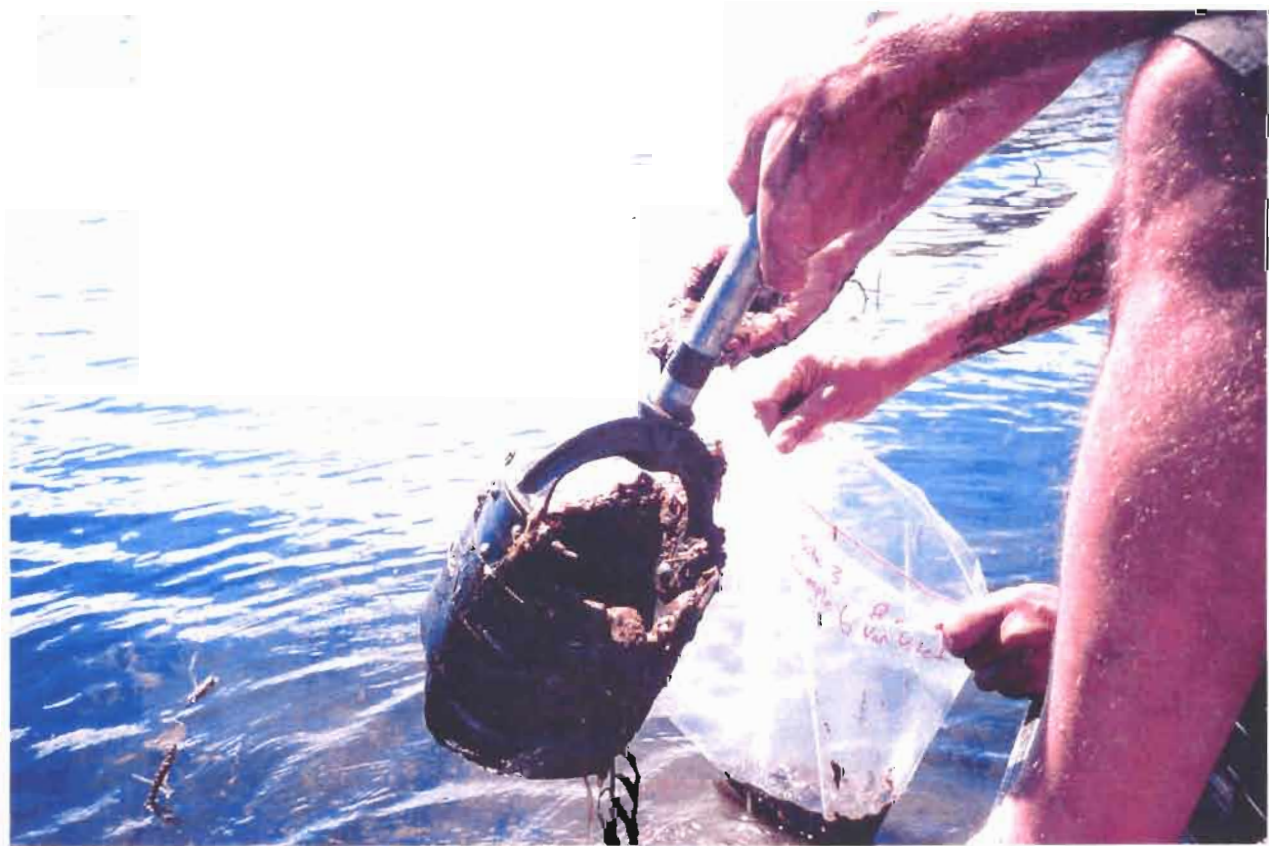
Lake Sediment Sample Objectives: Sampling results from over 50 lakes indicate lake sediment characteristics help delineate areas of potential nuisance versus non-nuisance growth for two invasive aquatic plant species, curlyleaf pondweed (*Potamogeton crispus*) and Eurasian watermilfoil (*Myriophyllum spicatum*) (where nuisance growth is defined as plants matting at the surface)(McComas, unpublished). Lake sediments were collected using a zone sampling program and standard agricultural soil test methods were used for lake sediment analysis. For curlyleaf pondweed, the primary parameter correlated with nuisance growth conditions was a sediment pH above 7.7. Other important parameters included a bulk density less than 0.50 g/cm³-dry, organic matter greater than 30% and a Fe:Mn ratio of less than 1.6. Nuisance growth of Eurasian watermilfoil was influenced by different conditions. The two most significant sediment parameters were nitrogen, as exchangeable ammonia greater than 10 µg/cm³-dry, and organic matter, less than 20%.

Knowing the delineation of potential nuisance and non-nuisance plant growth using lake sediment sampling assists managers in formulating aquatic plant management actions. For example, where sediment results indicate non-nuisance growth conditions would be expected, those areas can be left alone because the non-native plants present no ecological or recreational problem.

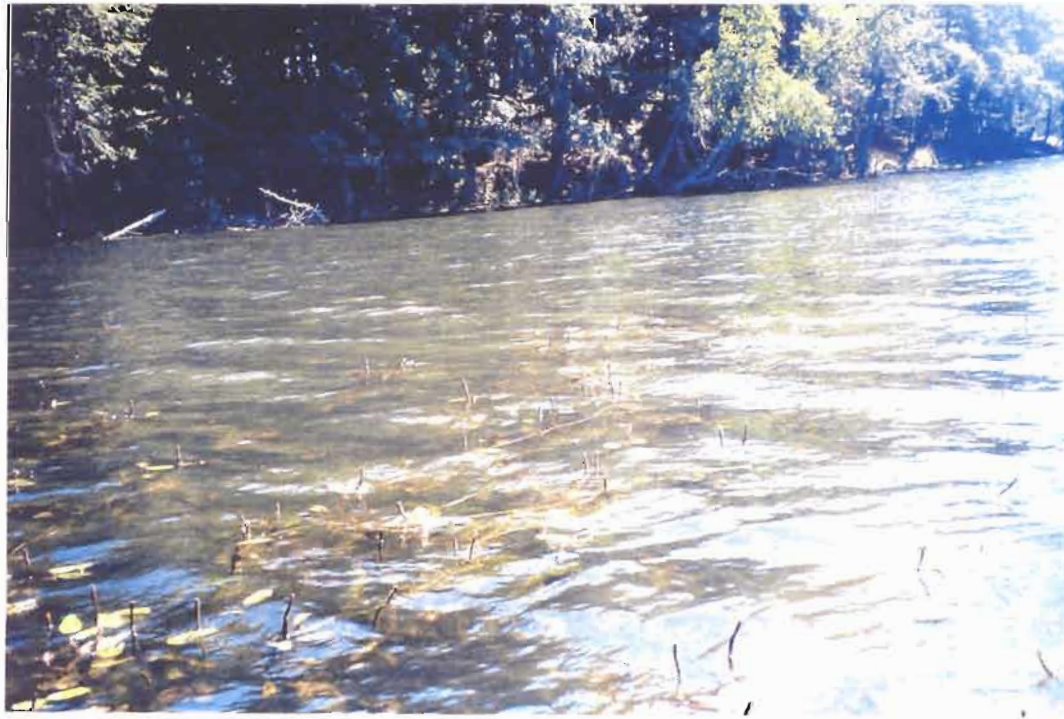
Sediment results indicate there is only a moderate potential for the exotic plant, curlyleaf pondweed, to grow to nuisance conditions at three locations sampled in VanVliet Lake. Currently, curlyleaf pondweed is not found in VanVliet Lake.
