# Finger Lake Stewardship Program

## Aquatic Plant Management Plan – Finger Lake

**Date: May 2019**

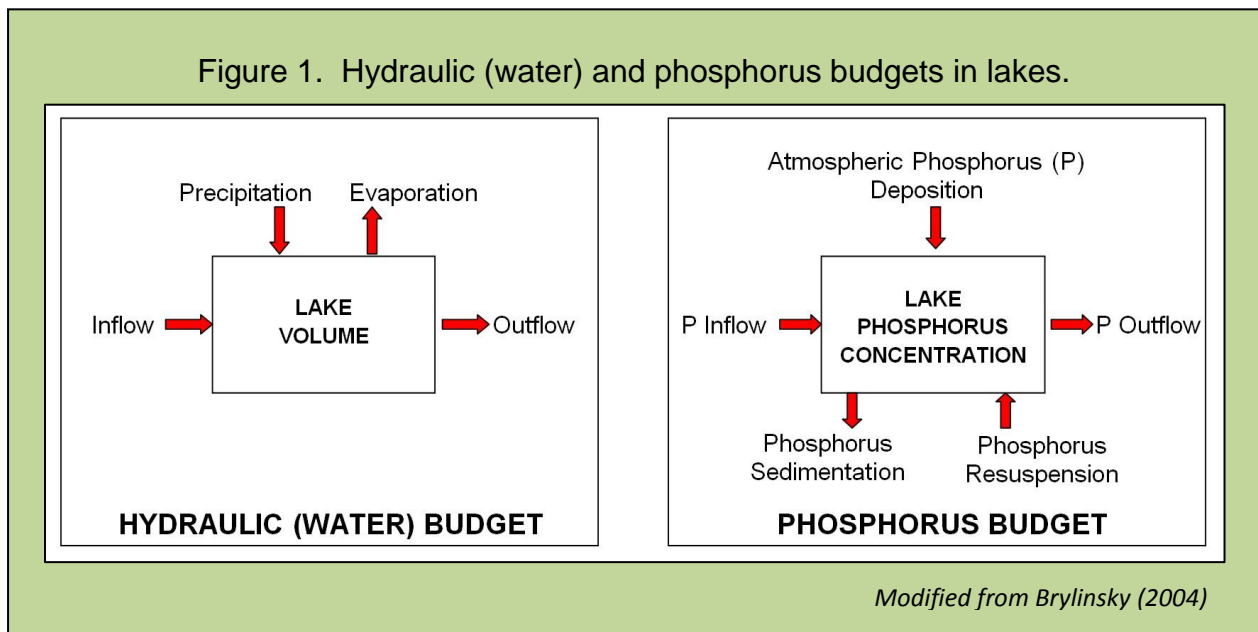
The water (hydraulic) budget of a lake is closely associated with the phosphorus budget (both illustrated in Figure 1). The graphics show in general terms the overall movement of water and phosphorus into and out of a lake ecosystem.
