**Blackhawk Lake, Iowa County, Wisconsin  
Aquatic Invasive Species Education, Prevention, and Planning  
Report and Aquatic Plant Management Plan  
2014 - 2018**

**Final Report  
for Wisconsin Department of Natural Resources  
AIS Education, Prevention, and Planning Grant AEPP-410-14**

Cobb-Highland Recreation Commission  
Blackhawk Lake Recreation Area  
and  
DFS Conservation Consulting

January 2019

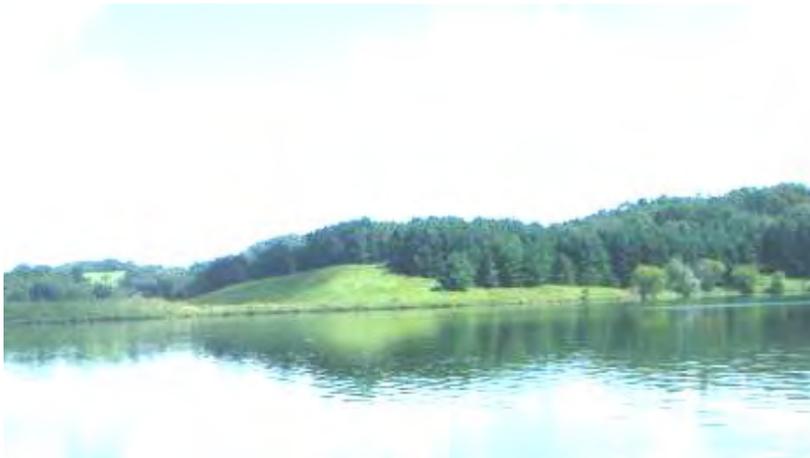
**Fig. 2. Blackhawk L, areas of pioneer EWM infestation, 2006.**

NNE side of lake, right side of photo (to right of left dam)

Three small colonies of the non-native, invasive Eurasian watermilfoil (*Myriophyllum spicatum* or EWM) were observed in Blackhawk Lake during the June 2006 APS. Two of the colonies were on the NNE side near the sand ridge near the left dam and the other was near the SSW pontoon mooring bay (Fig. 2 -4).

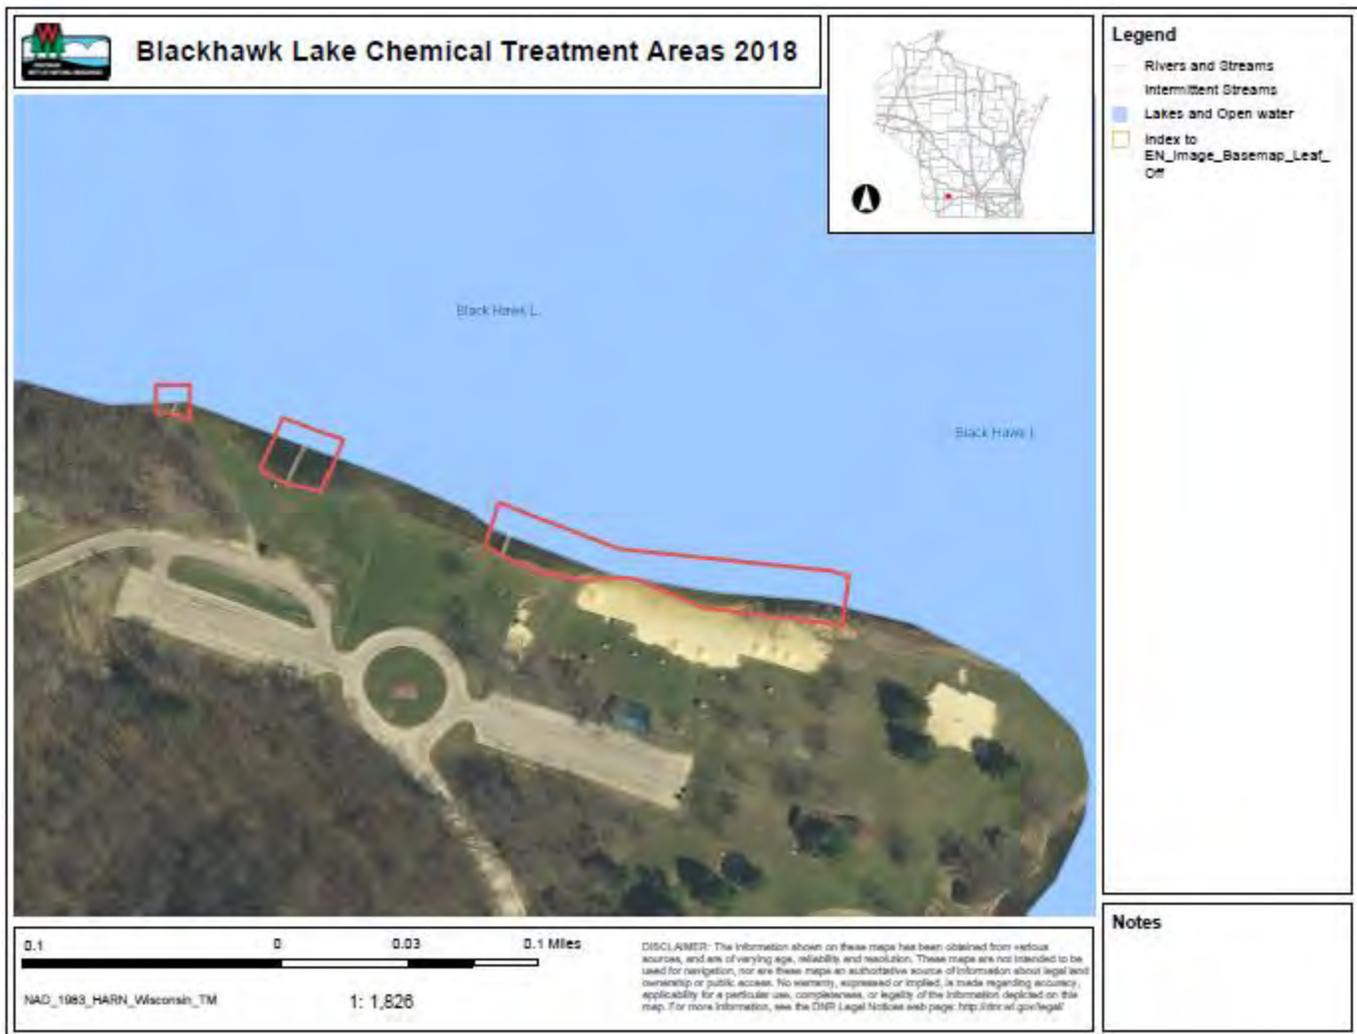
**Fig. 17. Recommended Areas of Herbicide Treatment for Blackhawk Lake.**

- Herbicide treatments should be done by the third week in May in most years, before the plants are at nuisance levels and to allow time for the treatment to be effective before the Memorial Day weekend.

- Blackhawk Lake Recreation Area should apply to DNR for a Chemical Aquatic Plant Control permit early in the year so the areas identified as having nuisance vegetation that will impair navigation, fishing, and swimming can be treated before the plants become a nuisance in later May. The permit application should include provision for two treatments between mid-May and mid-June if needed. If cattails impair use of the southern end of the beach, they should also be treated.

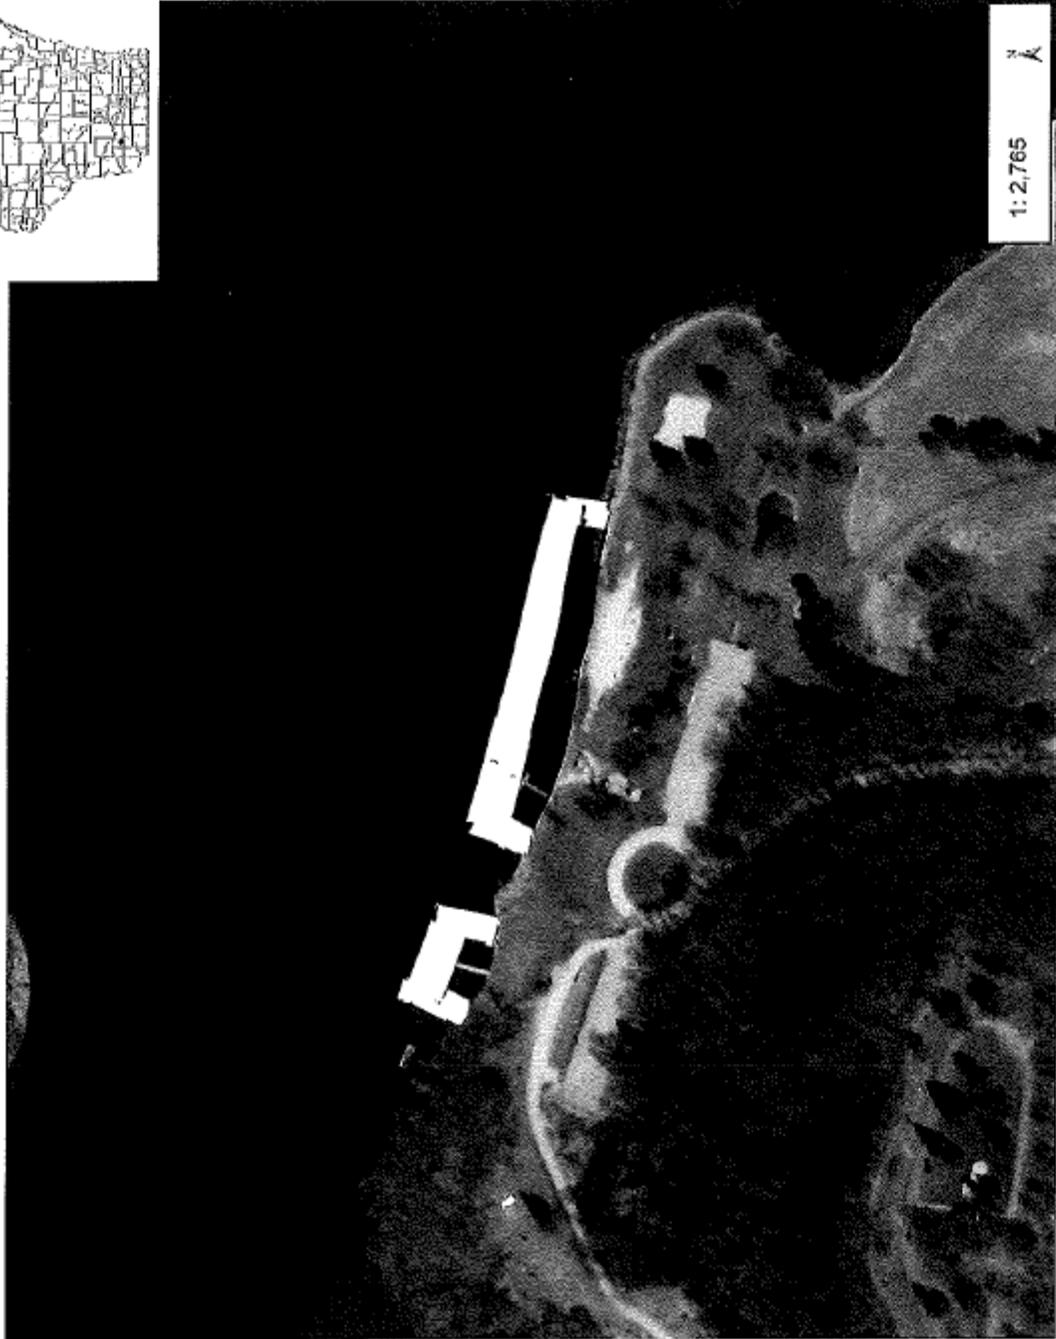
Treatment area is inside the white lines  
.58 acres at beach  
.08 acres at boat pier  
.66 acres total

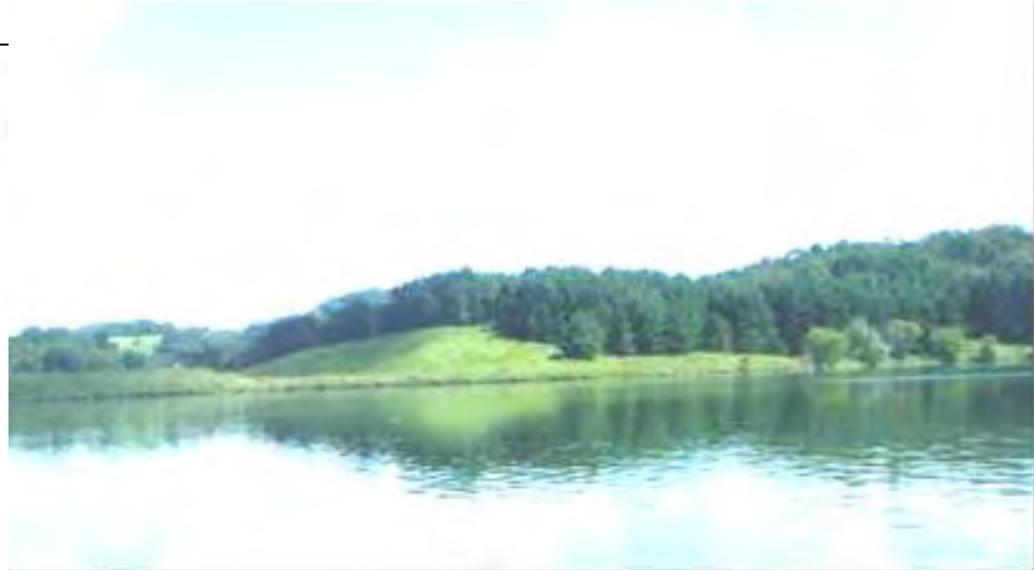
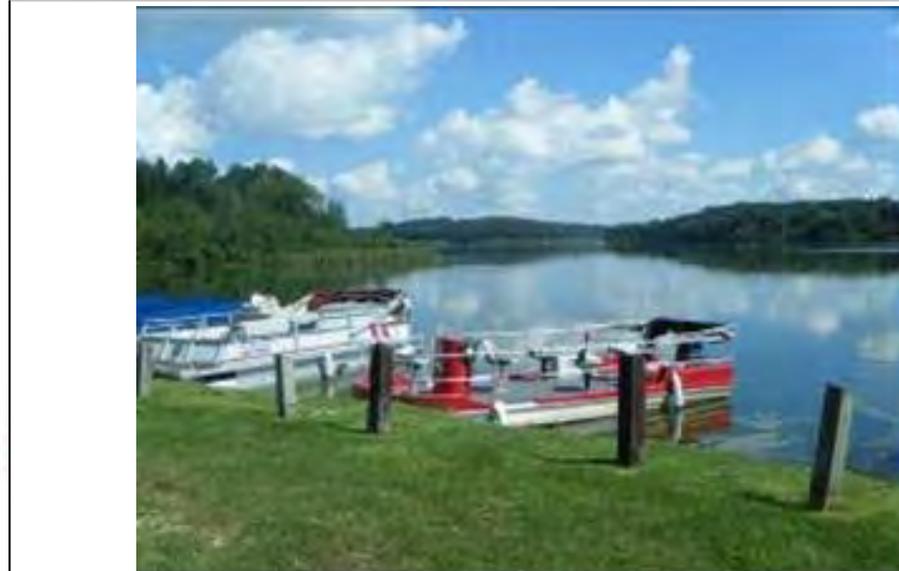
# Blackhawk L 2006 APS found EWM

Eurasian watermilfoil visual discovery  
(near Pontoon Bay) (near Left Dam)
