Curly-leaf pondweed (*Potamogeton crispus*) Fall Turion Survey Long Lake – WBIC: 2478200 Polk County, Wisconsin

Endangered Resource Services, LLC
Matthew S. Berg, Research Biologist
St. Croix Falls, Wisconsin
October 27-28, 2018

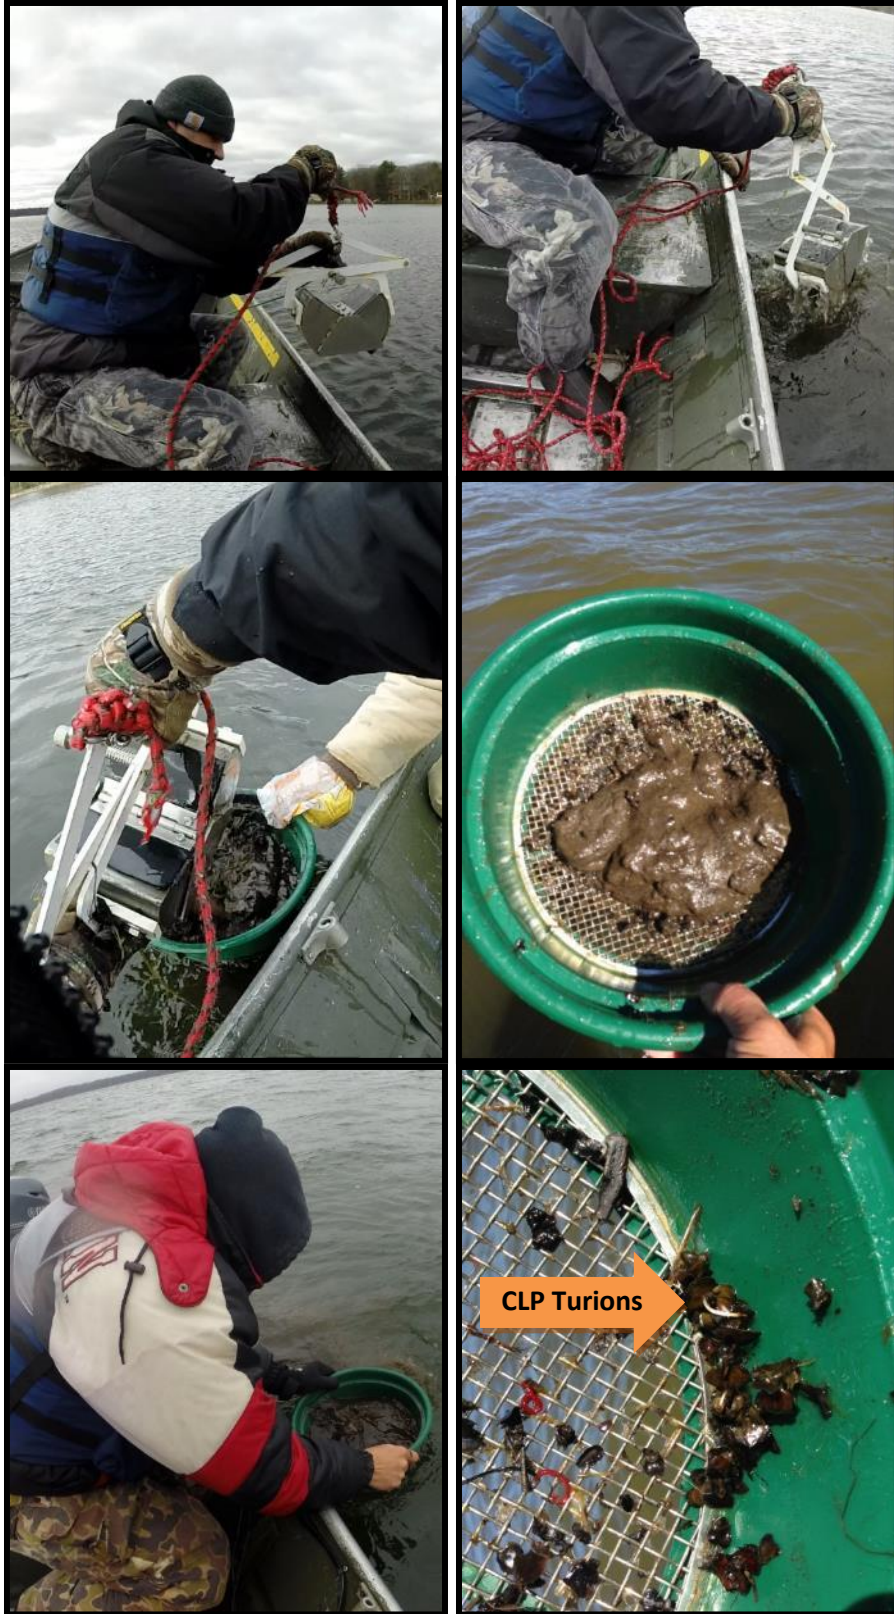
Figure 6: Ponar Grab and Turion Sieving

During the surveys, we located each point with a handheld mapping GPS unit (Garmin 76CSx) and used a Petite Ponar dredge with a 0.0232m^2 (36in^2) sample area to take a bottom sediment grab from each side of the boat at each location. These samples were then rinsed in a fine sieve to separate out the sediment (Figure 6). Samples with high numbers of turions or significant amounts of detritus were bagged for later analysis; at which time we discarded all rotten turions, tallied all live turions, and multiplied the combined total live turions from the two samples by 21.53 to estimate turions/ m^2 at each location. This value gives an idea of how many CLP plants will germinate in an area during the 2019 growing season.
