Eurasian water-milfoil (*Myriophyllum spicatum*) and Curly-leaf pondweed (*Potamogeton crispus*) Pre/Posttreatment Surveys Lower Vermillion Lake – WBIC: 2098200 Barron County, Wisconsin

Vermillion Lakes Association, Wisconsin Department of Natural Resources
and Lake Education and Planning Services, LLC (WDNR Grant ACEI20518)

Endangered Resource Services, LLC
Matthew S. Berg, Research Biologist
St. Croix Falls, Wisconsin
June 4 and June 23, 2018

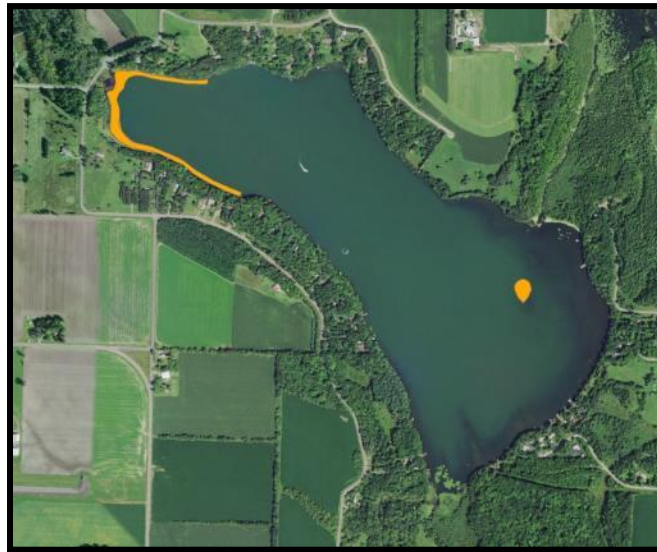
Figure 1: Aerial of 2018 EWM/CLP Treatment Areas

Lower Vermillion Lake (WBIC 2098200) is a 215 acres stratified drainage lake in northwestern Barron County, Wisconsin in the Town of Cumberland (T35N R13W S22 SW NE). It reaches a maximum depth of 55 feet in the central basin and has an average depth of approximately 25ft (Busch et al 1967). The lake is mesotrophic in nature, and, from 2000-2018, water clarity has been fair to good with summer Secchi readings ranging from 6-12ft and averaging 9.0ft (WDNR 2018). This clarity produced a littoral zone that reached approximately 11ft in 2018. Bottom substrates along the north, south, and southeastern shorelines are primarily rock and sand, while most of the east bay and main basin are organic muck or sandy muck.

In 2008, the Wisconsin Department of Natural Resources (WDNR) confirmed the presence of Eurasian Water-milfoil (EWM) (*Myriophyllum spicatum*) in Lower Vermillion Lake, and the Vermillion Lakes Association (VLA) has been actively working to control this invasive exotic species ever since. Following the 2017 fall EWM bed mapping survey that found scattered patches of EWM throughout the northwest bay near the boat landing and a small but dense canopied bed in the east bay, the VLA, under the direction of D. Blumer - Lake Education and Planning Services, LLC (LEAPS) and in accordance with their WDNR approved Aquatic Plant Management Plan, decided to chemically treat two areas totaling 4.54 acres (2.11% of the lake's total surface area) in 2018. The majority of these areas were simultaneously treated for Curly-leaf pondweed (*Potamogeton crispus*) – another exotic invasive species that is locally abundant early in the growing season (Figure 1).

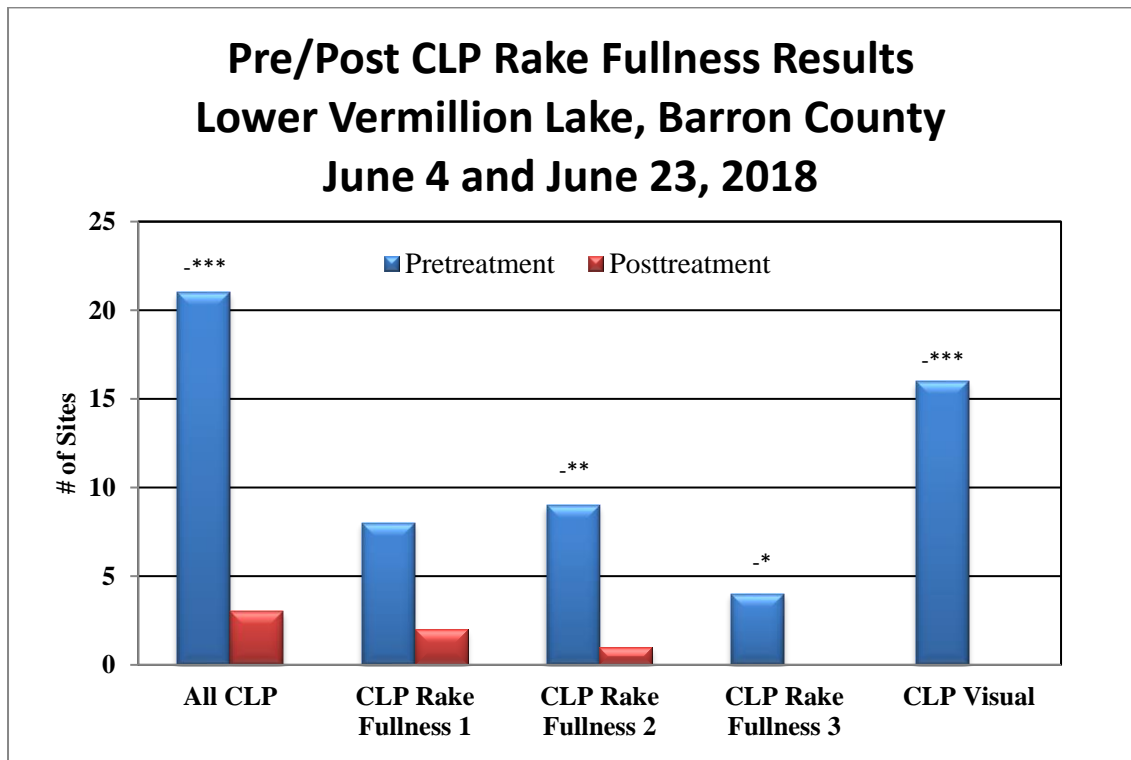
Figure 11: Pre/Posttreatment Changes in CLP Rake Fullness

Curly-leaf pondweed was present at 21 of 80 sites during the pretreatment survey (26.3% coverage) with 16 additional visual sightings (Figure 10). Of these, four had a rake fullness rating of 3, nine rated a 2, and the remaining eight were a 1. This produced a mean rake fullness of 1.81 and suggested that 16.3% of the treatment areas had a significant infestation (rake fullness 2 or 3). During the posttreatment survey, we found CLP at just three points (3.8% coverage) with one point rating a 2 and the other two rating a 1 (mean rake fullness of 1.33) (Appendix V). **Our results demonstrated a highly significant decline in total CLP distribution and visual sightings; a moderately significant reduction in rake fullness 2; and a significant decline in rake fullness 3** (Figure 11).

Significant differences = * $p < .05$, ** $p < .01$, *** $p < .001$
