RED CEDAR LAKES BARRON COUNTY

2018 AIS EDUCATION, PREVENTION, AND PLANNING PROJECT IMPLEMENTATION SUMMARY REPORT

Prepared by: Dave Blumer, Lake Educator

February 6, 2019

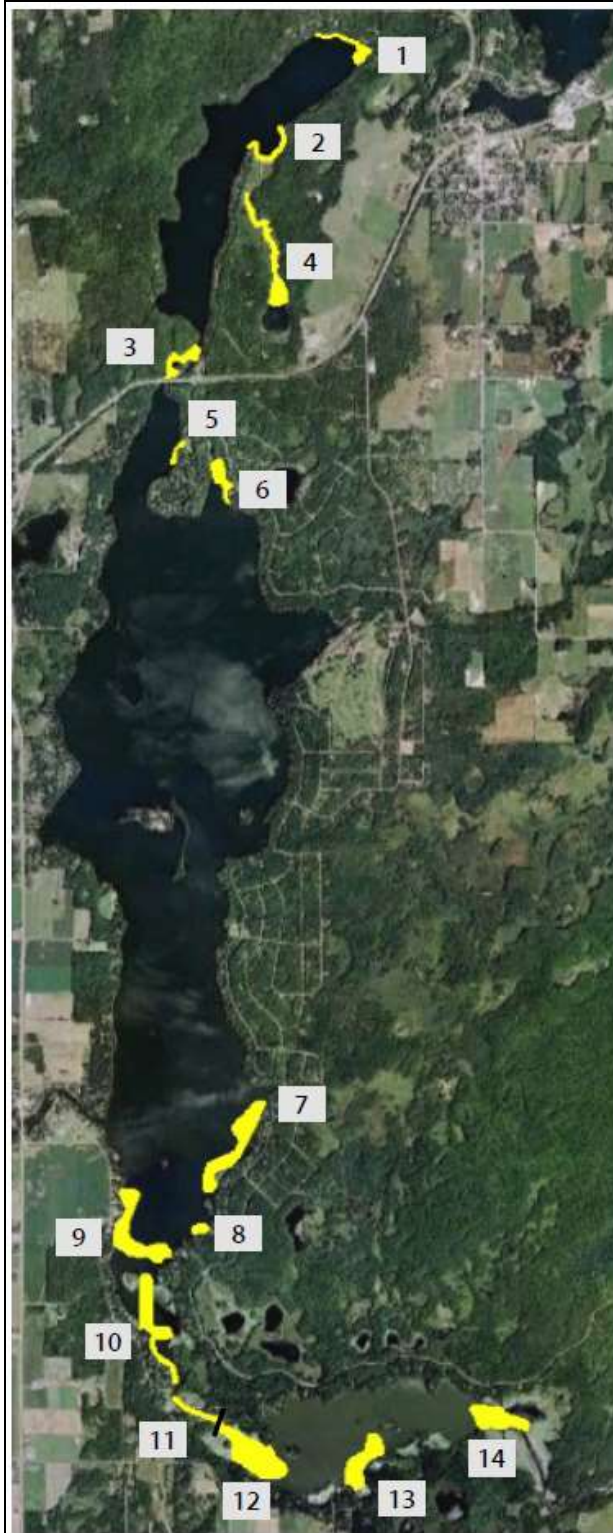
Figure 5 – 2011 CLP Delineation/Bedmapping Results from FSS

Figure 12. *Curlyleaf Pondweed Beds* in the Red Cedar Lakes; June 2011. Each curlyleaf bed is identified by number. See Table 3 for area of each delineated bed; Figure 13 for curlyleaf density ratings associated with each bed.

In 2018, the amount of CLP in the Red Cedar Lakes system was down from what was mapped in 2017 by RCLA volunteers (91.58-ac, Appendix A), and from what it was in 2011 when FSS last mapped CLP (152.6-ac, Figures 5-7). Part of this difference is likely due to how the mapping was done and how results were recorded. In both the 2011 FSS survey and the 2017 RCLA survey, CLP was documented and then a total acreage of the surface water where the plant was found was determined. CLP density in those areas documented was noted in the mapping. The 2018 mapping survey only identifies the acreage of the densest areas of CLP. If all the water with CLP in it were mapped with varying levels of density, then the surface areas with CLP would be much higher than what is documented in the 2018 survey results. While the amount of CLP found during the 2018 delineations was down, CLP was still found in pretty much all of the areas mapped by RCLA volunteers from previous years.

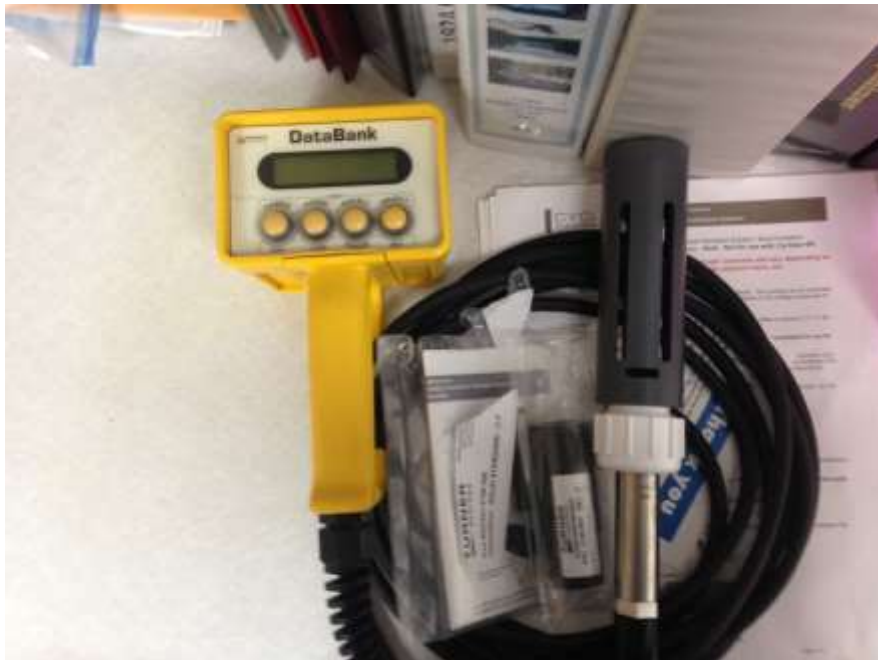
Figure 13 – Turner Designs Cyclops-7F and DataBank Datalogger

Once applied, dye readings using a Turner Designs Cyclops-7F probe with Rhadmine WT Optics and a DataBank DataLogger borrowed from the WDNR to take dye readings in the water at 16 different sites at 8 different times (1,2,3,4,8,24, 48, and 72 hours after treatment (HAT)).

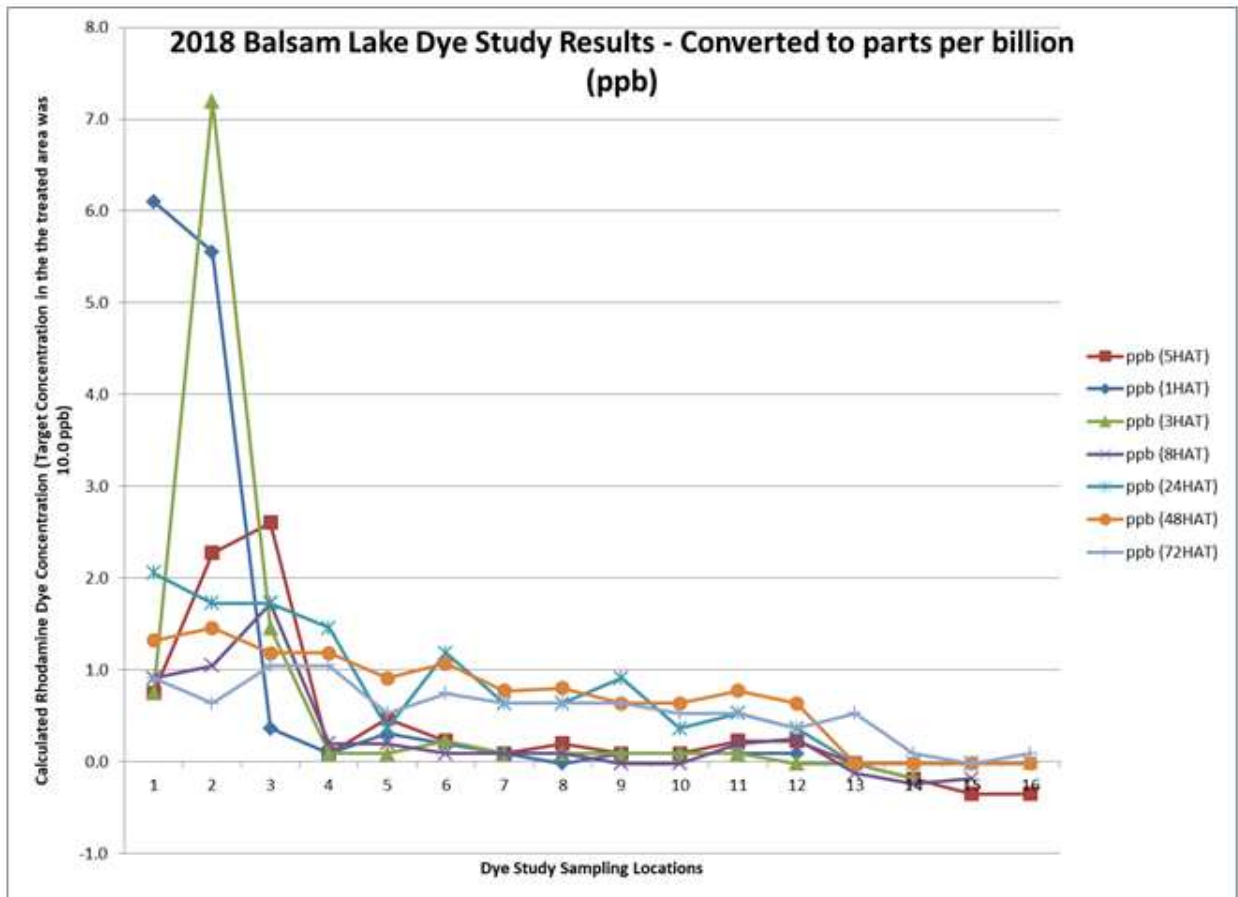
Figure 14 – 2018 Rhodamine Dye Study Results in Balsam Lake

Figure 14 reflects the results obtained during the Rhodamine dye study completed in Balsam Lake in 2018. The dye was applied to a sample CLP treatment area of 7.6-ac area in the north end of the lake at the inlet from upstream waters. Sampling site 1 & 2 were on either side of the river channel coming into the lake. The rest of the sampling sites were spread throughout Balsam with a couple in Red Cedar. The fluorimeter was used to collect a reading of dye concentration. That reading was then converted to ppb. The target goal for the dye in the proposed CLP treatment area was 10.0 ppm.

Based on the readings, the target concentration of dye was never reached even in the treated area. It did reach a bit more than half the target concentration in both sites 1 and 2, and that concentration was maintained through 3-HAT. After 3-HAT, the concentration of dye dropped off rapidly, with several sites (those in Red Cedar Lake) never registering any concentration even 3-days after application. Site 5 was located at the mouth of the Mud Lake channel to Balsam Lake. It is in this area that wild rice is present in some abundance. One of the concerns is whether or not herbicide applied north of the Mud Lake channel would reach the wild rice in sufficient quantities to potentially impact its growth. This does not appear to be the case, given that the concentration of dye reached at that site never exceeded 1.0-ppb (its highest level at 48-HAT), and dropped back below 1.0-ppb a day later (Figure 15).

Based on these results, it may be possible to chemically treat CLP in the north end of Balsam Lake but likely only in the back waters on either side of where the channel comes in. The concentration of herbicide used should be higher to accommodate for the dissolution of the herbicide away from the treatment site.

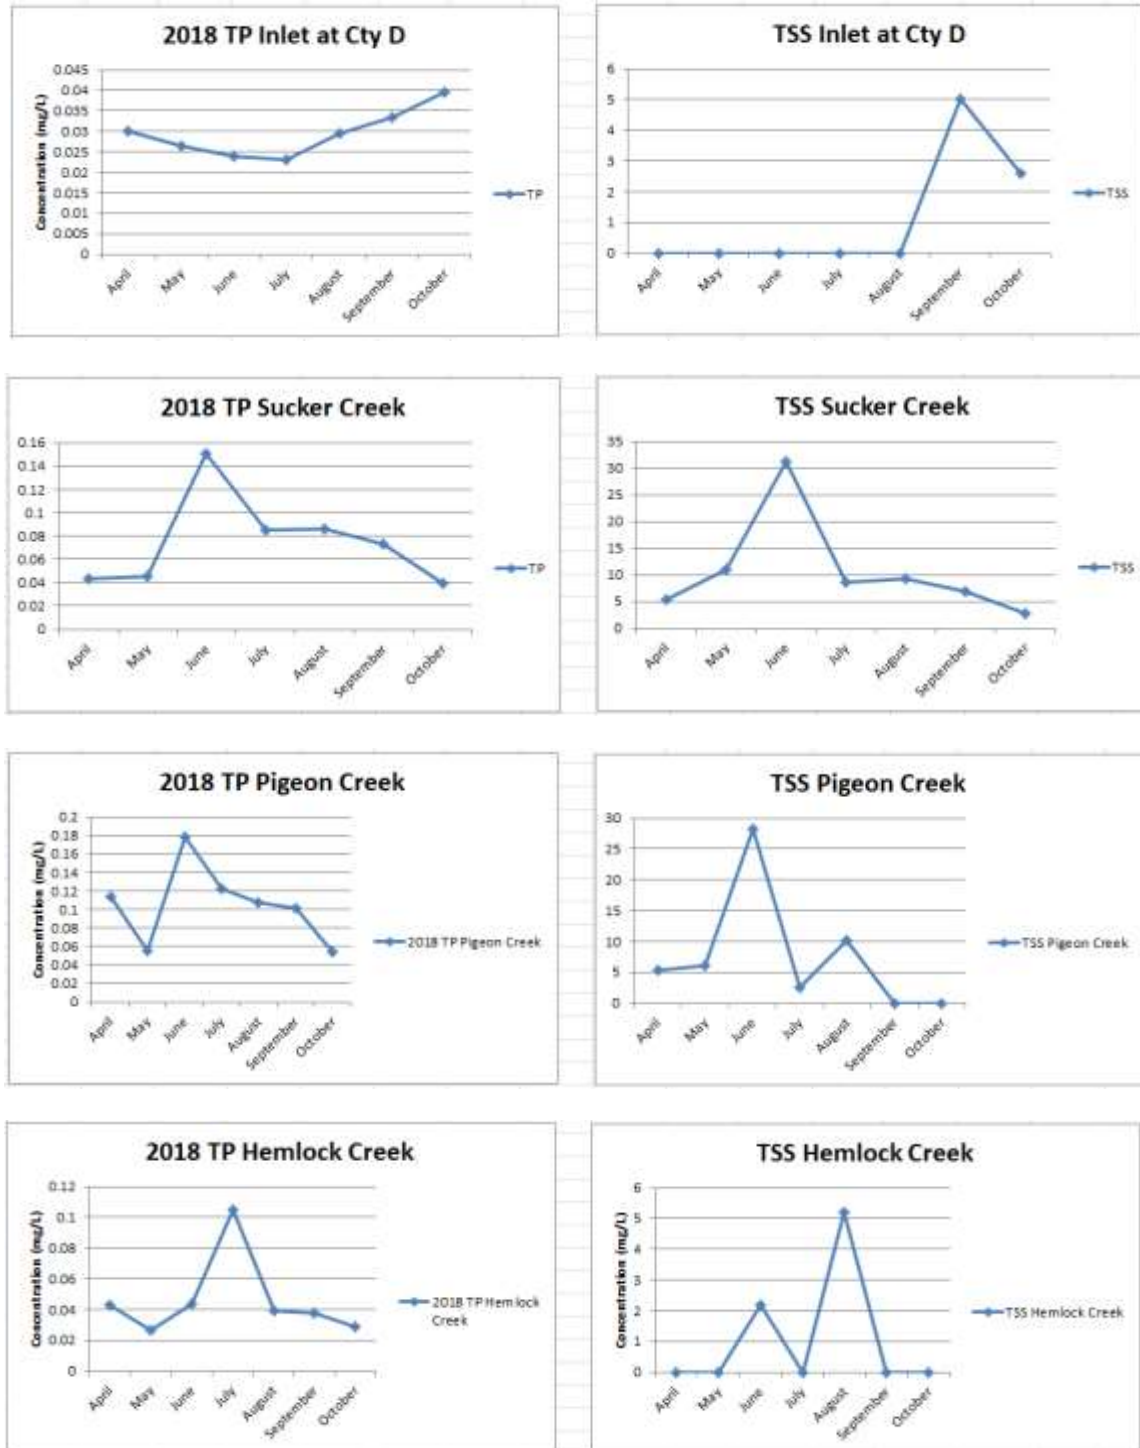
Figure 17 – 2018 Total Phosphorus (TP) and Total Suspended Solids (TSS) from the Inlet and three tributaries to the Red Cedar Lakes (April-October)

scheduling a training with the WAV Program Coordinator, this did not get done. It is expected that this will be done in the spring/early summer of 2019. Volunteers from the RCLA, led by a University of St. Thomas (MN) Professor and several of his students led the sampling project. Figures 17 and 18 show the results of TP and TSS sampling in 2018.

Monthly flow readings have been recorded for each site monitored during this project and will be combined with the SLOH results for TP and TSS to provide a snapshot analysis of nutrient loading in 2018.
