**Eurasian water milfoil (*Myriophyllum spicatum*)  
June Littoral Zone and Bed Mapping Surveys,  
August Warm Water Point Intercept Survey, and  
October Herbicide Assessment Swimover Survey  
Horseshoe Lake (WBIC: 2470000)  
Washburn County, Wisconsin**

Project Initiated by: Horseshoe Lake Property Owners Association  
and the Wisconsin Department of Natural Resources

Surveys Conducted by and Report Prepared by:  
Endangered Resource Services, LLC  
Matthew S. Berg, Research Biologist  
St. Croix Falls, Wisconsin  
June 12, August 2-3, and October 8, 2011

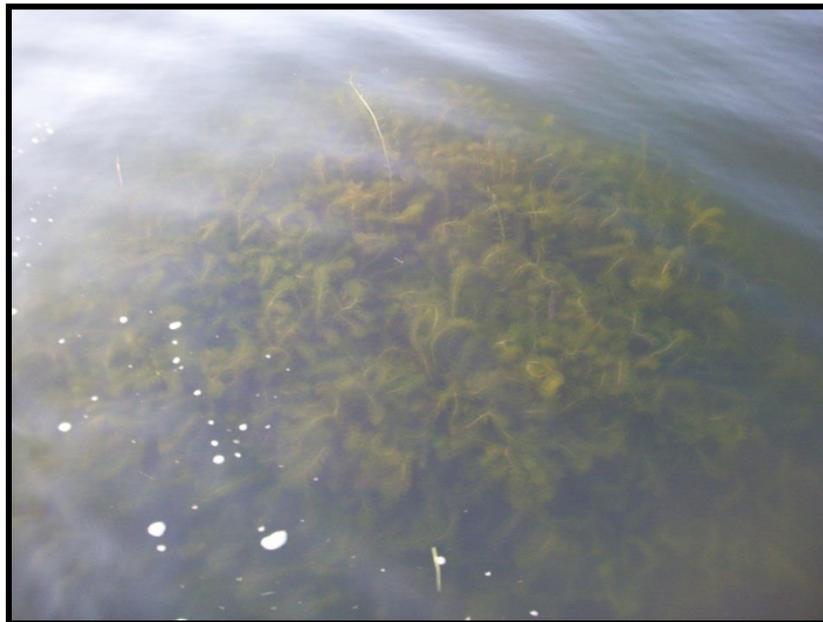
**Figure 9: Tower of EWM in Bed 1 – June 2011**

To assist in meeting these goals, lakeshore owners should minimize the removal of native plants from the lake unless absolutely necessary as these patches of barren substrate can provide an easy place for EWM fragments to take root and become established. Training volunteers to recognize EWM is another low cost management strategy that we strongly encourage. At least monthly volunteer meandering shoreline surveys of the whole lake would likely result in early detection of new beds. The sooner these beds can be found, the greater the chances the infestation can continue to be economically maintained at its current low level (Figure 9).

As there are no similar looking native milfoils in the lake, any suspicious looking plants that are found in the future should be immediately investigated to determine species. If any lake resident or boater discovers a plant they even suspect may be EWM, they are invited to contact Matthew Berg, ERS, LLC Research Biologist at 715-338-7502 [mberg@grantsburg.k12.wi.us](mailto:mberg@grantsburg.k12.wi.us) and/or Pamela Toshner/Alex Smith, Regional Lakes Management Coordinators in the Spooner DNR office at 715-635-4073 for identification confirmation. If possible, a specimen, a jpg, and the accompanying GPS coordinates of the location it was found at should be included.

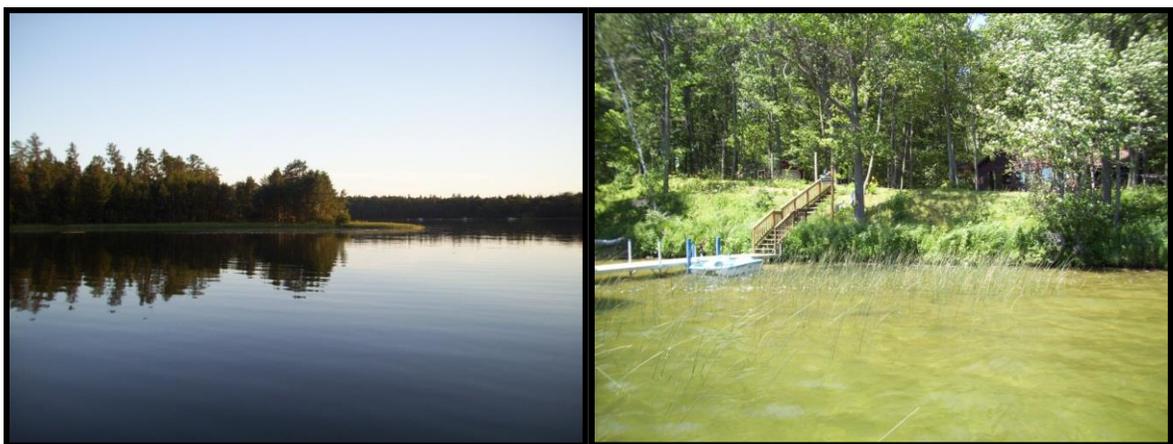
**Figure 10: Model Natural Shorelines on Horseshoe and Another Nearby Washburn Co. Lake**

During our time on the lake, we immediately noticed that most residents were currently practicing good shoreline conservation (Figure 10). We also noticed that there were few filamentous or floating algae in the lake. This is likely not a coincidence. These algae proliferate in the presence of excessive nutrients in the water. Because the lake's plant community is so limited, even a small percentage decline in macrophyte plants or a small increase in nutrient input could tip the lake's current balance allowing algae to proliferate and leading to a decline in both water clarity and quality. Conversely, working to limit nutrient input could result in fewer algal blooms and better clarity throughout the summer. It could also inhibit EWM growth as it favors higher nutrient waters.

Such things as internal loading from sediments, failed septic systems, and lawn and field fertilizer runoff are common causes of excess nutrients in surface water. Educating lake residents about reducing nutrient input directly along the lake is one of the easiest ways to limit algal growth and maintain or even improve water clarity and quality. Not mowing down to the lakeshore, bagging grass clippings, and switching to a phosphorus-free fertilizer or eliminating fertilizer altogether would all be positive steps to this end. Wherever possible, restoring shorelines, building rain gardens, and establishing buffer strips of native vegetation would also enhance water clarity/quality by preventing erosion and runoff.

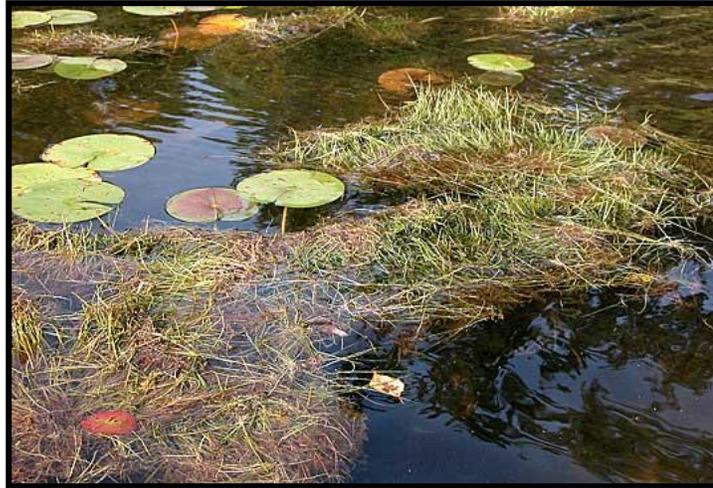
**Figure 11: Dislodged Floating Mat of Native Vegetation**

On Horseshoe, we also noticed evidence of motor start-ups in shallow water and the grounding of personal watercraft. These actions can lead to the tearing of the underwater “turf” of native vegetation which can then float away and create obstacles for watercraft (Figure 11). It also results in the release of nutrients from the lake bottom into the water column which promotes algal growth. As previously mentioned, these exposed bare patches of substrate also present EWM with an ideal place to establish. To prevent this, residents are encouraged to use lifts for their watercraft whenever possible, and try to avoid starting their motors in water less than 5ft in depth.
