**August Warm Water Point Intercept Survey and  
Eurasian water milfoil (*Myriophyllum spicatum*) Dive Removal  
George Lake (WBIC: 2465700)  
Bayfield County, Wisconsin**

Project Initiated by: The Town of Barnes  
and the Wisconsin Department of Natural Resources

Surveys Conducted by and Report Prepared by:  
Endangered Resource Services, LLC  
Matthew S. Berg, Research Biologist  
St. Croix Falls, Wisconsin  
August 4-5, 2011

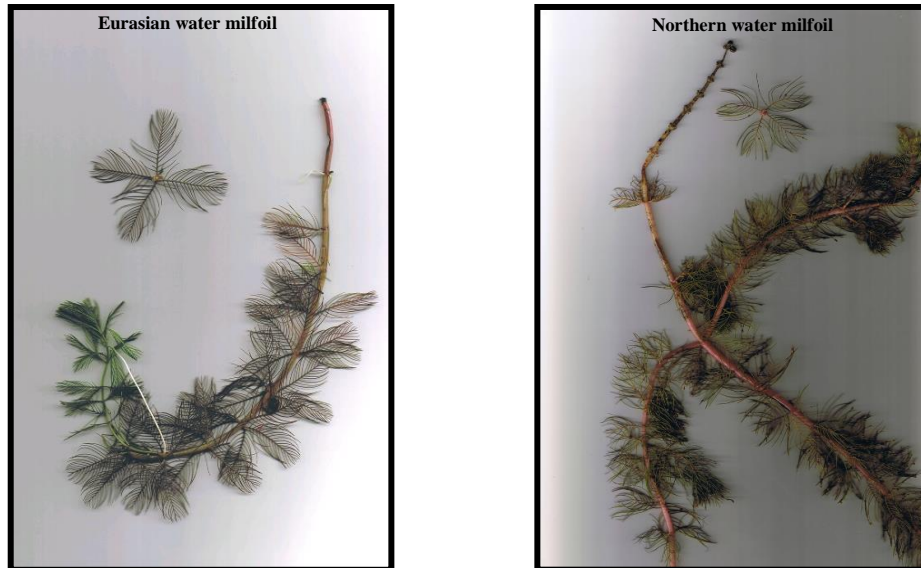
**Figure 8: Eurasian and Northern Water Milfoil Identification**

Although the very similar native species Northern water milfoil (*Myriophyllum sibiricum*) does occur in the lake, it is extremely rare (Figure 8). Because of this, any suspicious looking plants that are found in the future should be immediately investigated to determine species. If any volunteer, lake resident or boater discovers a plant they even suspect may be EWM, they are invited to contact Matthew Berg, ERS, LLC Research Biologist at (715) 338-7502 [mberg@grantsburg.k12.wi.us](mailto:mberg@grantsburg.k12.wi.us) and/or Pamela Toshner/Alex Smith, Regional Lakes Management Coordinators in the Spooner DNR office at 715-635-4073 for identification confirmation. If possible, a specimen, a jpg, and the accompanying GPS coordinates of the location it was found at should be included.

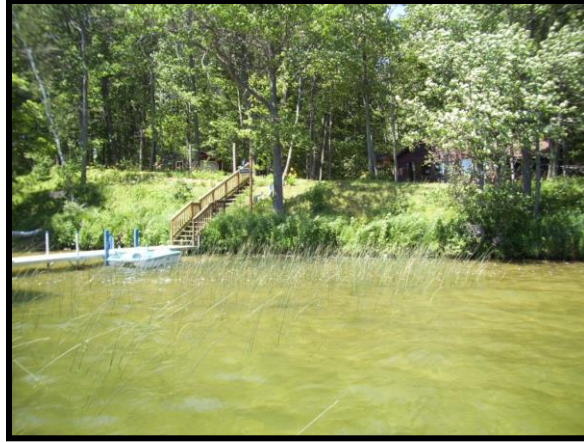
**Figure 9: Model Natural Shoreline on a Nearby Lake**

Such things as internal loading from sediments, failed septic systems, and lawn and field fertilizer runoff are common causes of excess nutrients in surface water. Educating all lake residents about reducing nutrient input directly along the lake is one of the easiest ways to limit algal growth and maintain or even improve water clarity and quality. Not mowing down to the lakeshore, bagging grass clippings, and switching to a phosphorus-free fertilizer or eliminating fertilizer altogether would all be positive steps to this end. Wherever possible, restoring shorelines, building rain gardens, and establishing buffer strips of native vegetation would also enhance water clarity/quality by preventing erosion and runoff.
