Long Lake

Aquatic Plant Management Plan Update

July 2019

Long Lake
Fond du Lac County, Wisconsin
Aquatic Plant Management Report
July 2019

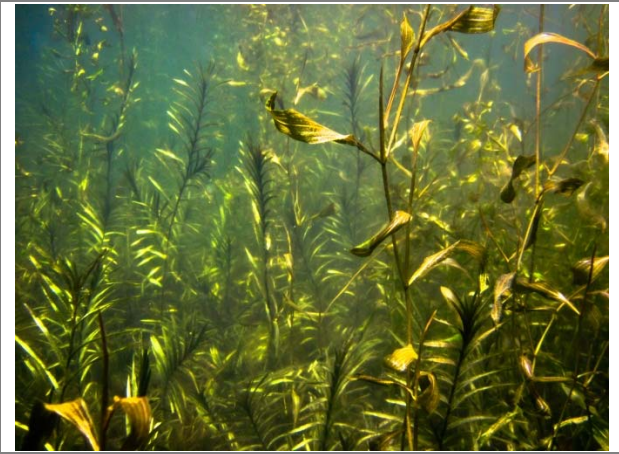
Photo 2.1-1. Native aquatic plants.

Native aquatic plants are an important element in every healthy aquatic ecosystem, providing food and habitat to wildlife, improving water quality, and stabilizing bottom sediments (Photo 2.1-1). Because most aquatic plants are rooted in place and are unable to relocate in wake of environmental alterations, they are often the first community to indicate that changes may be occurring within the system. Aquatic plant communities can respond in a variety of ways; there may be increases or declines in the occurrences of some species, or a complete loss. Or, certain growth forms, such as emergent and floating-leaf communities may disappear from certain areas of the waterbody. With periodic monitoring and proper analysis, these changes are relatively easy to detect and provide relevant information for making management decisions.
