Presque Isle Wilderness Waters Program

Aquatic Plant Management Plan – Mabel Lake

Date: March 2019

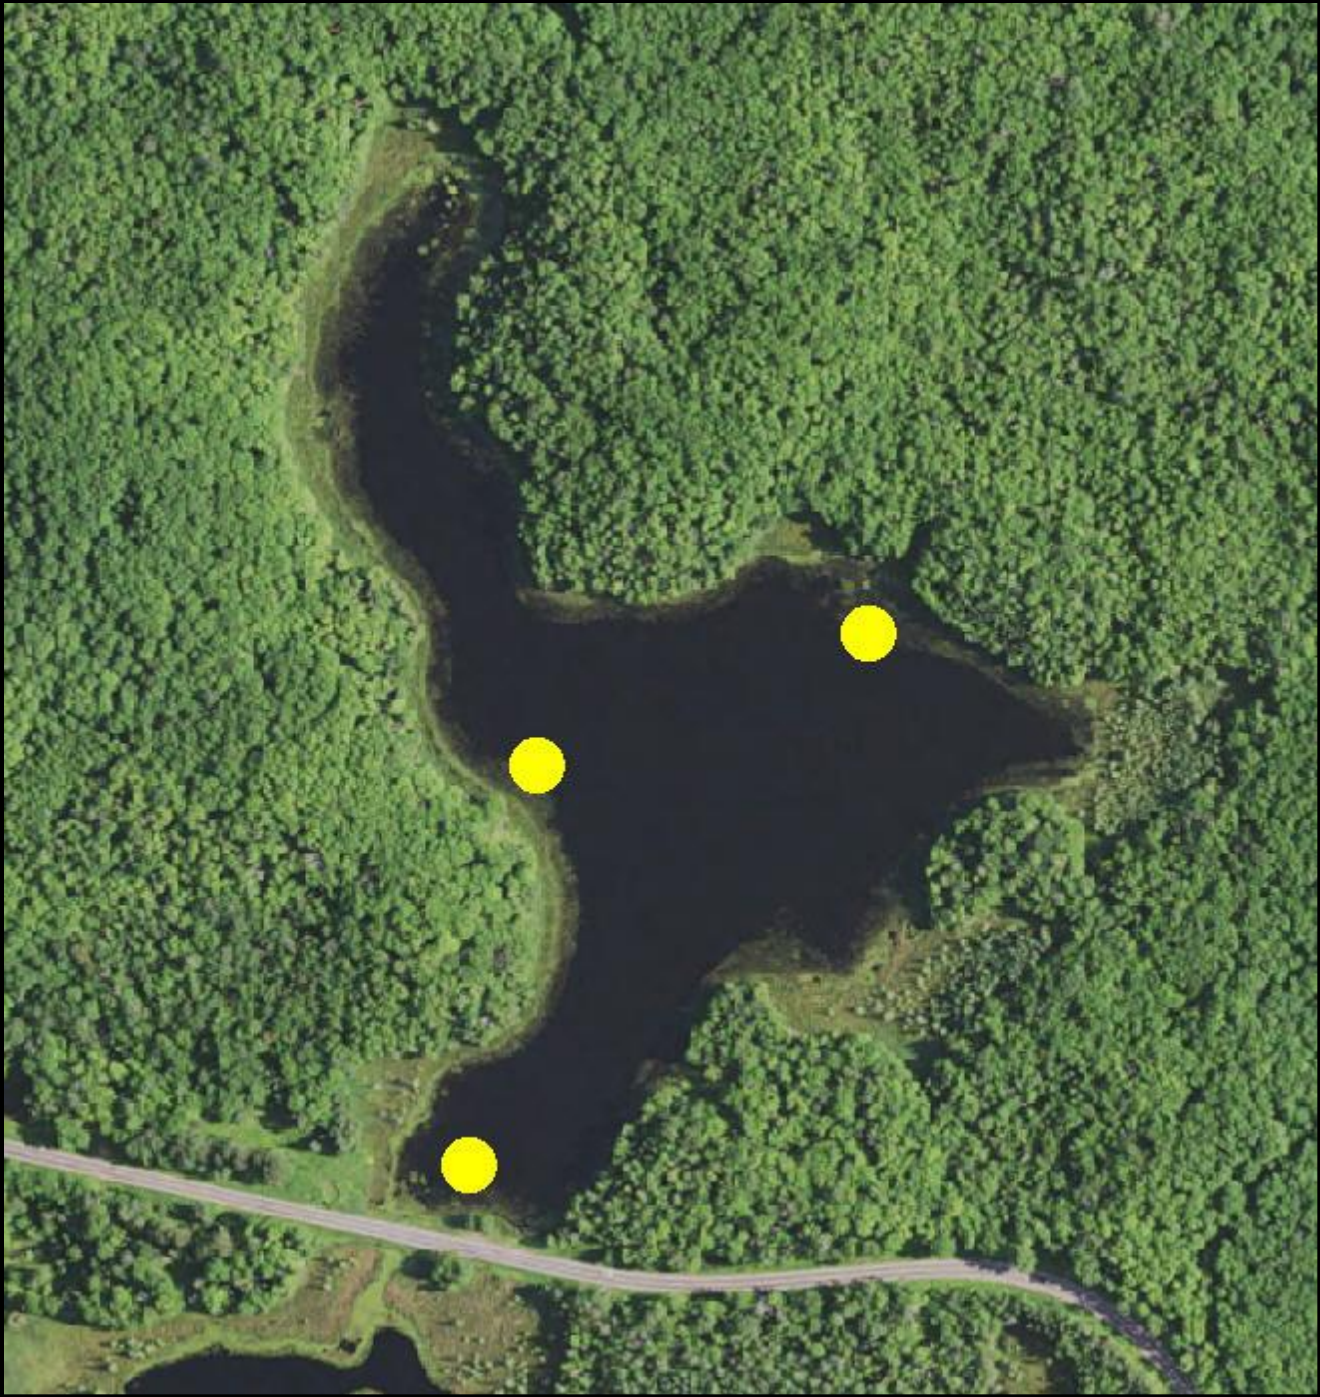
Figure 2. Rake fullness ratings for Mabel Lake sample sites (2017).

**Rake fullness
(all species)**

- 1
- 2
- 3

Species richness refers to the total number of species recorded. When considering the plant species recorded at sampling points only, species richness in 2008 was 7 (species collected on the rake). In 2017, a total of 5 species of aquatic plants were recorded in Mabel Lake at the sampling points (one species was not collected on the rake). Other species were observed from the boat at other places in the lake (not at a sample points). If these species are also included in the richness tabulation, the overall number of species present is 14 in 2017 (see Exhibit 9). Table 1 displays summary statistics for the 2008 and 2017 survey. Table 2 provides a list of the species encountered, including common and scientific name along with summarizing statistics for the 2017 survey.² In 2017, the number of species encountered at any given sample point ranged from 0 to 2. The actual number of species encountered at each of the vegetated sites in 2017 is graphically displayed on Figure 1. Plant density is estimated by a “rake fullness” metric (3 being the highest possible density). These densities (considering all species) are displayed for each sampling site on Figure 2.

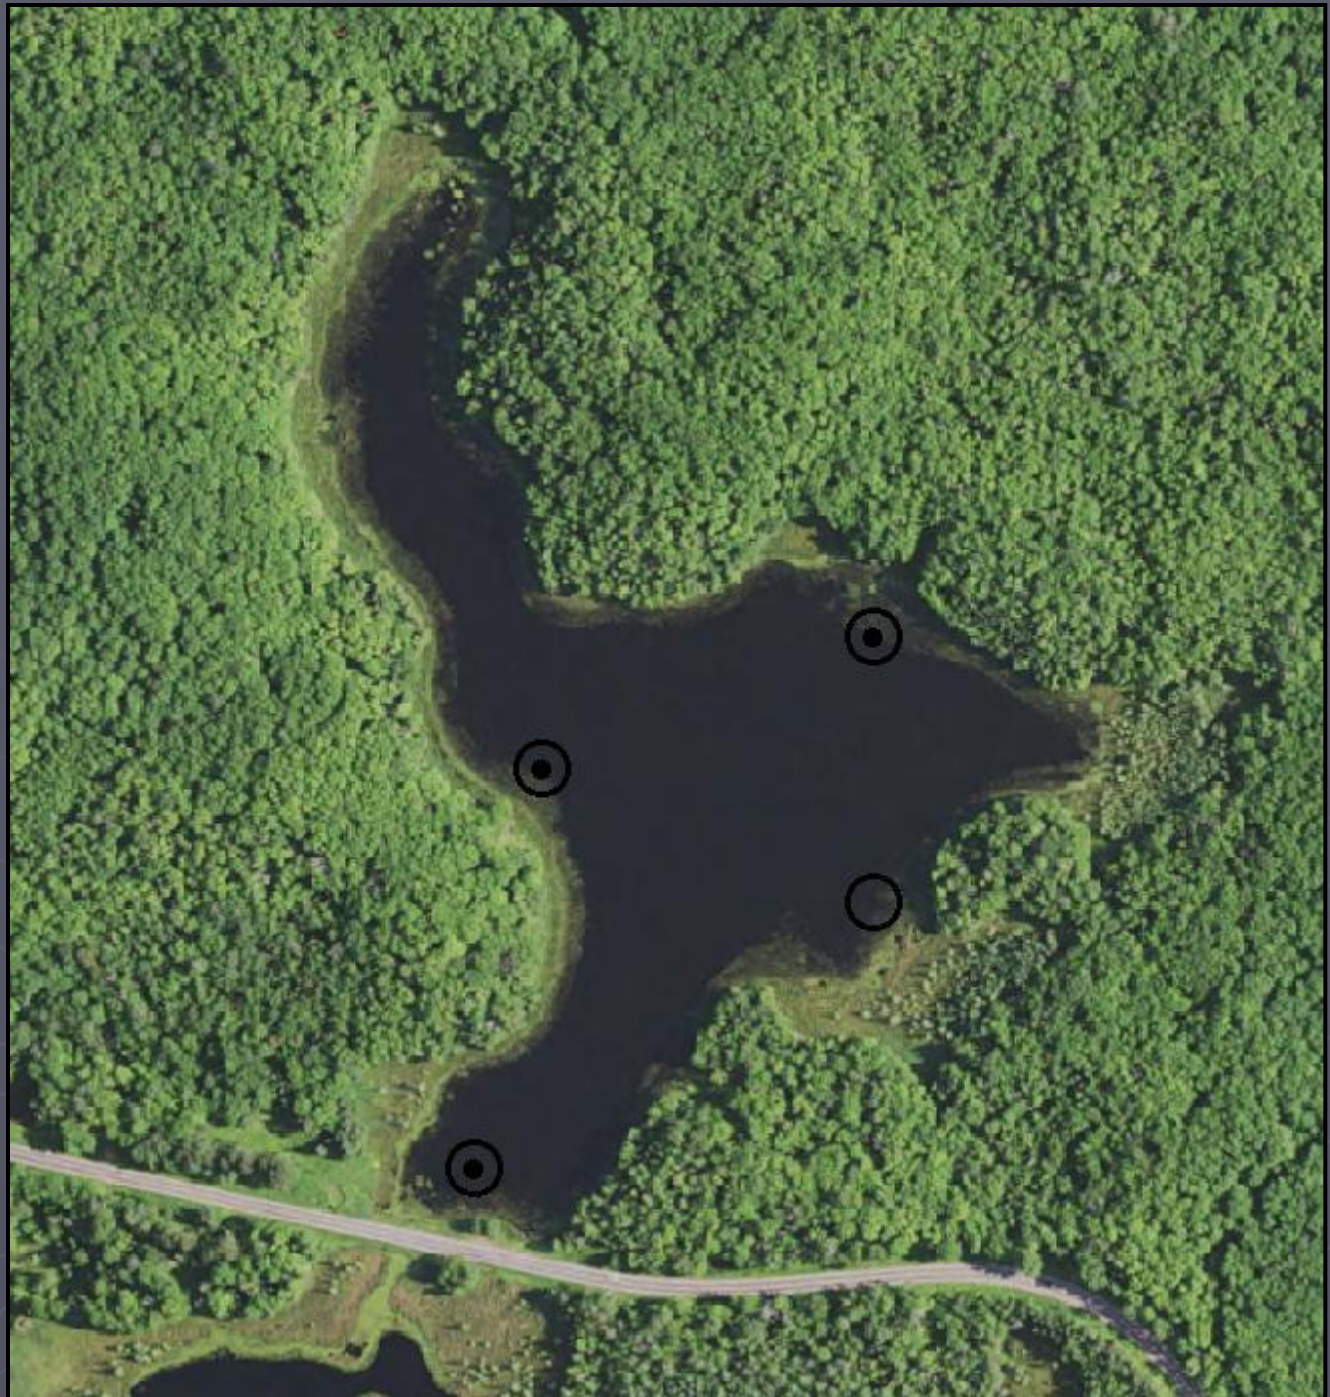
Figure 4. Mabel Lake sampling sites less than or equal to maximum depth of rooted vegetation (2017).

- Site less than or equal to maximum depth of plant colonization (MDC).
- Plant find(s) at site less than or equal to MDC.

The maximum depth of plant colonization in 2017 was 6.5 feet (Table 1 and Figure 3). Rooted vegetation was found at 3 of the 4 sample sites with depth \leq the maximum depth of plant colonization (75.0% of sites). These sites are displayed as a black dot within a circle on Figure 4. This indicates that although availability of appropriate depth may limit the distribution of plants, it is not the only habitat factor involved. Substrate is another feature that influences plant distribution (e.g., soft substrate often harbors more plants than hard substrate). Figure 5 presents the substrates encountered during the aquatic plant survey (mud, sand, or rock).

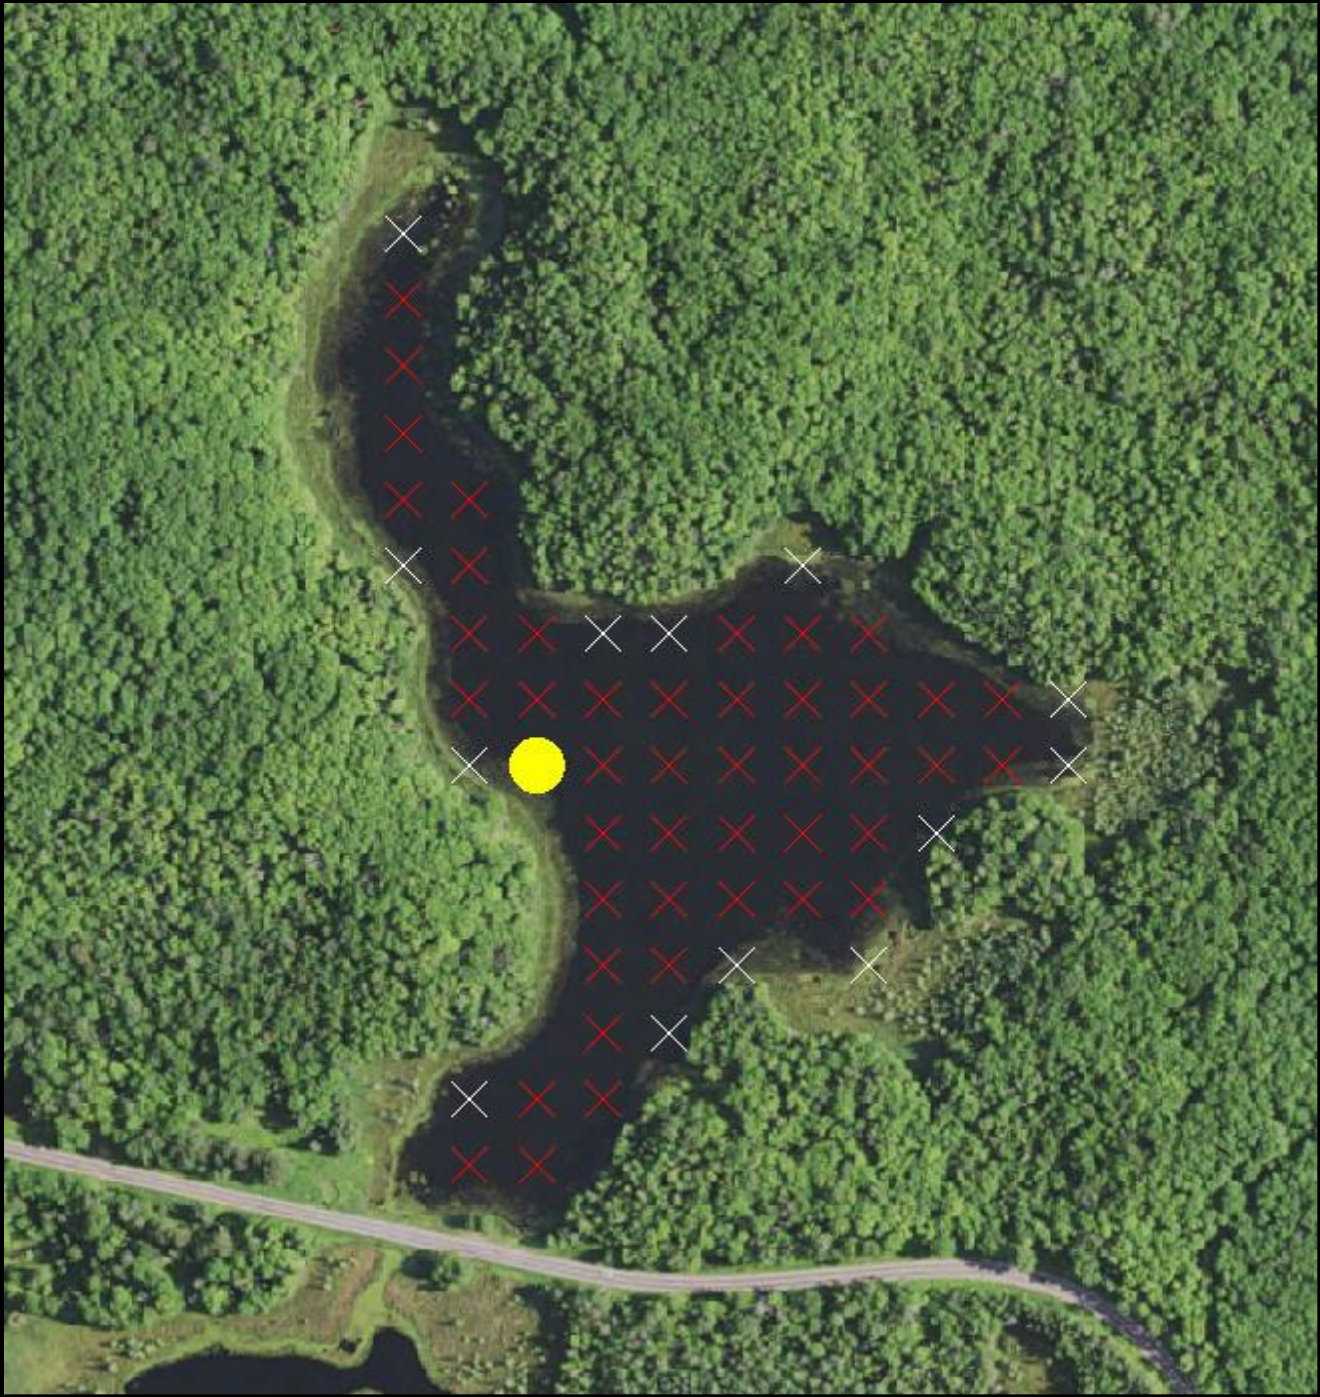
Figure 9. Distribution of plant species, Mabel Lake (2017).

Myriophyllum heterophyllum, Various-leaved water-milfoil

- 1 (Rake fullness)
- 2
- 3
- ▼ Visual
- × Not found
- × Unsampld (depth)
- × Non-navigable

Table 2 and 3 provides information about the frequency of occurrence of the plant species recorded in the lake in 2017 and 2008, respectively. Several metrics are provided, including total number of sites in which each species was found and frequency of occurrence at sites \leq the maximum depth of rooted vegetation. This frequency metric is standardized as a “relative frequency” (also shown in Table 2) by dividing the frequency of occurrence for a given species by the sum of frequency of occurrence for all plants and multiplying by 100 to form a percentage. The resulting relative frequencies for all species total 100%. The relative frequencies for the 2017 plant species collected with a rake are graphically displayed in descending order on Figure 6. This display shows that *Brasenia schreberi* (Watershield) had the highest relative frequency followed by *Myriophyllum heterophyllum* (Various-leaved water-milfoil) in 2017. The lowest relative frequencies are at the far right of the graph. Figure 7 displays sampling sites with emergent and floating aquatic plants. As examples of individual species distributions, we show the occurrences of a few of the most frequently and least frequently encountered plants in Figures 8-12.

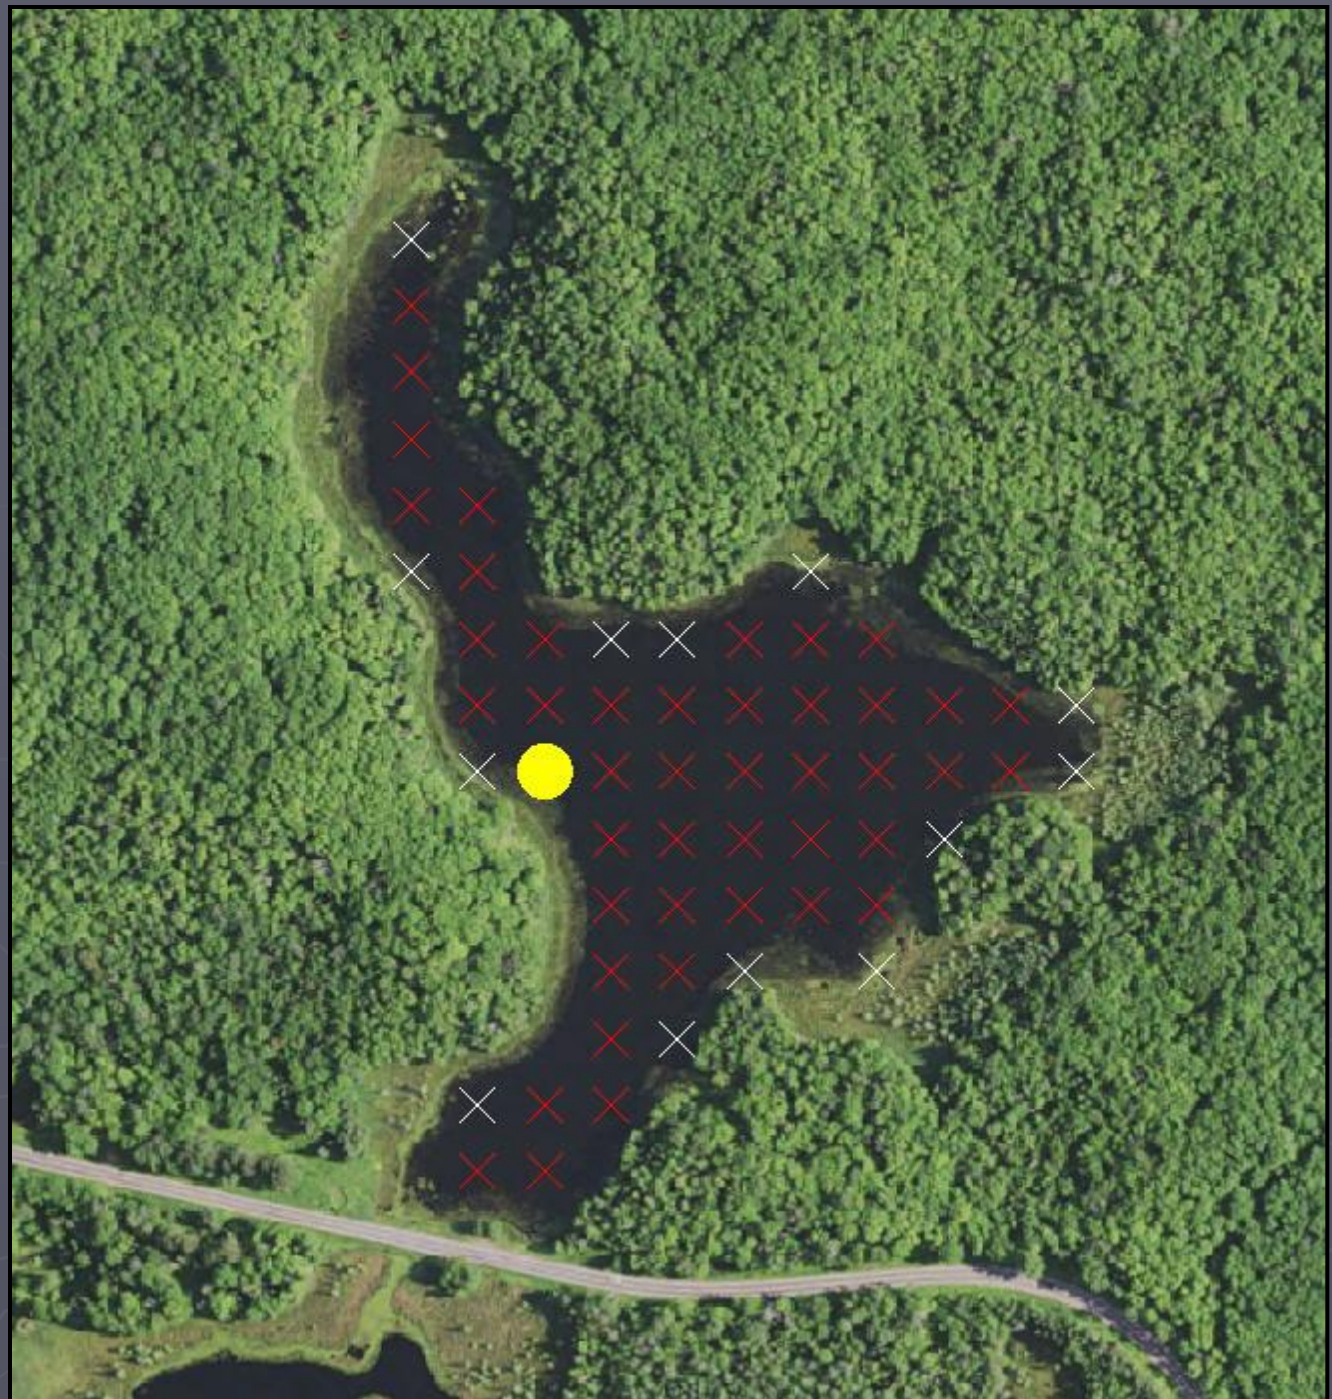
Figure 10. Distribution of plant species, Mabel Lake (2017).

Nuphar variegata,
Spatterdock

-   1 (Rake fullness)
-   2
-   3
-   Visual
-   Not found
-   Unsamped (depth)
-   Non-navigable

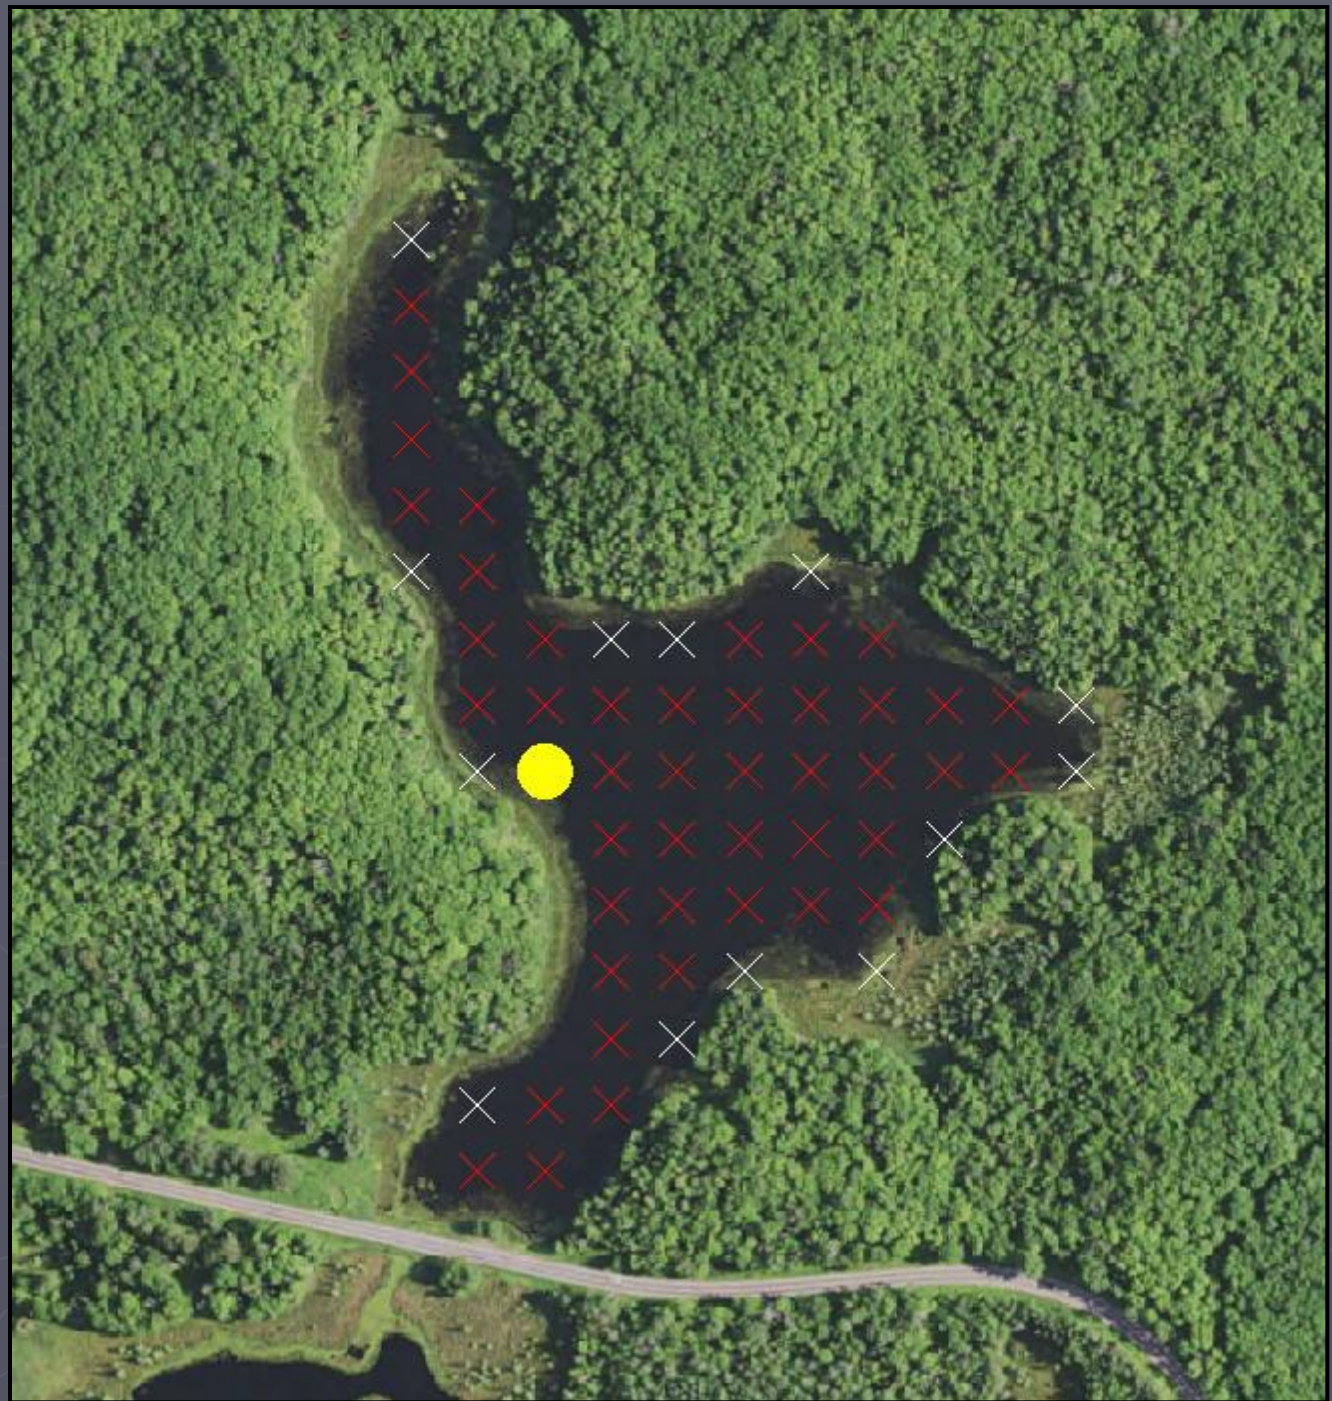
Figure 11. Distribution of plant species, Mabel Lake (2017).

Potamogeton pusillus,
Small pondweed

- 1 (Rake fullness)
- 2
- 3
- ▼ Visual
- × Not found
- × Unsampled (depth)
- × Non-navigable

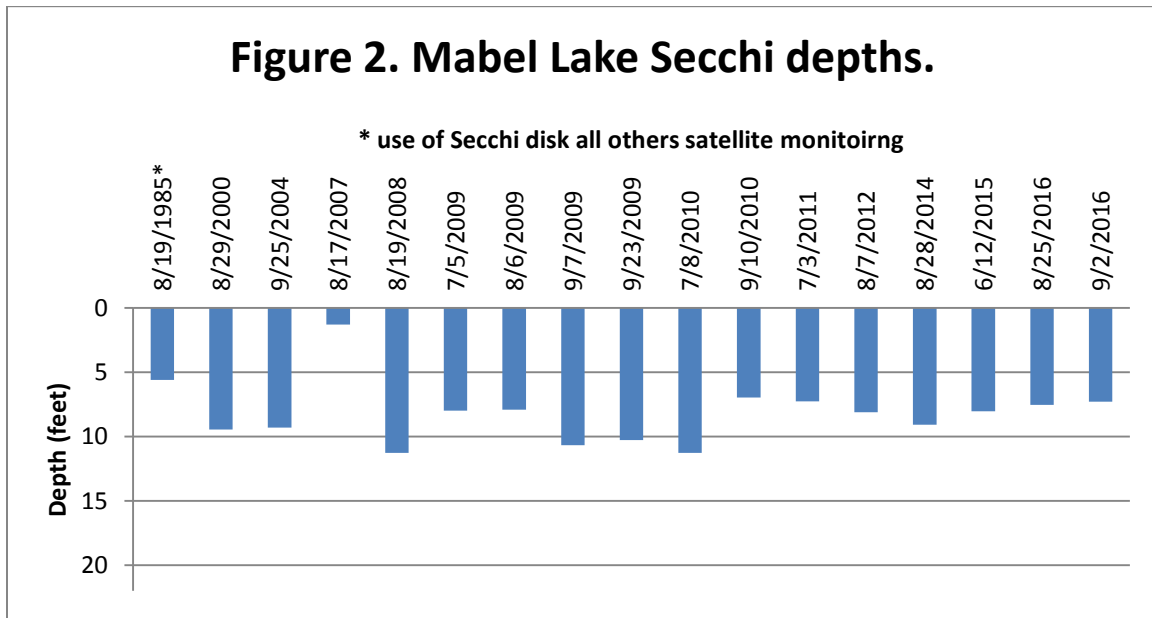
Figure 2 shows the Secchi depths from 1985, 2000, 2004, 2007-2016. According to Table 1, Mabel Lake’s most recent Secchi reading is considered “fair” with respect to water clarity.

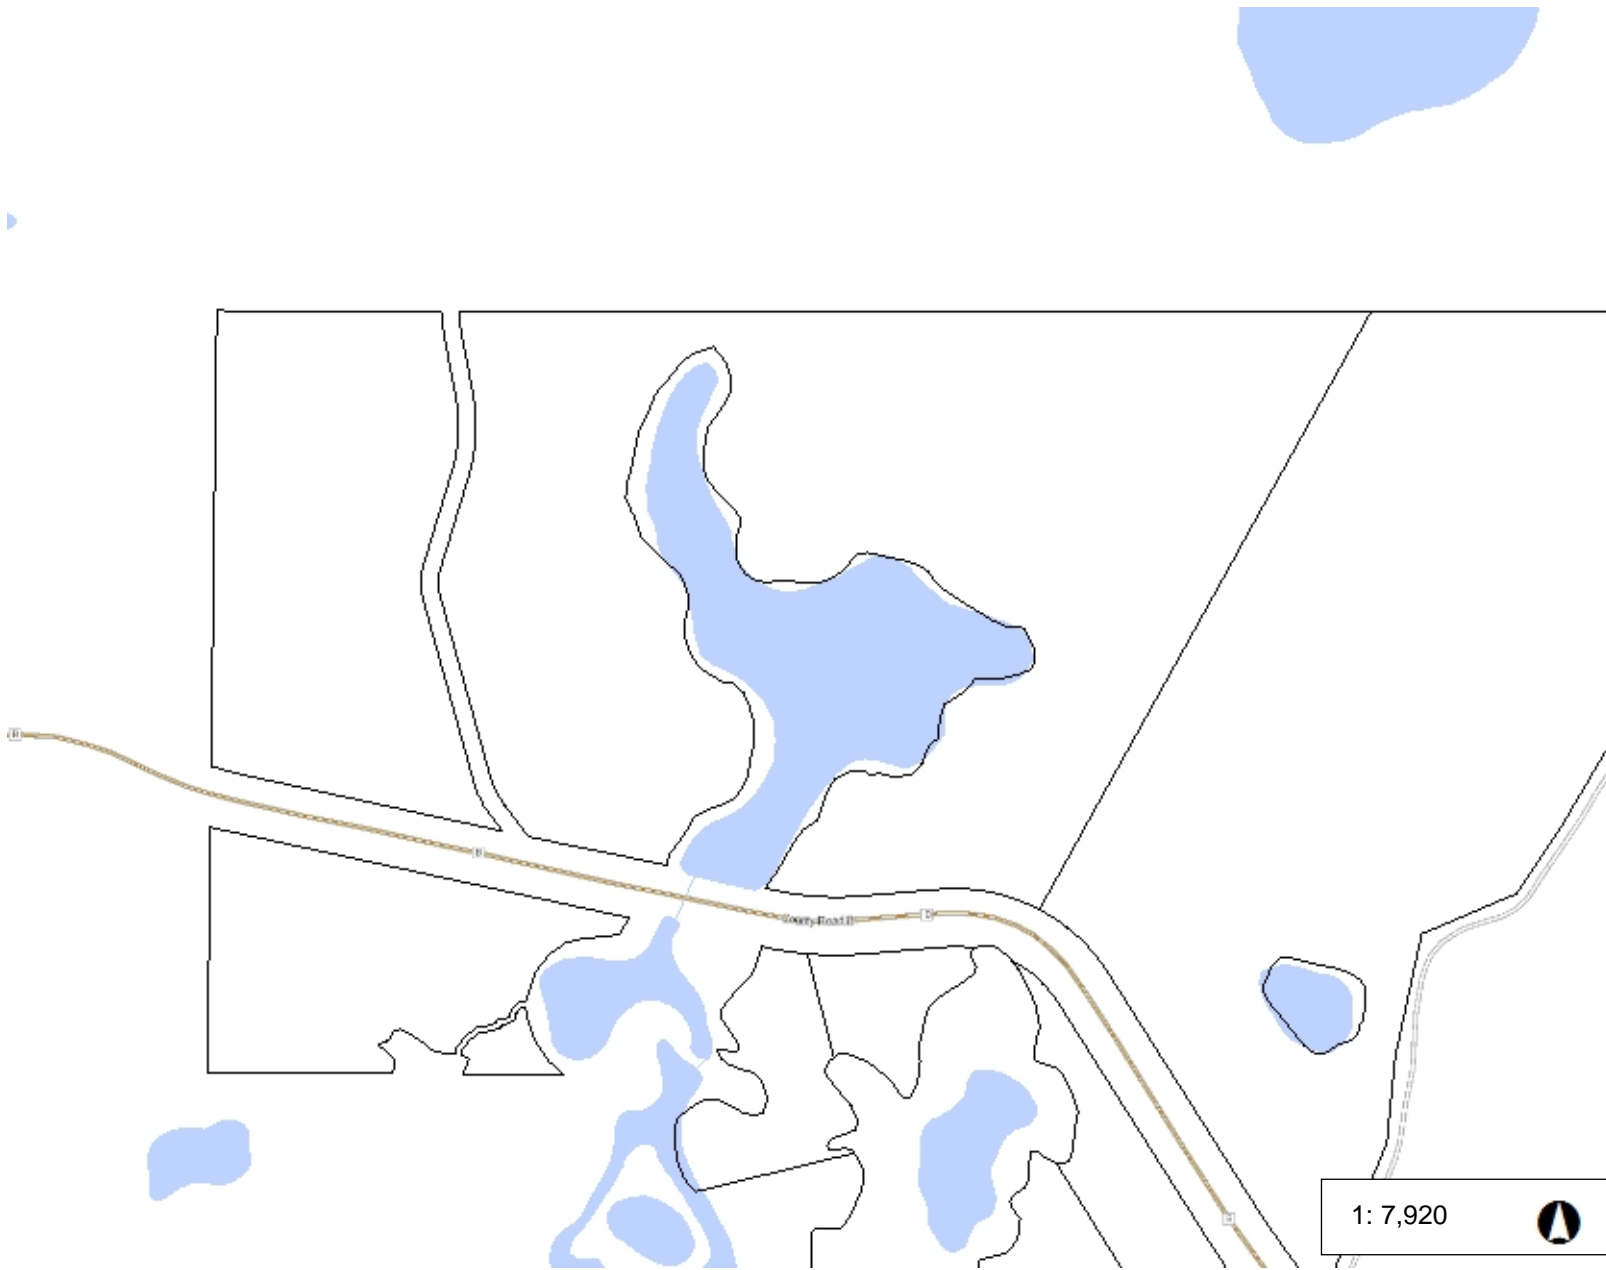
Exhibit 10. Mabel Lake Runoff Concerns - 2018

- Channelized Flow
- Point Source
- Shoreland Parcels
- County Boundary
- Municipality
- State Boundaries
- County Boundaries
- Major Roads**
 - Interstate Highway
 - State Highway
 - US Highway
- County and Local Roads**
 - County HWY
 - Local Road
- + Railroads
- Tribal Lands
- Rivers and Streams
- Intermittent Streams
- Open Water
- Great Lakes

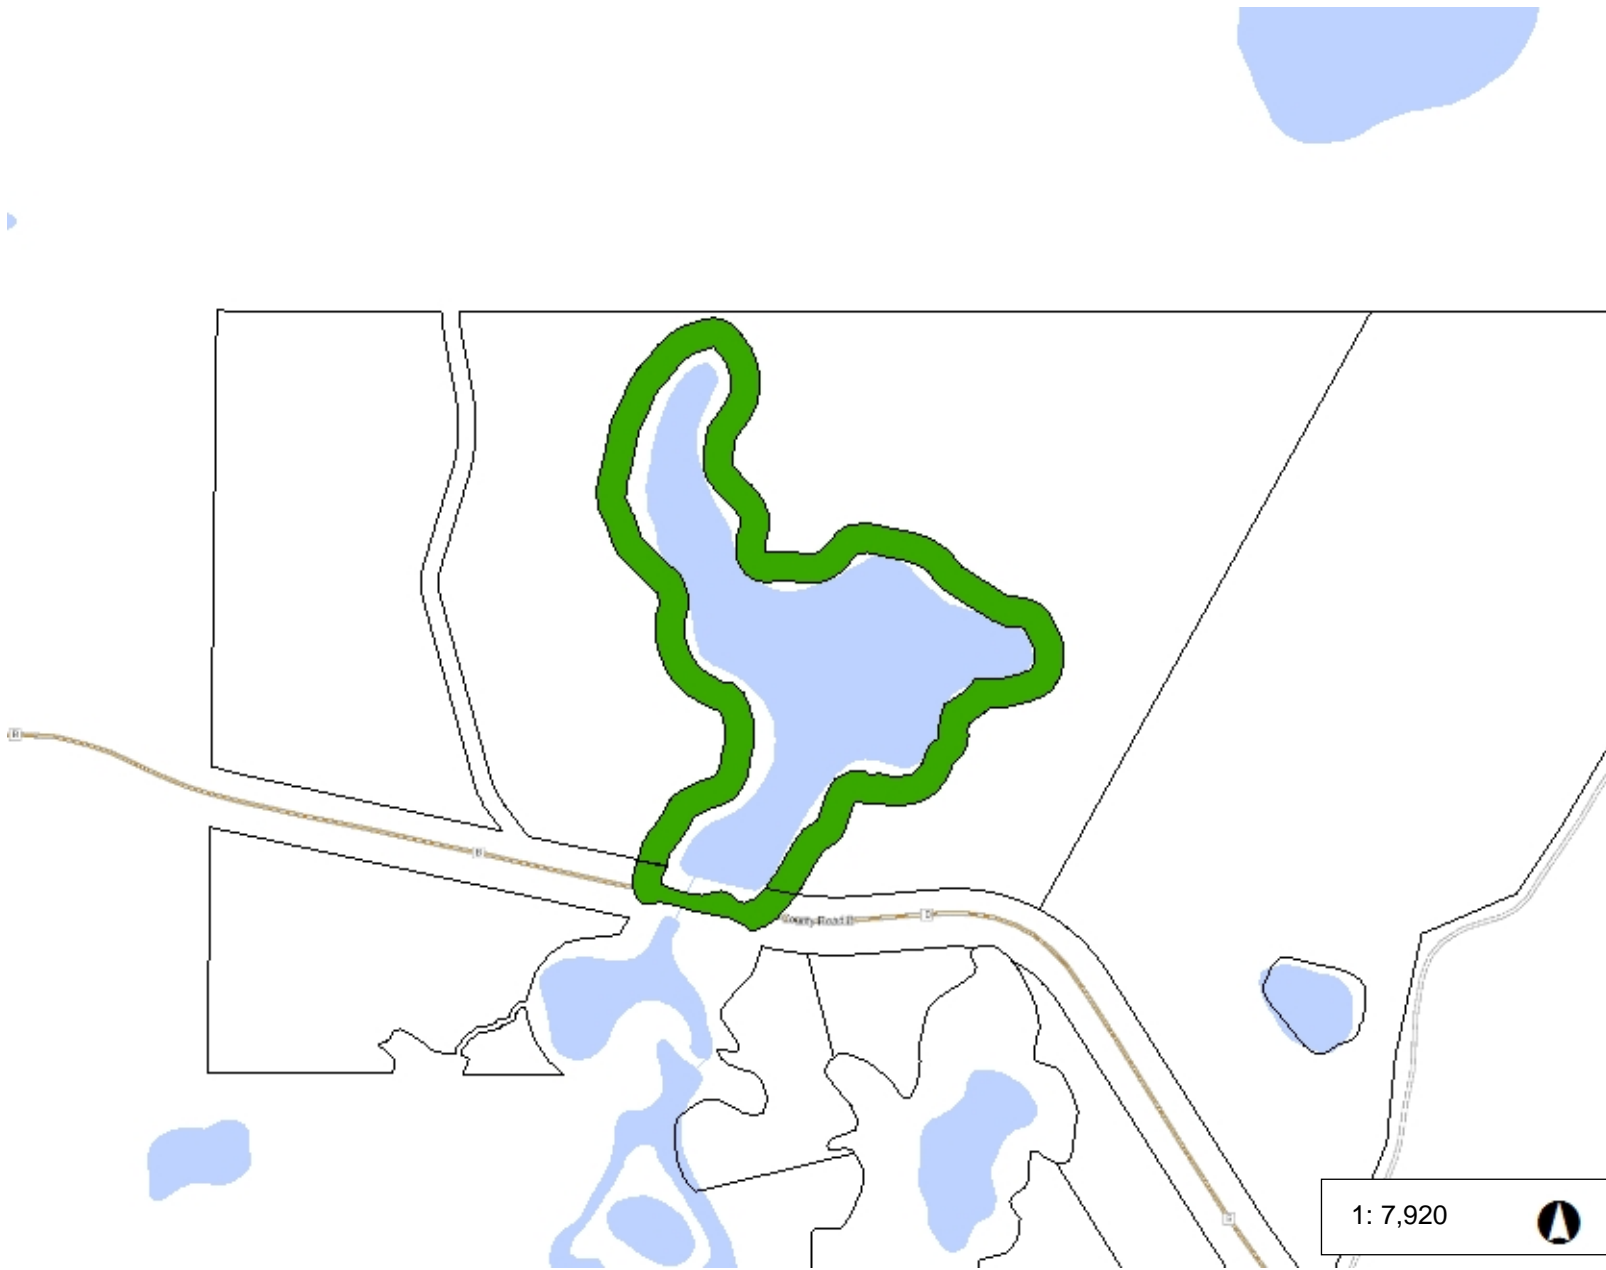
Exhibit 11. Mabel Lake Littoral Zone - Aquatic Plants - 2018

- Aquatic Plant Removal
- Floating & Emergent Plants
- Emergent Plants
- Floating Plants
- Shoreland Parcels
- County Boundary
- Municipality
- State Boundaries
- County Boundaries
- Major Roads**
 - Interstate Highway
 - State Highway
 - US Highway
- County and Local Roads**
 - County HWY
 - Local Road
- Railroads
- Tribal Lands
- Rivers and Streams
- Intermittent Streams
- Open Water
- Great Lakes

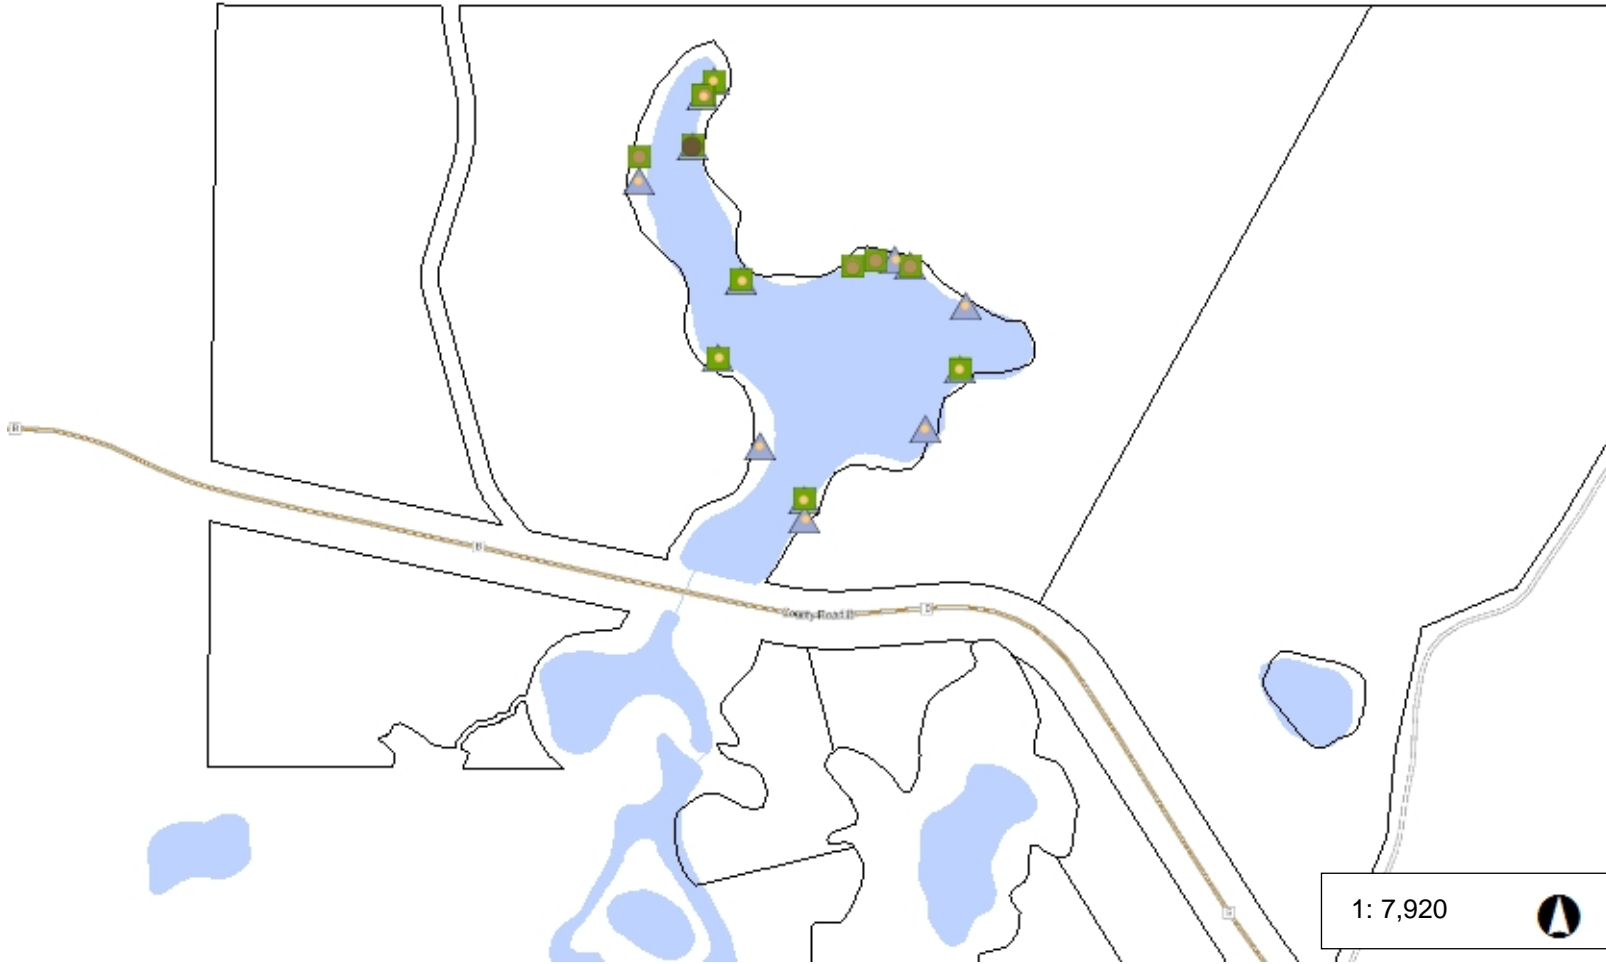
Exhibit 13. Mabel Lake Woody Habitat - 2018

- WH Branchiness**
 - No branches (small orange circle)
 - Few branches (medium brown circle)
 - Full tree crown (large brown circle)
- WH Touching Shore (green square)
- WH In Water (blue triangle)
- Shoreland Parcels (black outline)
- County Boundary (thin black line)
- Municipality (yellow fill)
- State Boundaries (dashed black line)
- County Boundaries (yellow outline)
- Major Roads**
 - Interstate Highway (thick orange line)
 - State Highway (orange line)
 - US Highway (orange line with 'H')
- County and Local Roads**
 - County HWY (thin orange line)
 - Local Road (grey line)
- Railroads (black line with cross-ticks)
- Tribal Lands (tan fill)
- Rivers and Streams (blue line)
- Intermittent Streams (dashed blue line)
- Open Water (light blue fill)
- Great Lakes (medium blue fill)
