Aquatic Plant Management Plan

Big Round Lake

Polk County, Wisconsin

2019-2023

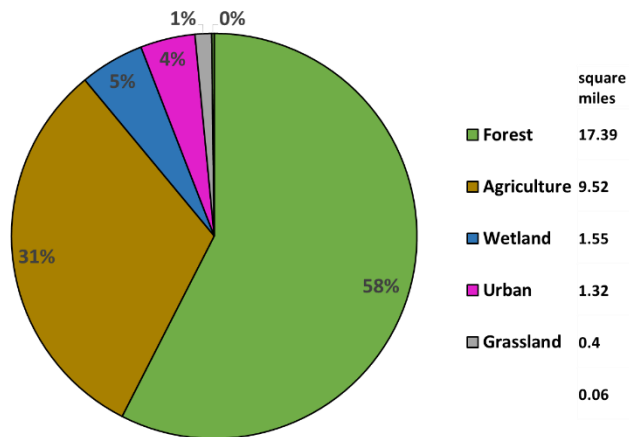
Figure 4 – Straight River Land Use Map & Chart

Big Round Lake is situated within the Straight River sub-watershed (33.5 sq mi), which is within the larger Beaver Brook-Apple River watershed (Figure 1). Forested land covers 58% of the Straight River sub-watershed and is the most common land use with agriculture covering 32% of the sub-watershed (Figure 4). The Straight River originates just upstream of Straight Lake and then flows into and out of Big Round Lake before flowing out of the sub-watershed via Little and Big Blake Lakes (Figure 3).

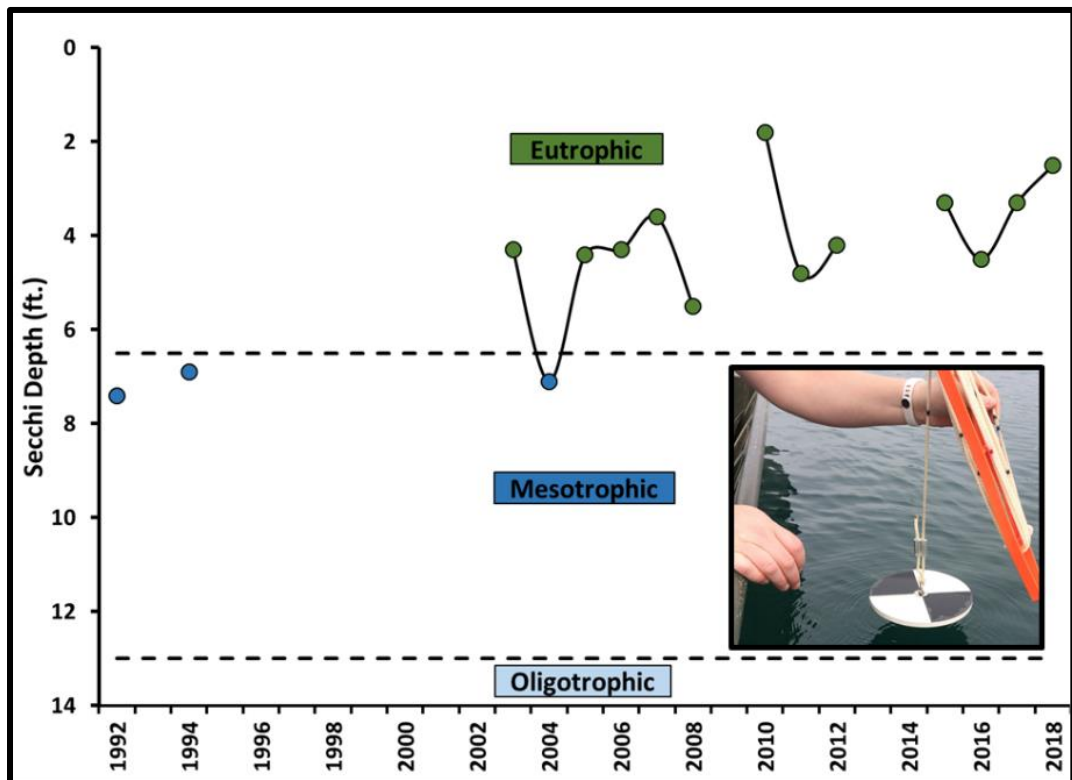
Figure 7 - Average Summer (July-Aug) Secchi Depths, 1992-2018

Water clarity has been monitored in Big Round Lake since 1992 with an intermission in data collection between 1995 and 2002. Average summer Secchi depths ranged from 2 feet to 7.5 feet (Figure 7) with an overall average Secchi TSI of 58. From a water clarity perspective, this classifies Big Round Lake as **EUTROPHIC**.

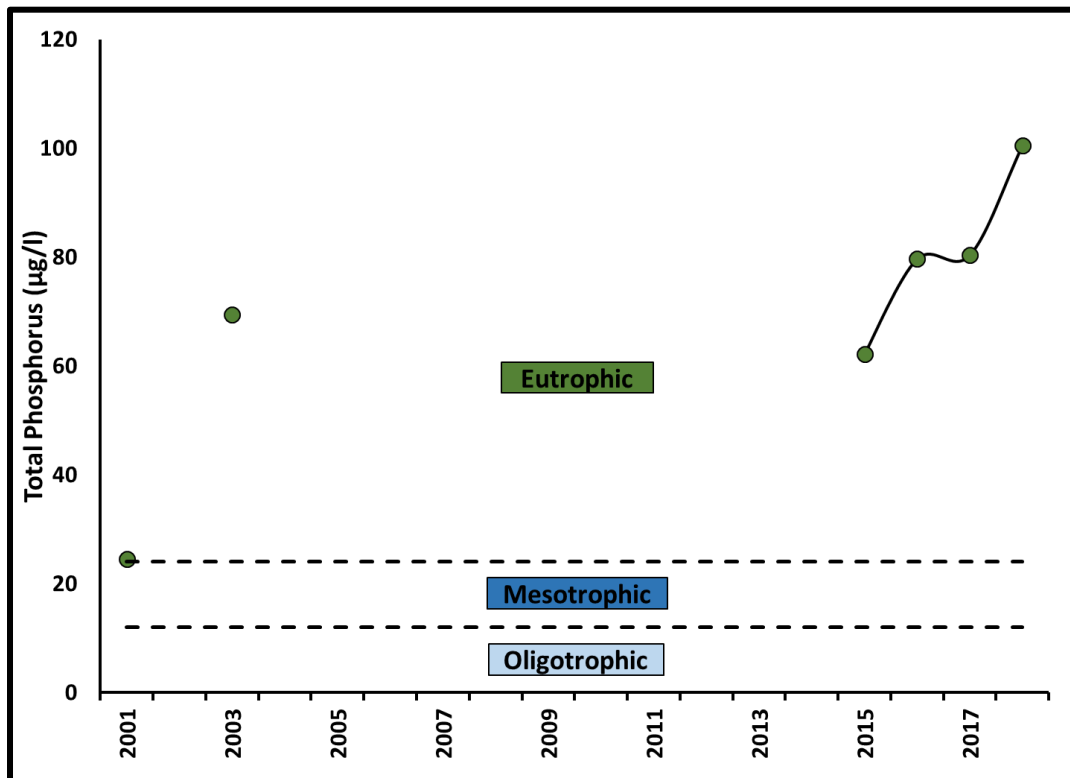
Figure 8 - Average Summer (July-Aug) Total Phosphorus, 2001-2018

Total phosphorus was monitored by volunteers in Big Round Lake in 2001, 2003, and 2015-2018. The mean Trophic State Index (TSI) values ranged from 43 (approx. 25 $\mu\text{g/l}$) to 70 (approx. 100 $\mu\text{g/l}$). Figure 8 illustrates average total phosphorus values in July and August with all the points falling within the **EUTROPHIC** classification and the overall average value of 69 $\mu\text{g/l}$.

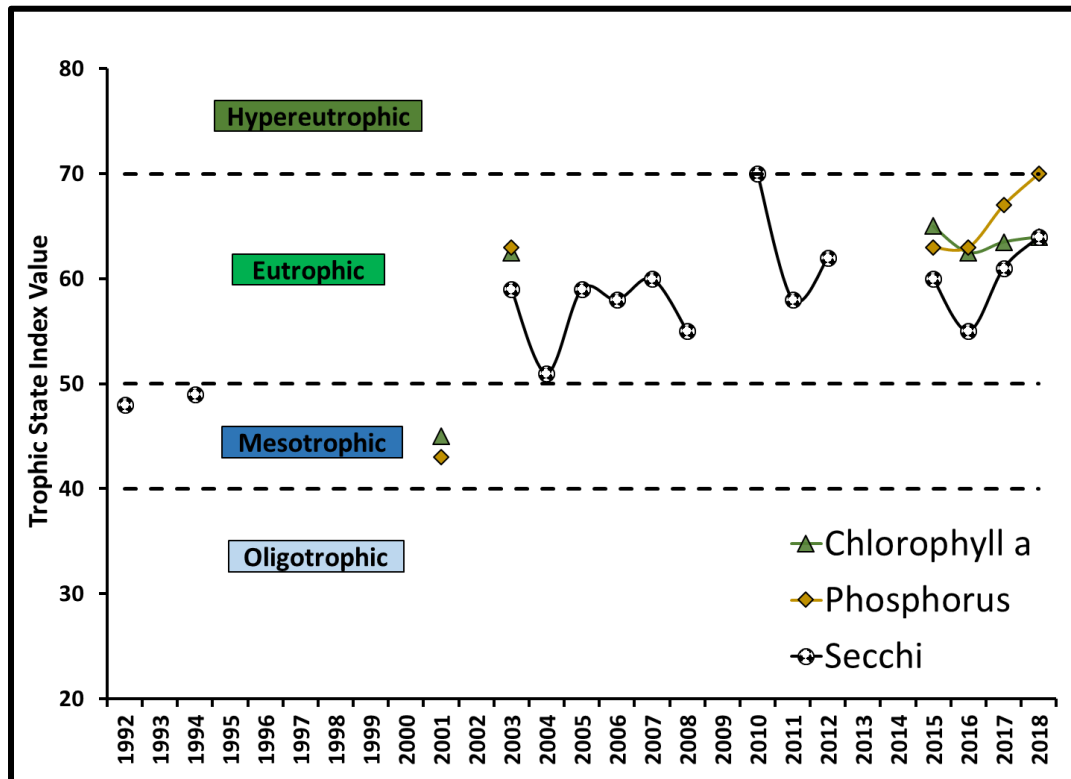
Figure 9 - Average Summer (July-Aug) TSI Values for Secchi Depth, Phosphorus, & Chlorophyll a, 1992-2018

Chlorophyll-a was monitored in Big Round Lake in 2001, 2003, and 2015-2018. Average summer (July-Aug) TSI_{CHL} values ranged from 45 (7.5µg/l) to 65 (54µg/l, eutrophic). The overall mean TSI_{CHL} was 60 (48µg/l), which classifies Big Round Lake as **EUTROPHIC**.

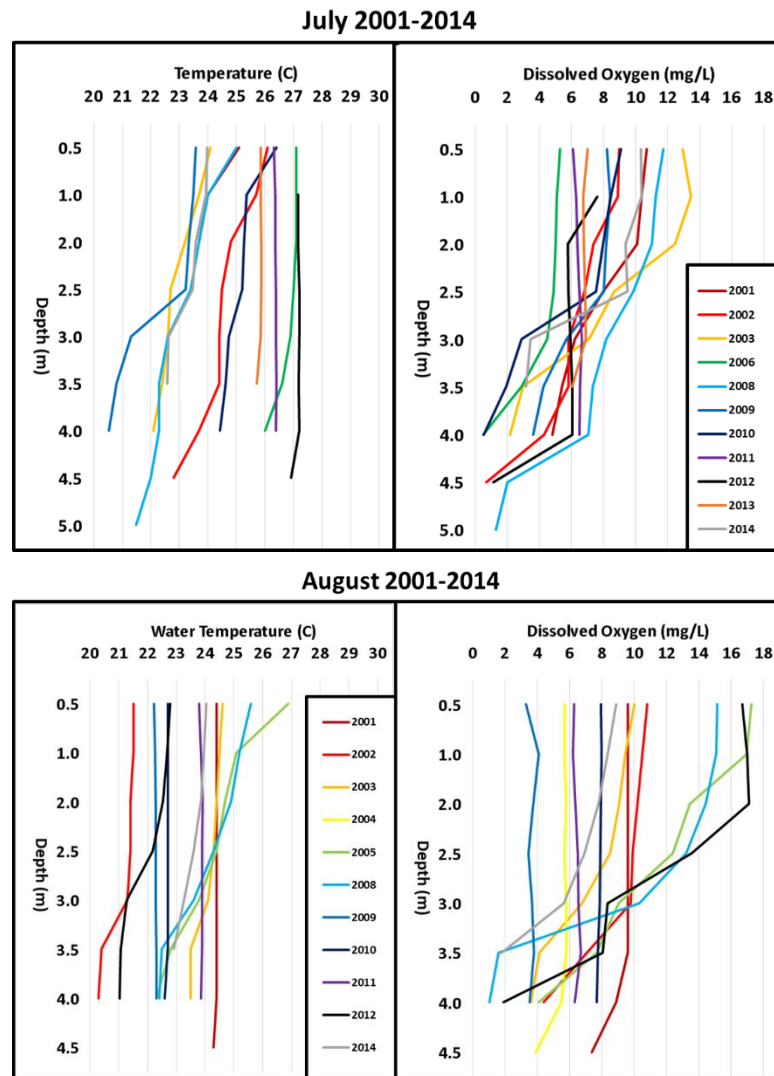
Figure 10 – Temperature & DO Profiles 2001-2014

Big Round is a shallow lake³ that weakly stratifies in summer and dissolved oxygen (DO) depletion can occur in the deepest areas. DO and temperature data collected by St. Croix 2001-2014 support this claim (Figure 10). Because of its shallow depths, Big Round Lake is likely to mix, possibly several times, during the growing season with intense sediment-water interactions. Although this means DO can then mix into the deeper water, it also means nutrients may be mixed as well and available for uptake by algae. Although many studies of Big Round Lake by different entities have provided valuable information, a comprehensive analysis of internal phosphorus loading in one cohesive study is needed to guide future management and is further described in Goal 3, Section 23.0.

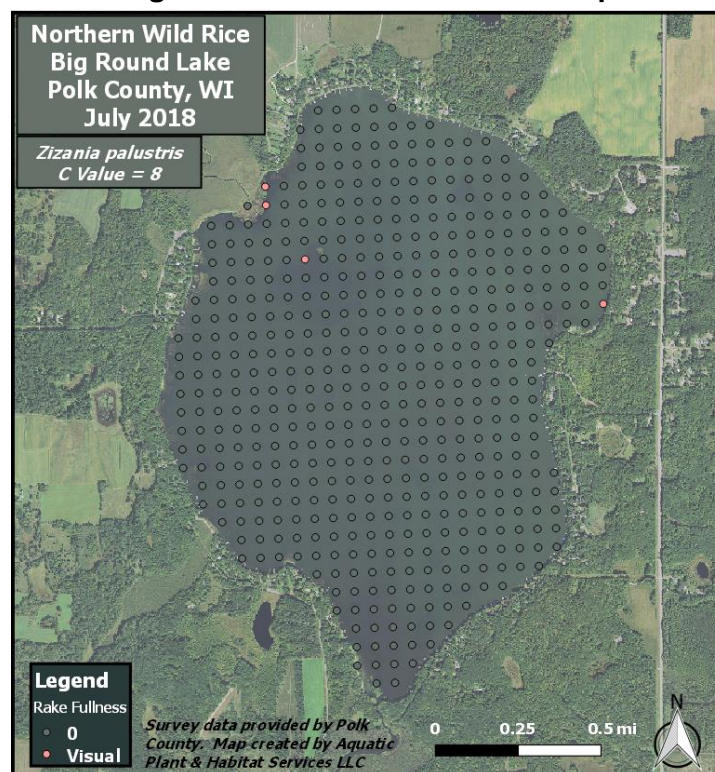
Figure 14 – Northern Wild Rice Map

Northern wild rice (*Zizania palustris*) has been documented during plant surveys of Big Round Lake since 2003, but with low frequency. In 2018 it was found as a visual observation (none on the survey rake but within 6 feet of the sample point) at only 4 locations (Figure 14). Even so, wild rice is an important resource for social, cultural, and ecological reasons lending special statutory protection under NR 19.09(1)⁴. At the time of writing this management plan, the WDNR is undergoing a Wild Rice Management Strategic Analysis and works with Ojibwe Tribes on proposed projects that have potential to impact wild rice in the Ceded Territory.

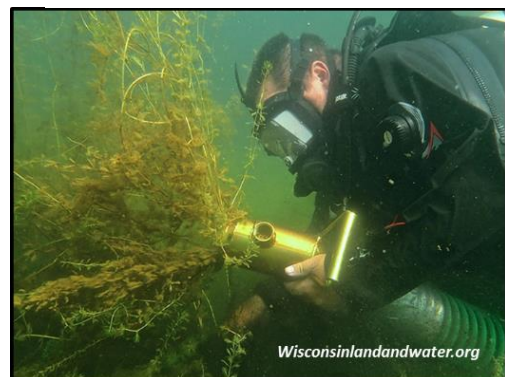
Figure 21 – DASH Photo

This form of mechanical removal involves the use of suction tubes connected to pumps mounted on a barge or pontoon. The suction tubes reach to the bottom of the lake and SCUBA divers manually uproot invasive plants to be sucked through the tubes, up to the barge, and strained. Uprooting aquatic plants causes suspension of sediments. Sites with native plants rooted in the sediment may help keep sediment suspension at a minimum, but complicates the underwater process of selectively

harvesting only non-native species. This method is labor intensive and costly (\$2,300 per day), and mainly appropriate for small areas of Eurasian watermilfoil

(EWM) control (i.e., less than 1/2-acre). **DASH is not recommended as a feasible means of control for CLP at this time** because sediment suspension can increase the internal phosphorus loading. Also, CLP in Big Round Lake is widespread. The control of AIS using DASH is appropriate for small and isolated beds of aquatic plants.

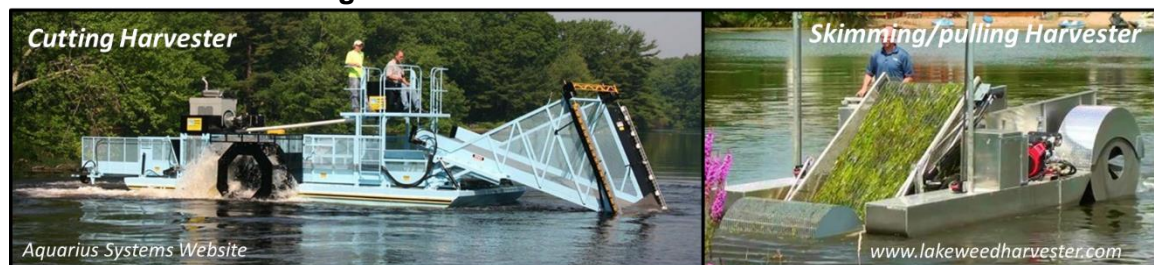
Figure 22 – Mechanical Harvester Photos

This method includes “mowing” of aquatic plants down to depths of 5 feet and then collecting the plants and removing them from the lake. This technique is most appropriate for lake systems with large-scale or whole-lake aquatic plant issues. Mechanical harvesters provide immediate results and usually cause minimal impact to lake ecology while removing some nutrients from the lake via plant biomass reduction. Harvesting lanes in dense plants beds can improve growth and survival of some fish species. Also, if harvesting is done early enough in the season, impacts to native plants should be minimal (Barton et. al. 2013). However, care should be taken when harvesting early in the season to minimize impacts to spawning fish⁹. A disposal site for harvested plants is a necessary part of a harvesting plan. Hiring mechanical harvesters to visit the lake costs \$2,200 per acre (\$2,000/acre for more than 3 days). The purchase of a brand new harvester is highly variable and depends on the type of harvester purchased. Cutting harvesters begin at \$100,000. A harvester that can skim and pull the plants from their roots is \$76,000. The use of skimming harvesters to pull aquatic plants from the roots is not currently recommended by the WDNR due to causality of sediment suspension that can fuel algae. Furthermore, the cutting of aquatic plants 5 feet below the lake surface leaves vegetation to serve as structural habitat while pulling aquatic plants by the roots removes structural habitat and exposes sediment for possible AIS introduction/expansion. Chetek Lake Protection Association in Barron County uses a skimmer to remove floating duckweed, filamentous algae, and some limited CLP harvesting work¹⁰. With a cutting harvester, a shore conveyor (starting at \$35,000) is needed to offload the plants into a truck or dumpster for transport to a disposal site. A Recreational Boating Facilities Grant may help pay for up to 50% of eligible costs associated with purchasing harvesting equipment. Annual costs include paying an operator, storage of the harvester, insurance, and maintenance. As an example, nearby Blake Lake’s 2018 harvesting budget was \$27,700¹¹. **Mechanical harvest is a viable option for Big Round Lake plant management and is further discussed in Section 25.0.**

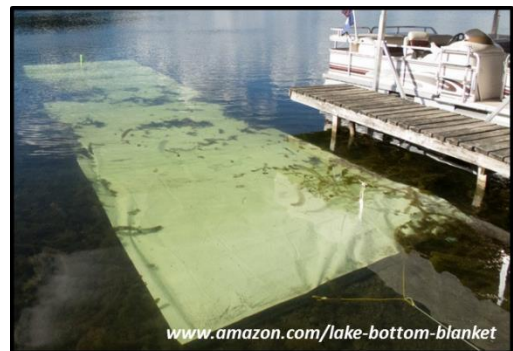
Figure 23 – Bottom Barrier Photo

Bottom barriers prevent light from reaching aquatic plants but allow for gas accumulation under the barrier and subsequent dislodging. They can also impact fish spawning and food sources, and an anaerobic environment below the barrier could cause nutrient release from the sediment. **Bottom barriers were not recommended during the public planning meetings in April-May, 2019.** However, if individual property owners are interested in this approach, they should contact the DNR directly for a miscellaneous structure permit under Chapter 30.¹³

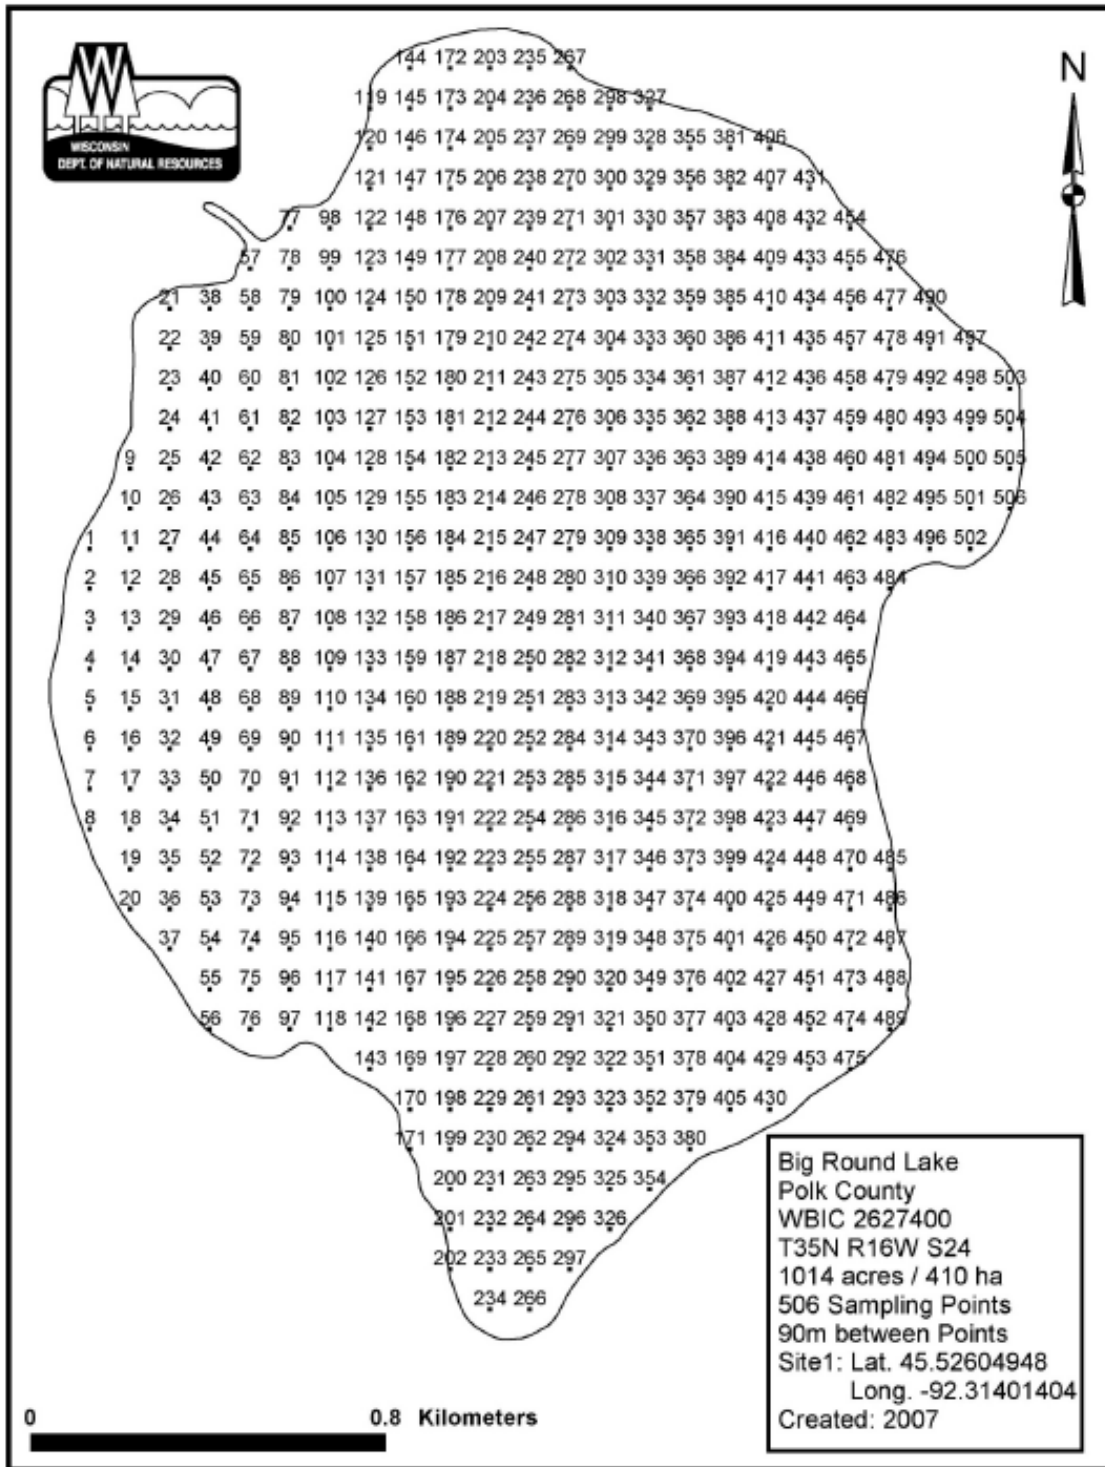
27.0 Appendix A – Aquatic Plant Survey Map

This section will focus on the results of the 2018 survey and how they compare to previous surveys. There were a possible 506 survey points in Big Round Lake based on the point-intercept survey grid (Appendix A). There were 484 points shallower than the maximum rooting depth of 15.5 feet. Vegetation was present at 288 points with an average rake fullness of 1.56. There were 26 species found, three of which were visual observations only. The Simpson Diversity Index was also relatively high with a value of 0.85 out of a maximum possible value of 1.00, suggesting the plant community is moderately heterogeneous. The mean coefficient of conservatism and floristic quality were 5.8 and 23.3, respectively, and both were higher than the average value for other lakes in the same ecoregion (Nichols, 1999). Overall, the statistics suggest that the Big Round Lake aquatic plant community is diverse, moderately heterogeneous, and vegetation occurrence is high.
