**Curly-leaf pondweed (*Potamogeton crispus*)  
Point-intercept and Bed Mapping Surveys, and  
Warm-water Macrophyte Point-intercept Survey  
Echo Lake - WBIC: 2630200  
Barron County, Wisconsin**

Endangered Resource Services, LLC  
Matthew S. Berg, Research Biologist  
St. Croix Falls, Wisconsin  
June 23, and July 24, 27, 2017

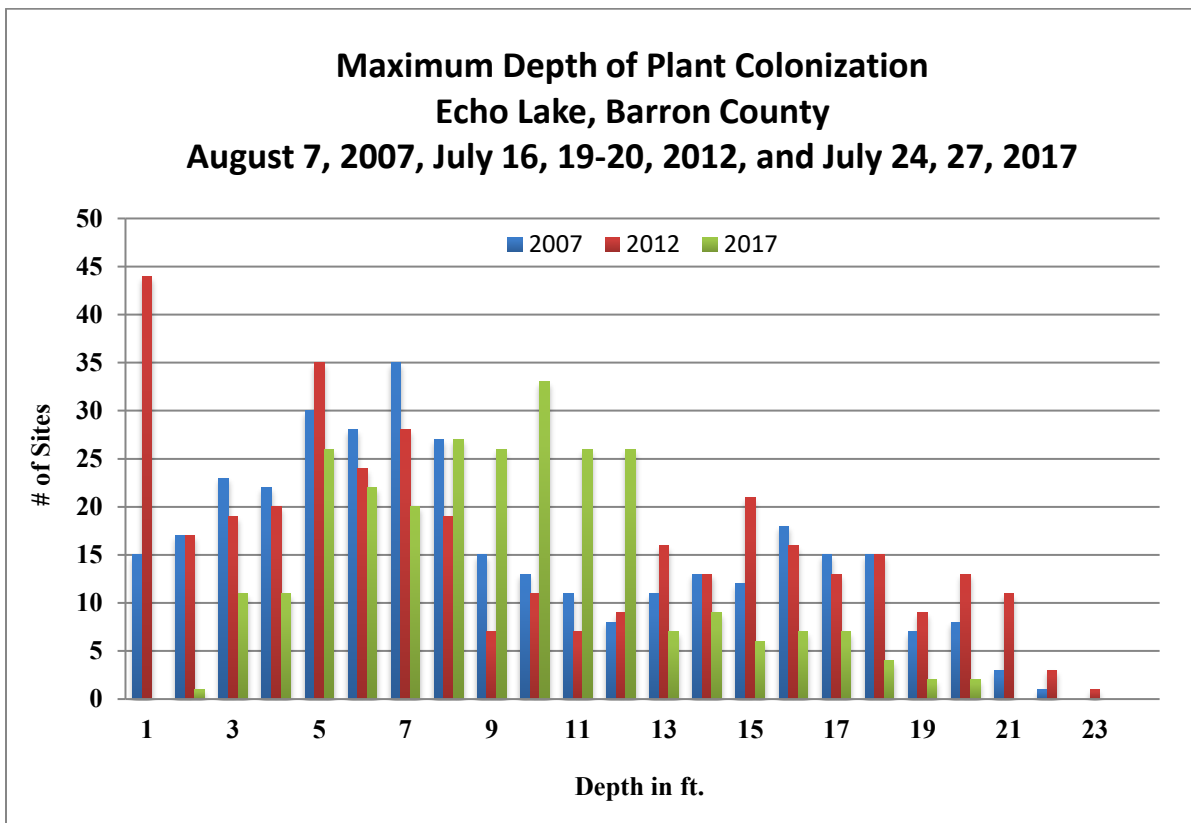
**Figure 9: 2007, 2012, and 2017 Plant Colonization Depth Chart**

In 2017, we found plants growing to 19.5ft (down from 22.5ft in 2012 and 21.5 in 2007) (Table 2) (Figure 8). The 273 points with vegetation (approximately 45.6% of the entire lake bottom and 84.8% of the littoral zone) represented a highly significant decline ( $p < 0.001$ ) from the 2012 survey when we found plants growing at 371 points (63.9% of the bottom and 87.7% of the littoral zone) (Appendix V).

Growth in 2017 was slightly skewed to deep water as the mean depth of 9.2ft was higher than the median of 9.0ft. The mean were similar to the 2012 survey (9.1ft), but the median was much higher (7.0ft in 2012) suggesting a shift in growth patterns. Looking at the depths of plant coverage for the three surveys (Figure 9) showed that the 2007 and 2012 surveys exhibited a bimodal (twin peak) distribution. This unusual growth depth chart (most lakes show decreasing coverage with depth in a more or less normal distribution with skew to deep water) captured both the tendency to drop off rapidly from the shallower shoreline areas and flats as well as the nearly universal coverage of Charophytes (valuable habitat producing colonial algae that look like higher plants) from 11ft to the edge of the littoral zone. In 2017, the entire graph demonstrated a shift of approximately 2-3ft to the right that mirrored the lake's rise in water. The formerly diverse and nearly universal shoreline community in water <2ft was absent in 2017 - apparently not having the ability to keep up with rapidly rising water levels. In the 9-12ft range where most vascular macrophytes disappeared in the past, we found many pondweeds "hanging on" although they were visibly stressed with dead or dying leaves. Areas deeper than 12ft were often devoid of any vegetation other than a few Charophyte strands. This was a dramatic difference from 2012 when we often found beds of *Nitella* (*Nitella* sp.) that were several feet thick in a mat covering the bottom.

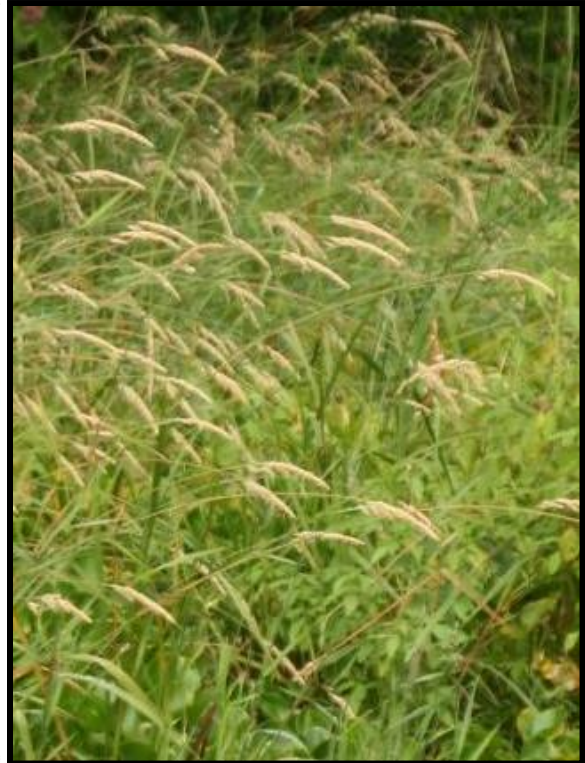
**Figure 20: 2017 Reed Canary Grass Density and Distribution**

In addition to Eurasian water-milfoil, we found one other exotic species on the lake: Reed canary grass was present in the rake at three survey points, and we recorded it as a visual at three additional sites (Figure 20). A dominant plant just beyond the lakeshore, we noticed patches in wetlands adjacent to the lake and next to mowed and otherwise disturbed shorelines. A ubiquitous plant in the state, there's likely little that can be done about it.
