# **Aquatic Plant Management Plan**

## **Tarrant Lake**

**Columbia County, Wisconsin**  
December 2012

Sponsored By  
Columbia County Land and Water Conservation

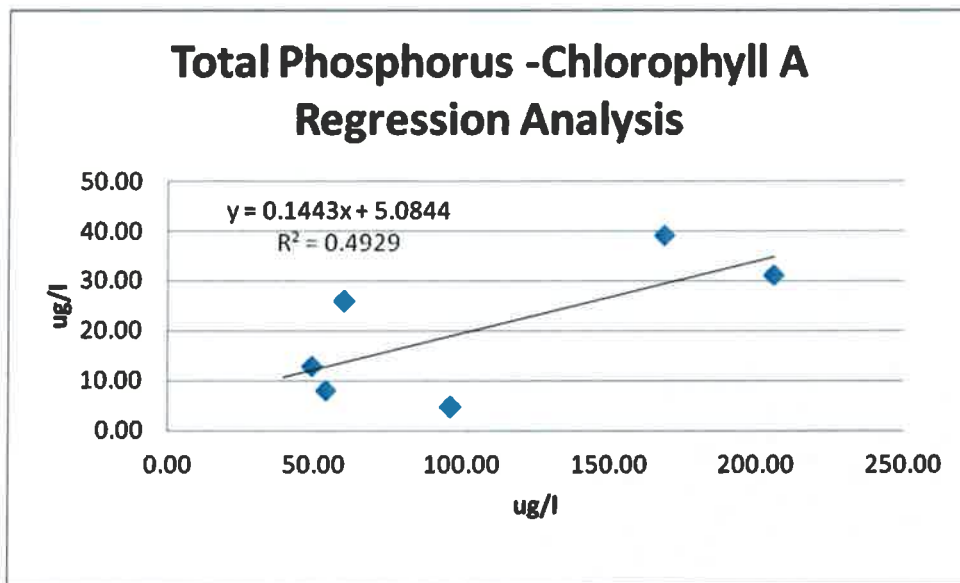
Figure 10. Total Phosphorus, Chlorophyll A

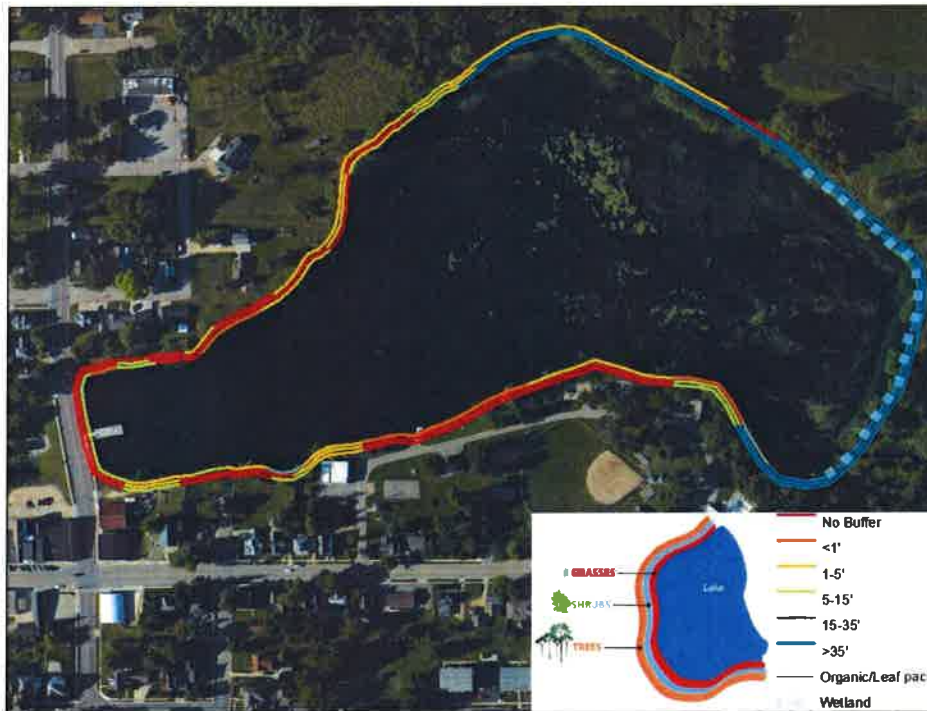
Figure 13. Shoreland Health Study Summary

AS can be seen in Figure 13 much of the developed shoreline on Tarrant Lake is lacking a tree and shrub layer and has blue grass sod with 1-5' of the lake.
