Herbicide Treatment Analysis for *Potamogeton crispus* (Curly-leaf pondweed)

Deer Lake, Polk County Wisconsin

2019

*Survey and analysis conducted by: Ecological Integrity Service, LLC
Amery, WI*

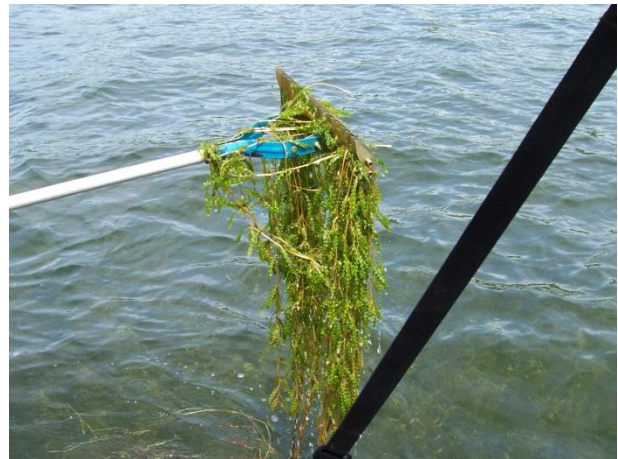
Figure 3: Density rating system and example CLP rake sample.

The second survey is referred to as the post treatment survey. This survey involves going to the same GPS coordinates as the pre-treatment survey and doing a rake sample at the point. If any CLP is on the rake, the density of the CLP is recorded (see Figure 3 for reference). All other species are also recorded from the rake sample in order to verify no damage to the native plants.

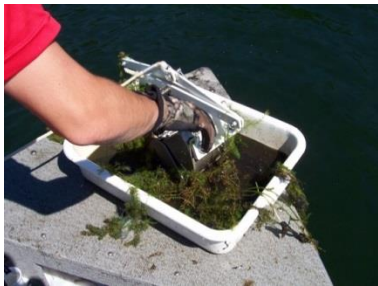
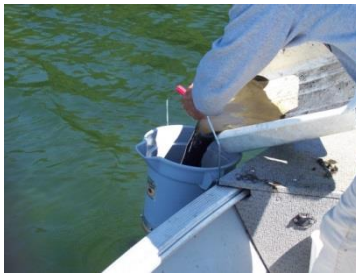
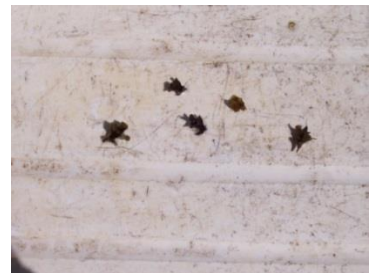
Figure 4: a shows sediment sample; b shows separation; c Shows separated turions.

In order to further reflect potential future growth and the cumulative success of treatments, a turion analysis is conducted. This analysis involves going to sample points near the middle of the CLP bed (assuming this will reflect the highest density). At each sample point a sediment sampler is lowered to the lake sediment and a sediment sample is obtained. Two samples are obtained from each side of the boat at each location. The samples are then separated with a screened bucket to isolate the turions. The turions are then counted and the density of turions is calculated in turions/square meter. Consistently successful treatments should show a trend of reduced turion density each year. This way we know the treatments are killing plants prior to turion production, resulting in overall reduction in CLP in those beds.

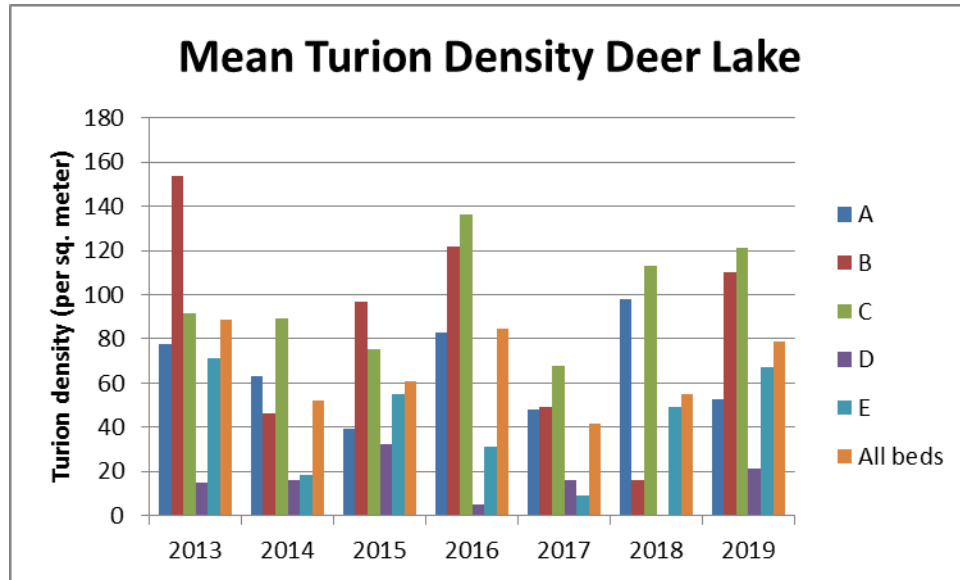
Figure 10: Graph of mean turion density in each bed and all beds 2013-2019.

The 2019 turion analysis resulted in a turion density increase in each bed except Bed A, of which there was a decrease. There was an increase mean turion density in all combined beds in 2019, compared to 2018. This increase is likely due to some CLP growth that occurred after herbicide treatment in 2019. An increase in turion density is not desirable and indicates that there could likely be an increase in CLP growth in 2020. Figure 12 shows the mean turion changes from year to year.

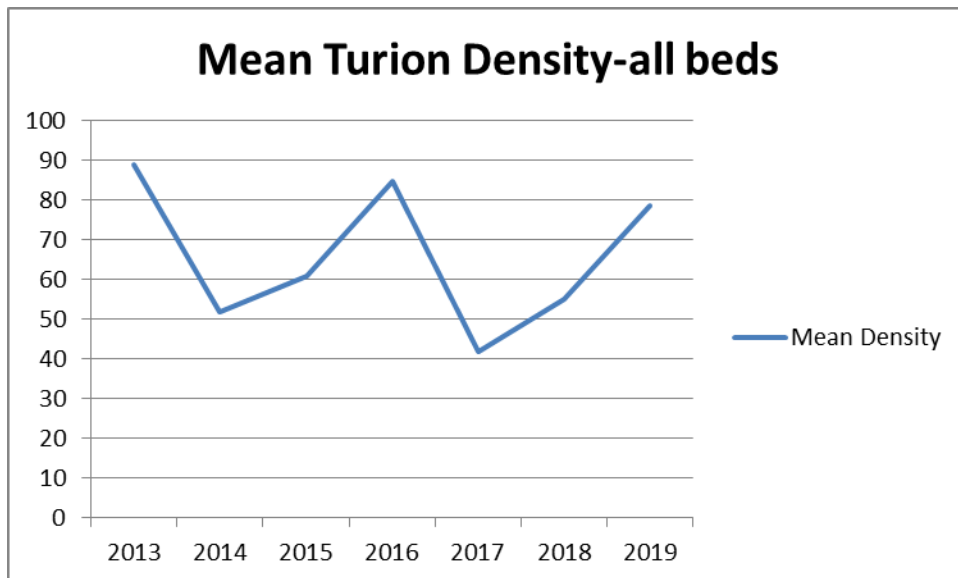
Figure 12: Mean turion density for all beds combined 2013-2019.
